February 15, 2013
File No. PM6843-01

Subject: Geotechnical Assessment
231 Cobourg Street, Ottawa, Ontario

Further to your request and authorization, Paterson Group have conducted a geotechnical assessment at the existing building located at 231 Cobourg Street in Ottawa, Ontario.

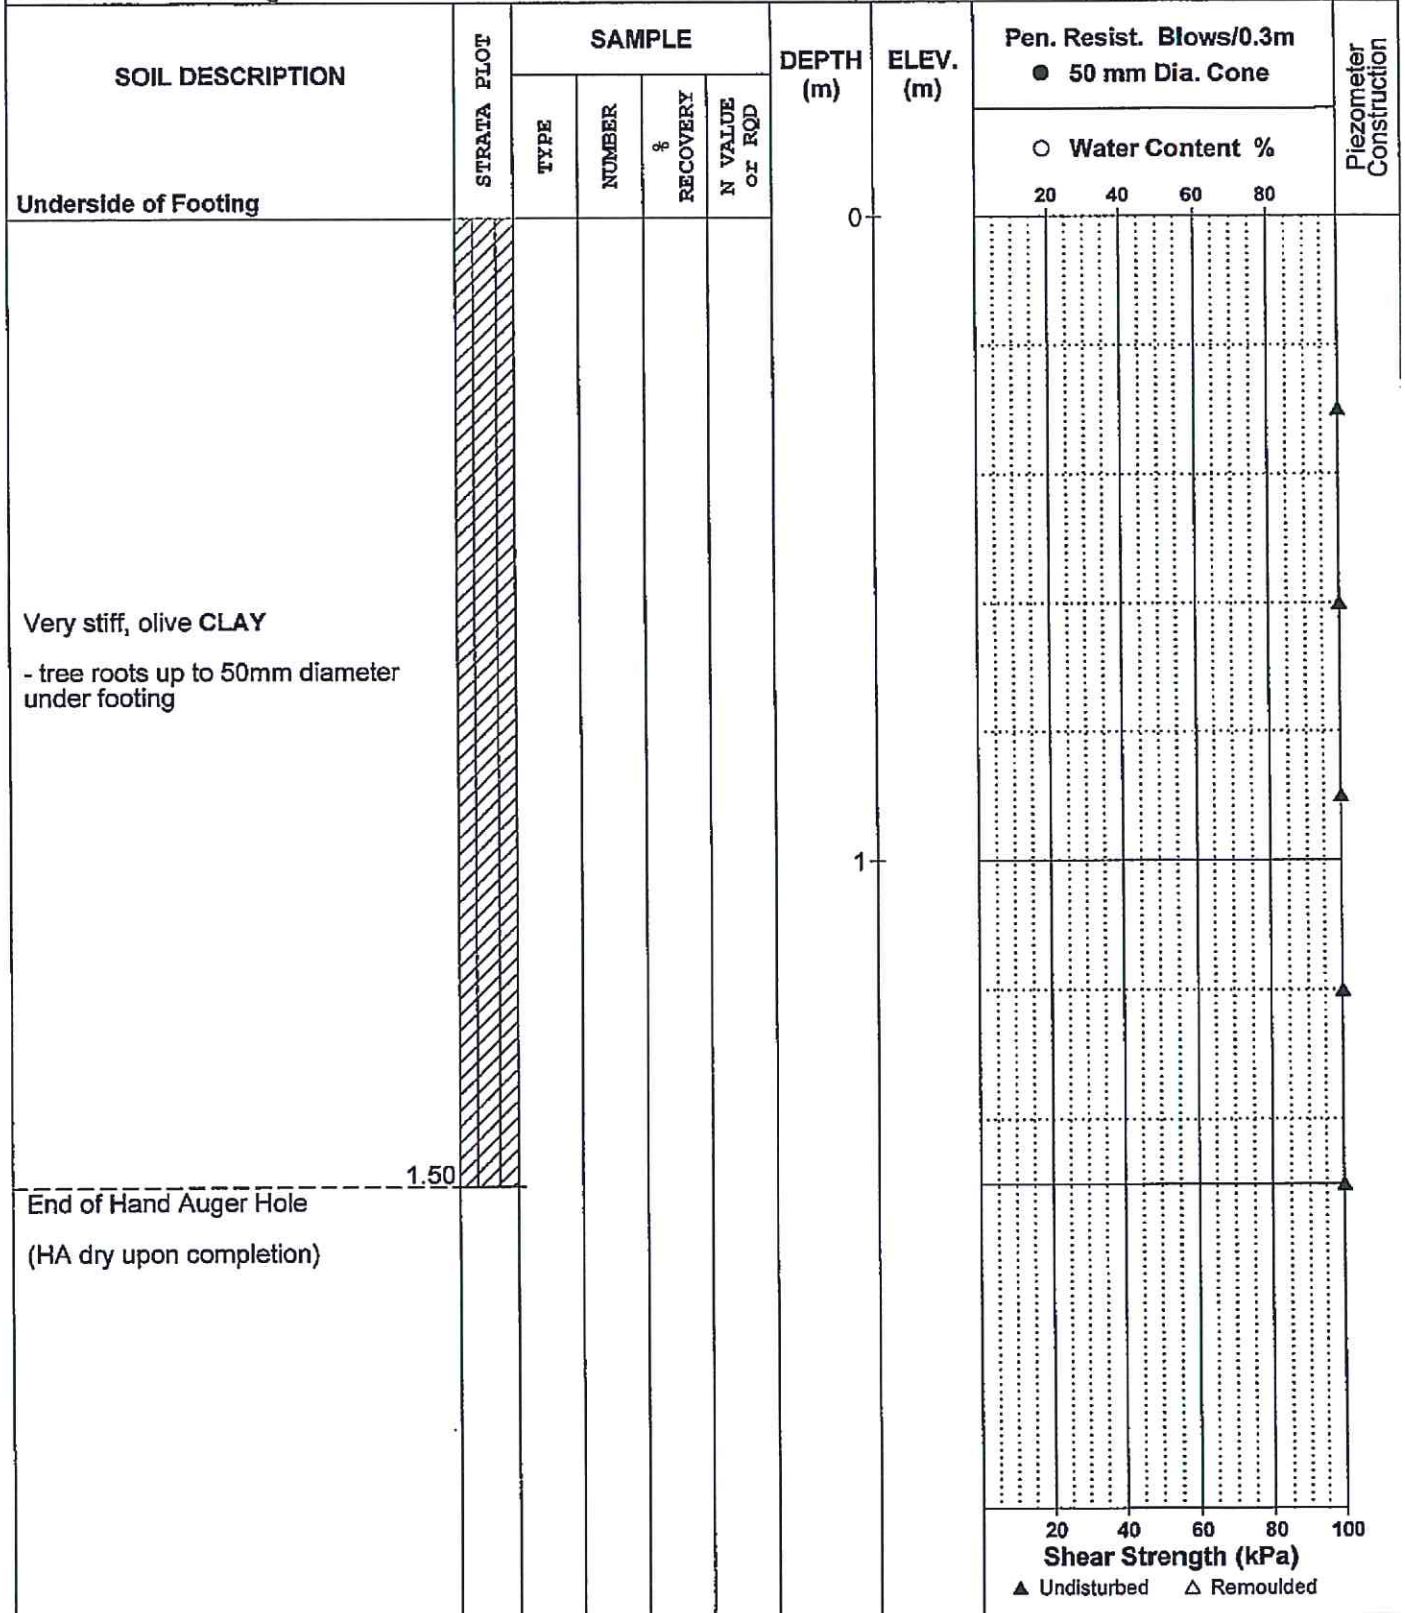
HOLE NO. **HA 1**

In order to determine the nature of the foundation soils, a series of five test holes were made through the basement floor slab, on February 12, 2013. The initial test hole is located at the northeast corner. The footing is rough formed and projects 180 mm past the interior face of the east foundation wall. The top of footing is just below the floor slab, and the footing is 300 mm thick. Finishing elements obscured the contact between the foundation wall and footing. The footing was found to be in contact with very stiff clay. Tree roots up to 50 mm in diameter were found in the soil below the footing. A hand auger hole put down adjacent to the footing terminated in very stiff clay at a depth of 1.5 m below the underside of footing. Our observations in this hand auger hole are shown on the enclosed Soil Profile and Test Data sheet for HA 1.

REMARKS In test pit, through basement floor, at northeast corner.

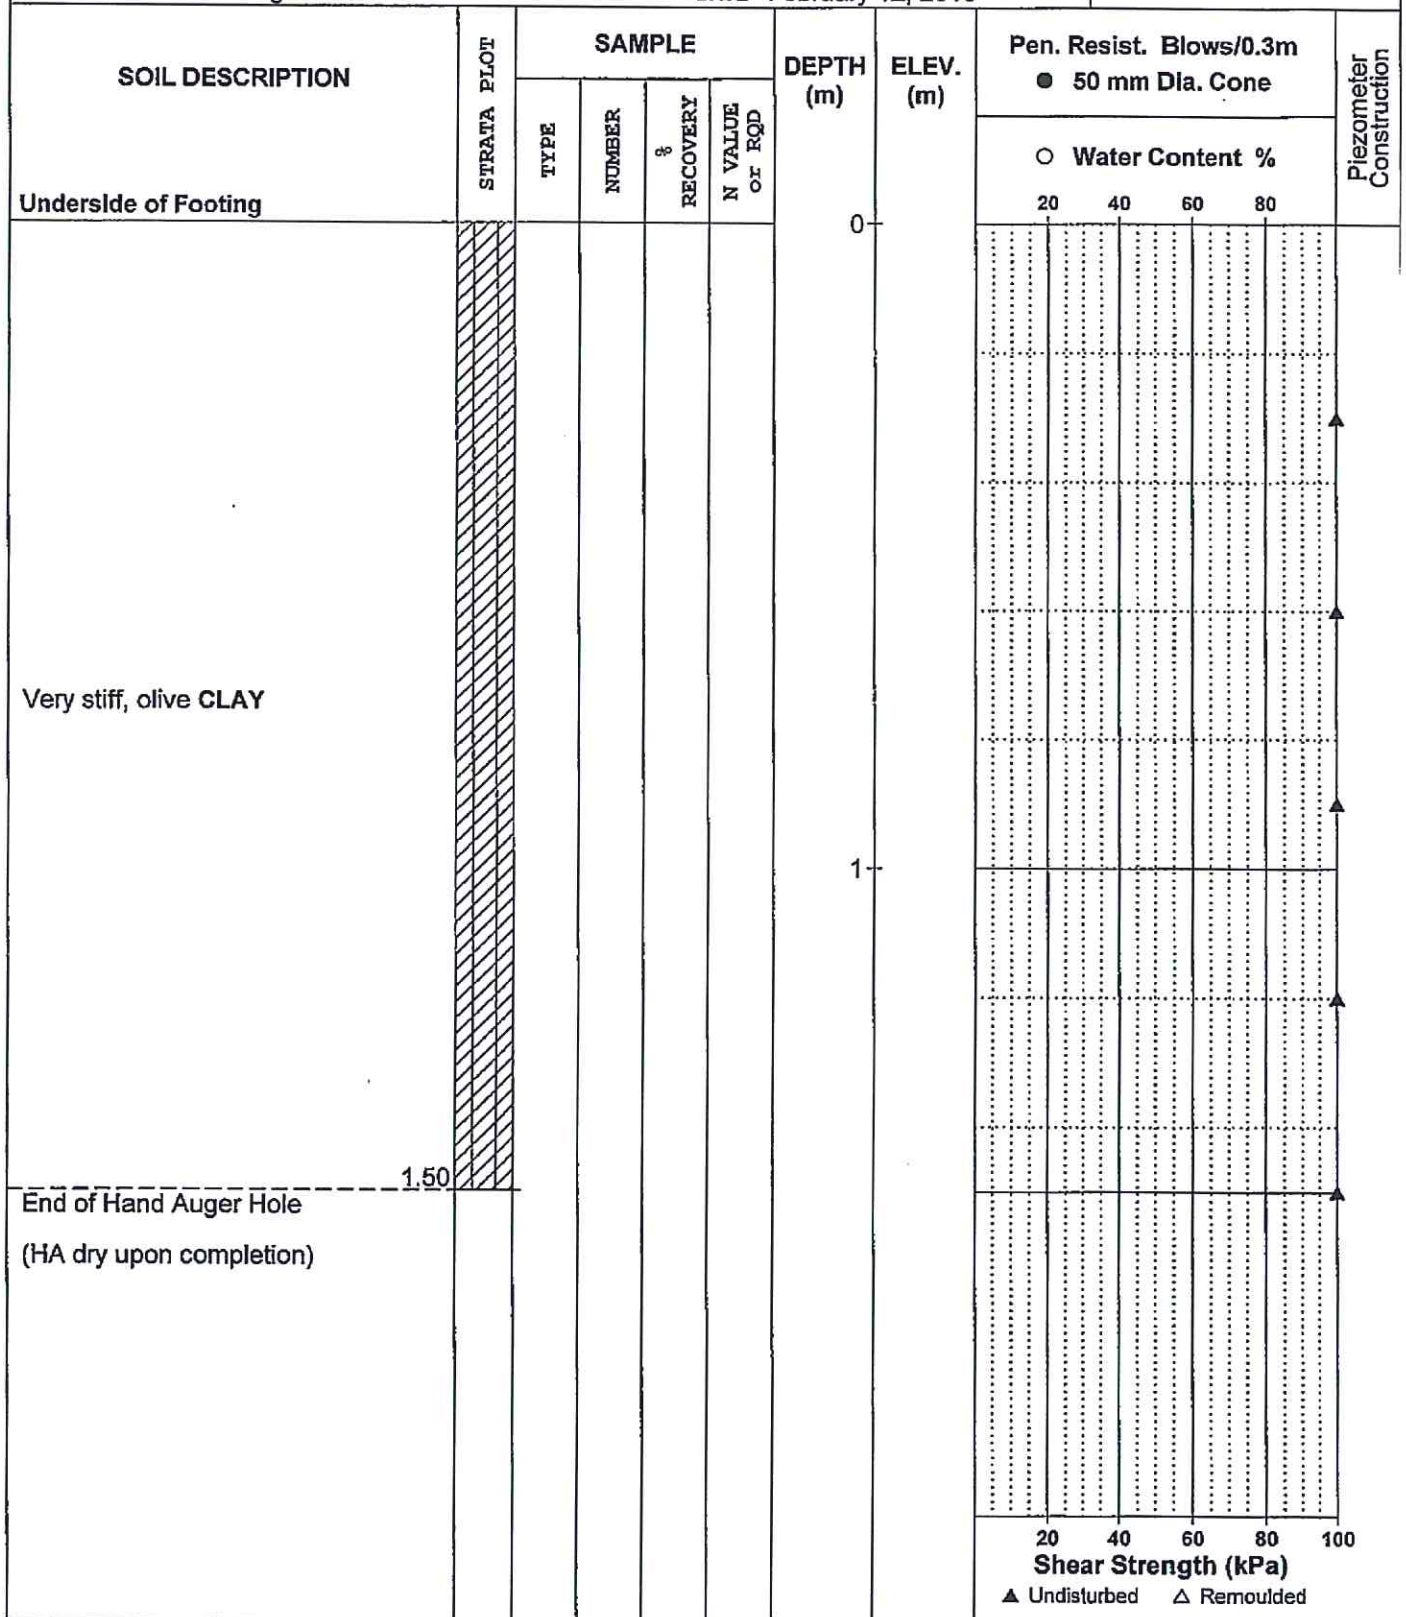
HOLE NO. **HA 2**

The third test hole is located at the northwest corner of the basement. At this location, the footing projects 180 mm past the interior face of the west foundation wall and 300 mm past the interior face of the north foundation wall. The foundation walls were observed to be in contact with the footings. The formed concrete footing was found to be 380 mm thick, and in contact with very stiff clay. A hand auger hole put down adjacent to the footing terminated in very stiff clay, at a depth of 1.5 m below underside of footing. Our observations in the hand auger hole at this location are shown on the enclosed Soil Profile and Test Data sheet for HA 2.

REMARKS In test pit, through basement floor, at northwest corner.

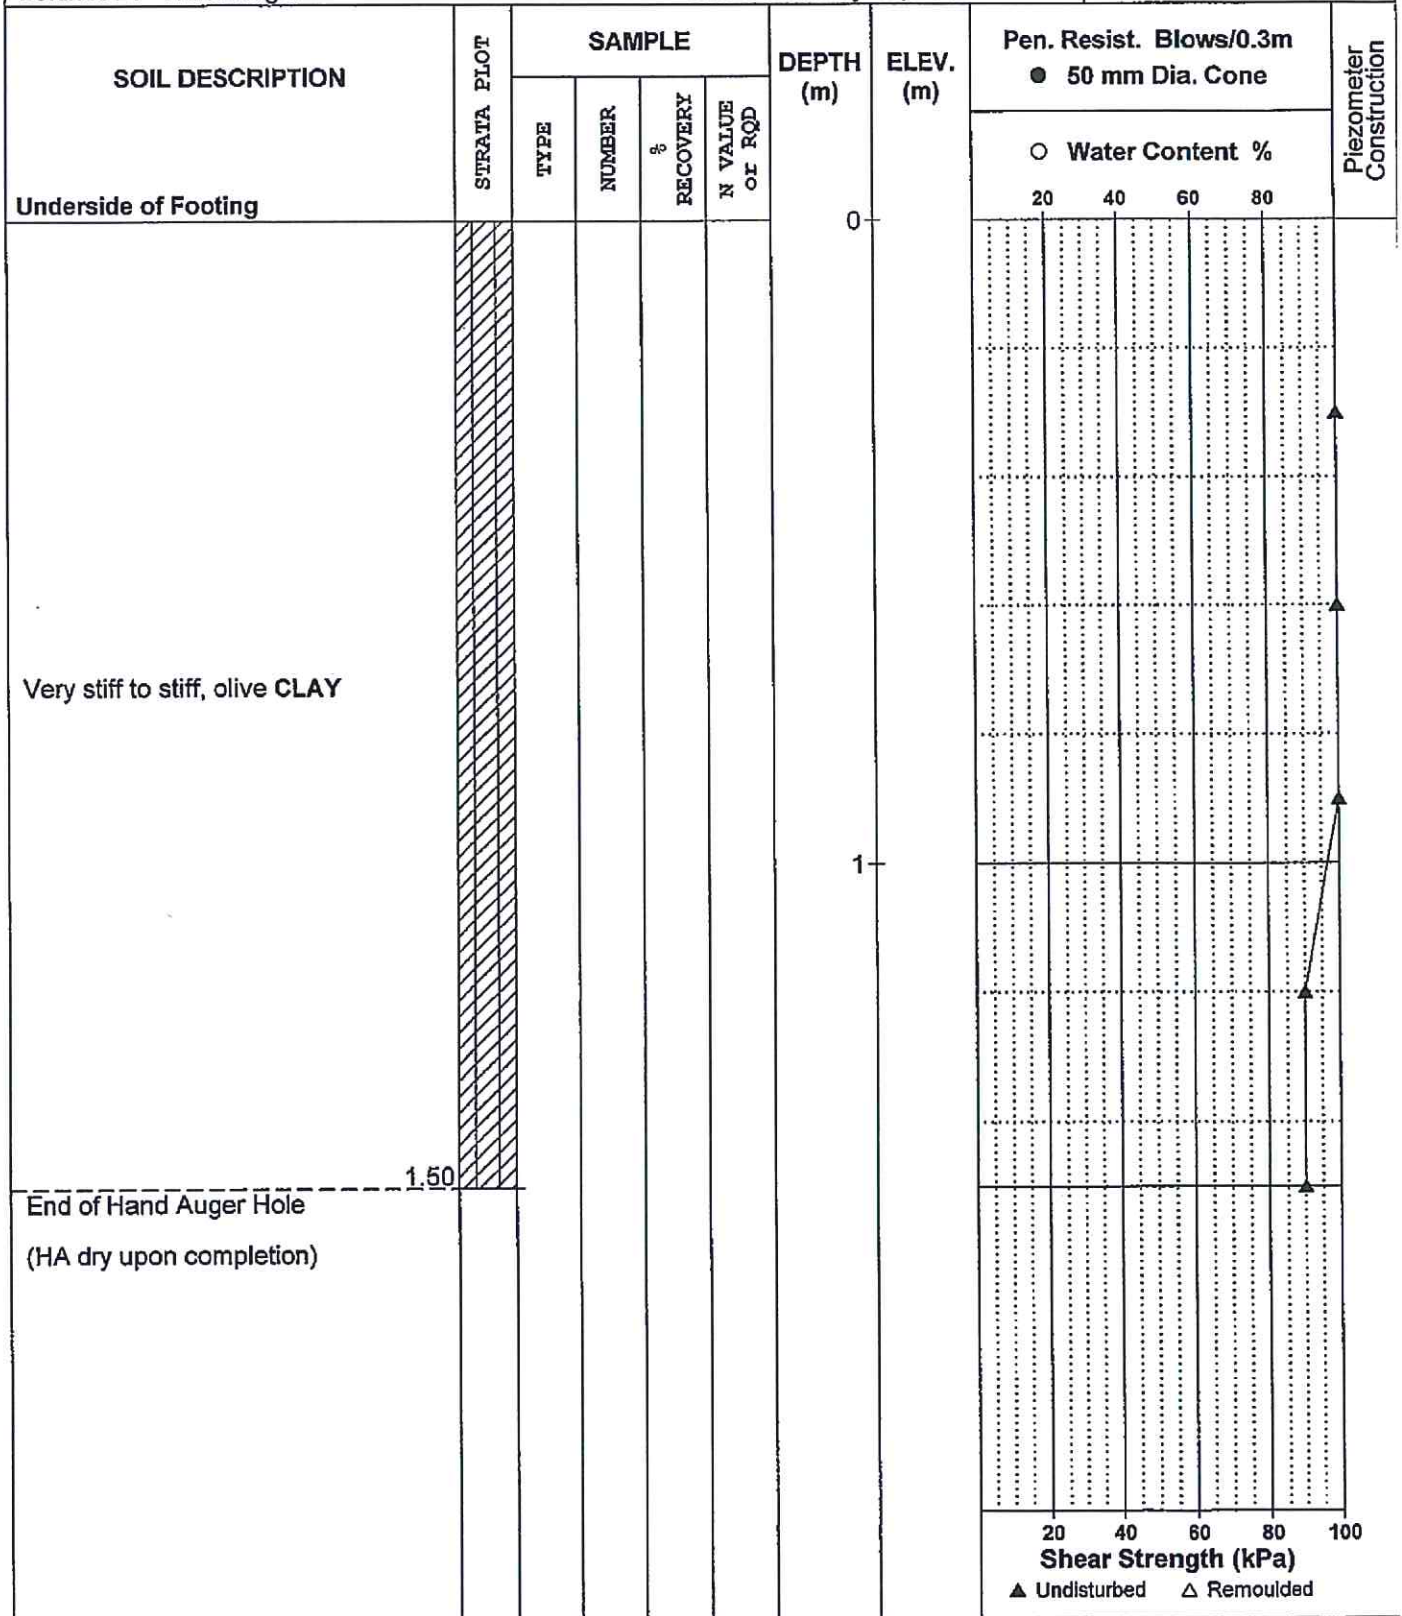
HOLE NO. **HA 3**

The fifth test hole is located adjacent to the east foundation wall, in the southeast room of the basement. The footing was found to project 165 mm past the interior face of the east foundation wall and is 355 mm thick. The foundation wall was found to be in contact with the footing and the footing was found to be in contact with very stiff clay. A hand auger hole put down adjacent to the footing terminated in stiff clay, at a depth of 1.5 m below the underside of footing. Water was not found in the hand auger holes. Our observations in this hand auger hole are shown on the enclosed Soil Profile and Test Data sheet for HA 3.

REMARKS In test pit, adjacent to east wall footing, in southeast room of basement.
