## Building Condition Assessment

Commercial Property  
231 Cobourg Street  
Ottawa, Ontario

March 11, 2013

PB1244-BCA.01

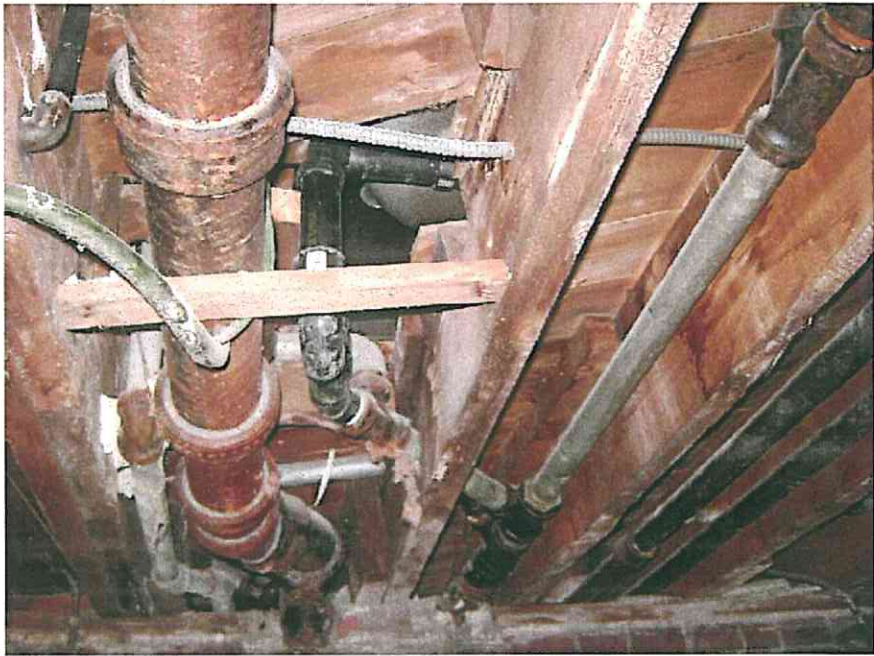
Photograph No. 3

Date: 1/17/2013	
Description Typical plumbing in the ceiling space on the basement. Note the not insulated heating piping on the right

<b>Item:</b>	<b>Replacement Cost/Unit</b>	<b>Replacement Period</b>
Domestic Water Piping Insulation	\$3,750.00	Immediately
Sanitary & Storm Piping Replacement	\$12,250.00	3 Years

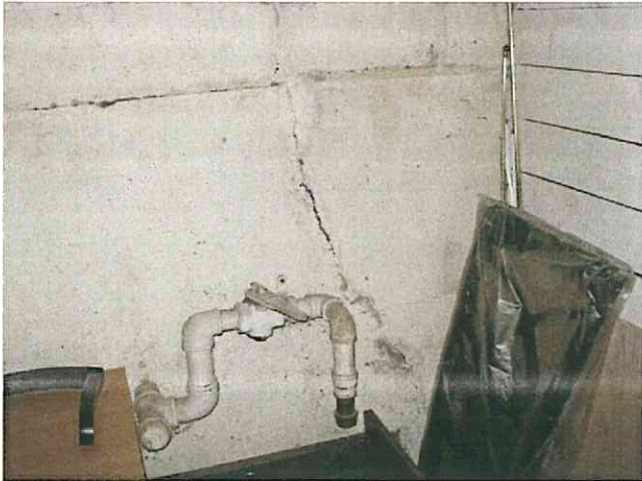
Overall, numerous cracks were observed in the foundation walls, in the interior load bearing walls, in the concrete floor slab-on-grade and in many interior partition walls and ceilings. The concrete floor slab-on-grade is in unsatisfactory condition, and in particular, the slab at the north end of the building is severely cracked and has sunken significantly. Wood framed floors at the rear of the building are sloped up to 1-1/2" over a 4' span, and a "hump" exists in the ground floor at the rear of the building due to an interior partition wall in the basement heaving the floor above. Additionally, several interior doors are not plumb within the door frames. As reported in our Geotechnical Assessment report, dated February 15, 2013, all of the above irregularities are related to building settlement.

Photo 1 - Showing an example of a crack in the foundation wall.

The above noted irregularities should be repaired now, by means of excavating the surrounding soil and installing a waterproofing membrane to repair all cracked foundation walls from the exterior, reconstructing the severely cracked and sunken slab-on-grade areas and sealing all other cracks within the slab-on-grade, repointing the cracked mortar joints in the concrete block masonry walls, re-levelling the sloped wood framed floors by constructing a new plywood floor on shims over the existing floors and/or by using self-levelling concrete topping (provided that existing framing is strong enough to support the weight of the new concrete), repairing / replacing the cracked drywall and ceiling finishes and resetting all offset interior doors to a plumb position.

The concrete block and cast-in-place concrete foundation walls are experiencing widespread cracking. According to information provided, portions of the foundation wall were replaced near the northwest corner about 10 years ago. The foundation wall cracks should be repaired this year.

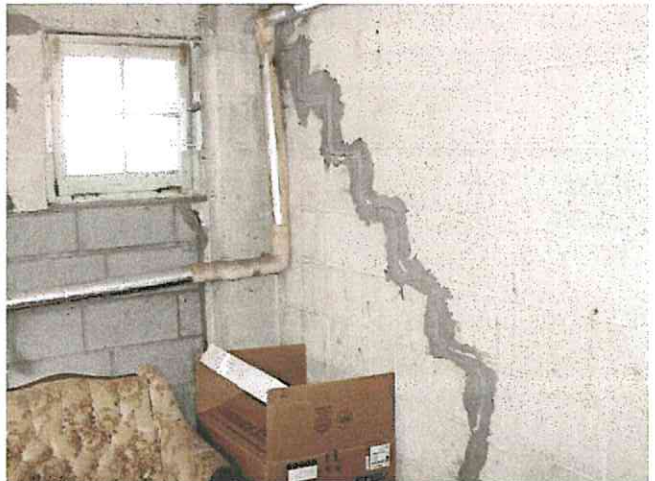
Photo 2 - Showing an example of a crack in a load bearing wall.

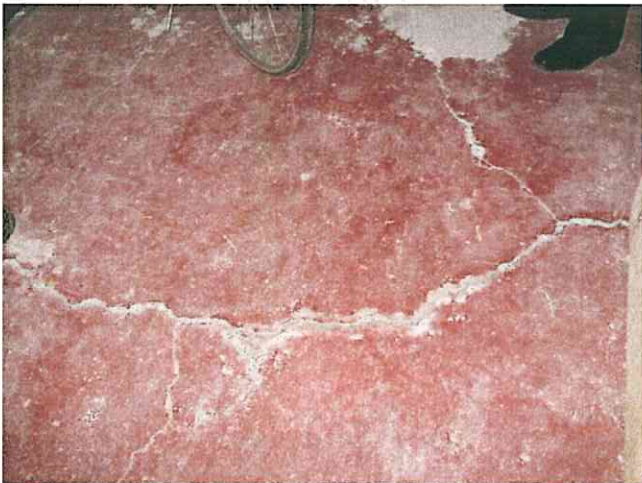
Photo 3 - Showing an example of a crack in the slab-on-grade.

Note that the concrete slab-on-grade repairs include only partial reconstruction of the slab since complete reconstruction is not warranted at this time. However, if complete reconstruction of the slab is desired then we estimate approximately \$60,000 would be required for this work.

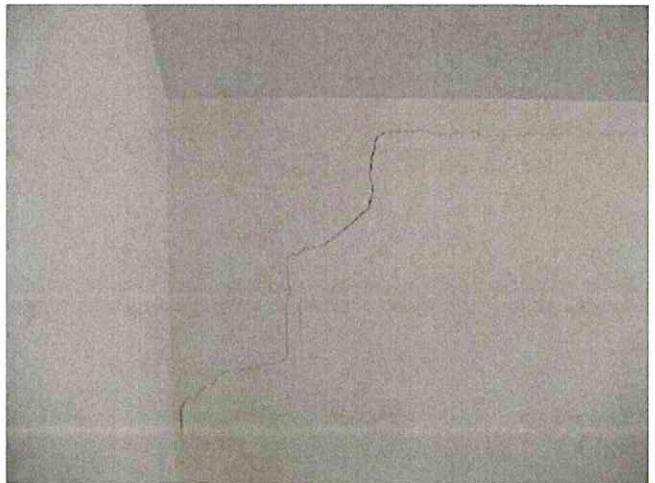
Photo 4 - Showing an example of a crack in the interior drywall.

Many of the interior finishes were cracked throughout the building and these finishes should be repaired, as required. Furthermore, the sloped floors should be re-levelled and covered with new carpeting and/or tile flooring. Additionally, it was noted that little to no insulation exists within the exterior walls of the building. An exception is a portion of the exterior wall along the east elevation which appears to have been upgraded with insulation. As such, we recommend that insulation be added to the exterior walls during drywall repairs / replacement, in order to reduce heat loss and improve occupant comfort.

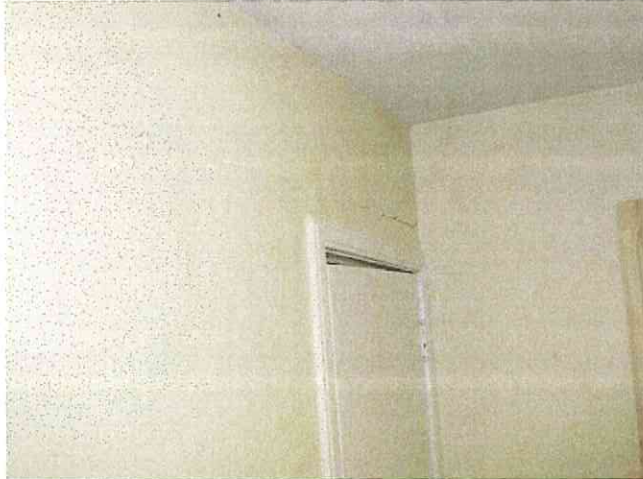
**Photo 5** - Showing an example of an off-level door within the door frame, and also showing an interior drywall crack.

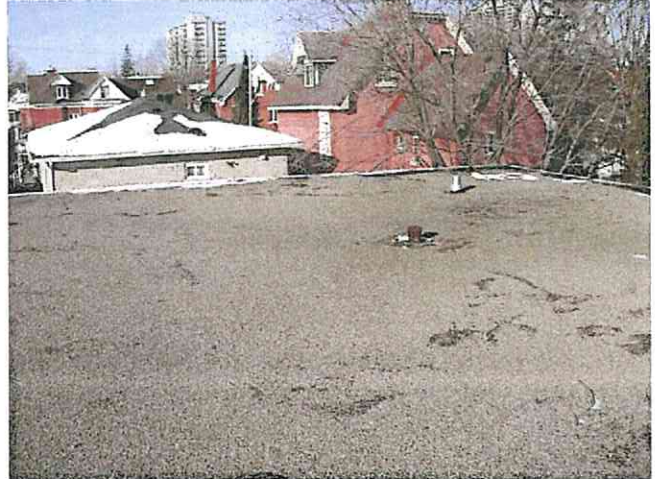
According to information provided, the flat roof over the main building was replaced in 1998 with a multiply built-up-roof (BUR) that includes a 12 mm wood fiberboard insulation directly over the wood roof deck. Drainage is provided by two internal roof drain assemblies. Several deficiencies were noted, including isolated "blueberrying" asphalt flood coat, wind scoured protective gravel topping at perimeters, corroded roof drains and roof hatch and an unsecured roof hatch.

**Photo 6** - Showing isolated exposed flood coat due to scoured gravel ballast, and also showing a corroded roof drain.

Overall, the roof is in generally fair condition, with no roof leaks reported and no evidence of moisture infiltration observed during this review. However, the roof is nearing the end of its reliable service life. Typically, conventional BUR roofs provide a reliable service life of approximately 20 years, but can last longer with proper, regular maintenance and repairs. Considering that the roof is nearing the end of its typical projected service and conditions are only fair, leak-free service is unlikely to continue for much longer. As such, we recommend that this roof area be replaced within the next five years.

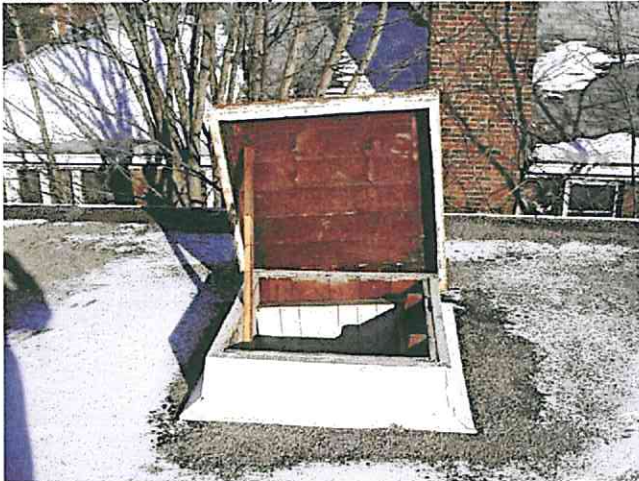
**Photo 7** - Showing an unsecured roof hatch as well as corrosion on roof hatch.

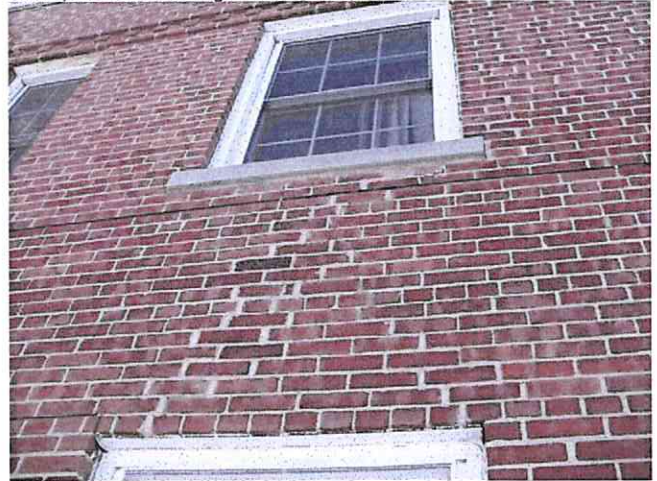
Solid brick masonry is utilized along each elevation and for the most part, displays a standard running bond configuration with recessed mortar jointing, while stack bond and accent detail configurations are found occasionally throughout the facade. A brick masonry chimney exists at the west elevation. Overall, the exterior brick masonry appeared to be in fair to satisfactory condition, however, numerous brick units and mortar joints are cracked due to the settlement of the building. All cracked brick units and mortar joints should be repaired within the next five years.

**Photo 8** - Showing typical cracked mortar joints in solid brick masonry between windows.

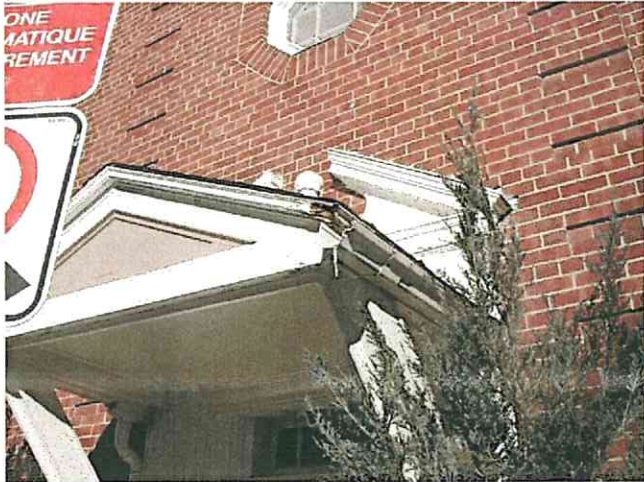
The pitched canopy roof is located above the main entrance and is covered with asphalt shingle roofing. The canopy roof was partially snow covered at the time of our visit, so the condition of the roof could not be adequately assessed. The roof deck is comprised of plywood sheathing which is presumed to be supported by wood truss members. Drainage is provided by an eavestrough system at the eaves. Where exposed, several deficiencies were noted, including decayed roof deck, curled shingles and degranulated shingles. The canopy roof system appears to be nearing or at its normal projected service life of 18 to 22 years. As such, we recommend that this roof area be replaced within the next few years.

Photo 9 - Showing deteriorated wood deck at canopy roof.

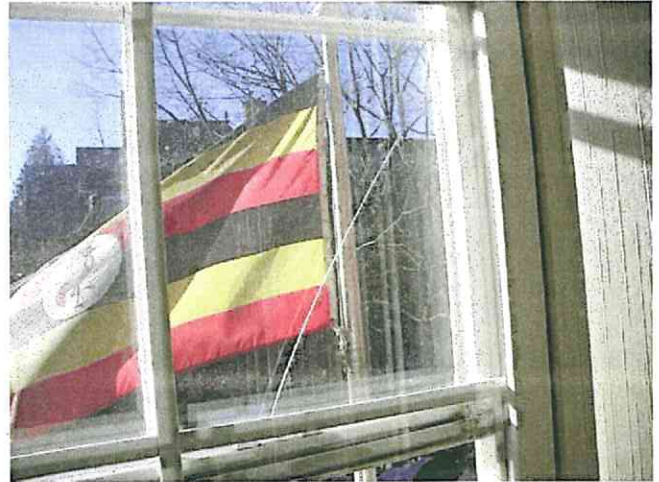
Photo 10 - Showing a cracked window pane.

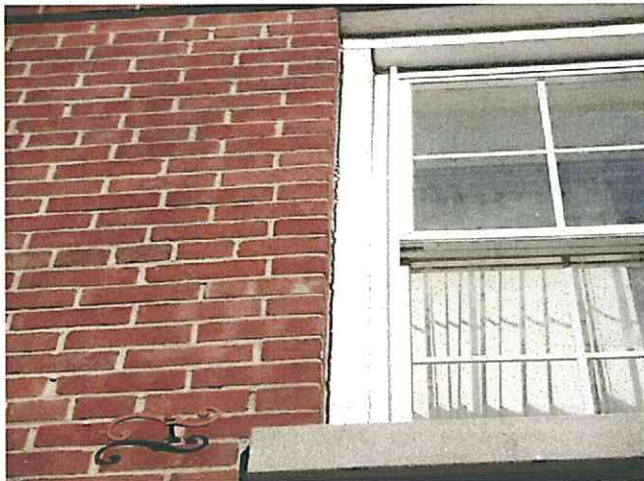
Caulking at the subject building is utilized along perimeters of windows, doors, metal flashings and at service penetrations. Caulking throughout the various building components was found to be in poor condition, as cracked, deteriorated or missing caulking was observed during our review. Replacement of all exterior caulking should be carried out within the next year.

Photo 11 - Showing cracked / deteriorated caulking along windows.
