September 6, 2017

Re: Tree Conservation Report – 575 Old Prospect Road, Rockcliffe

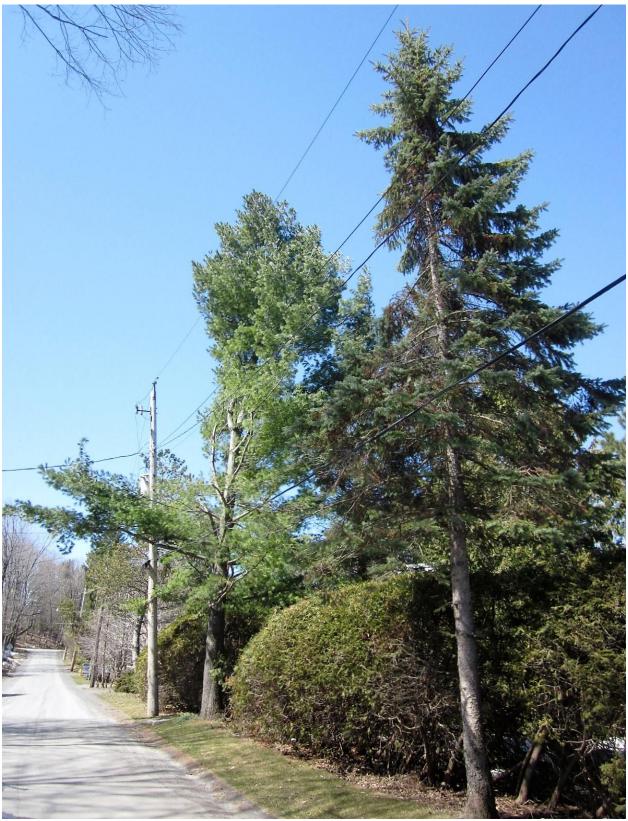
Picture 2. Trees #7 and 8 at 575 Old Prospect Road, Rockcliffe.

6	White spruce	Fair	20.3	Located on city property; crown asymmetrical
				due to competition for sunlight with tree #4; fair
				crown density and growth increment, good
				needle colour; to be retained
7	Colorado spruce	Fair	24.4	Located on city property; crown slightly
	_			misshapen due to pruning from Hydro lines; fair
				crown density and growth increment, good
				needle colour; to be retained
8	White pine	Poor	53.2	Located on city property; crown very misshapen
	(Pinus strobus)			due to aggressive pruning from Hydro lines; fair
				crown density and growth increment, good
				needle colour; shading tree #20; to be retained
9	Austrian pine	Poor	36.0	Located on city property; poor crown density,
	(Pinus nigra)			growth increment and needle colour-possibly
				due to Brown spot needle blight
				(Mycosphaerella dearnessii); co-dominant
				stems at 8m; sweeps in main stem; to be
				retained
10	Norway maple	Fair	20.8	Located on private property; generally good

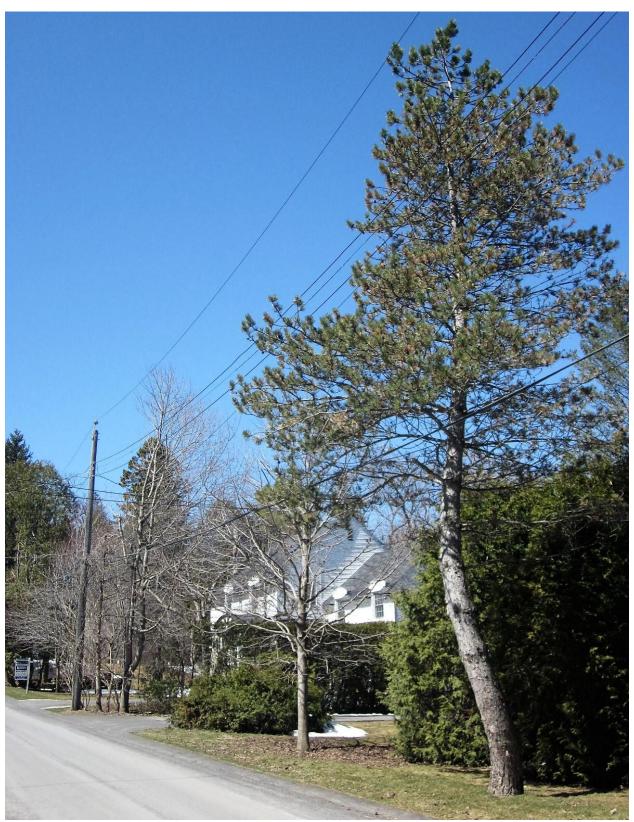
Picture 3. Trees #9, 10 and 11 at 575 Old Prospect Road, Rockcliffe.

(Acer platanoides)			growth form; highly invasive, undesirable
				species; to be retained
11	Norway maple	Fair	29.0	Located on private property; crown
				asymmetrical due to Hydro pruning; shading
				adjacent hedge-diminishing privacy screening;
				highly invasive, undesirable species; to be
				retained
	1
