Item Title / Titre du point de l'ordre du jour : Application to alter 70 Richmond Road, a property designated under Part IV of the *Ontario Heritage Act*

# A CONSERVATION PLAN

## CHAMPLAIN OIL COMPANY SERVICE STATION

70 RICHMOND ROAD OTTAWA, ONTARIO

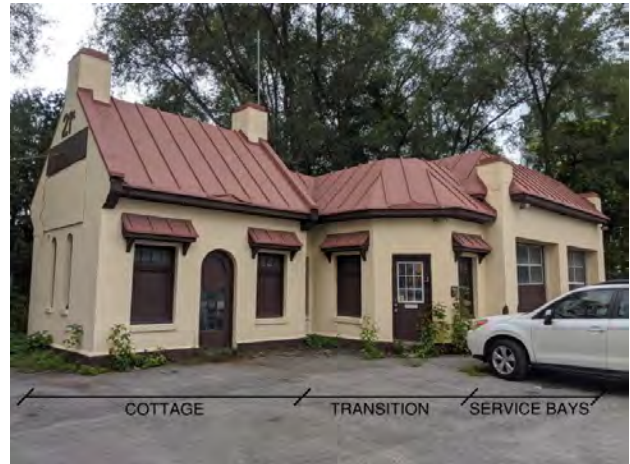
**The Champlain Oil Company Service Station** has been vacant for a number of years with no maintenance undertaken on the structure. Based on the assessment from both John G. Cooke Consulting Engineers and Cleland Jardine Engineering Limited, the building is in poor to fair condition.

Figure 1: View of the Service Station with the 3 sections cottage, transition, and service bays.

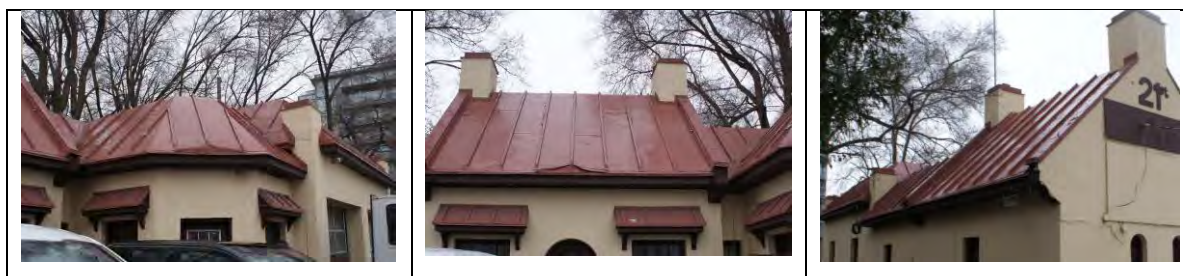
Figure 3A: images of the Roof

The standing seam metal roof membrane is an important character defining feature and will be preserved to the extent that it is feasible. The flashings in the valleys of the roof and around chimneys and at junctions between roof forms have failed as is evident by the stained wood sheathing as noted in John Cooke’s review. The standing seam metal roof will be rehabilitated. The distinctive standing seam metal roofs on the awnings above windows and doors will be preserved as they are in good condition. Remedial work prior to the move includes patching of the existing roof to prevent further damage.

Portions of the roof membrane and decking will have to be replaced due to the deteriorated condition of the roof deck. The roof structure, in addition to requiring repairs, will also be subjected to higher snow loads from being at the base of the new mid-rise structure. It is recommended to reinforce the roof structure for this higher snow load at the same time as the repairs, since many of the solutions will address both.

- The distinctive standing seam metal roof will be retained and where necessary replaced with a similar material.

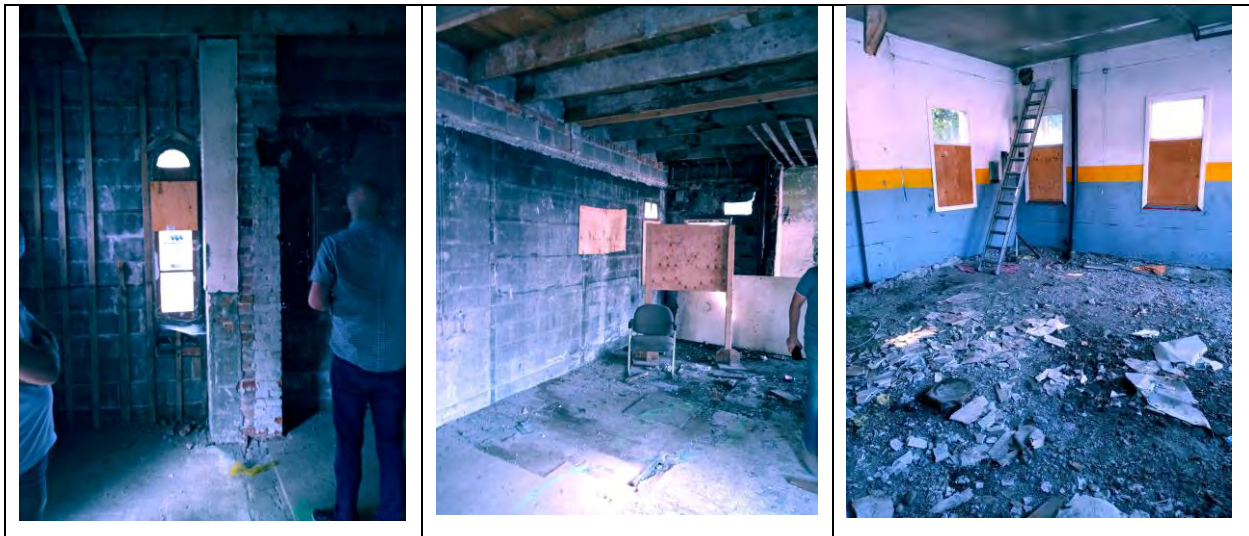
Figure 6: Interior views illustrating the condition, with the interior stripped down to the block walls.

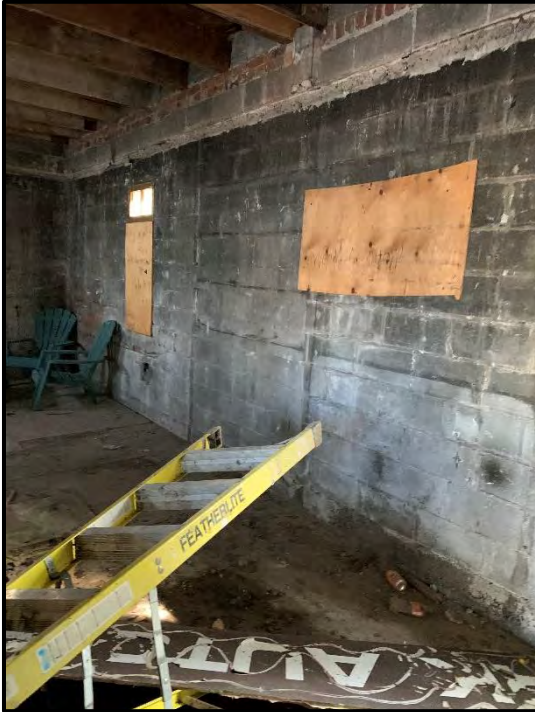
The masonry walls were in overall fair to poor condition with localized vertical cracking noted in several locations. Based on a few limited areas, where holes in the masonry were noted, the masonry does not appear to be grouted nor reinforced.

Exposed Masonry Wall Administration Area

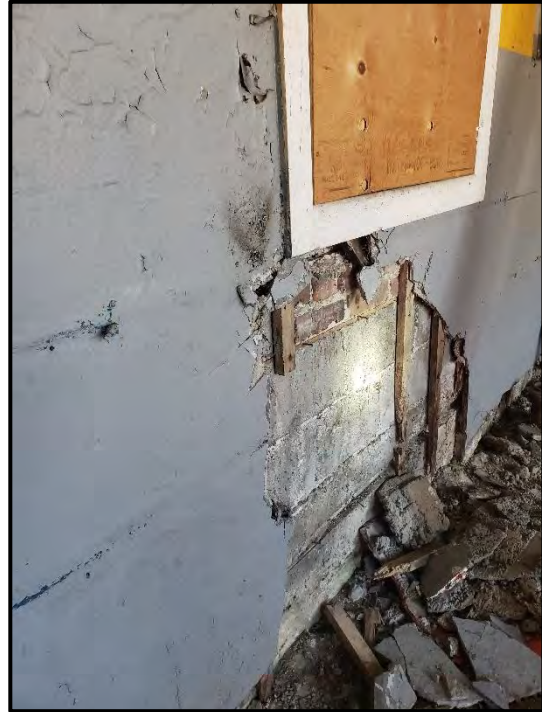
Masonry Wall Behind Plaster Lath - Service Bay

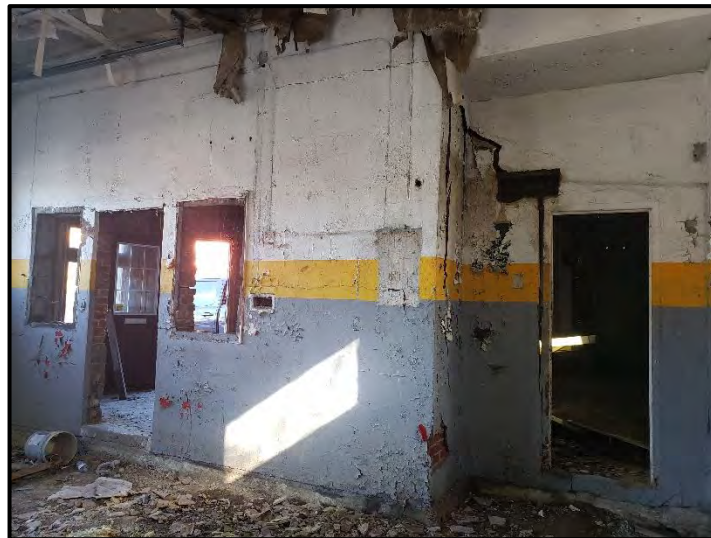
The load bearing masonry wall, between the service bay and administration area, is in poor condition with several cracks and major displacement (40mm) at the back portion.

Interior wall with major crack/displacement at door openings

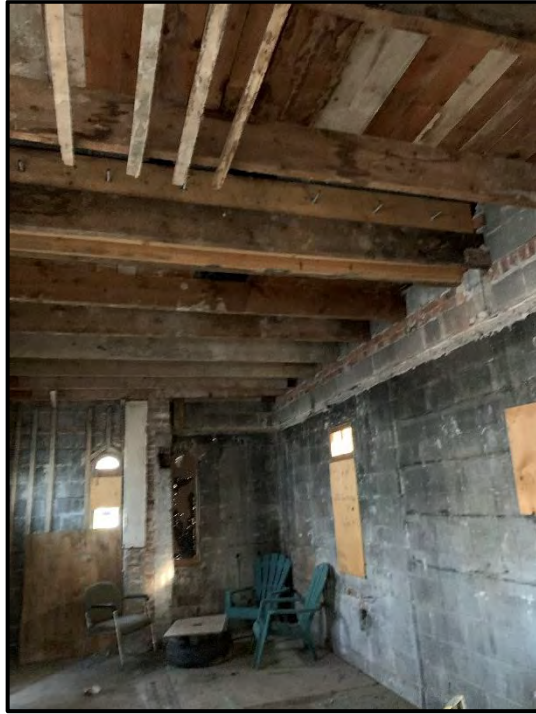
The roof framing has been subject to water infiltration and modification/patching over the years but remains in fair and sound condition.

Roof framing administration area

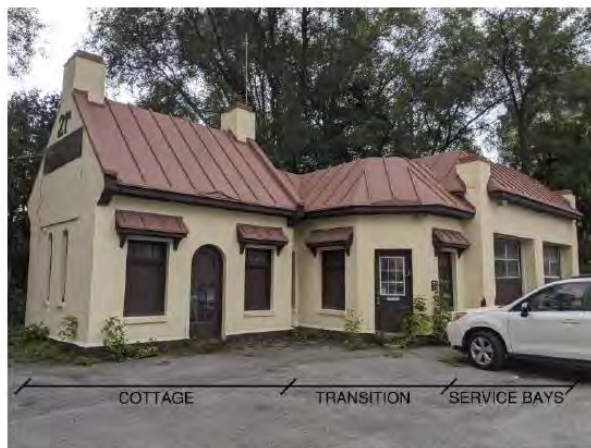
In general there are three main spaces; the cottage, the transitional area and the service bays, see Photo 1. The transitional area and garage are divided by an interior loadbearing brick wall. The separation of these spaces is visible by the differing roof structures from the exterior.

Photo 1: Overview of building [JCAL 2020]
