Engineering Assessment
Structural Assessment Following a Fire
Date of Loss: 30 November 2021
Location: 323 Daley Avenue, Ottawa
Our File Ref.: DFA21-370C

Hamze Mankal, B.Eng., P.Eng.

14 December 2021

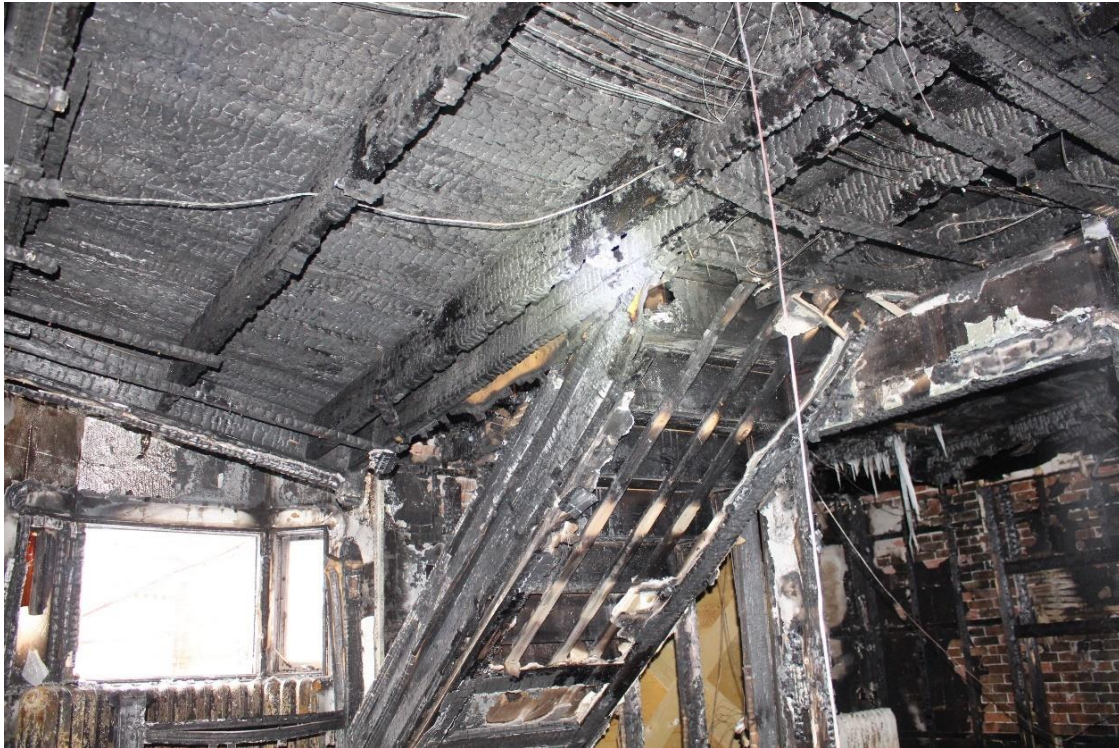
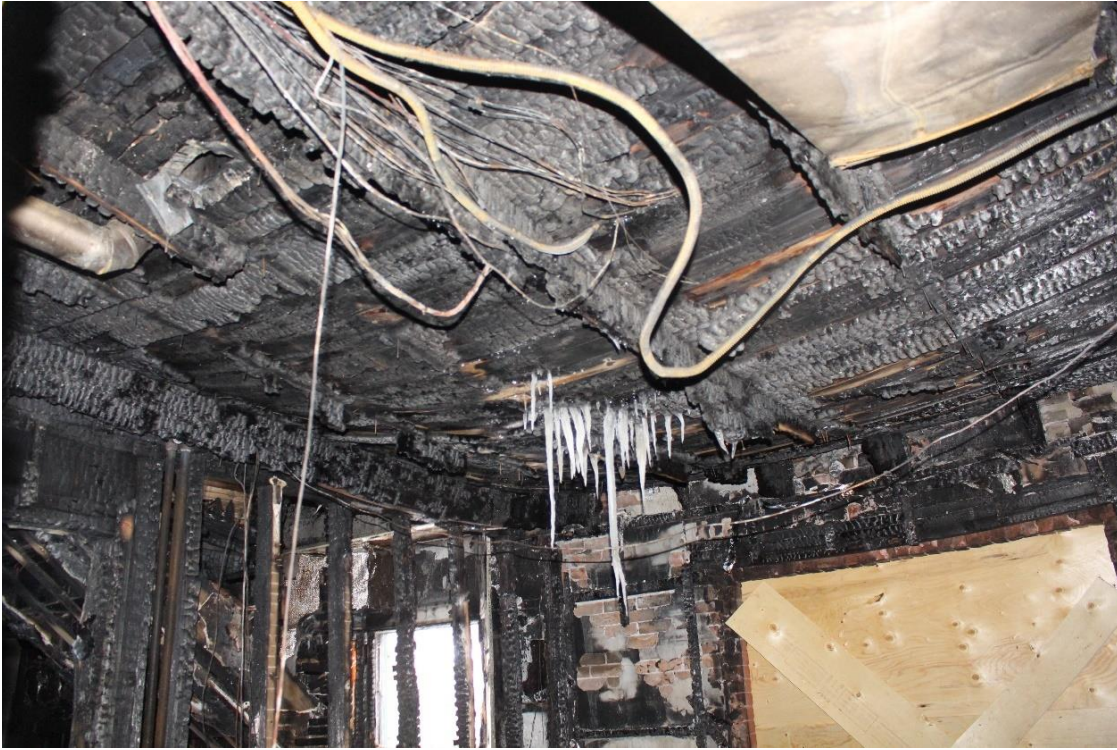
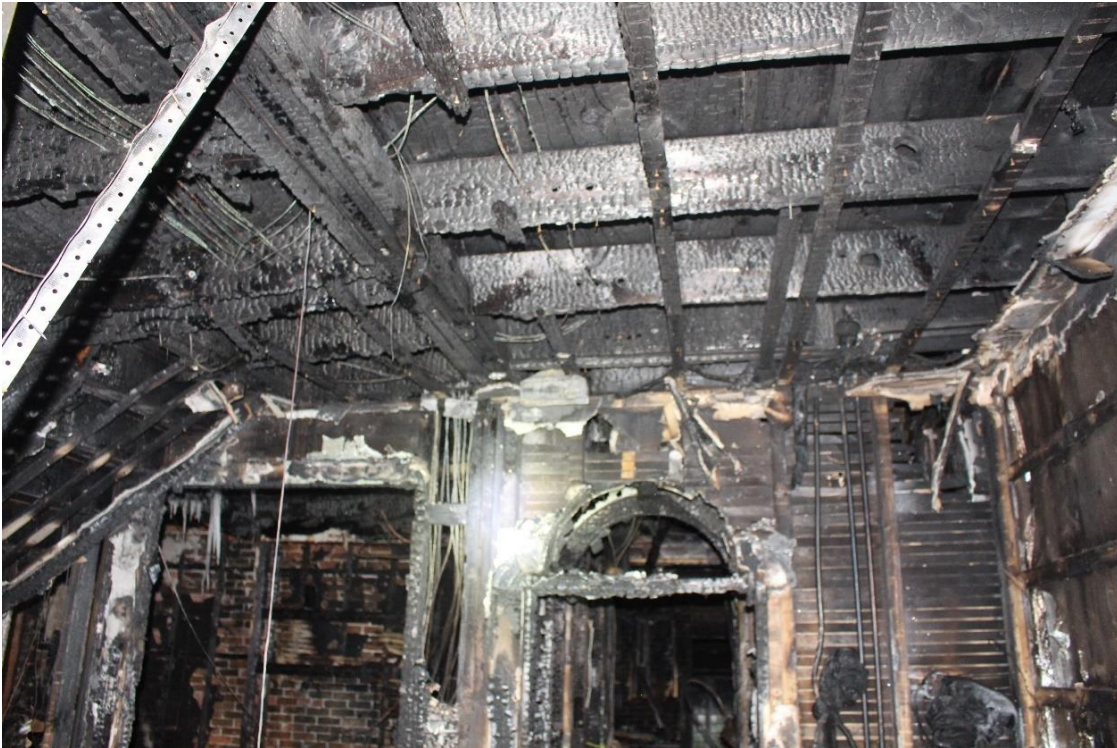
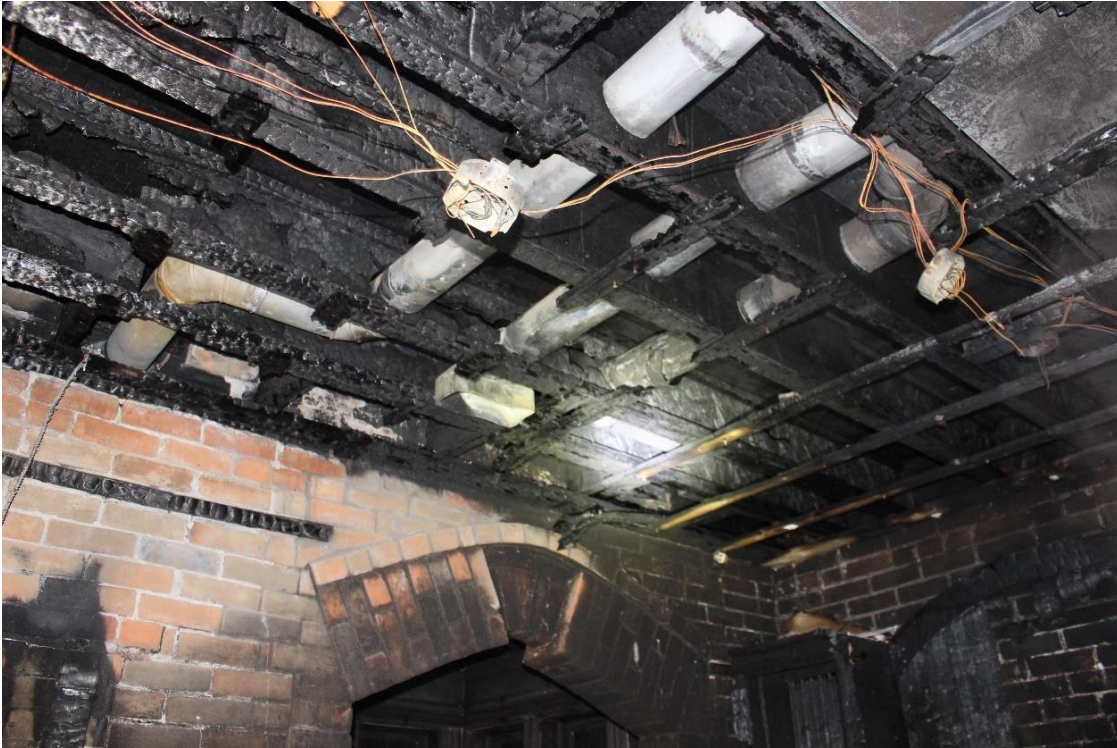
Our visual inspection of the subject building revealed the second-storey floor framing of the original building to be heavily charred and mostly collapsed, or on the verge of collapse (Photographs 4 through 7). The stairs leading to the second storey were mostly destroyed and there is no safe passage to enter the upper storeys (Photographs 4 and 8). From the exterior, evident fire damages to the roof can be observed (Photographs 1 through 3). Based on our extensive experience with fire-damaged buildings, it is our opinion that the upper levels and roof would be in a similar condition to the second-storey floor framing. It is also likely that the inner wythe of brick and mortar has sustained some level of heat damage, which has affected its strength.

The second-storey floor structure is completely compromised and highly unstable. The areas that have not yet collapsed are in a critical state and at risk of collapse. As such, the building is not safe to access, and it is our strong recommendation that it shall not be accessed by any persons at any time. The exception to this would be for necessary fire investigation purposes, with entry of the building done under the direction and supervision of a professional engineer.

Photograph 4: View of the second-storey floor framing.

Based on the above, it is our opinion that the building poses an immediate risk of collapse and should be demolished immediately in a controlled manner. Shoring of the structure is not feasible, and likely cannot be undertaken on the east side due to the proximity of the neighbouring building. The emergency fencing and boarding shall remain in place until the demolition is completed.

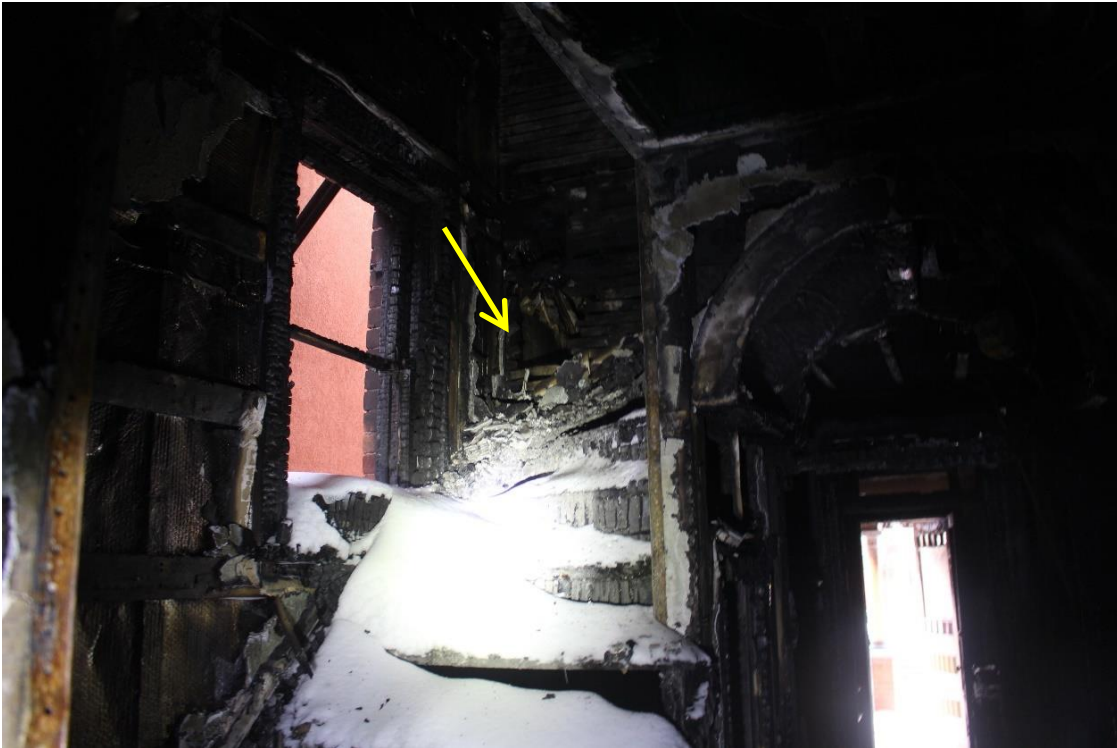
Photograph 8: View of second-storey stair structure.

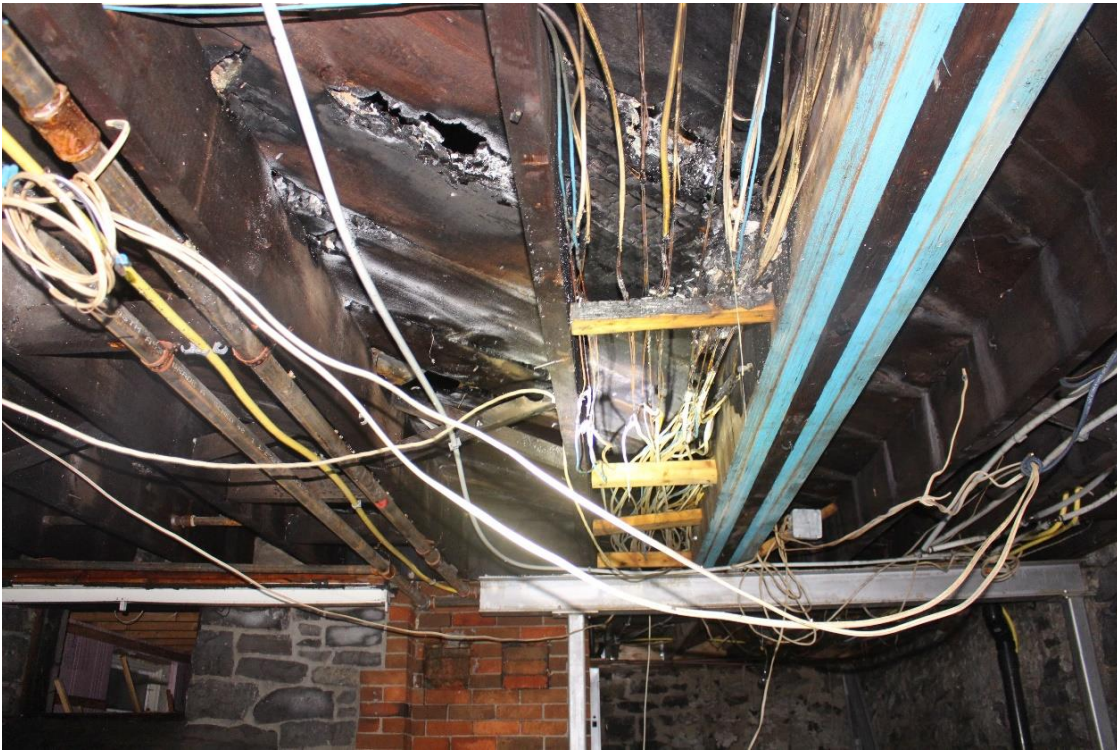
The basement area was less affected than the upper floors. The ground-floor framing (basement ceiling) was partially charred by areas of drop down from the fire (Photograph 9). The rest of the basement area was heavily affected by smoke and water (Photograph 10).

Photograph 9: View of drop down charring of the ground-floor framing.

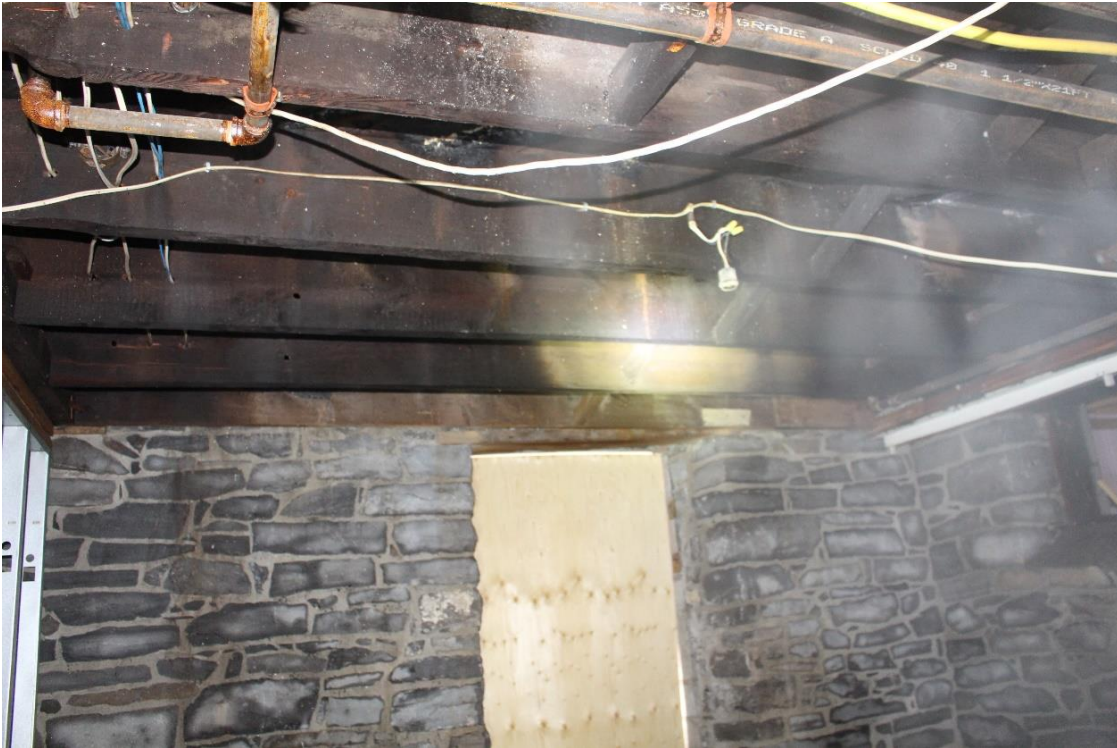
Photograph 10: View of smoke staining in the basement.
