City of Ottawa
Building Code Services Branch
101 Centrepointe Drive,
Nepean, ON

December 23, 2021
Project No. 22078

RE: 323 Daly Avenue
Fire Damage Assessment

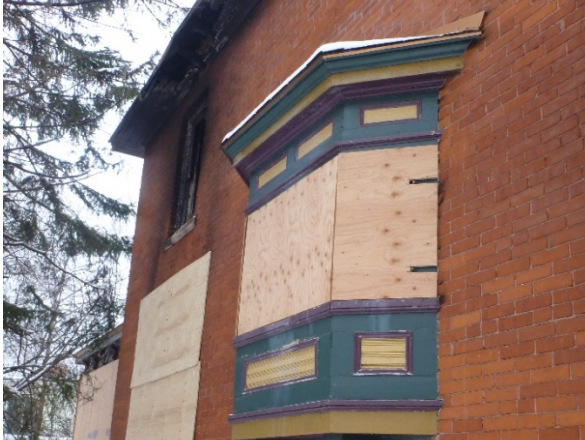
The brick masonry was generally in good condition. Inspection of all exterior elevations found no signs of cracking, bulging or other signs of damage or deterioration. It is possible that the interior bricks at the top of the walls at the third-floor sustained damage due to the high heat, however, these were not visible during the investigation.

Figure 2: Brick masonry, west facade [JCAL 2021]

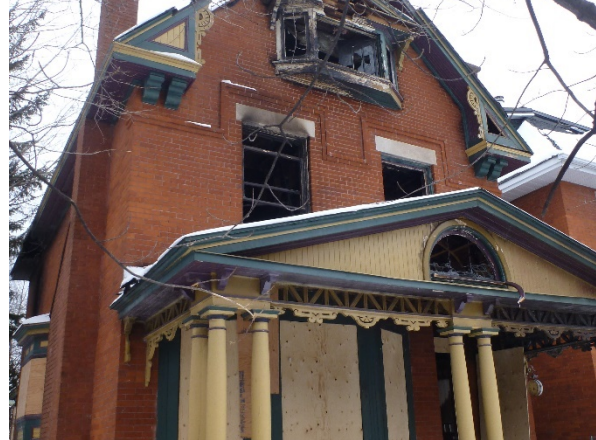
Figure 3: Brick masonry, south façade [JCAL 2021]

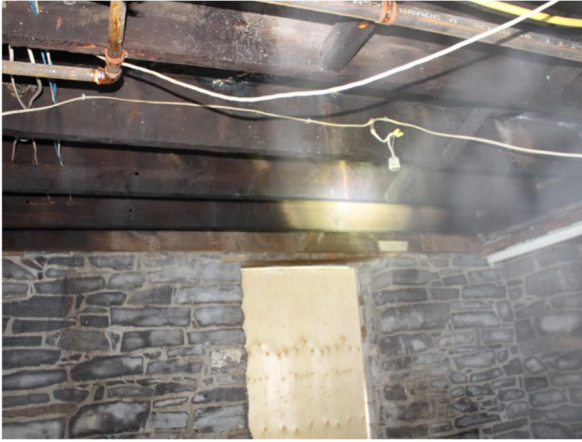
The first-floor timber structure was largely intact, with smoke staining throughout. Some of the planking had charred near the probable source of the fire, however, the existing structural joists and planking were otherwise in good condition.

Figure 4: Smoke-stained basement joists [DFA 2021]

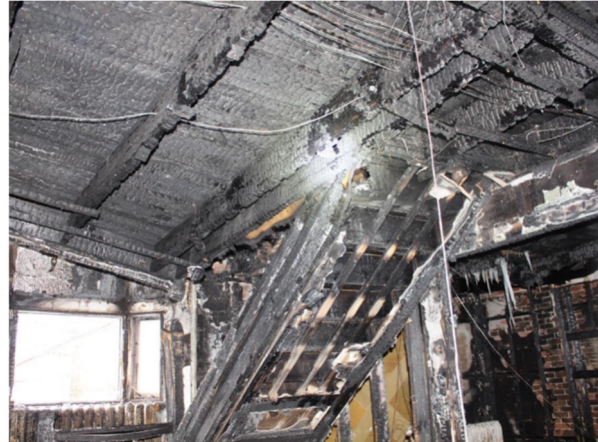
Figure 5: Charred and deflecting second floor joists [DFA 2021]

The second-floor joists were in poor condition; they suffered extensive fire damage and large deflections were observed, but no collapse had occurred. When wood is subjected to fire, the outside layers chars and expands, creating an insulating layer that protects the wood from damage. Over the course of a fire, the char expands, cracks and flakes off, exposing more of the wood, which gradually chars, continuing the cycle. In a standard fire, lumber typically chars at a nominal rate of around 0.65mm per minute, according to CSA O86-14 Engineering Design in Wood. The reduction in cross-section reduces the member's capacity until it can no longer support the applied load, at which point it collapses. Exposure to high heat and fire has not been shown to reduce the material properties of wood.

Old growth wood, such as what is seen in the building at 323 Daly, is slowly grown in dense forests over long periods of time. The long growth period contributes to a higher density of wood that tends to be much stronger than what is commercially available today. This high density contributes to a slower char rate which, combined with the high strength and quality of the old growth lumber, has prevented collapse due to the fire. Although the wood is severely damaged and structurally unsound, it maintains enough capacity to support the current dead load and provide lateral restraint to the brick masonry walls in the short-term.

If the structure is to be conserved, rather than demolished, it will be necessary to replace the wood framing above the first floor. The existing interior wood framing should be carefully demolished and rebuilt at the second and third floor level. Interior partition stud walls above the ground floor should be reconstructed.

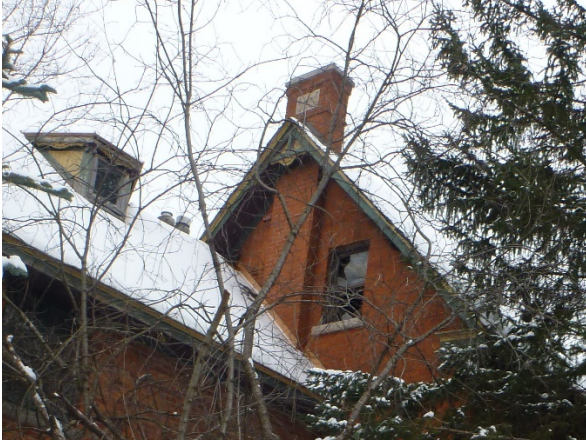
The two tall brick chimneys on the north end of the building appeared to be in good condition. No signs of damage were seen from grade.

Figure 6: North chimney in good condition [JCAL 2021]

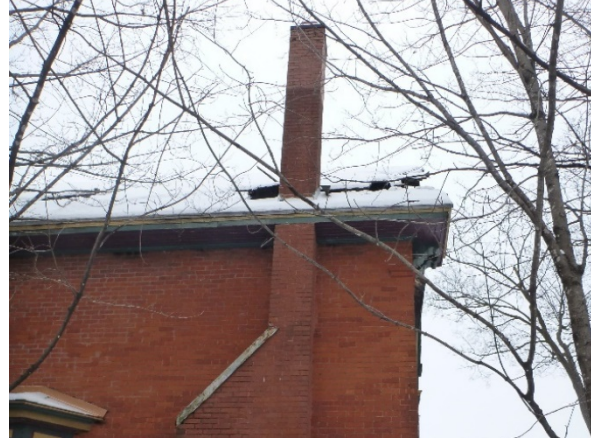
Figure 7: Laterally unsupported west chimney at large hole in roof [JCAL 2021]

The chimney on the west wall appears to be in fair condition with localized deterioration near the top. Due to the collapsed roof at this location, the chimney may not be supported laterally. This presents a fall hazard and must be addressed prior to any work completed at the roof level.

The chimneys appear to be structurally sound. However, the west chimney may need lateral bracing as the floor around it appears to be severely deflected and may be at risk of failure.

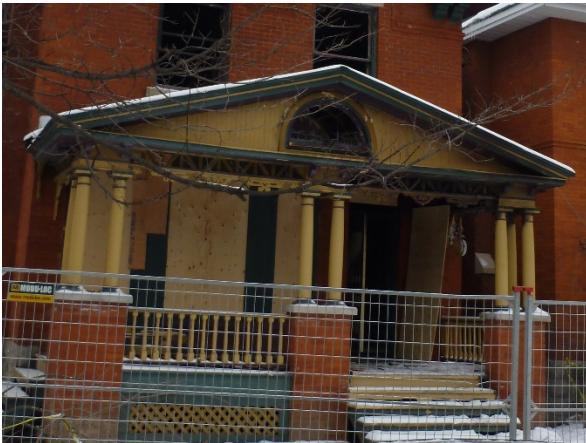
The front porch structure appeared to be in generally good condition, with minor localized damage at the spandrel. Minor damage to the cornices may have occurred during the firefighting efforts.

Figure 8: Front porch, smoke-stained spandrel [JCAL 2021]

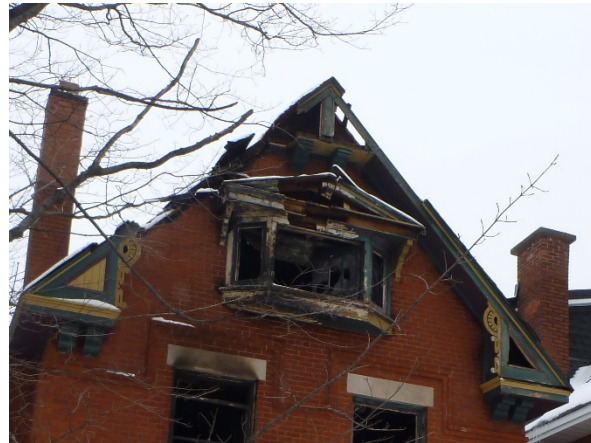
Figure 9: Damaged bargeboards on south gable [JCAL 2021]

The bay window on the southern gable is in poor condition, having suffered severe damage in the fire. Similarly, the bargeboard at the peak of the gable and along the west slope have been destroyed in the fire. The upper portion of the south brick gable may have sustained damage due to the high heat. Any lateral support at this location was likely damaged or destroyed by the fire, potentially rendering this portion of the wall unstable.
