June 30, 2022

**RE: TREE INFORMATION REPORT FOR 14 CRESCENT ROAD, ROCKCLIFFE PARK**

DRAWING: Tree Conservation Plan

PROJECT: 14 CRESCENT ROAD  
CITY OF OTTAWA

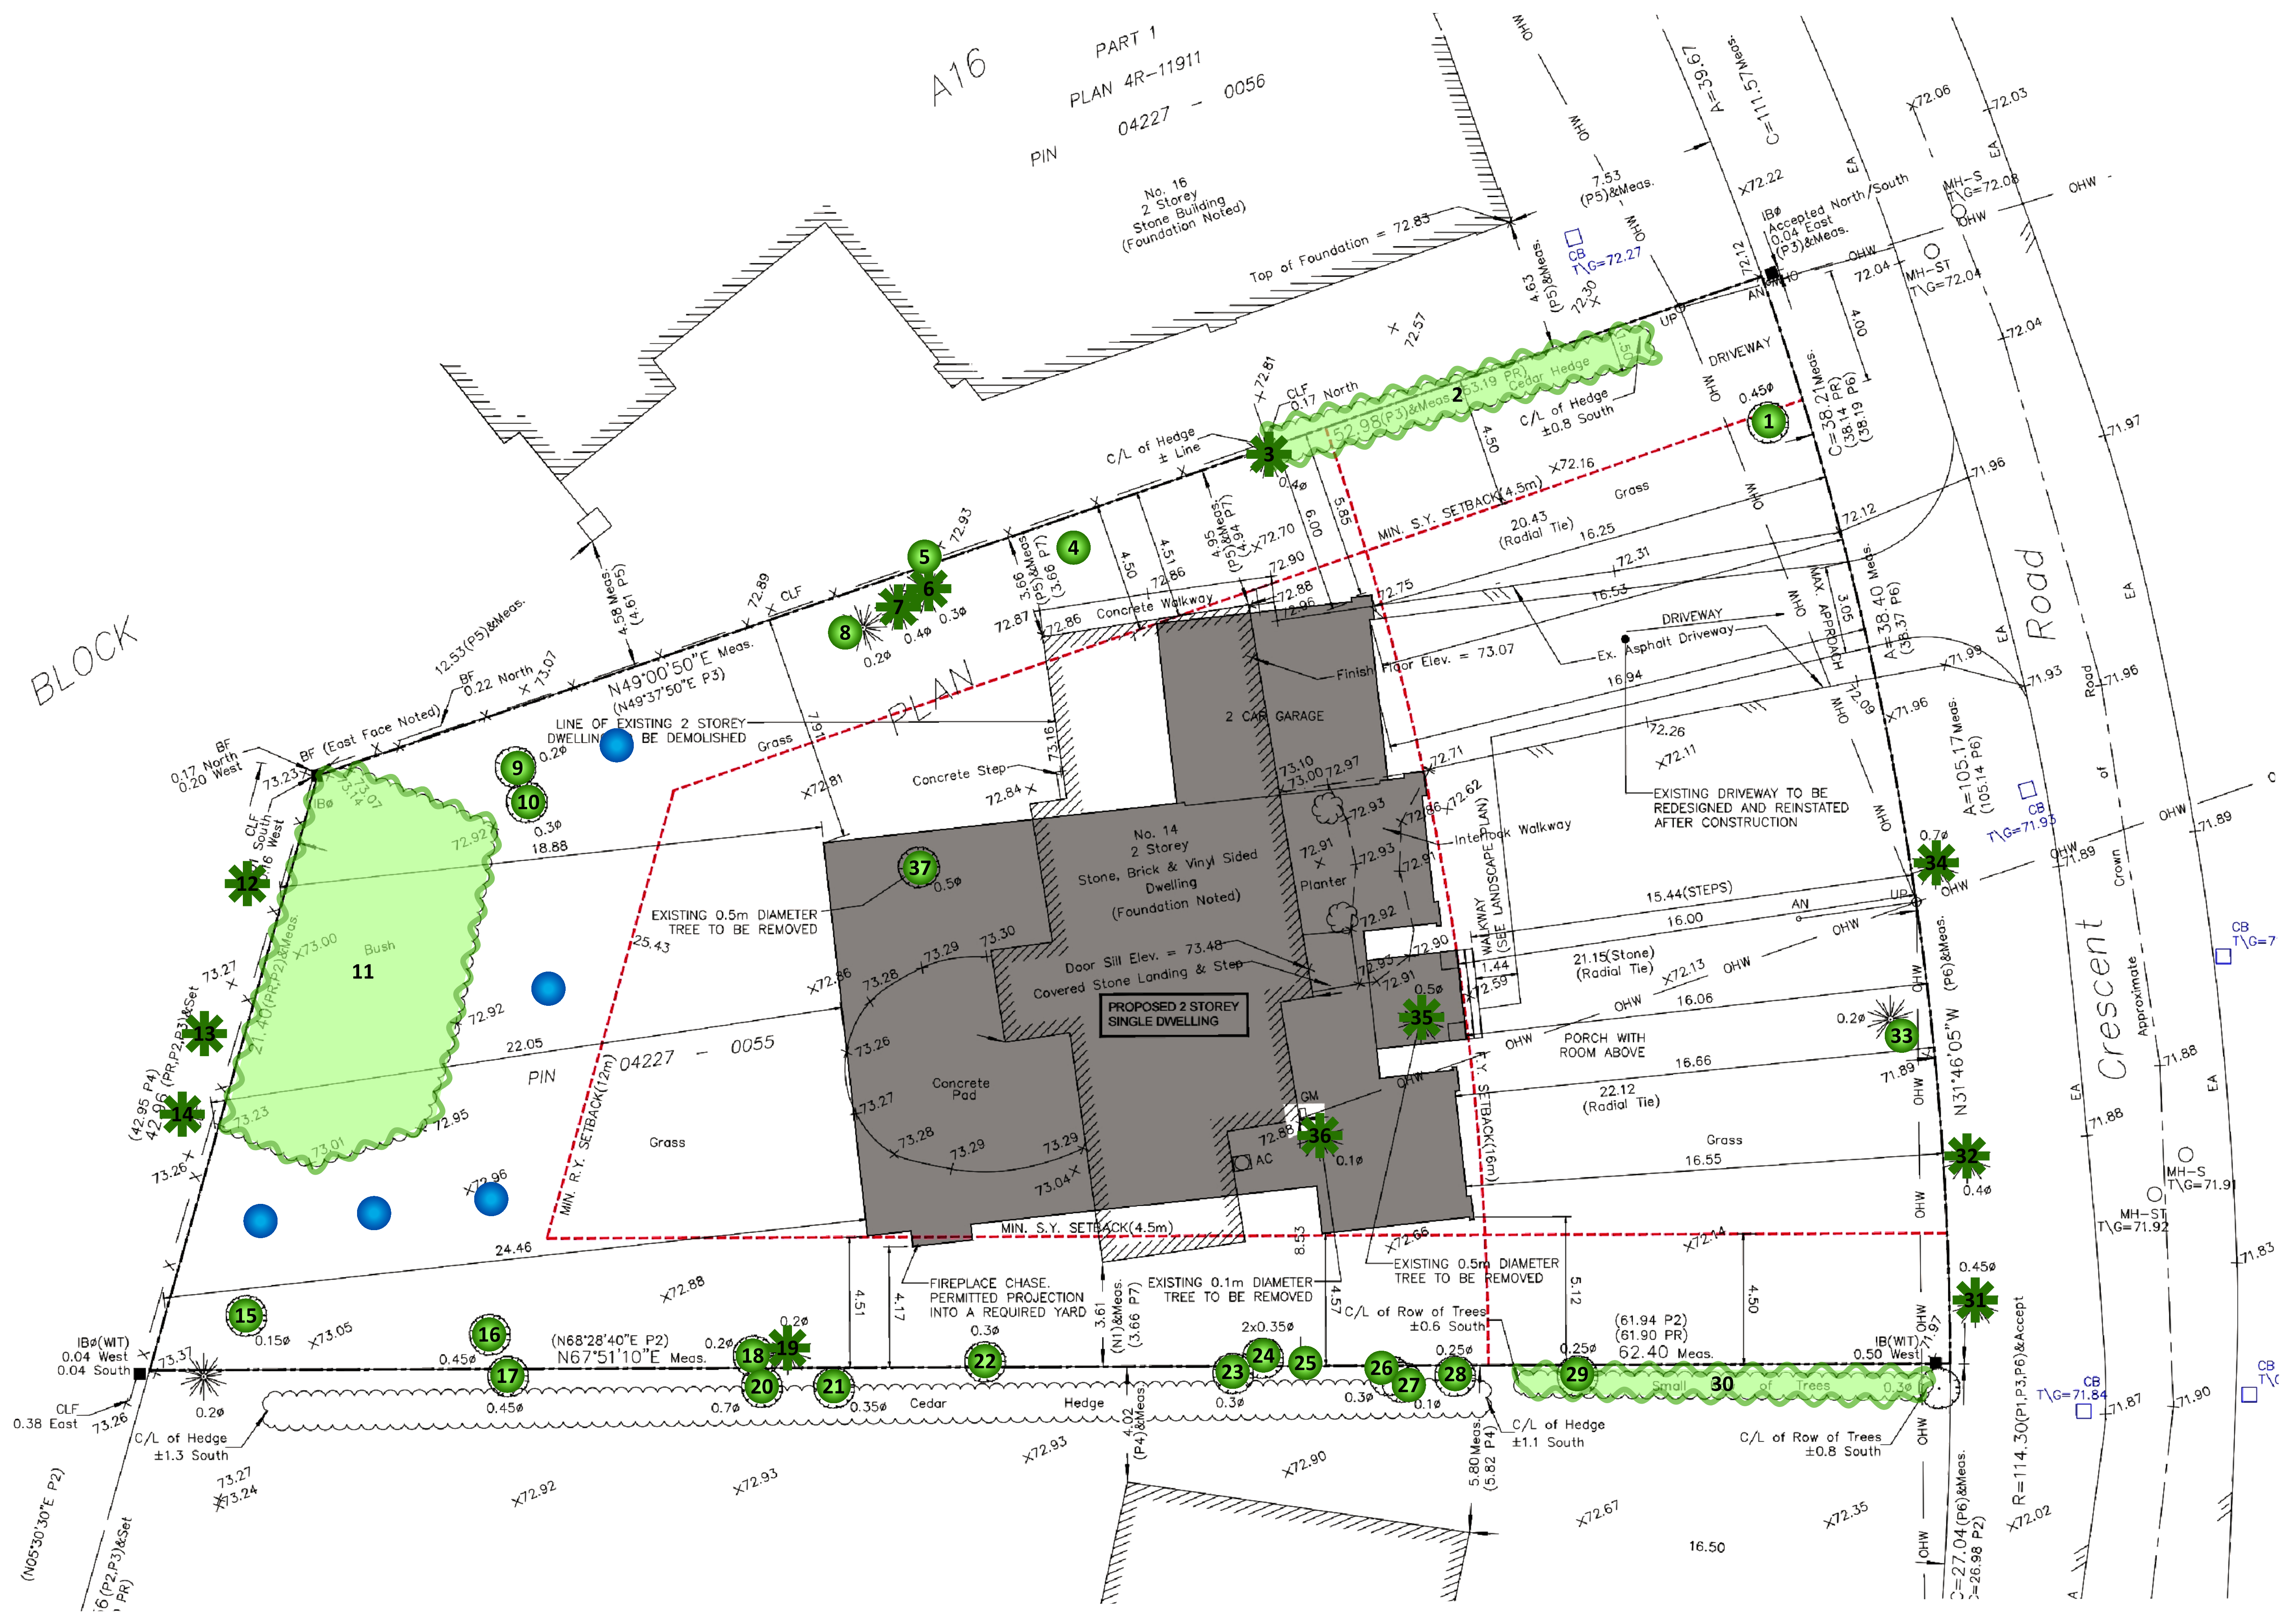
As the property is within the inner urban area the following ratios are used in terms of replacement tree planting: 2:1 for each distinctive tree measuring 30-49 cm in diameter and 3:1 for each distinctive tree measuring 50 cm or greater in diameter. With one tree between 30-49cm and one greater than 50cm being removed, five replacement trees are proposed for planting (see plan on page 11).

1. Erect a fence at the critical root zone (CRZ<sup>1</sup>) of trees;
2. Do not place any material or equipment within the CRZ of the tree;
3. Do not attach any signs, notices or posters to any tree;

4. Do not raise or lower the existing grade within the CRZ without approval;
5. Tunnel or bore when digging within the CRZ of a tree;
6. Do not damage the root system, trunk or branches of any tree;
7. Ensure that exhaust fumes from all equipment are NOT directed towards any tree's crown.

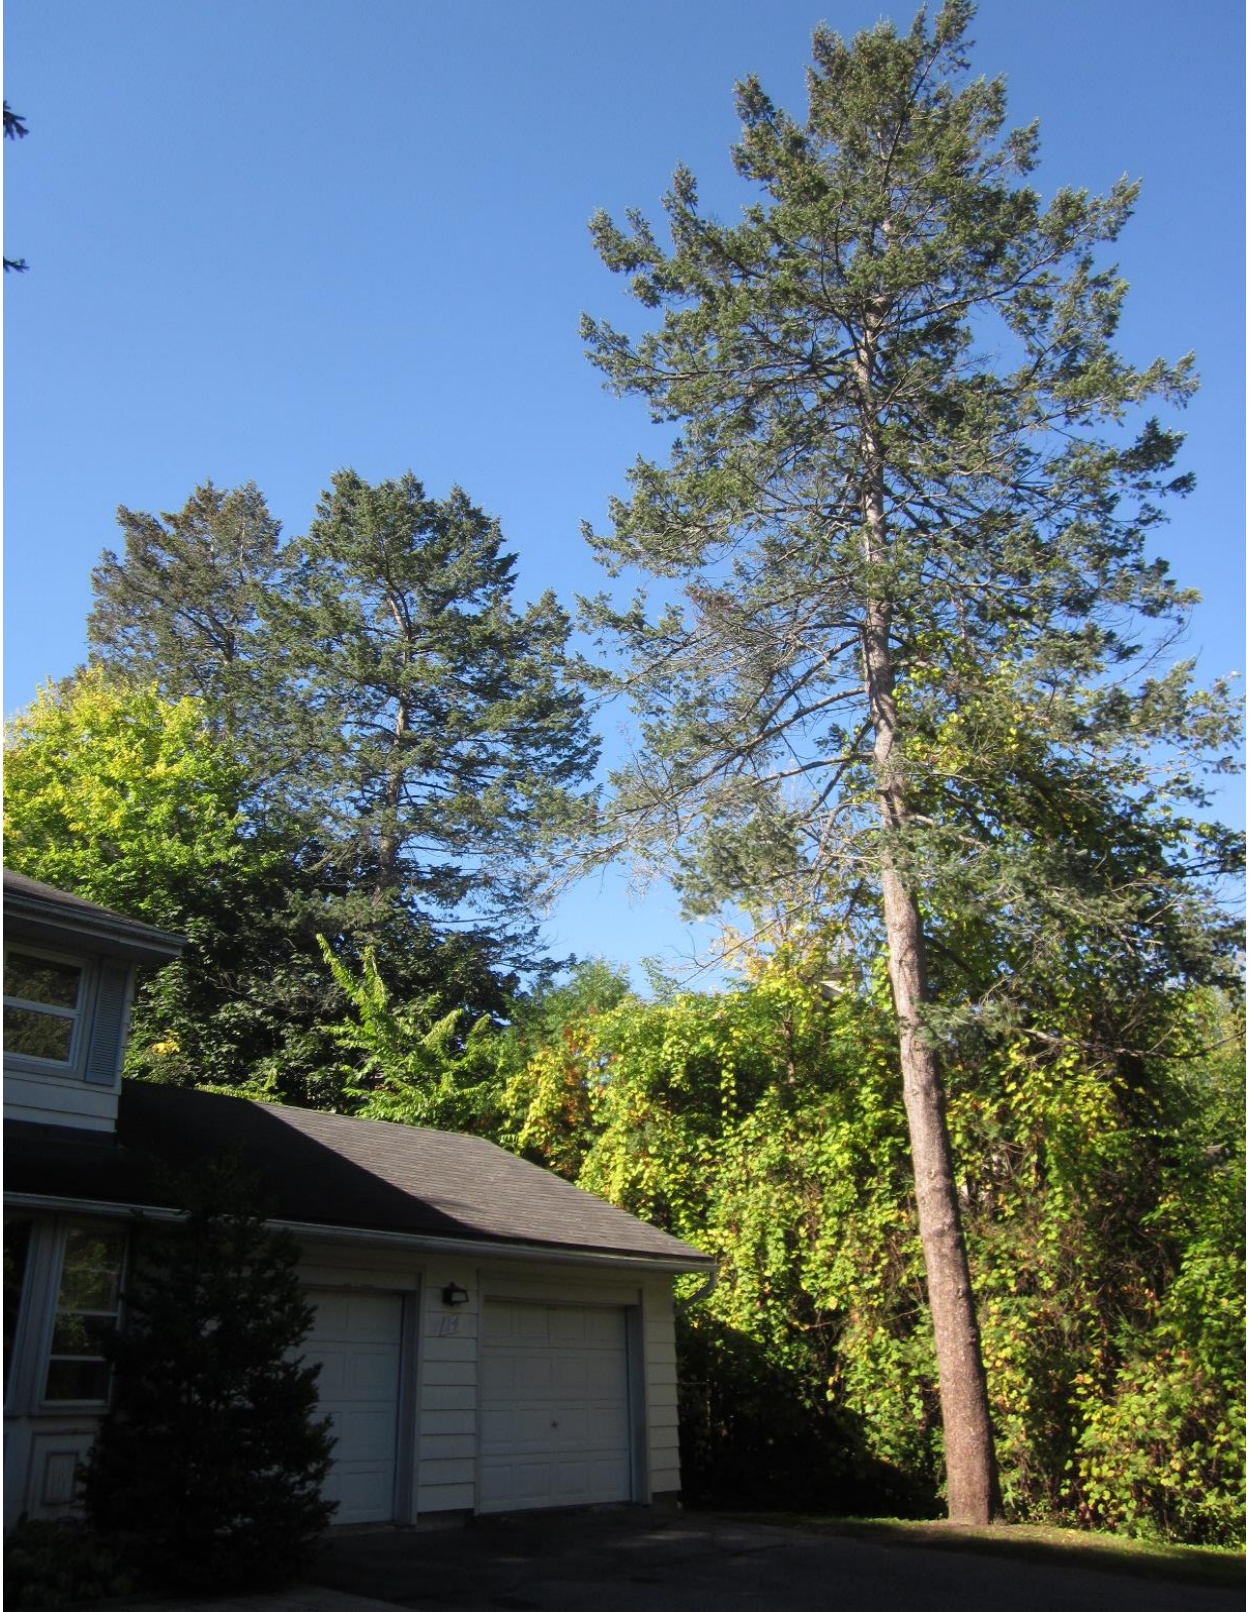
Picture 1. Private trees #2 and 3 (right) and upper crowns of 4, 6, 7 and 8 (left) at 14 Crescent Road, Rockcliffe

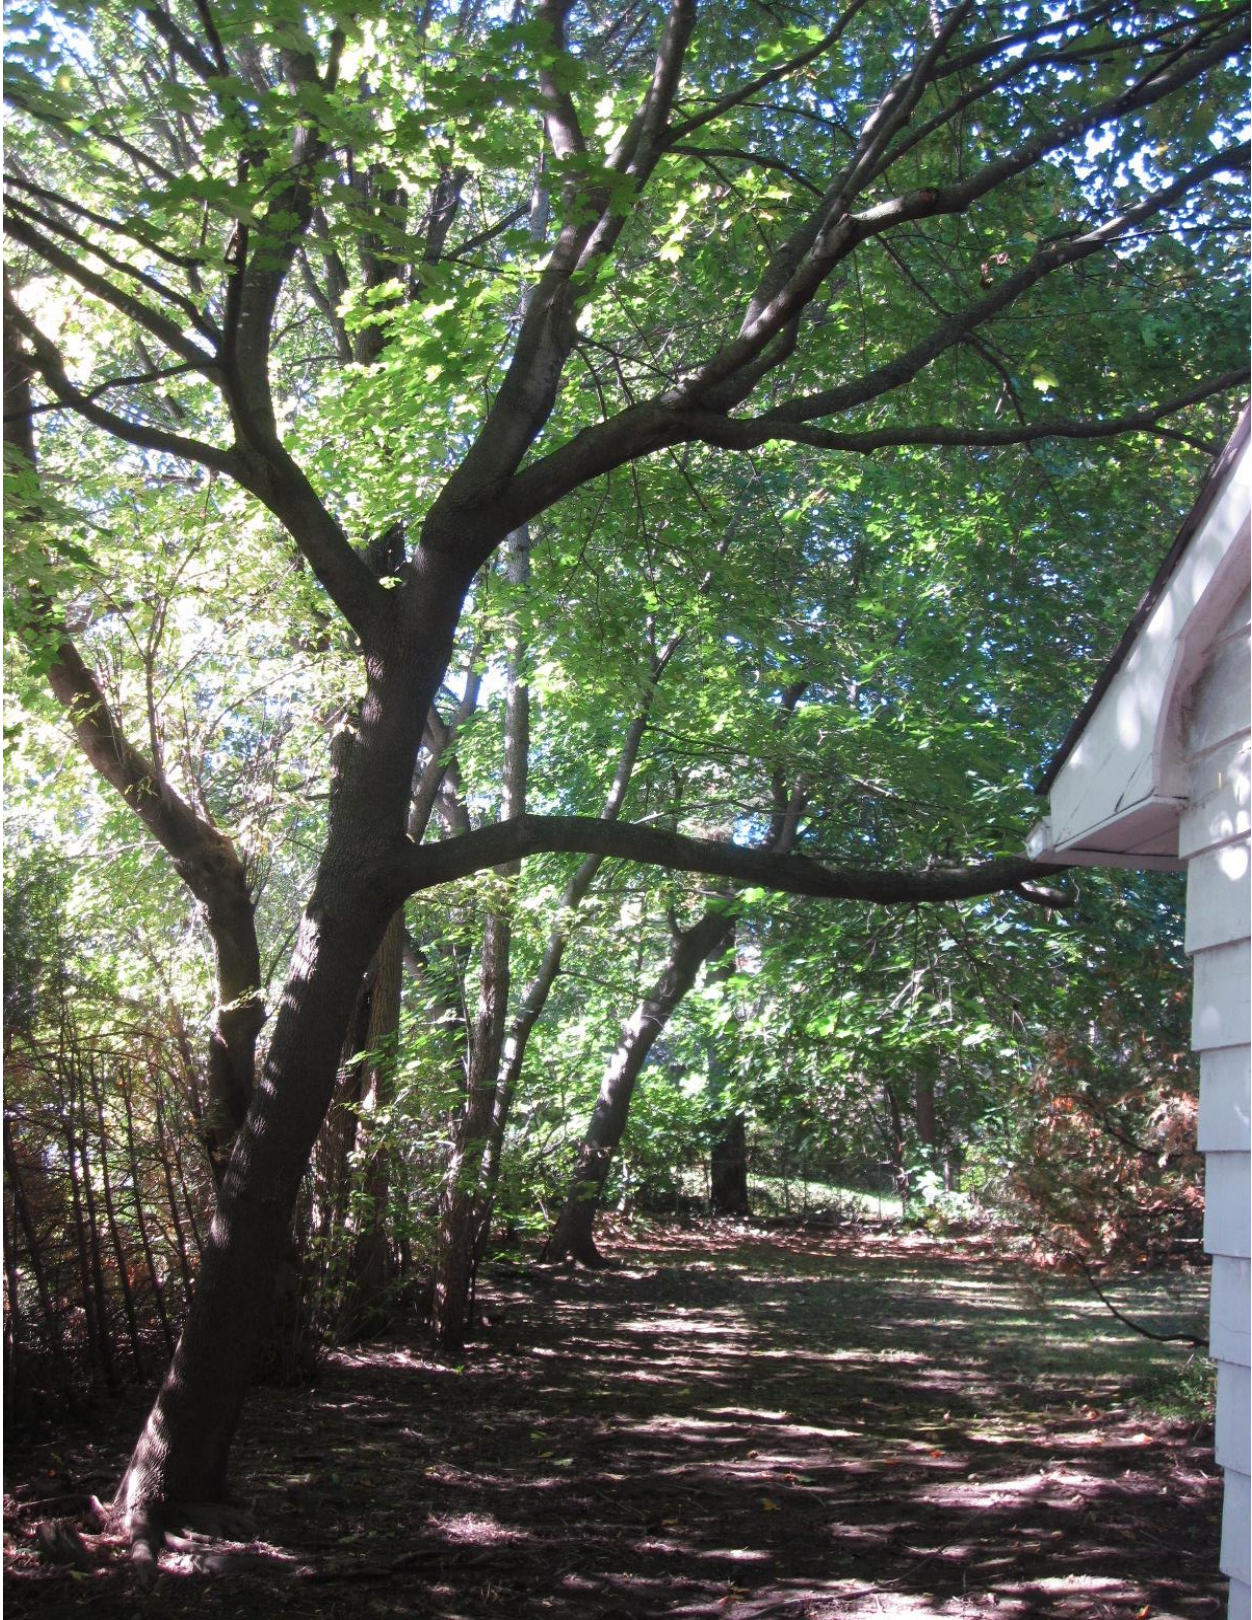
16	Norway maple ( <i>Acer platanoides</i> )	Poor	48.1	Private	Mature; dominant central stem with co-dominant leaders at 12m from grade; strongly divergent towards north; shear plane fracture at 1.5-4m from grade on south; introduced invasive species; <b>to be preserved and protected</b>
17	Norway maple ( <i>Acer platanoides</i> )	Poor	47.1	Neighbour	Mature; central stem with competing lateral at 5m on east; moderately strong union; mature Eutypella canker ( <i>Eutypella parasitica</i> ) at 2m on west (40% circumference); divergent and asymmetric form due to influence of tree #16; introduced invasive species; <b>to be preserved and protected</b>

Picture 2. Trees #22 to 16 (foreground to background), on and adjacent to 14 Crescent Road, Rockcliffe

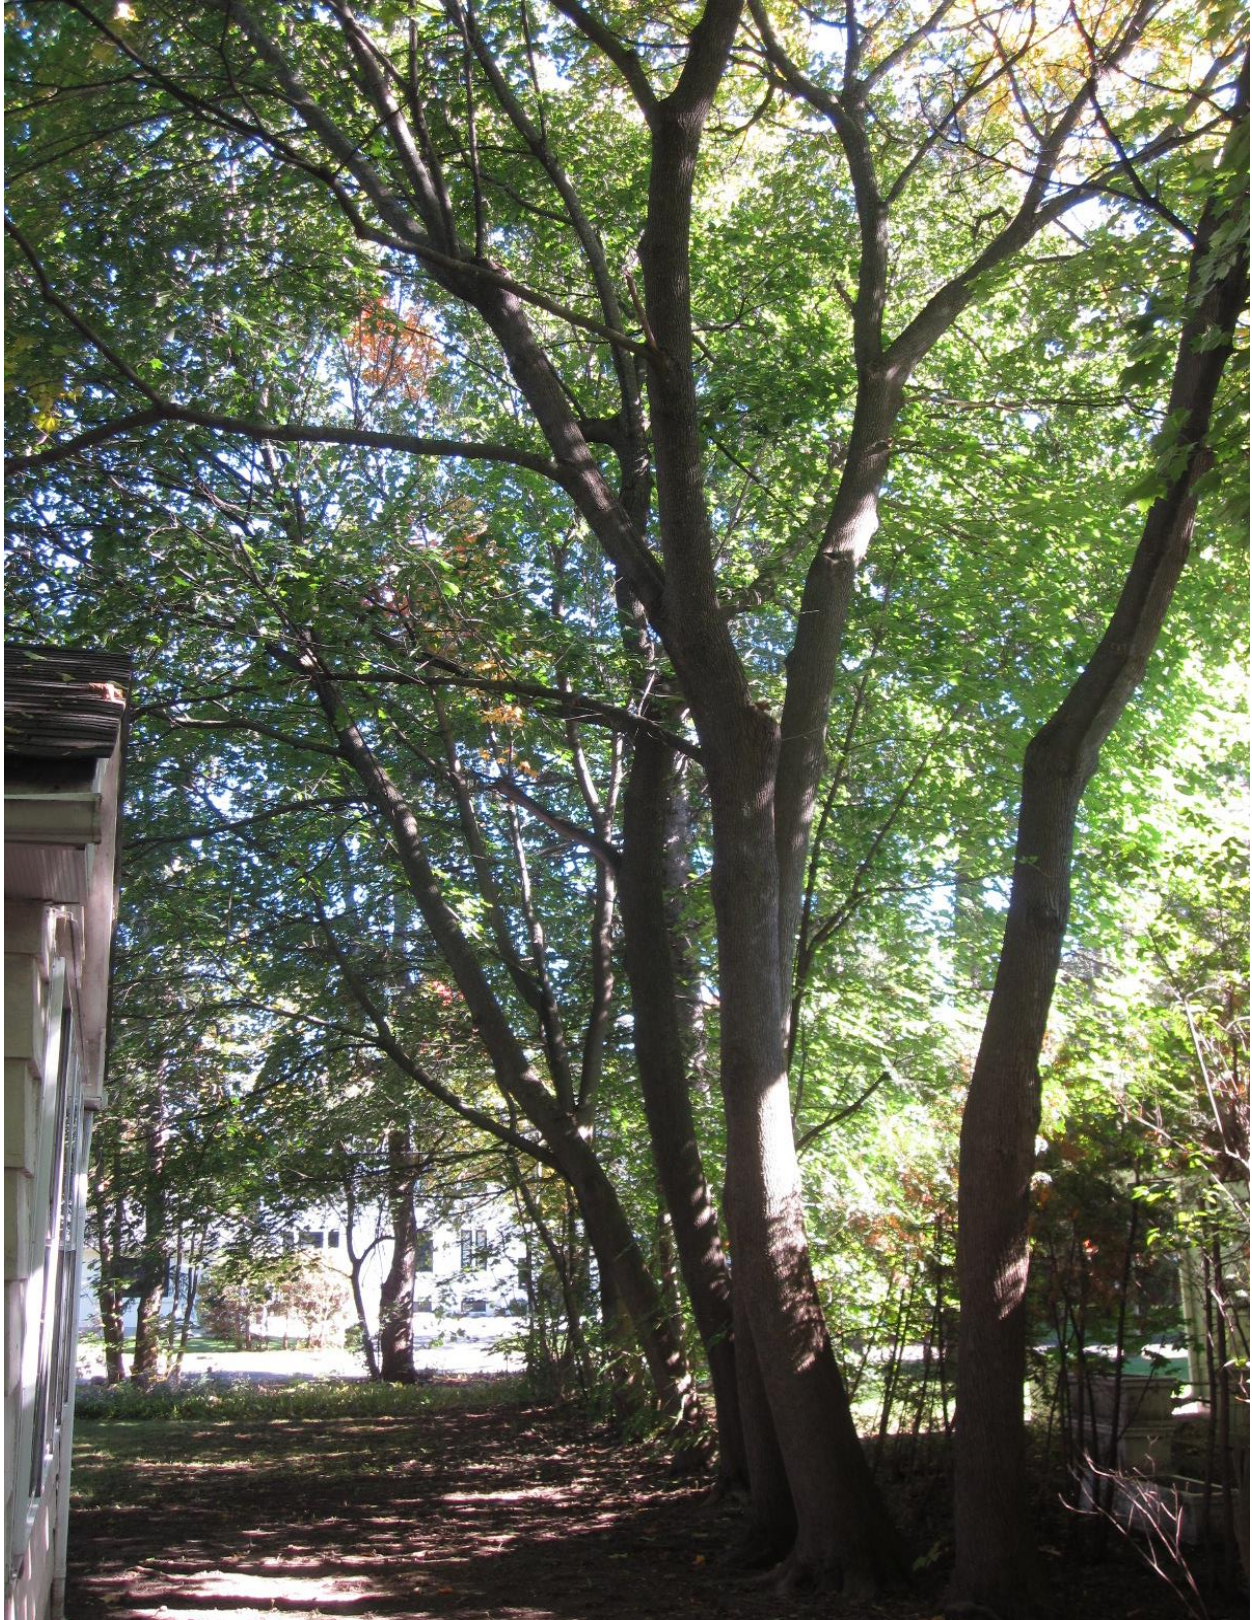
32	White spruce ( <i>Picea glauca</i> )	Poor	43.1	City	Mature; co-dominant leaders at 8m (previously topped); lower 2/3 of crown asymmetric due to clearance pruning from Hydro lines; poor crown density, growth increment and needle colour; multiple Norway maples growing at base; native species; <b>to be preserved and protected</b>

Picture 3. Trees #23-32 (foreground to background), on and adjacent to 14 Crescent Road, Rockcliffe

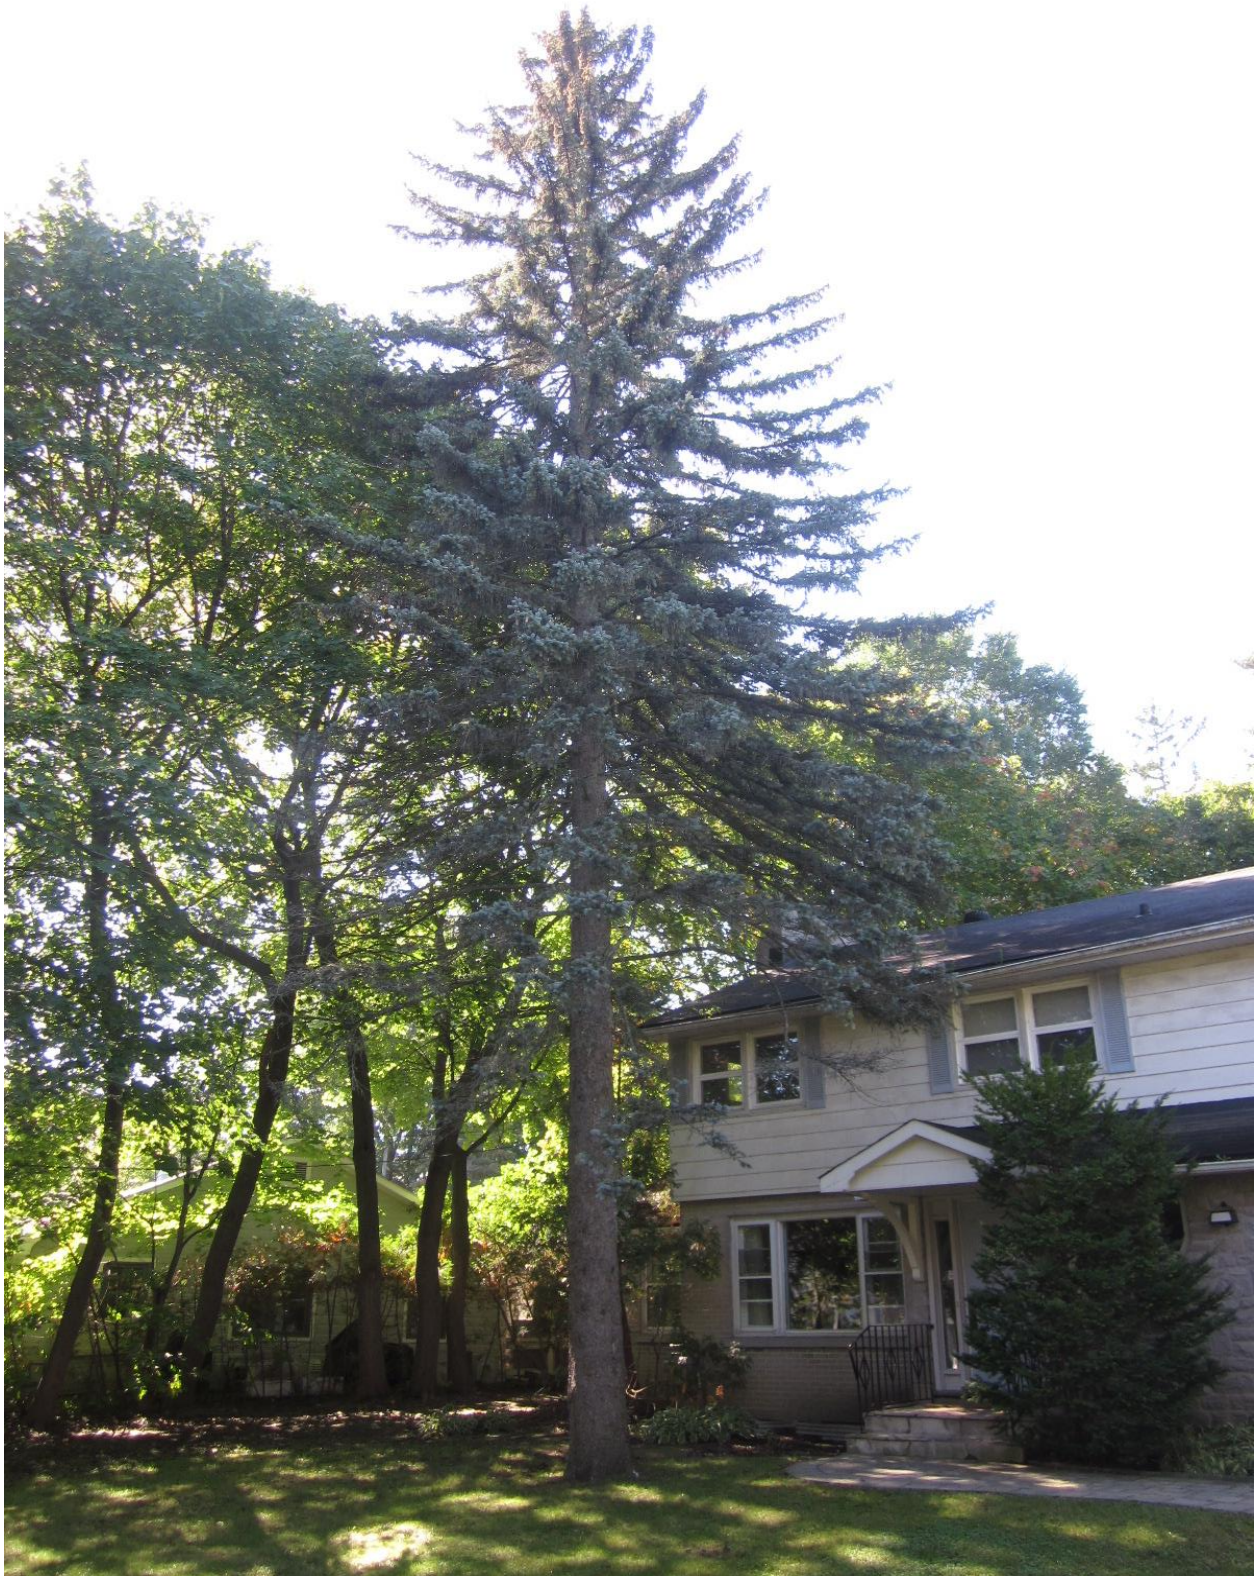
Picture 4. Tree #35, private Colorado spruce (foreground) and trees #23-28 (background right to left) at 14 Crescent Road, Rockcliffe

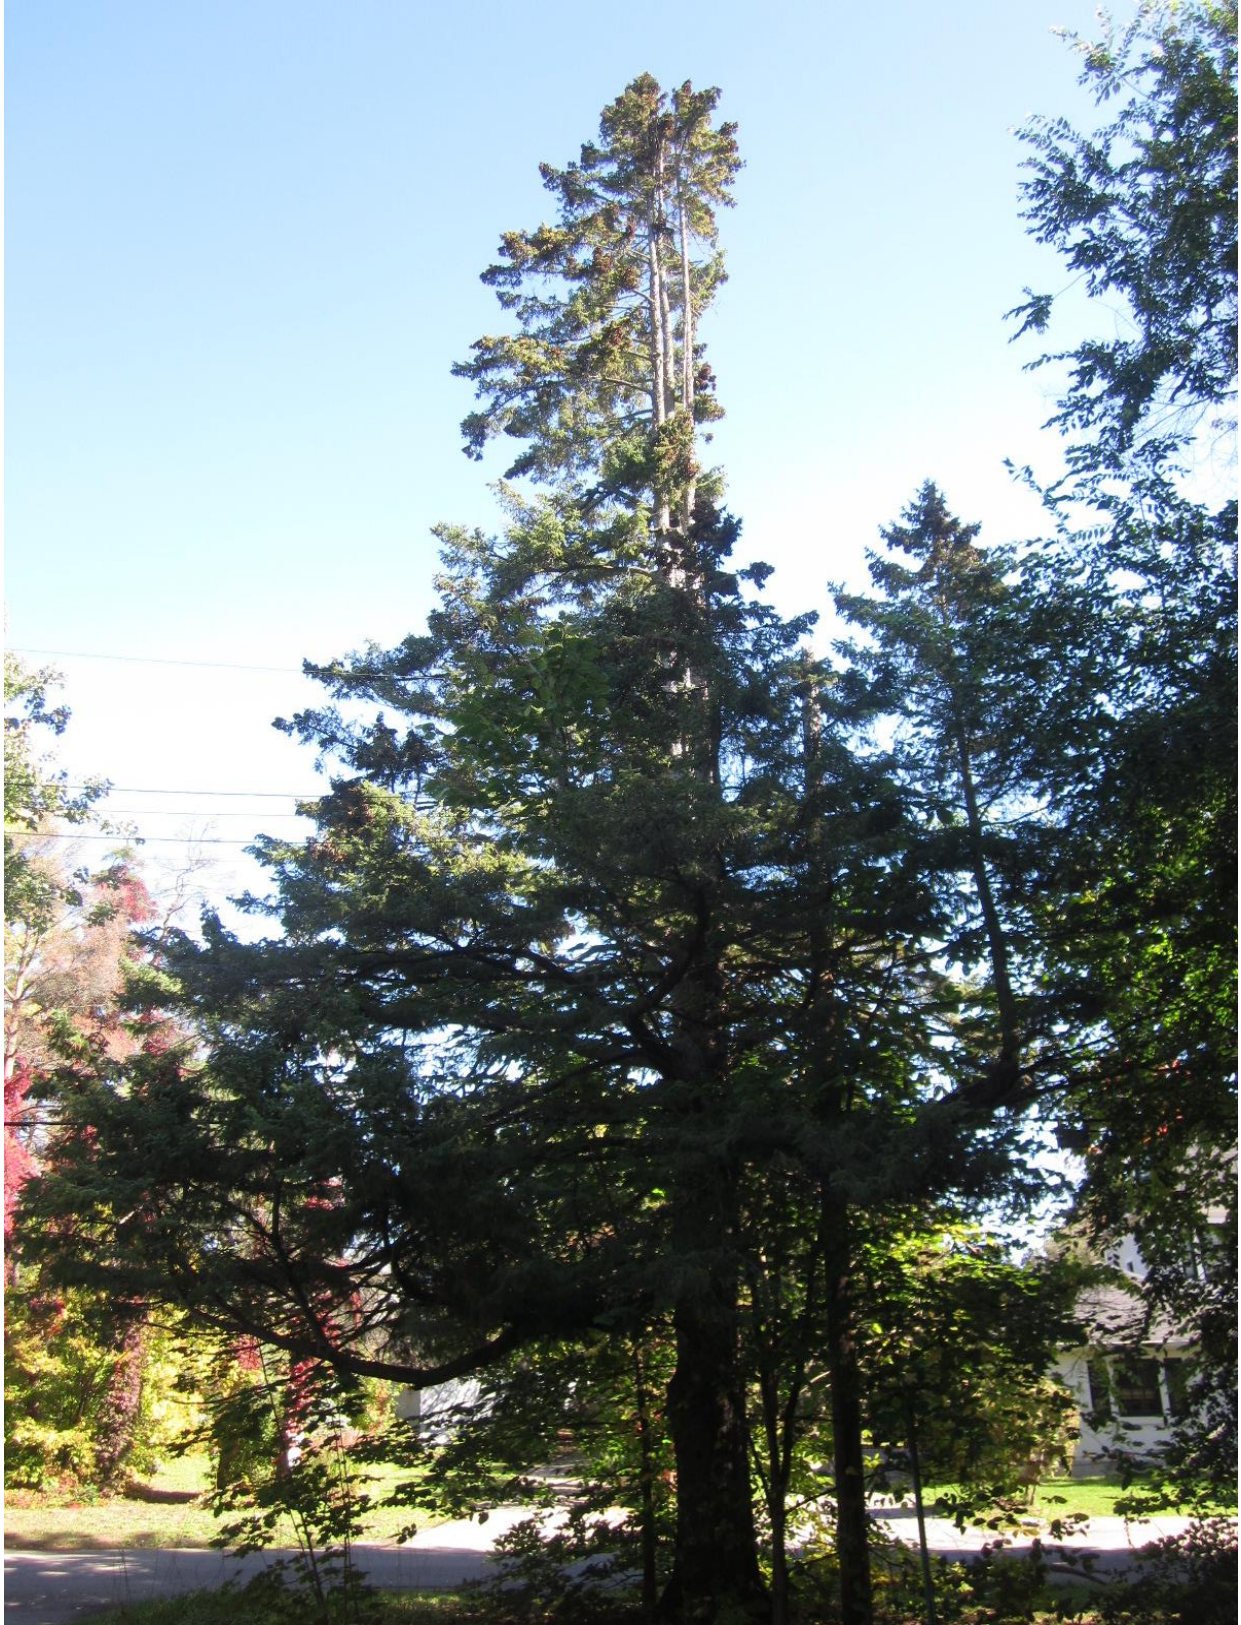
Picture 5. Tree #34, white spruce on City lands adjacent to 14 Crescent Road, Rockcliffe

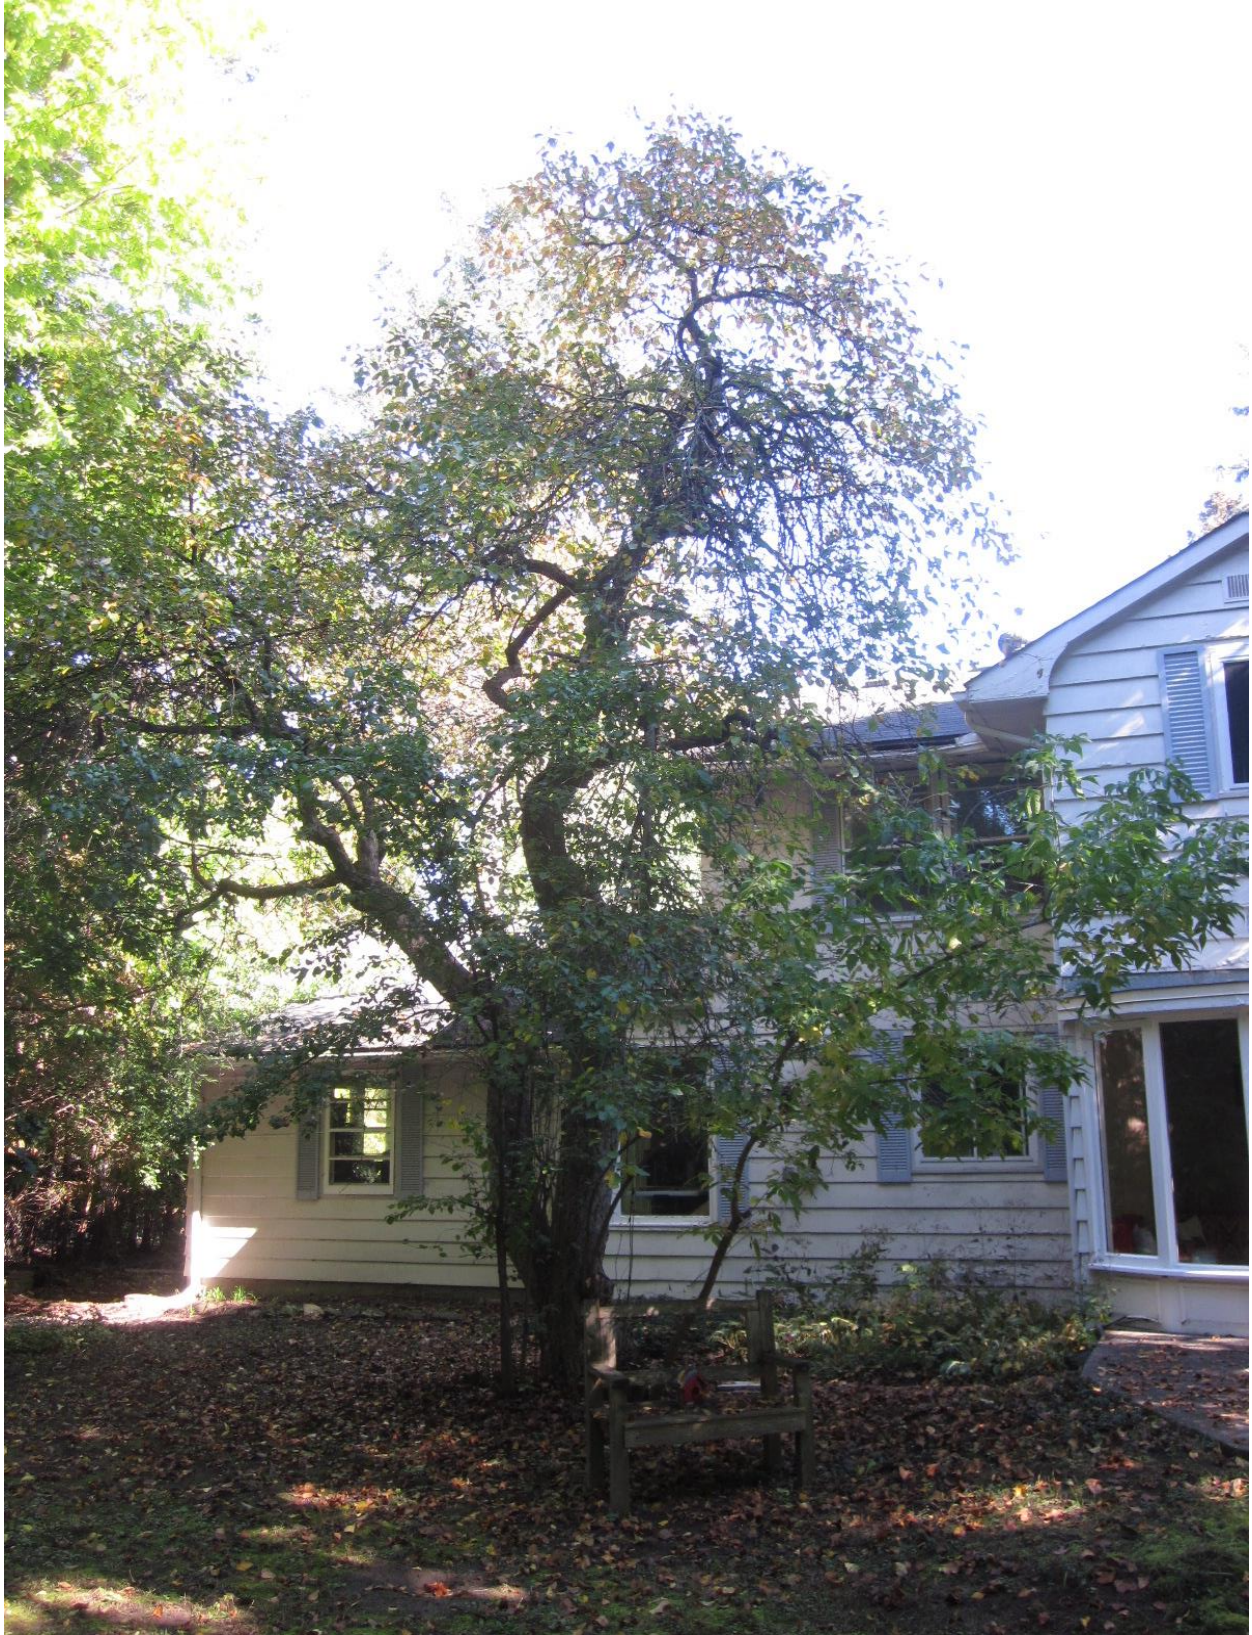
Tree No.	Tree species	Condition (very poor → excellent)	DBH <sup>1</sup> (cm)	Ownership <sup>2</sup>	Age class, tree condition notes & <b>preservation status</b> (to be removed or preserved and protected)
37	Crab apple ( <i>Malus spp.</i> )	Fair	31.3 & 37.6	Private	Mature; double stemmed at grade - central stem with competing stem on north; central stem with suppressed laterals starting at 3m on east; girdled by clothesline; both stems with basal cavities; combined crown is broad; cultivar; <b>to be removed</b> (conflicts with proposed footprint of new dwelling)

Picture 6. Tree #37, private crab apple at 14 Crescent Road, Rockcliffe
