Tree Information Report

Submitted as part of Committee of Adjustment Application to the City of Ottawa

Address: 1044 Secord Ave
Date of Report: November 17, 2022
Date of Site Visit: October 26, 2022
Prepared by: Astrid Nielsen, RPF, ISA Certified Arborist®
131 Smirle Ave, Ottawa, K1Y 0S4
Astrid.nielsen@dendronforestry.ca
Client: Cesare Santaguida, ces@vsclimited.com

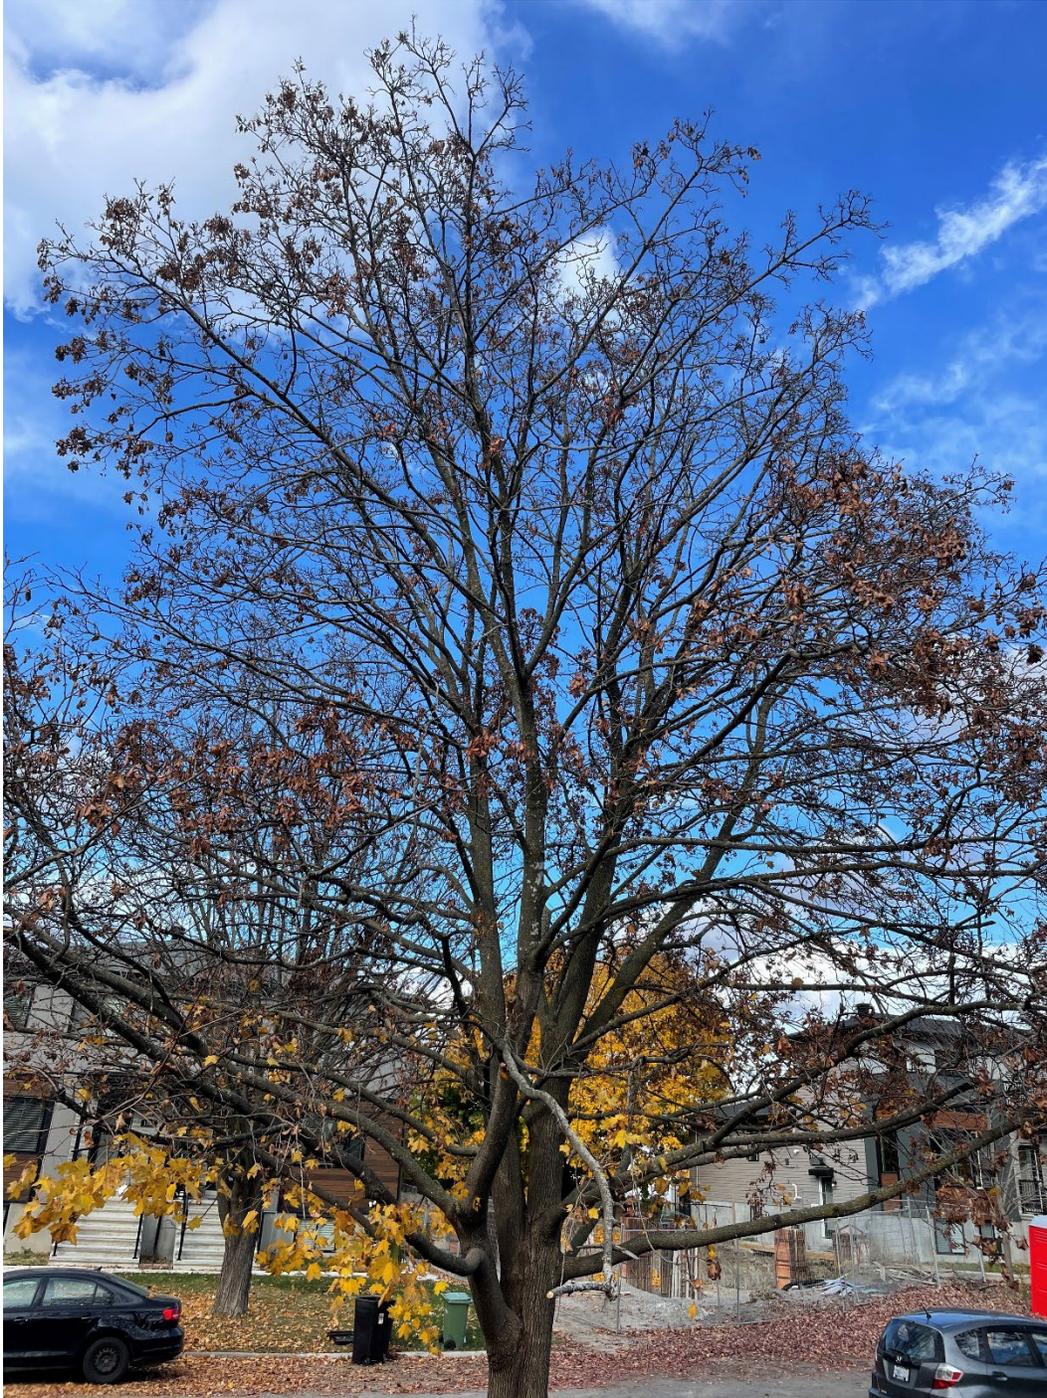
The Norway maple in the city right of way at the front of the property is in fair condition. The tree is vigorous, but it has a large root that is girdling approximately 1/3 of the trunk circumference. The effects of girdling roots are first seen in the crown when the tree begins to slowly dieback, and the dieback in the crown is approximately 10%.

This tree is located at the front of the property where there will be significant construction activity, particularly by large machinery to access the site (for demolition and excavation). The space will be limited as the housing density will increase from one to two units and the lot is only 15 m wide. In order to retain this tree effectively, it would require at least a 3 m protection zone around it where no activity at all takes place including site access, service installation and service shut off. Even with this level of protection, there would be impacts to the tree from the loss of roots for the new driveways and there is a likelihood of decline.

Figure 1: City owned Norway maple

The level of intensification and limited spacing combined with a tree that is in fair health, removal and replacement is the recommended option. If retention is preferred by the city and/or client, the following mitigations measures are recommended to maximize protection and the chance of long-term survival:

- Install new services underneath driveways, or via directional boring
- Cap existing servicing as close to the road and as far from the critical root zone as much as possible
- Have arborist pre-sever roots of tree prior to driveway installation
- Do not change the grade and avoid landscaping within the protection zone

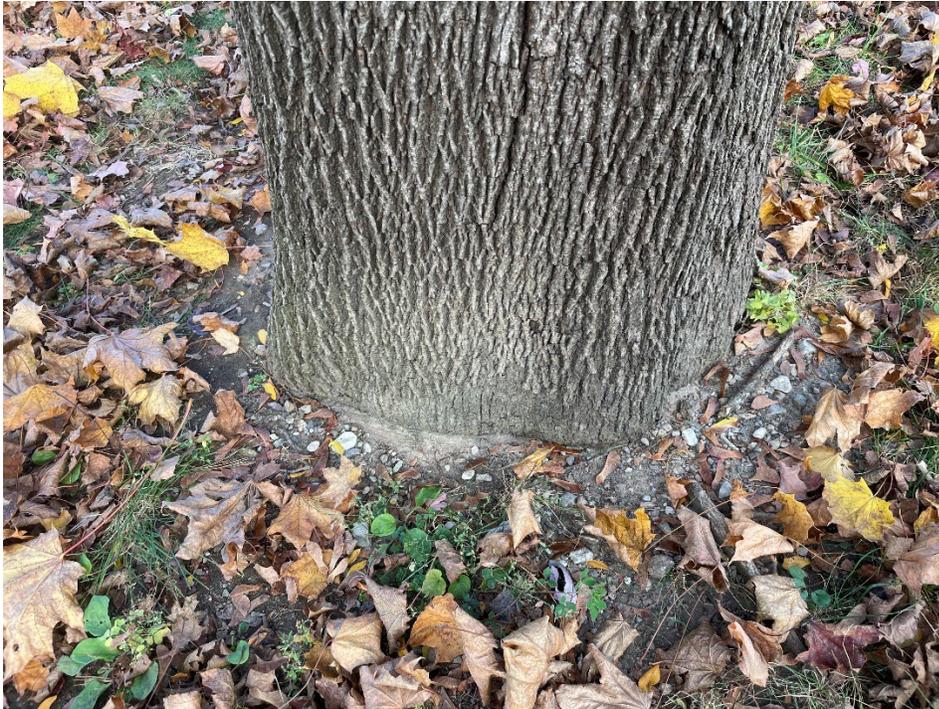
Figure 2: Girdling root encompassing 50 cm of tree circumference

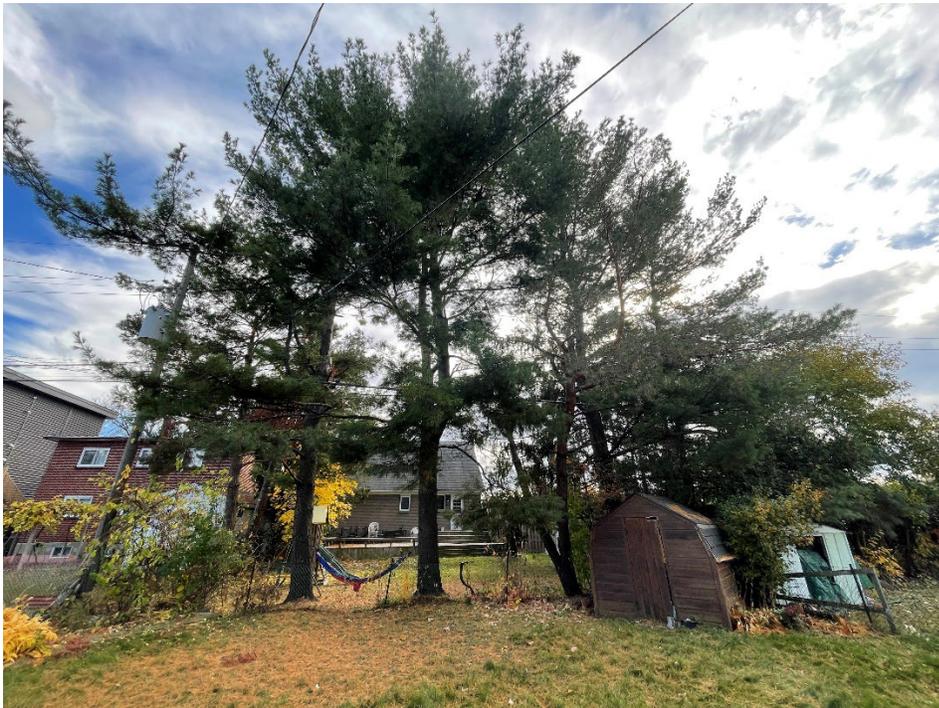
4	Scots pine (<i>Pinus resinosa</i>)	31,32 cm	Jointly owned with 1035 Heron	Fair	Retain	Retain and protect with City of Ottawa Tree Protection Specifications (March 2021);

recommend pruning of dead and failing branches
5	White pine (<i>Pinus strobus</i>)	44 cm	Jointly owned with 1035 Heron	Good	Retain	Retain and protect with City of Ottawa Tree Protection Specifications (March 2021); recommend pruning of dead and failing branches

Figure 3: Pine trees along the rear property line
