Dendron Forestry Services

Tree Information Report

Address: 3954 Shirley Avenue

Date of Report: April 5, 2023

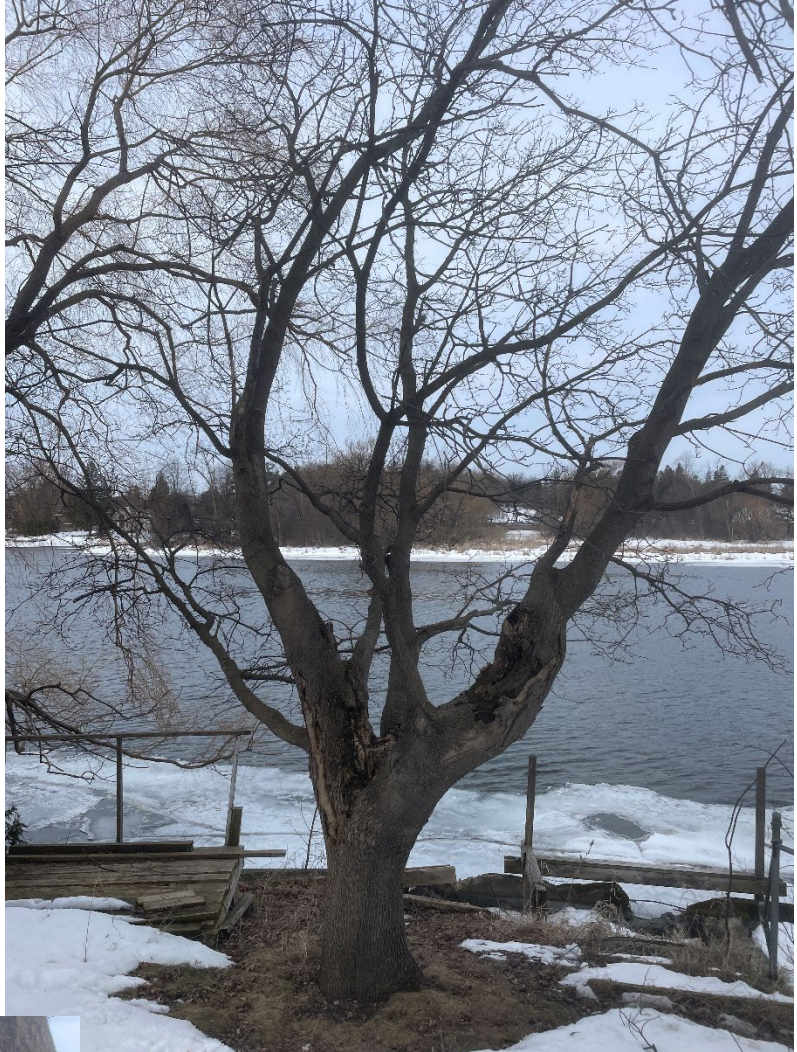
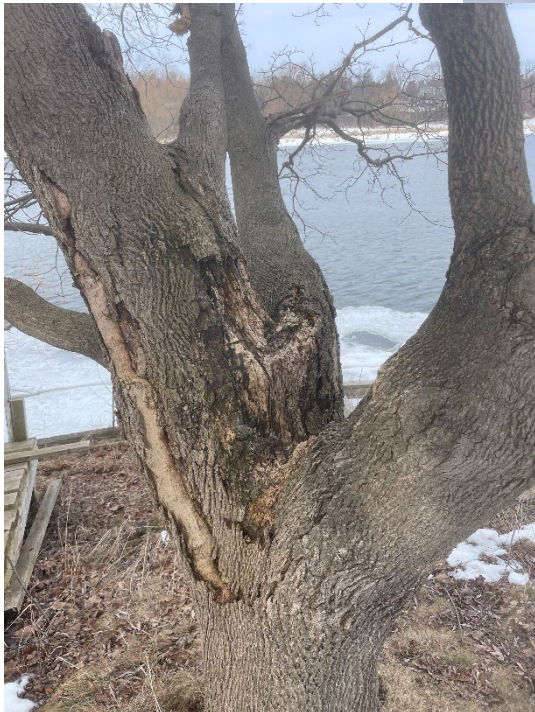
Tree 2 is a Norway maple in poor condition due to the high presence of canker within the key branch unions. Since there are currently few targets, the risk of this tree is relatively low. However, if the client would prefer to remove this tree to eliminate risk completely, this report may act as justification for removal.

*Figure 1 - (Above) Tree 2: private Norway maple to be retained.
(Left) Canker on Tree 2*

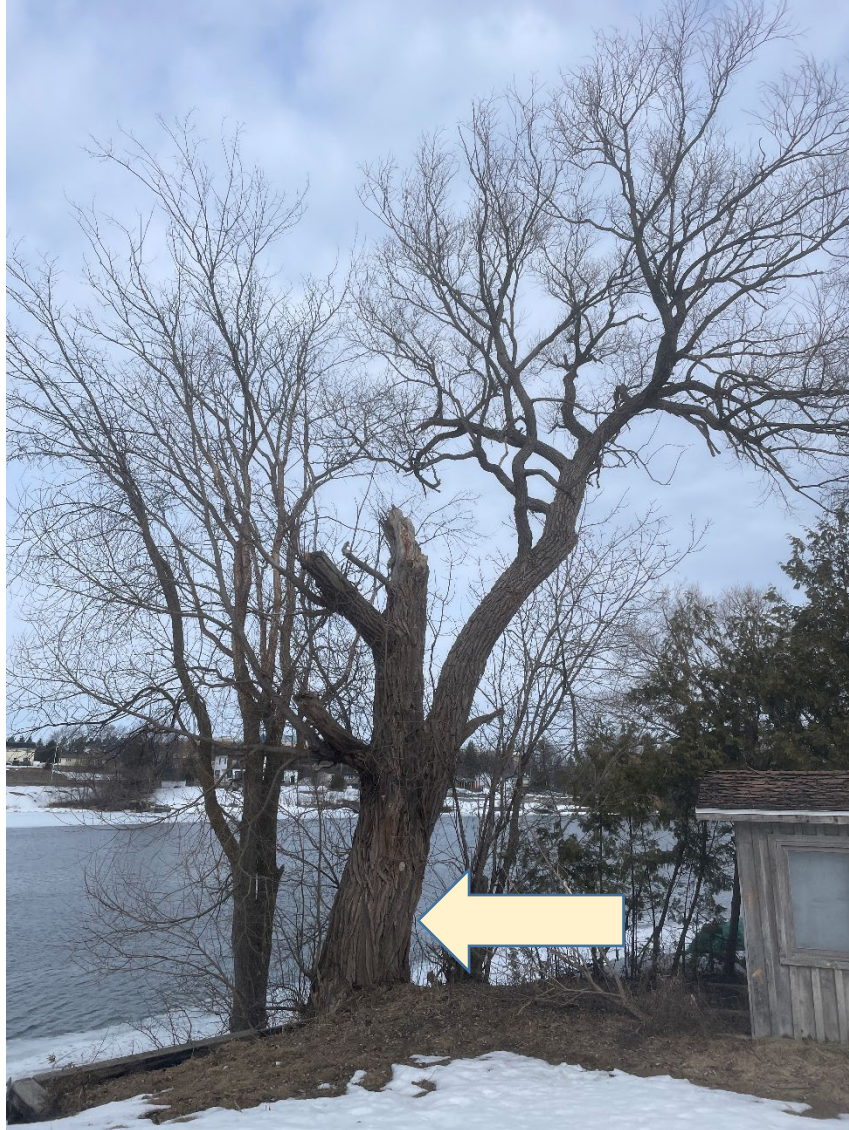
Figure 2 - Tree 5 (Right): private willow to be retained.

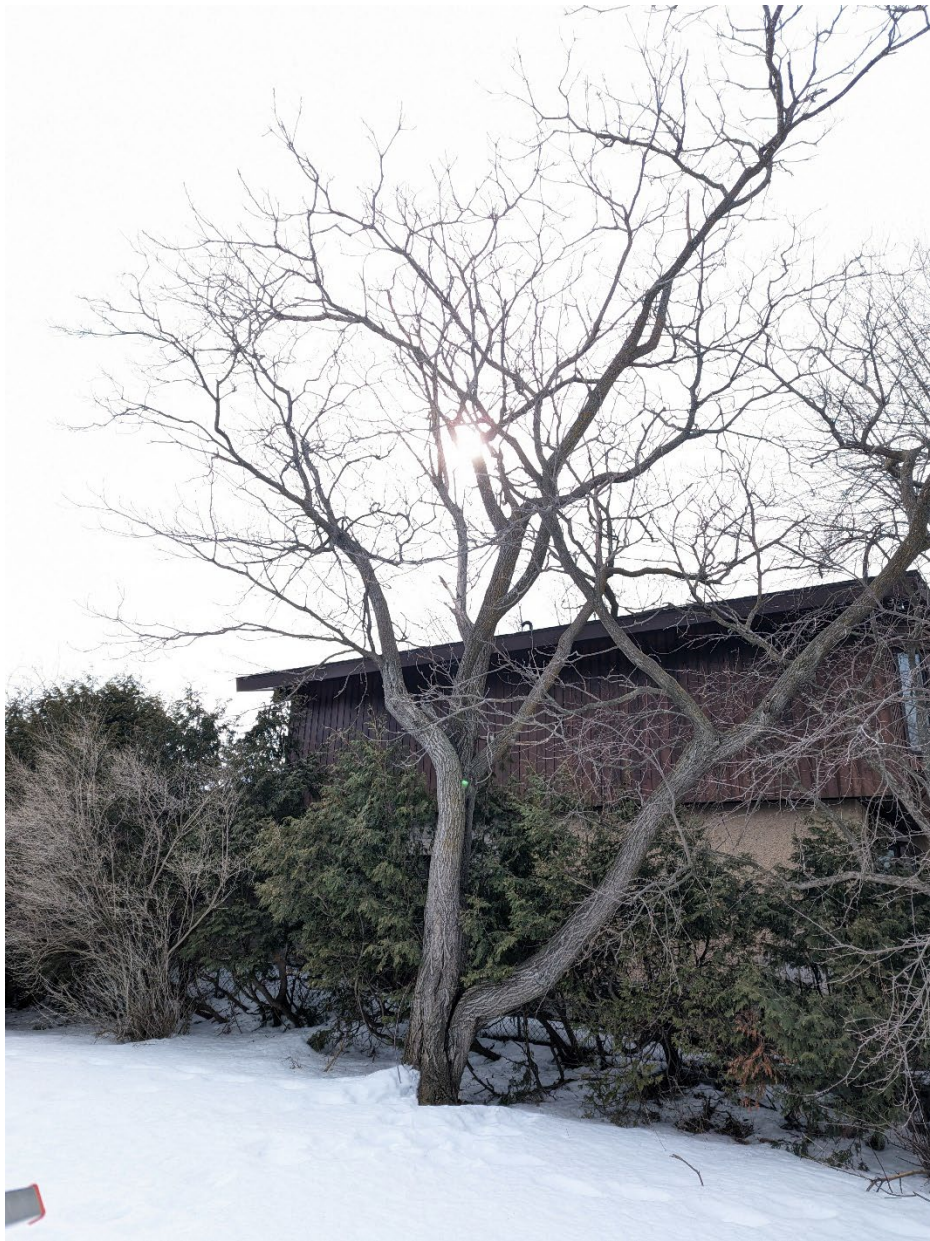
Tree 4 is a butternut tree which is a protected species under the provincial *Endangered Species Act (2007)*. The tree was assessed according to the butternut health assessment protocol and was determined to be *cultivated* and is therefore exempt under the Act. A letter confirming this finding was sent to the Ministry of the Environment, Conservation and Parks on April 5, 2023.

Figure 3 - Tree 4: private butternut to be removed.

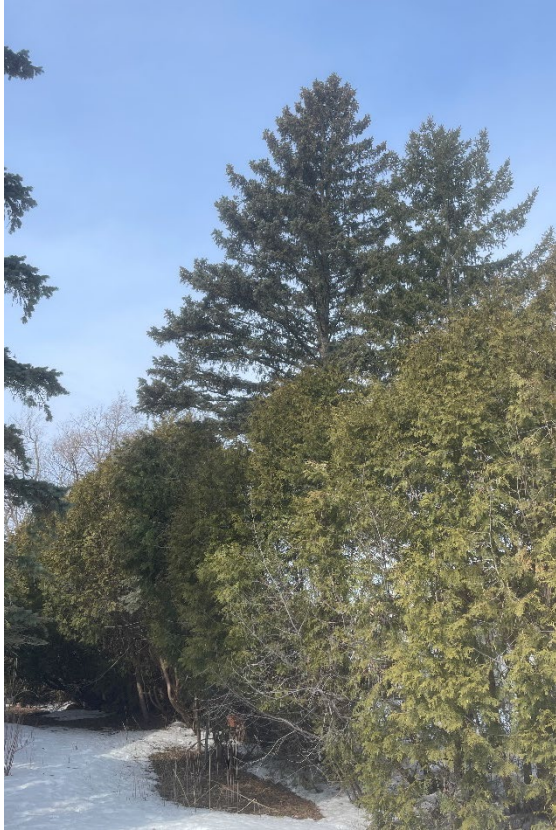
Figure 5 - Tree 7: adjacent Colorado spruce to be retained and protected.

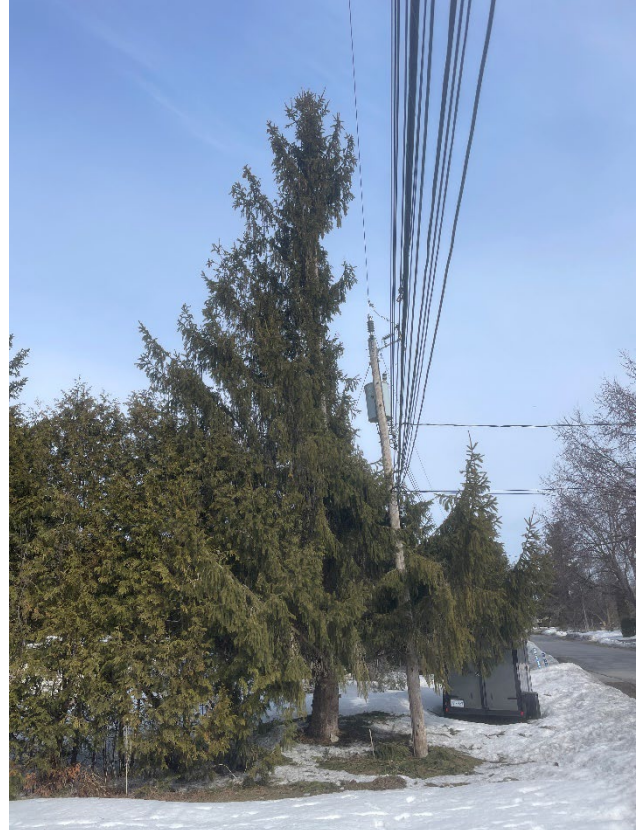
Figure 4 - Tree 8: Adjacent Norway spruce to be retained and protected.

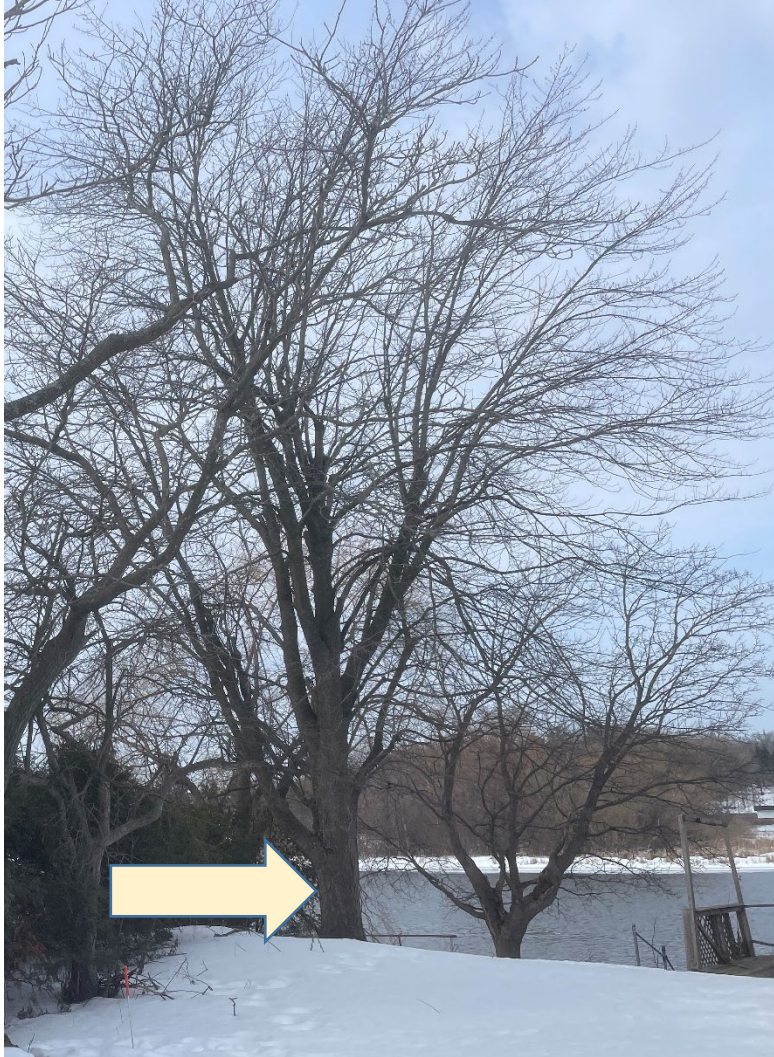
Figure 6 - Tree 3: private maple to be retained and protected.
