**RE: 1919, 1967 Riverside Drive (Schlegel Villages)
Tree Conservation Report for Minor Variance Application**

RE: TREE CONSERVATION REPORT FOR 1919 RIVERSIDE DRIVE, OTTAWA

DRAWING: Tree Conservation Plan

PROJECT: 1919 RIVERSIDE DRIVE
CITY OF OTTAWA

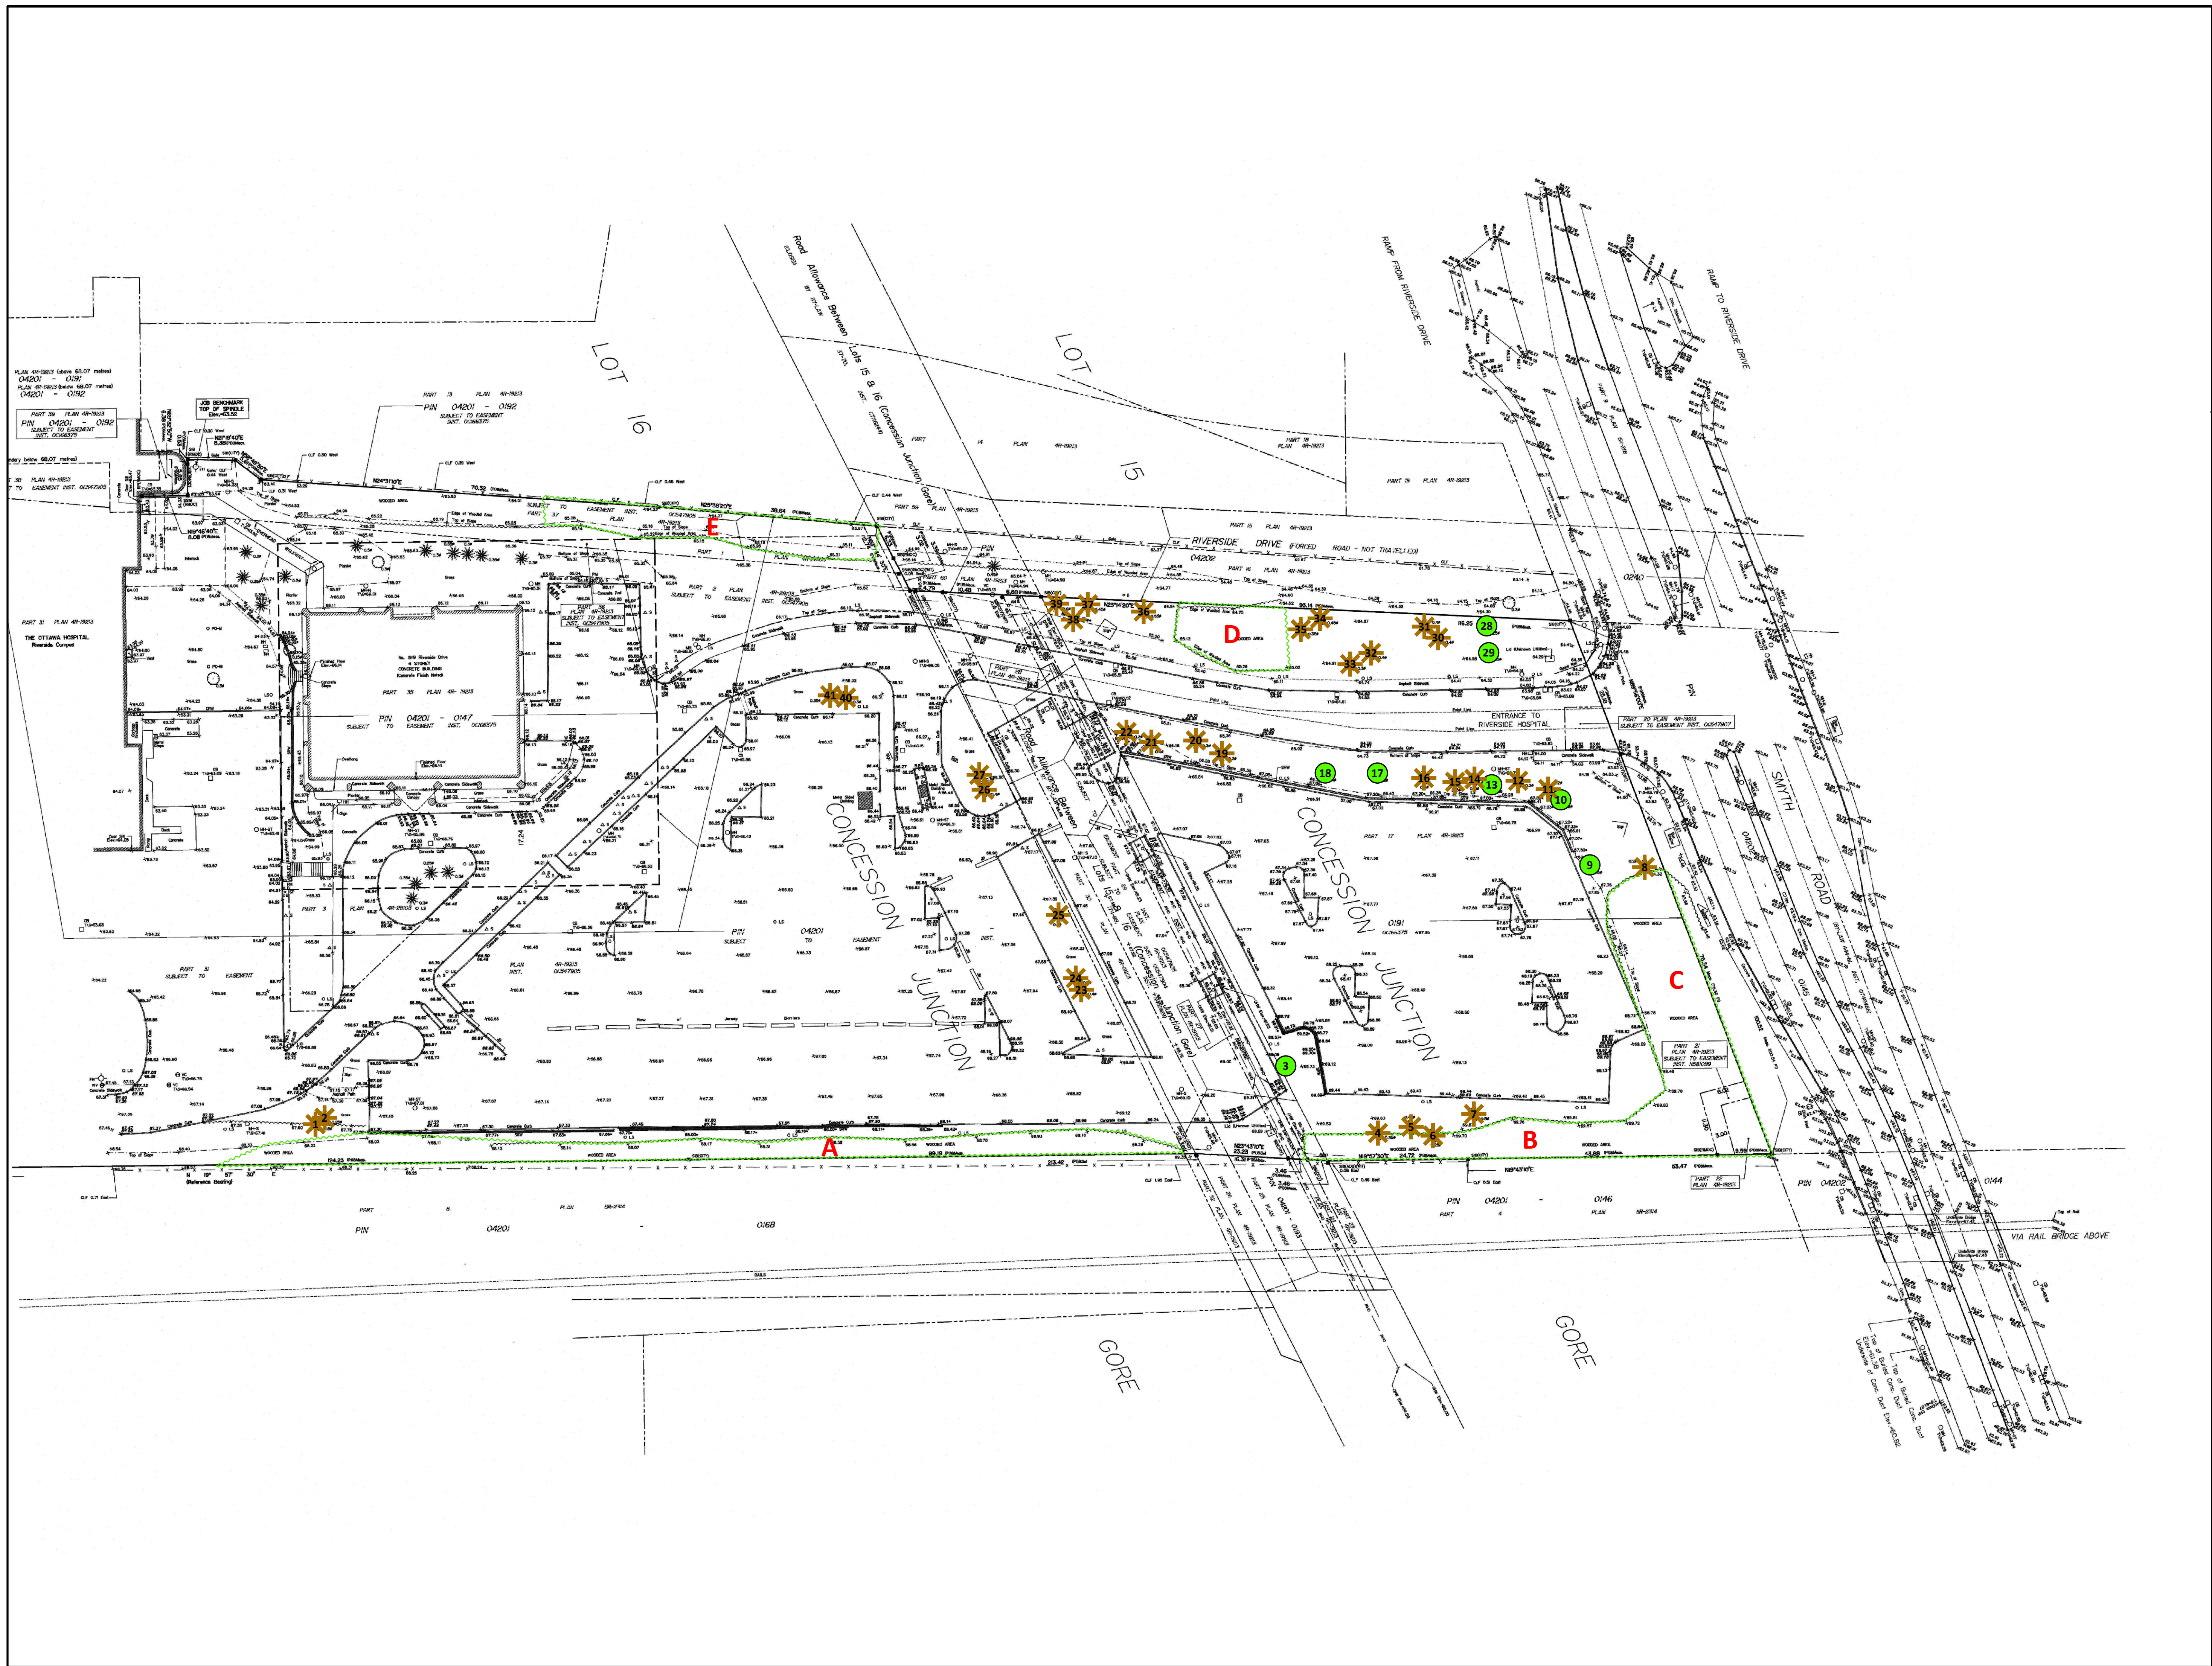
All current vegetation is shown on the tree conservation plan included on page 7 of this report. By the numbers indicated on the plan, each tree and grouping of trees is detailed below:

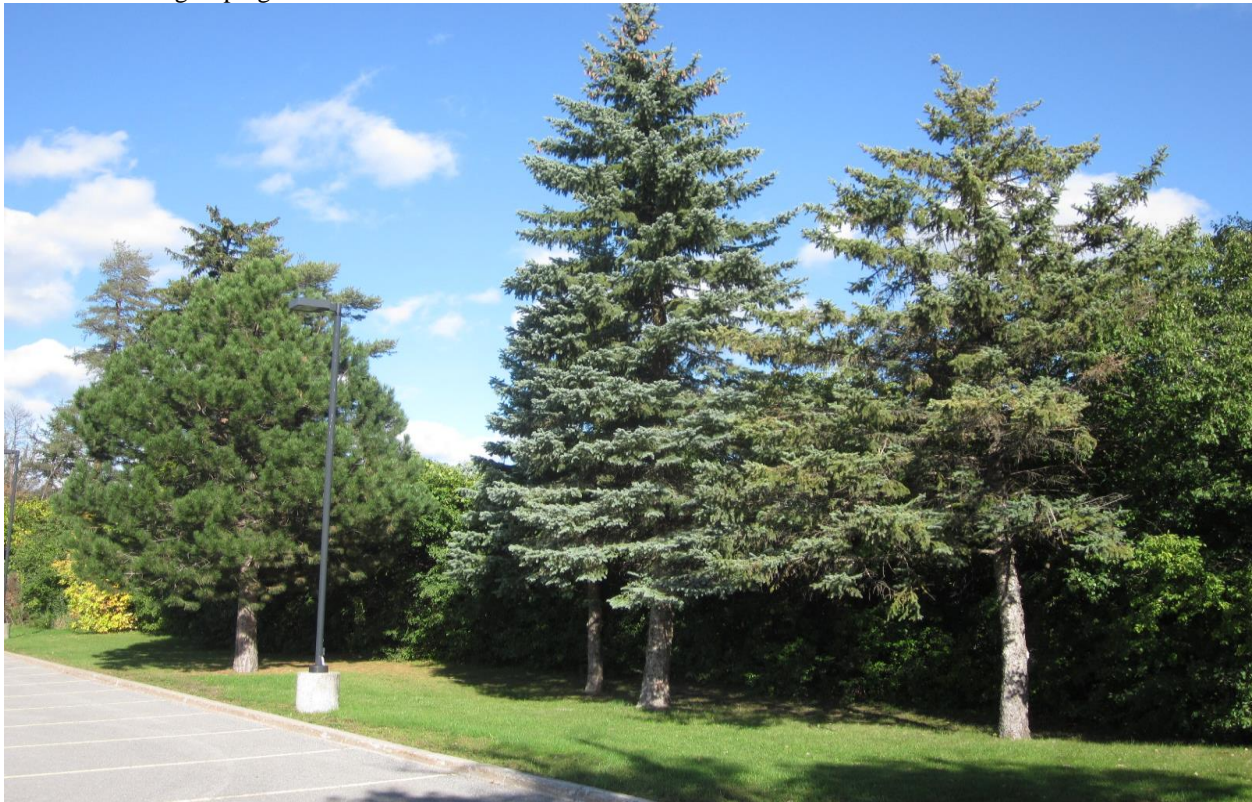
Picture 2. Trees #4-7 (right to left) at 1919 Riverside Drive

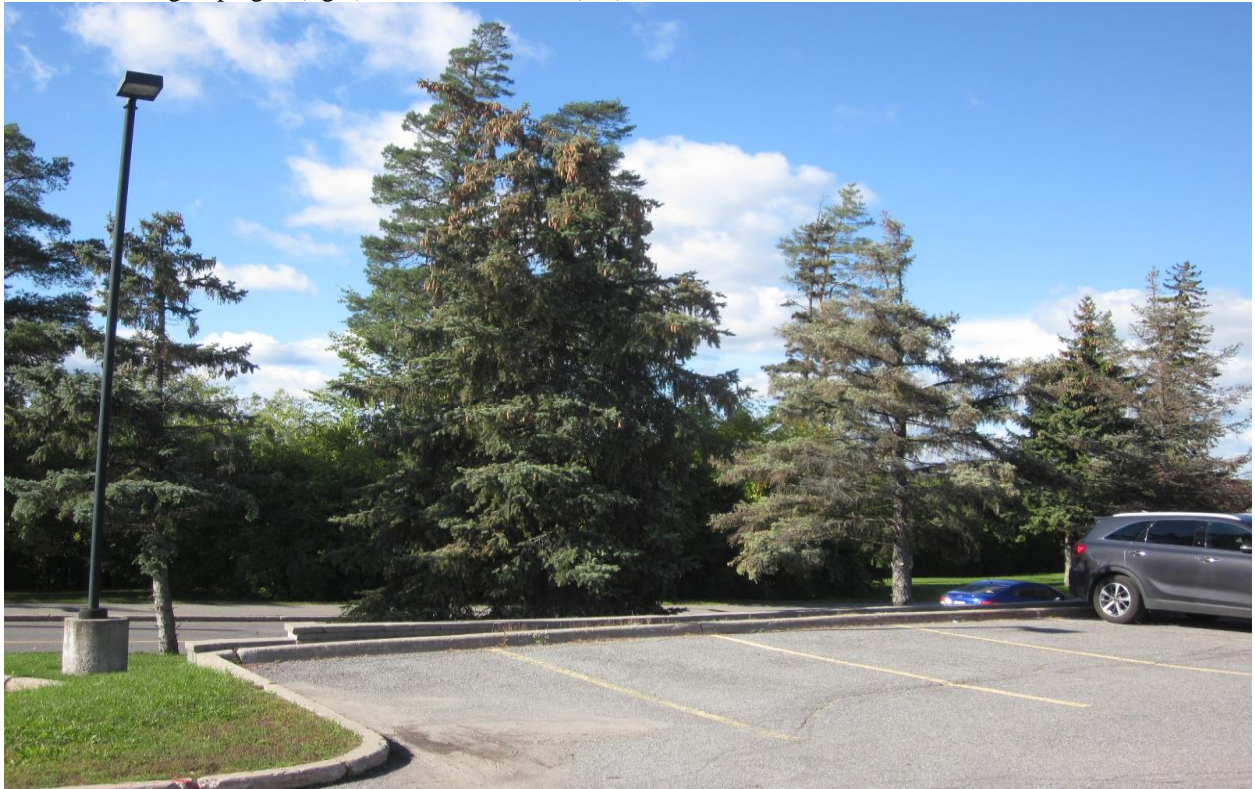
Picture 5. Trees #19-22 (right to left) at 1919 Riverside Drive
