URBAN FORESTRY & FOREST MANAGEMENT CONSULTING

April 5, 2022

RE: TREE INFORMATION REPORT (FULL) FOR 131 WINDING WAY

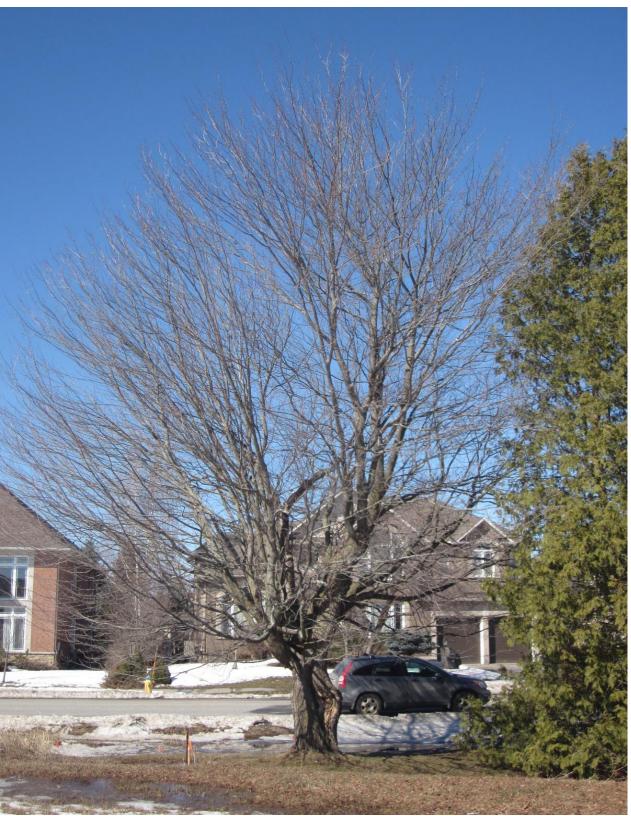
| Tree | Tree | DBH ¹ | CRZ^2 | Distance to | Owner | Condition, age class, condition |
|---|---|---|---|---|---|---|
| 2 | Red maple | 68.1 | 6.8 | +/-7 | City | Poor; mature; tri-dominant |
| | (Acer | (at | | | | stems at 2m from grade; |
| | rubrum) | 1.5m) | | | | dominant stem divergent |
| | | | | | | towards northeast with |
| | | | | | | epicormic growth on east and |
| | | | | | | south; broad, dense crown; old |
| | | | | | | wound on east at 0.5-1.2m, with |
| | | | | | | decay; major deadwood present; |

Picture 1. Red maple (tree #2) on City property adjacent to 131 Winding Way (photograph taken March 2021)

As the CRZ of trees #2 and 3 conflict with the excavation necessary for the proposed garage, measures intended to mitigate long-term damage to these trees will centre on minimizing root loss. To this end the following measure is recommended to promote their survival during and following construction:

1. Use of hydro excavation along the garage foundation in closest proximity to the trees so as to carefully expose any roots. This will allow any unearthed roots to be properly cut and sealed before being reburied. Excavation can then resume using traditional mechanical means. Sealing the cleanly cut root ends with a beeswax product will help prevent the loss of moisture and facilitate healing.

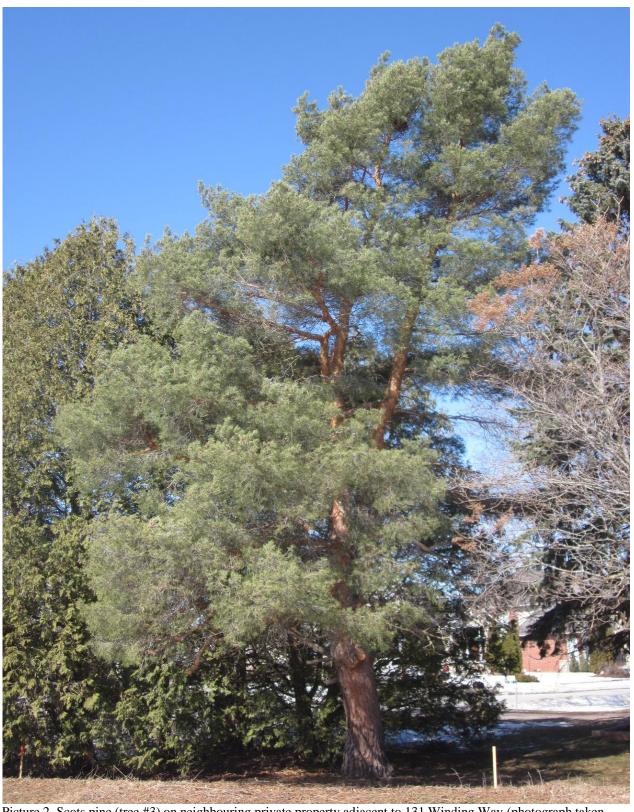
| Tree | Tree | DBH ¹ | CRZ^2 | Distance to | Owner | Condition, age class, condition |
|---|---|---|---|---|---|---|
| 3 | Scots pine | 61.5 | 6.2 | +/5 | Neigh- | Good; mature; co-dominant |
| | (Pinus | | | | bour | stems at 2.75m from grade; |
| | sylvestris) | | | | | crown asymmetric towards |
| | | | | | | south due to intercompetition |
| | | | | | | with adjacent trees; very good |
| | | | | | | crown density, growth |
| | | | | | | increment and needle colour |
| | | | | | | where exposed to sunlight; |
| | | | | | | good root collar – consistent |
| | | | | | | flaring; introduced invasive |

Picture 2. Scots pine (tree #3) on neighbouring private property adjacent to 131 Winding Way (photograph taken March 2021)
