URBAN FORESTRY & FOREST MANAGEMENT CONSULTING

September 14, 2022

RE: TREE CONSERVATION REPORT FOR 817 ROSEVIEW AVENUE, OTTAWA

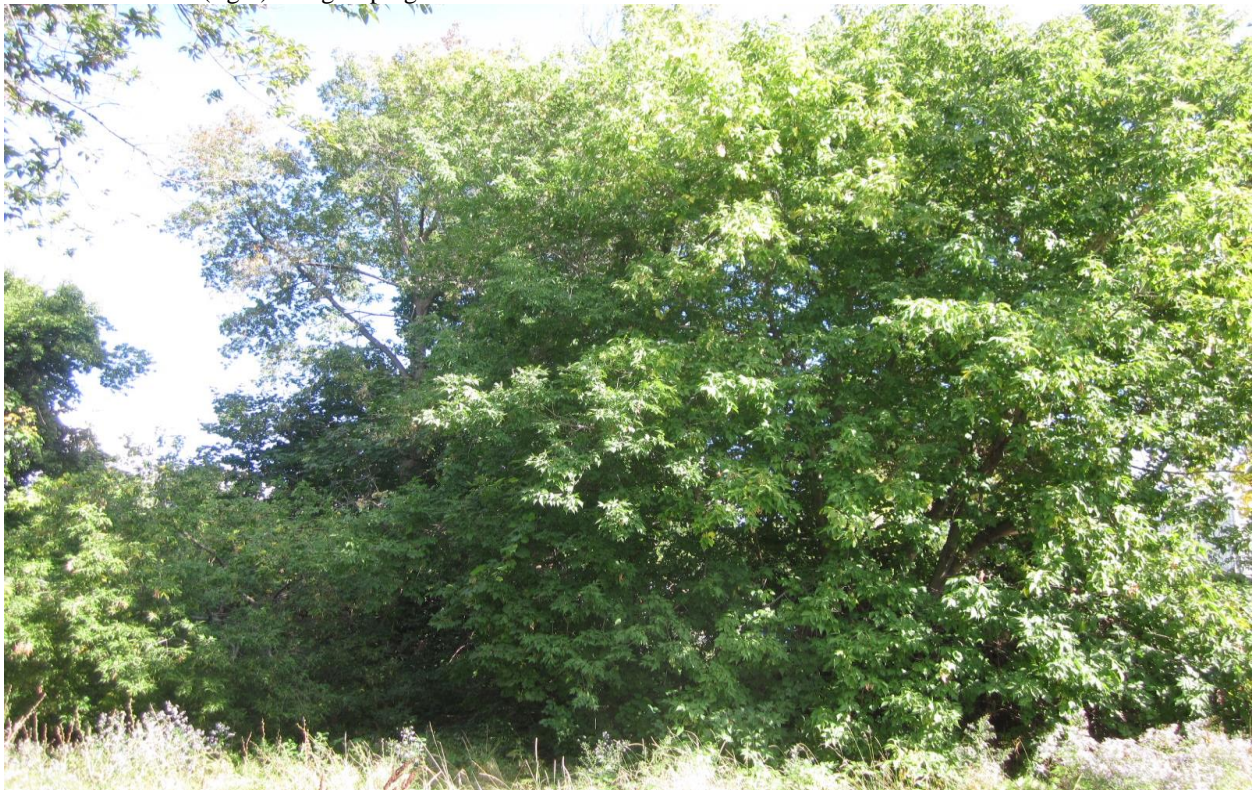
Tree grouping #4: A line of three Manitoba and two Norway maples (*Acer platanoides*). The Manitobas, all being in excess of 50 cm diameter, are mature while the Norway maples, ranging in diameter from 20-25cm, are considerably younger. Like the Manitoba maples, the Norway maples would have originated from seed. This species was introduced to North America and is considered invasive here. Importantly, several of these trees appear to be shared with the private property to the south. The neighbouring property owner's written permission is required prior to their removal.

Picture 2. Tree grouping #4 at 817 Roseview Avenue

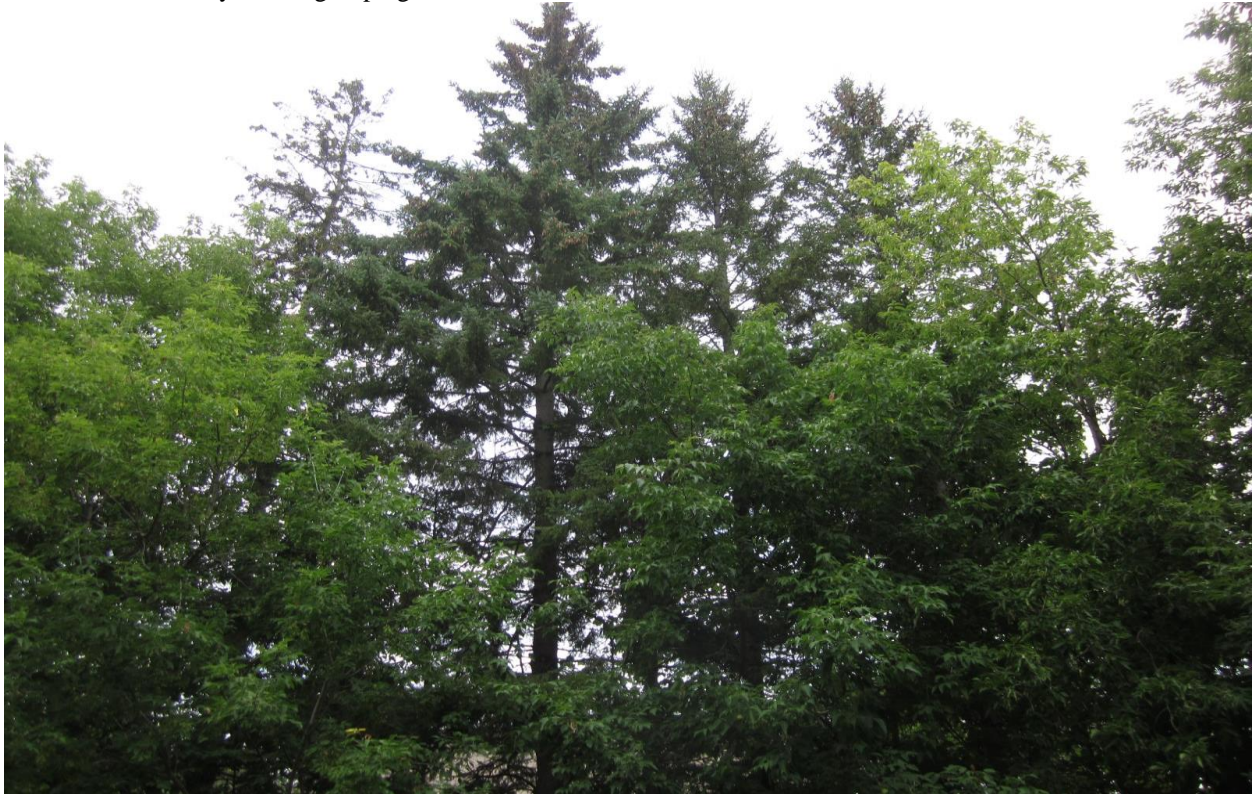
Tree grouping #5: A line of nine white spruce ranging in diameter from 12 to 36 cm. A single tree of the same species is present on the private property to the north. All would have been planted. The health of these trees has been negatively impacted by the growth of Manitoba maples in the understory and vine growth. Suppression from this competing vegetation has led to the death of two spruce and the decline of another four. The three largest spruce have grown above the competing canopy and appear to be in relative good condition – holding crowns of dense, good-coloured foliage.

Picture 4. Overstory of tree grouping #5 at 817 Roseview Avenue
