Tree Information Report 2.0

Submitted as part of Committee of Adjustment Application to the City of Ottawa

Address: 2175 Alta Vista

Date: July 4, 2023

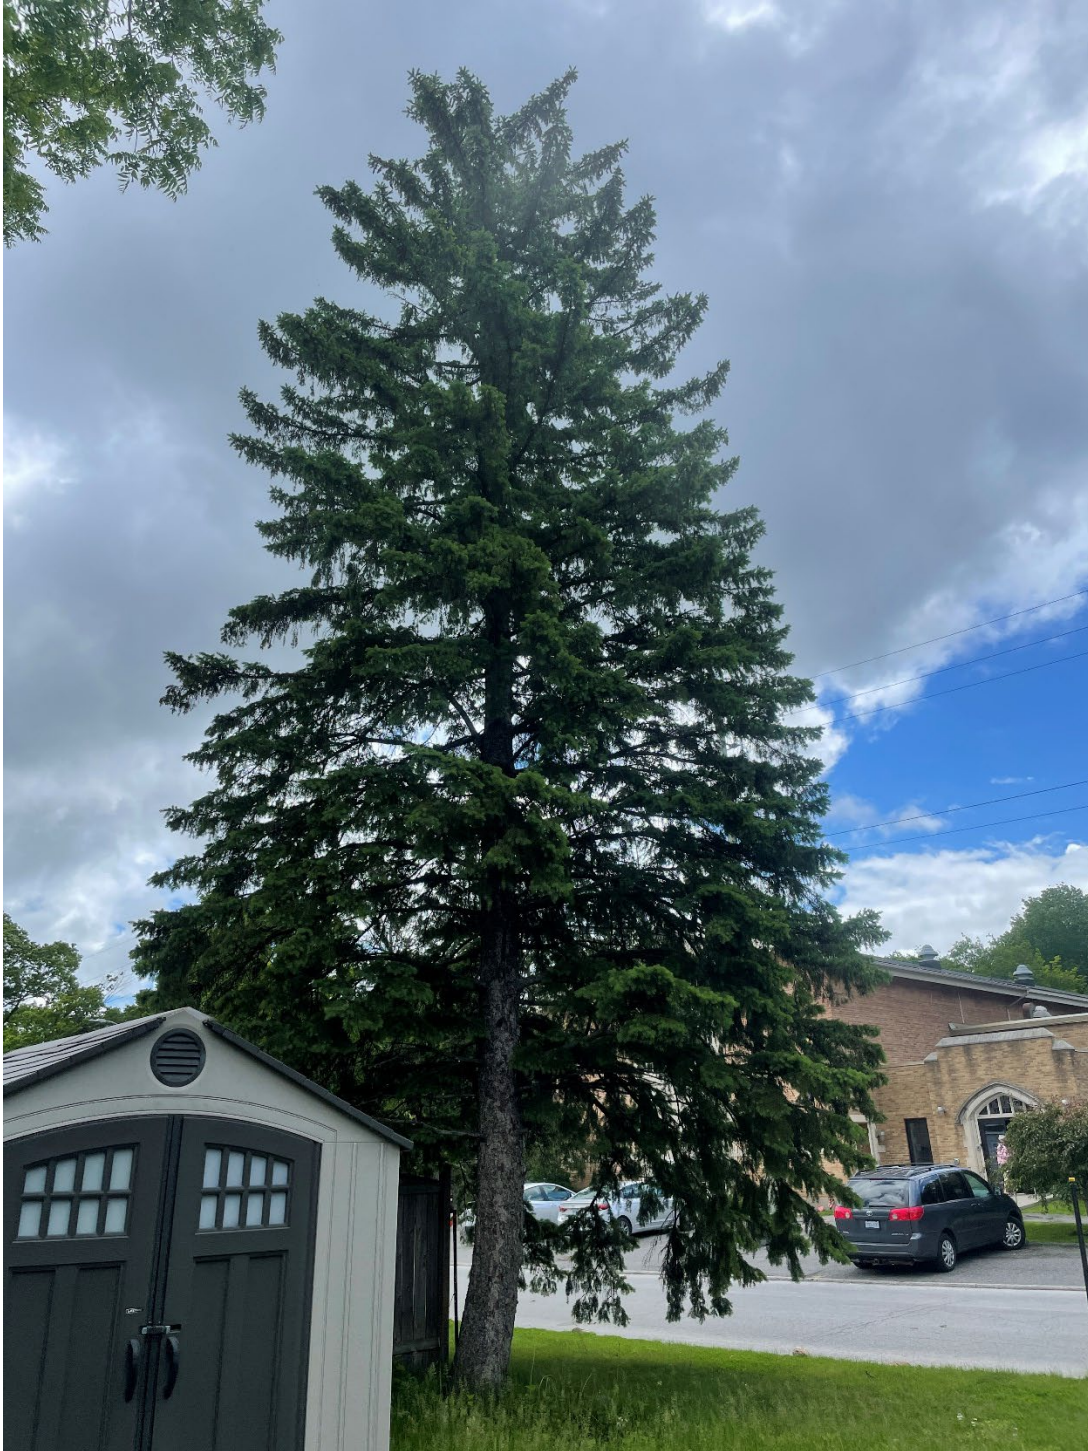
Figure 1: Tree 1, white spruce to be retained

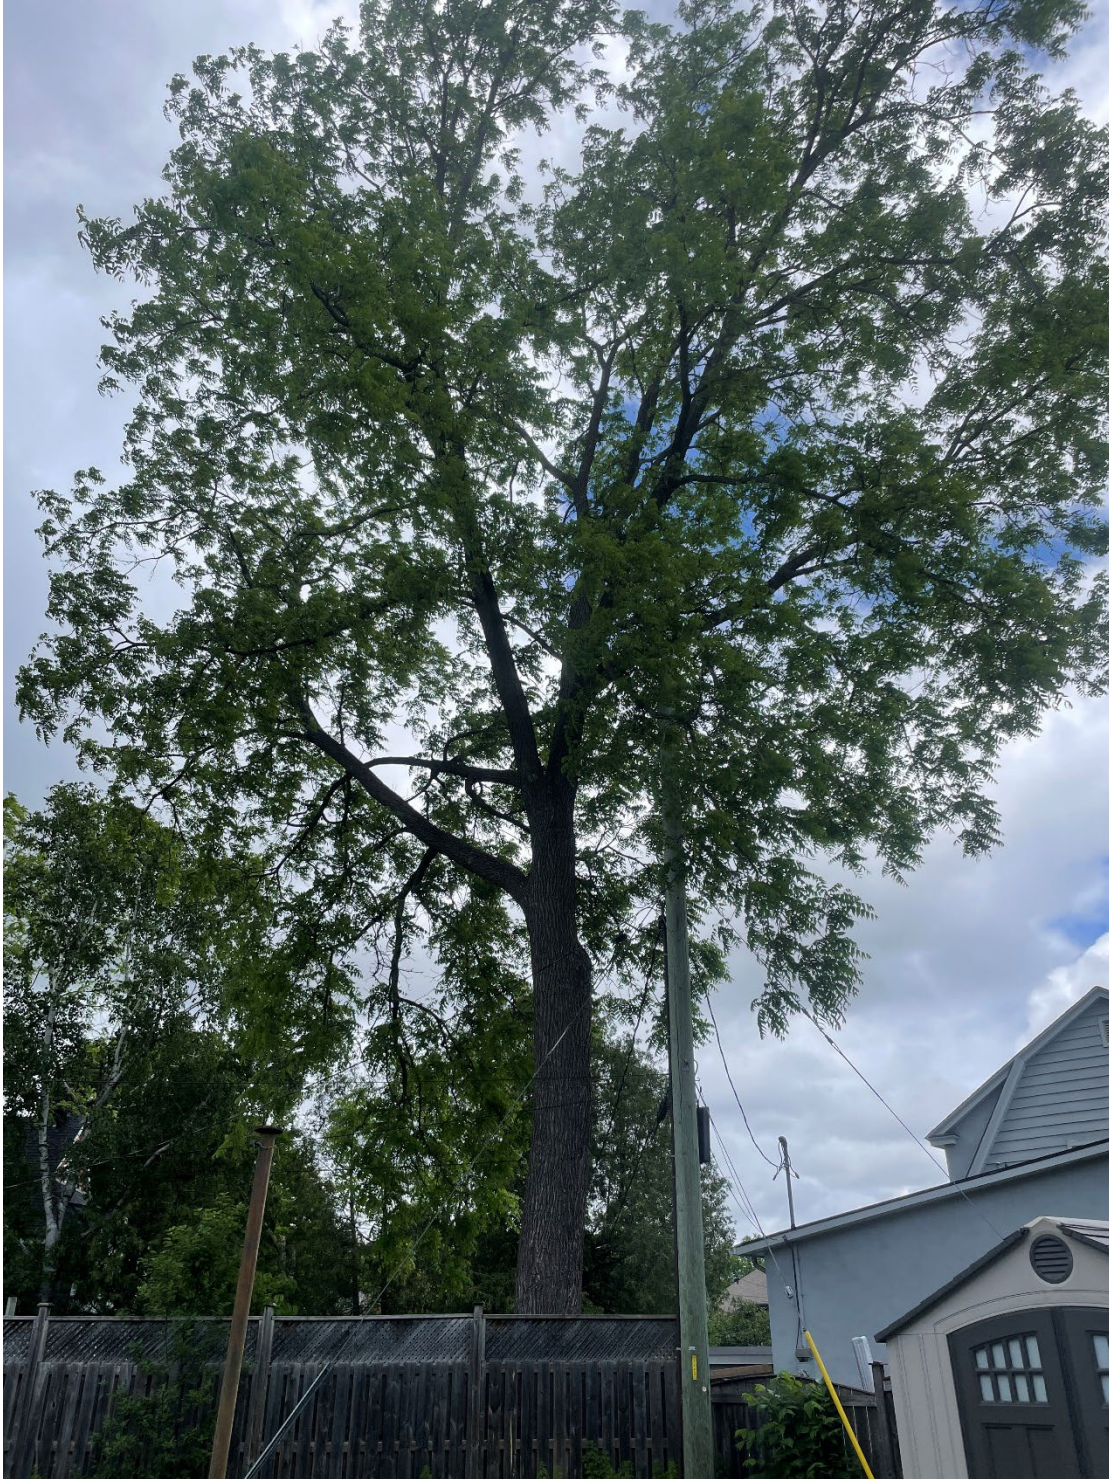
Figure 2: Tree 2, black walnut on adjacent property

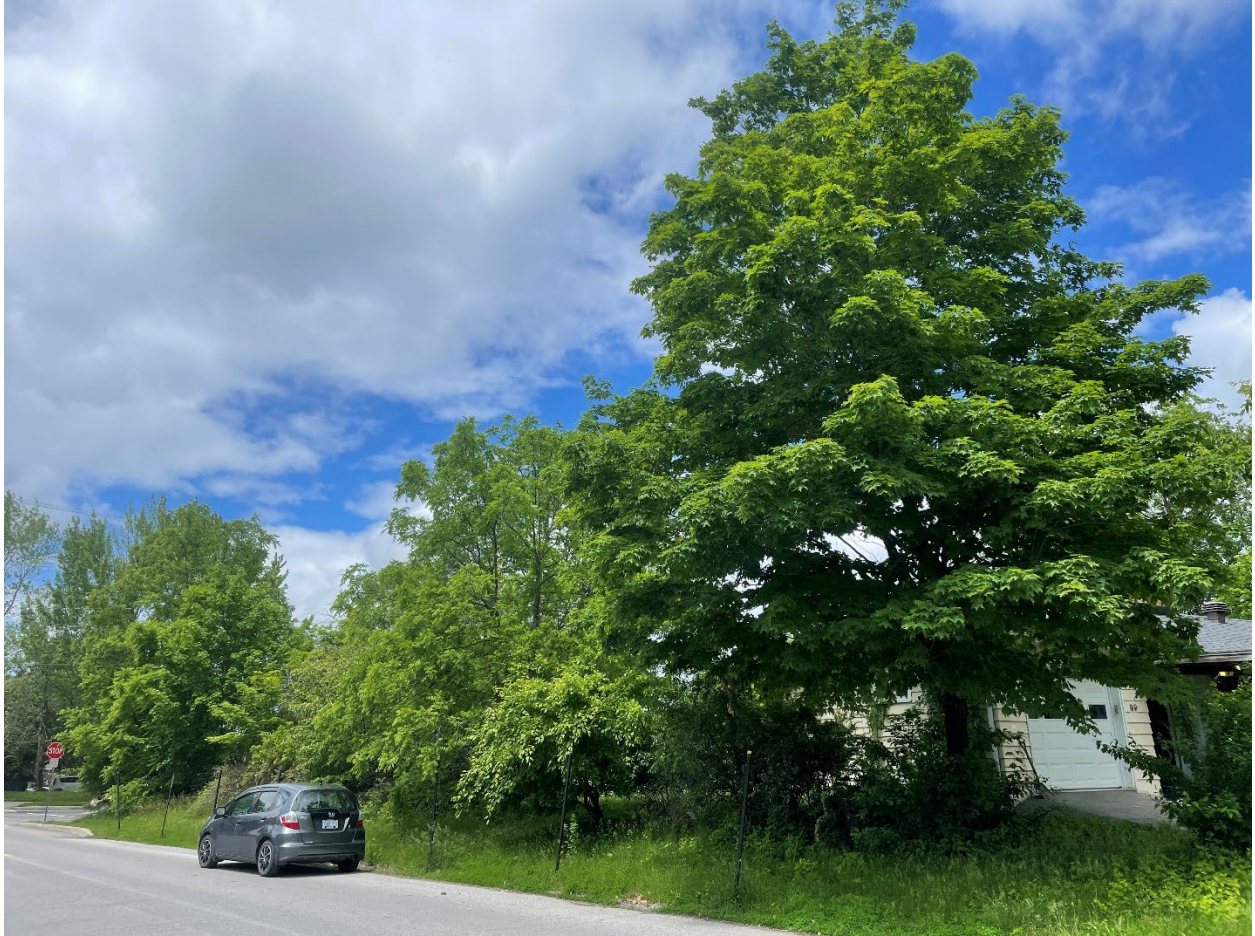
Figure 3: Trees 3-6, the southern edge, facing westward

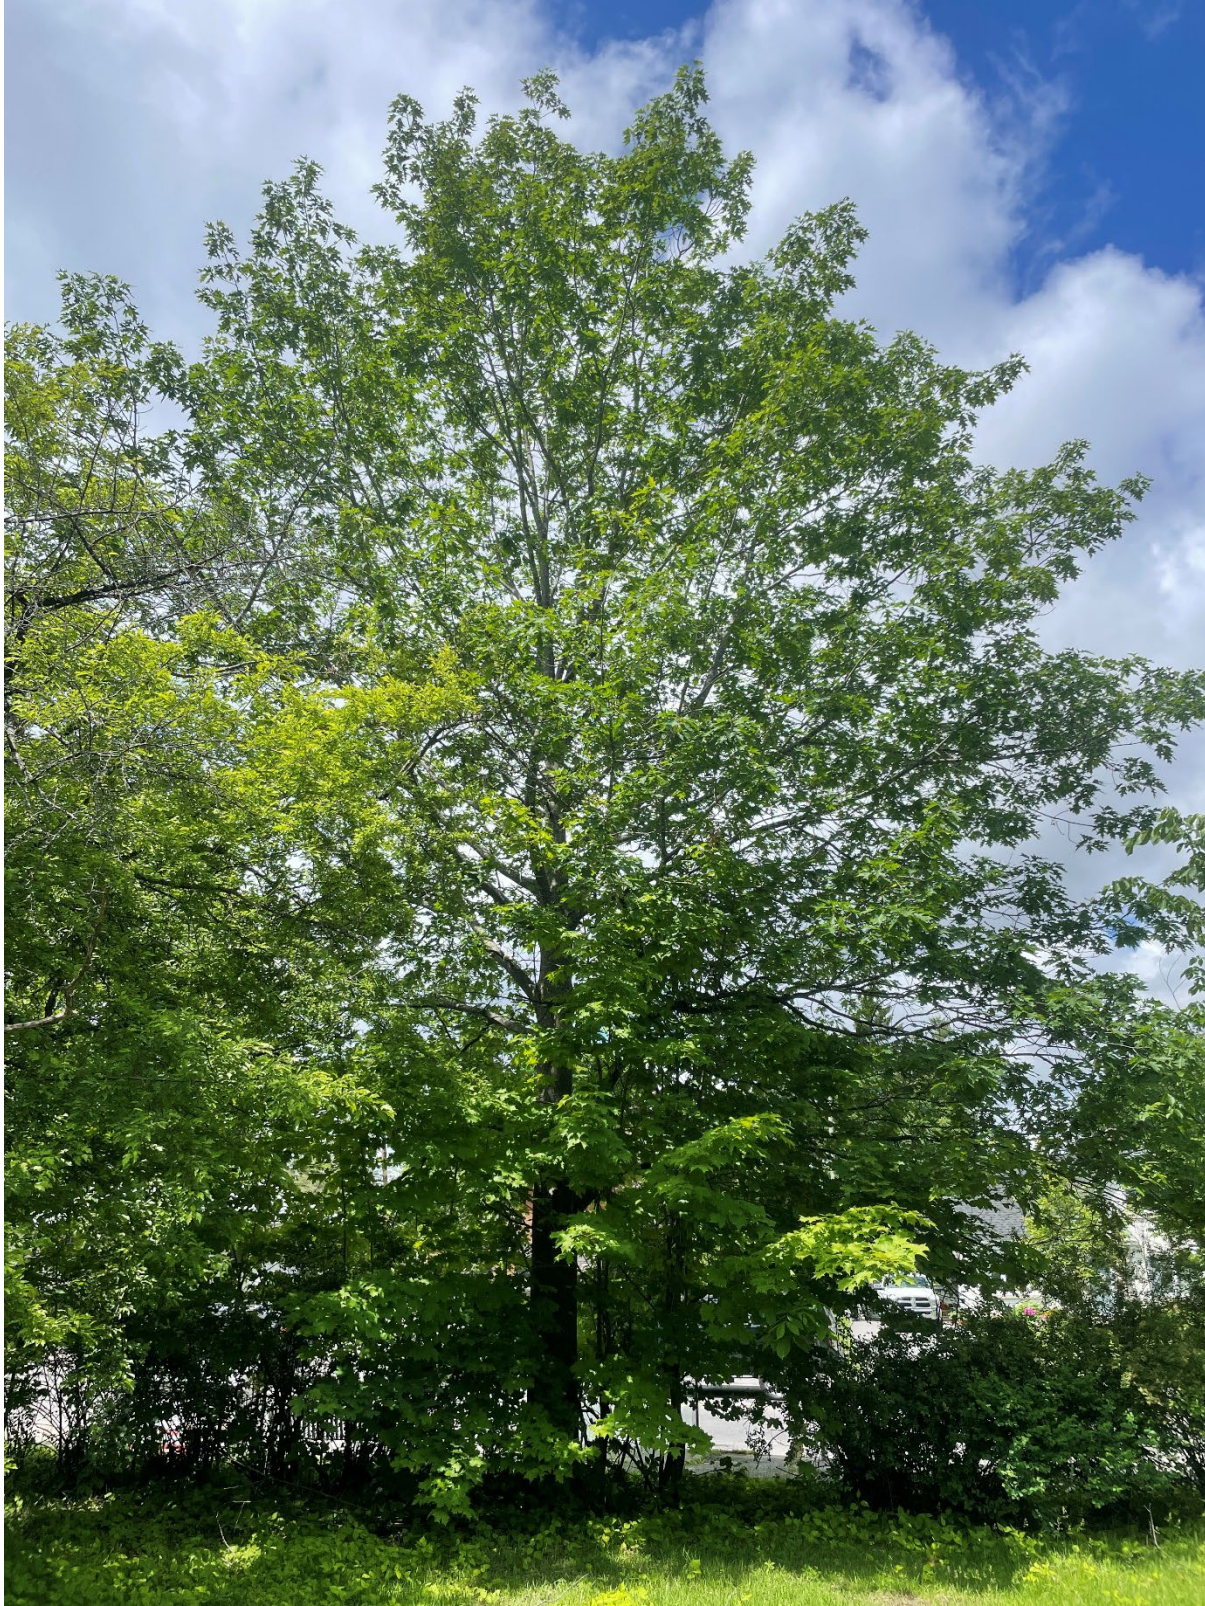
Figure 4: Tree 7, jointly owned red oak

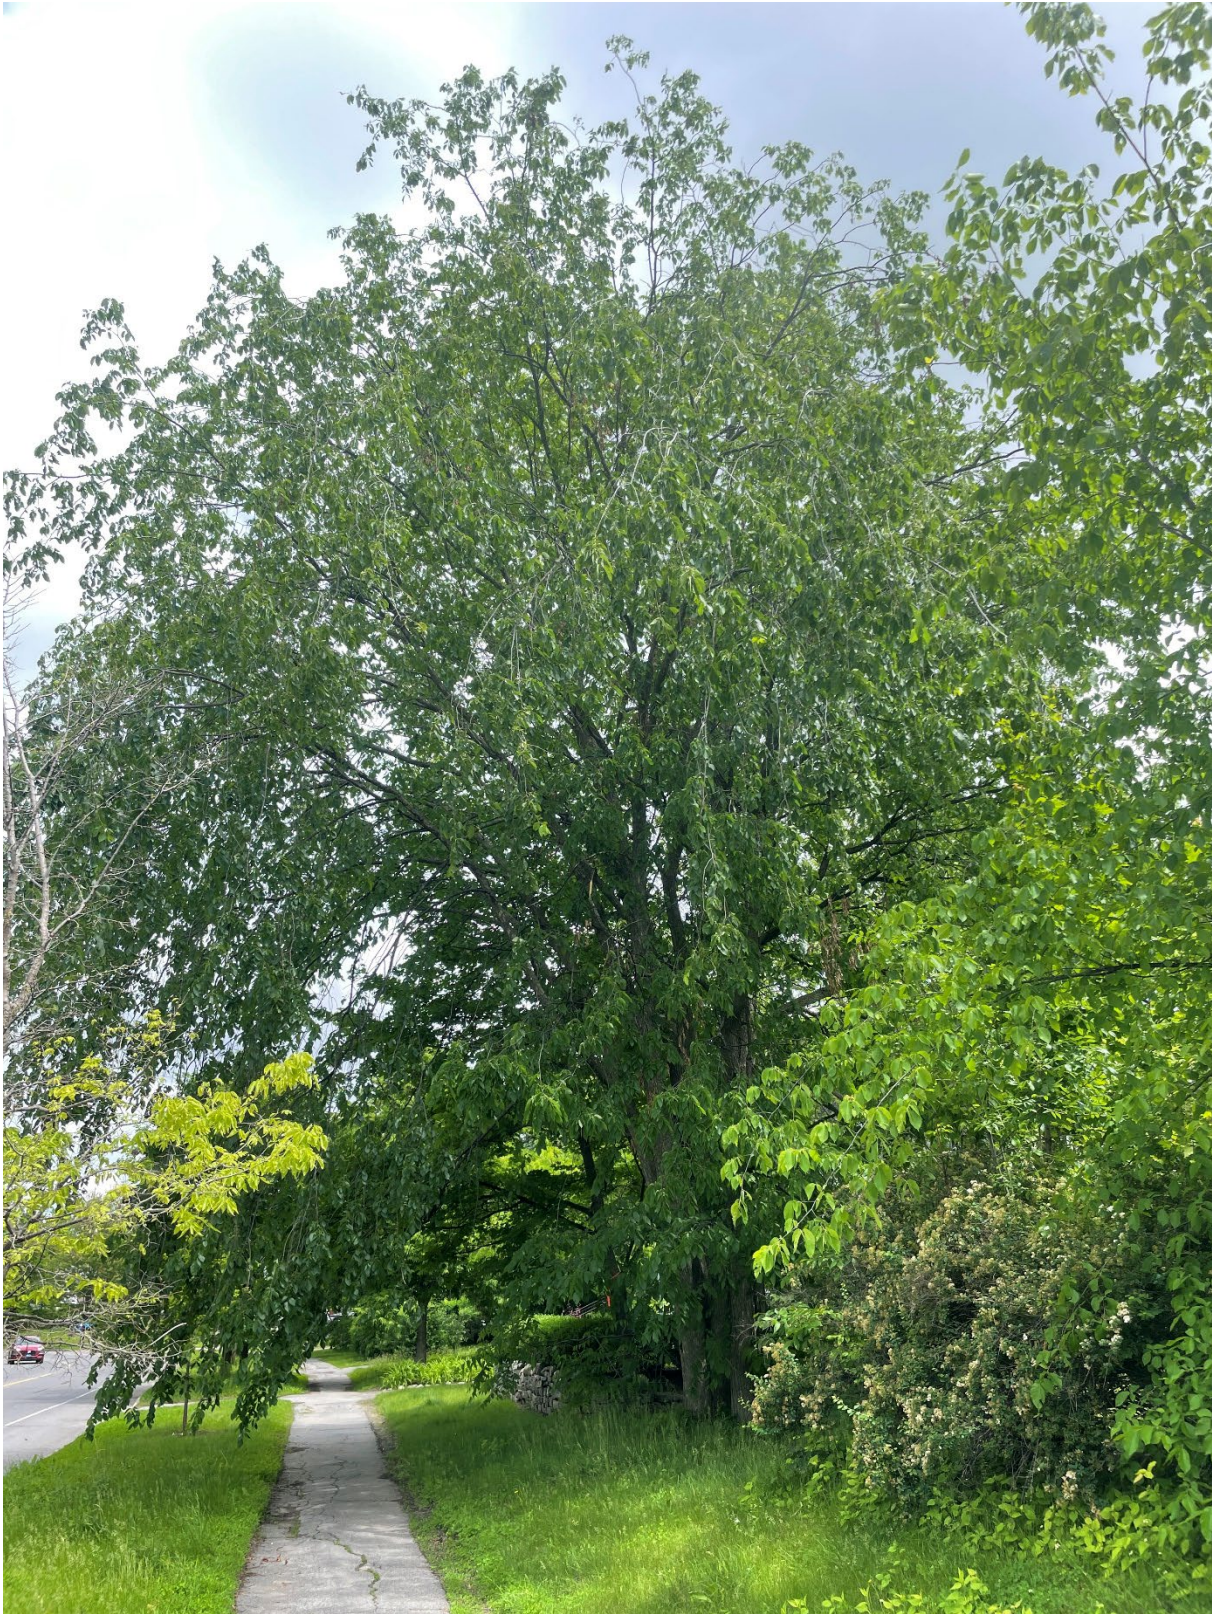
Figure 5: Clump of trees in the NW corner, trees 9-11

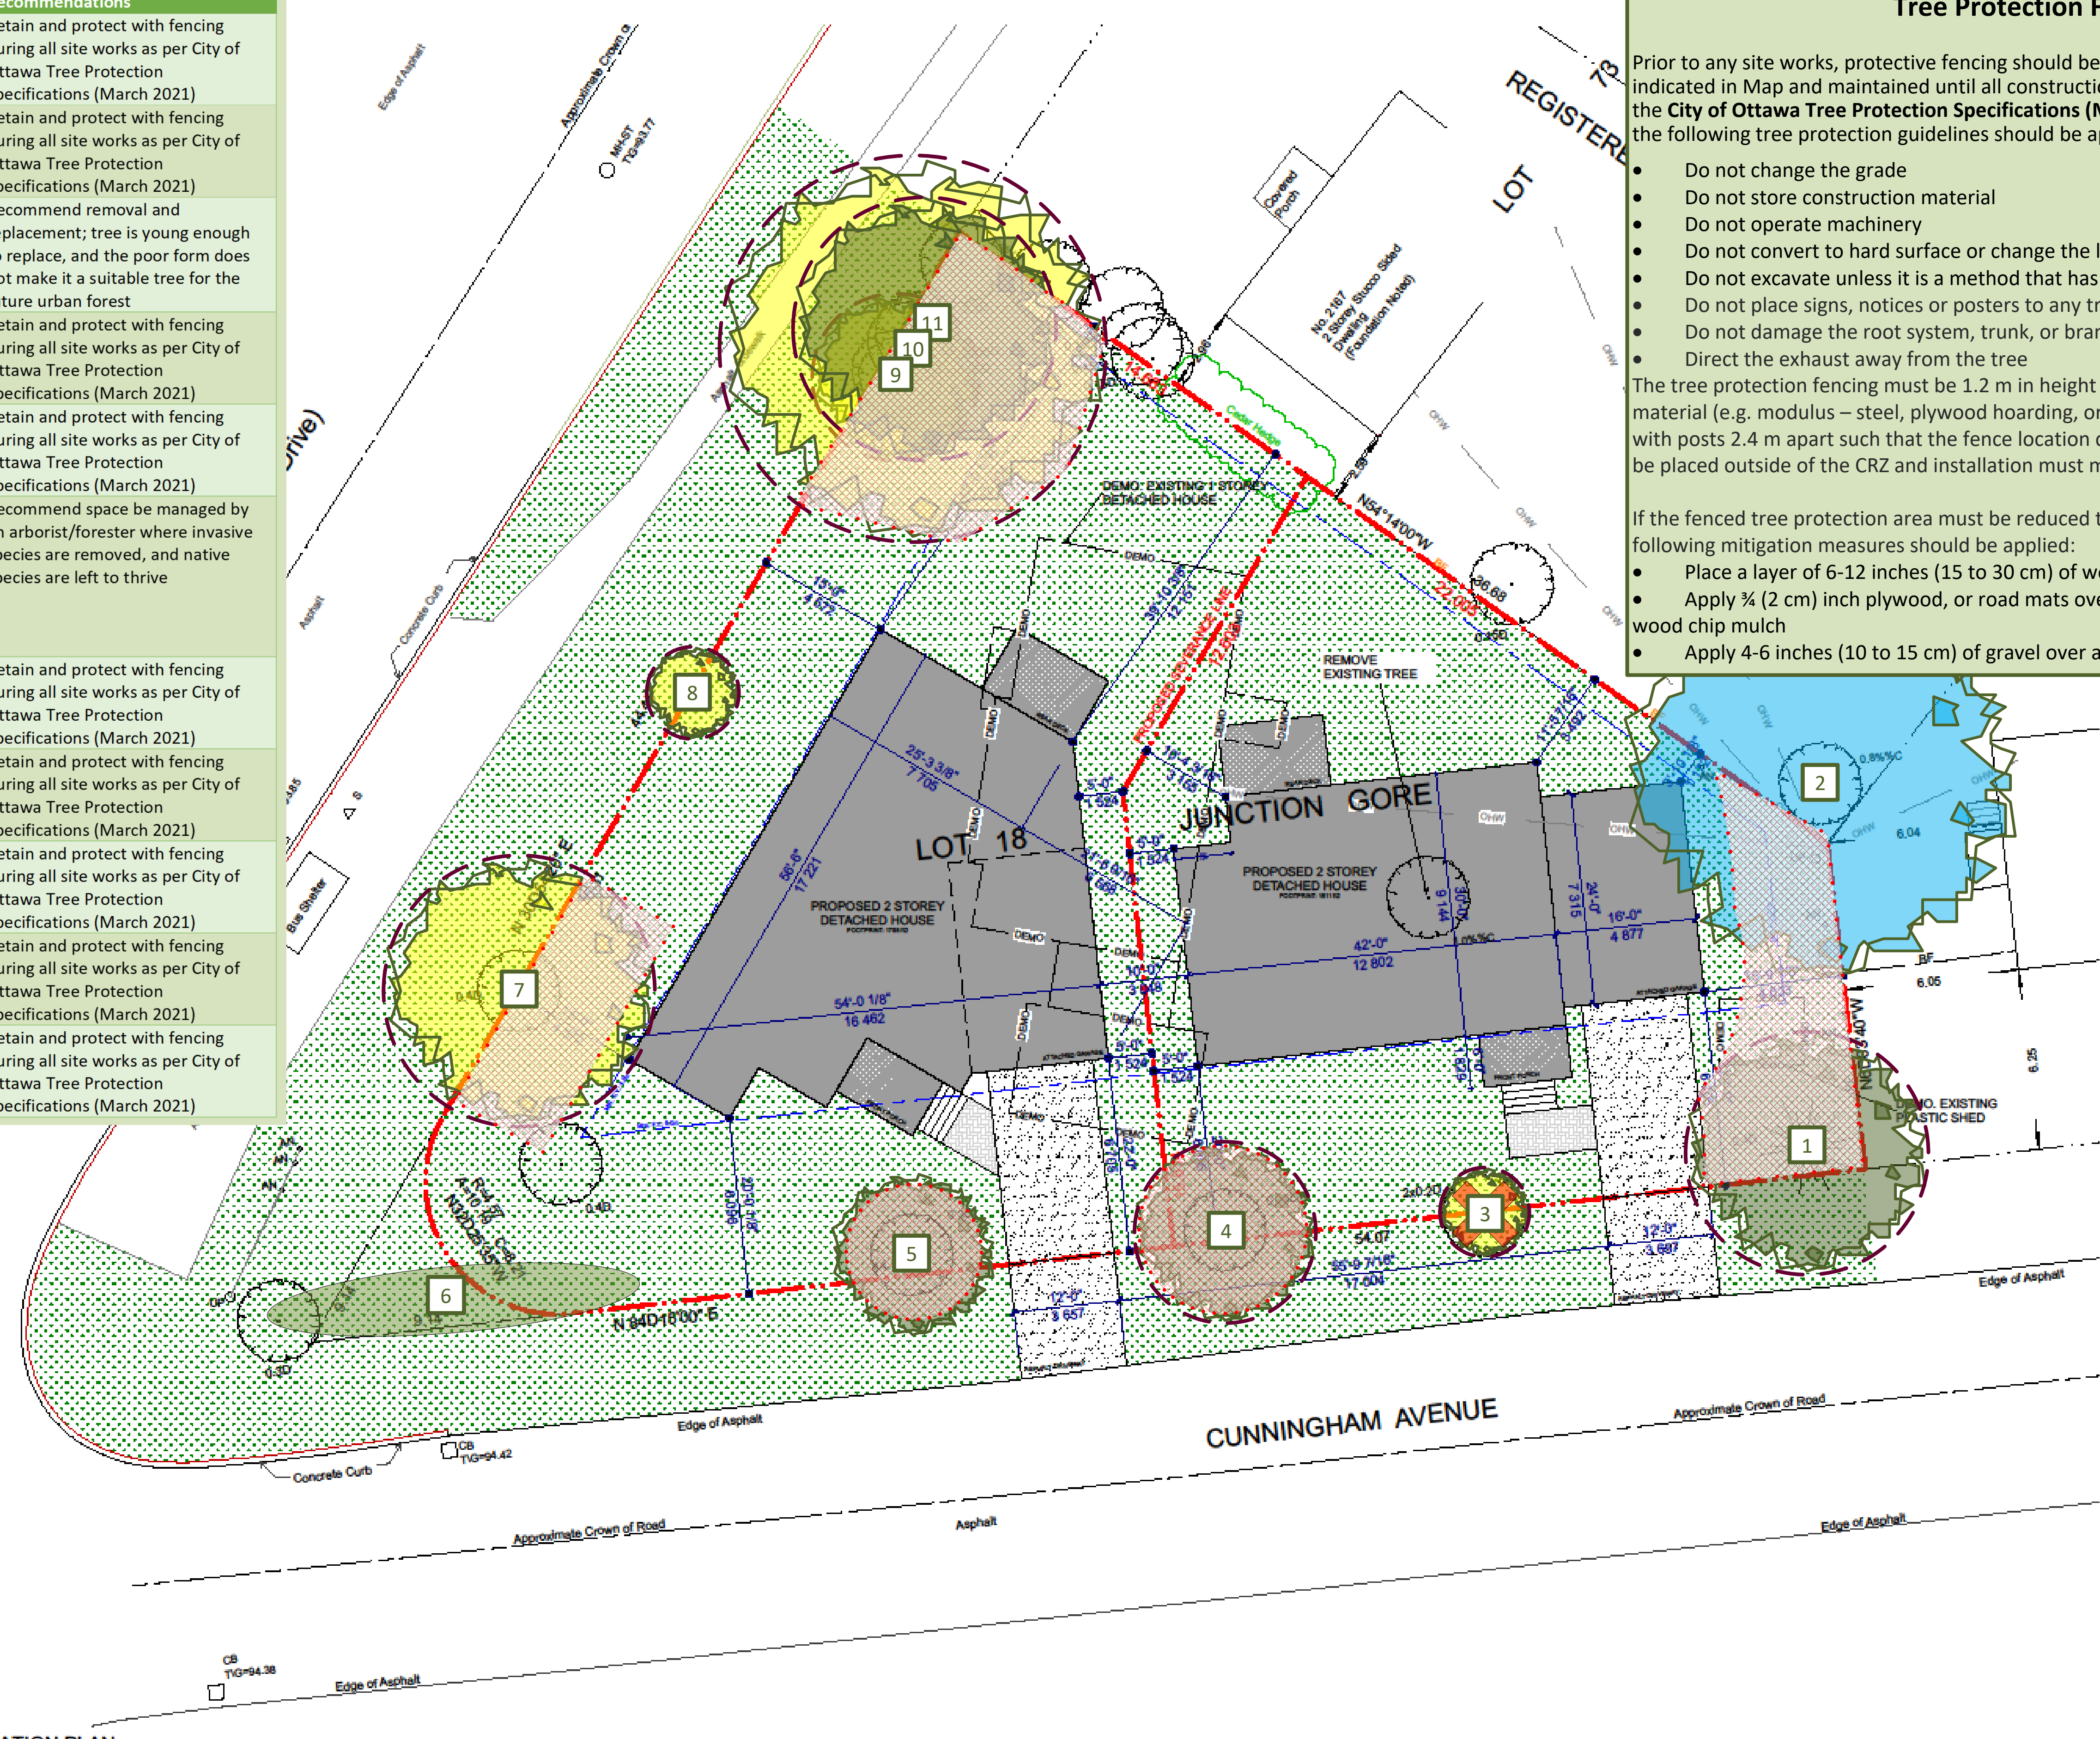
1 BUILDING LOCATION PLAN
A1 SCALE 5/64" = 1'-0"

Note that the tree layer has been added to the original site plan supplied by the client in pdf format. This layer refers to the trees only, and the original site plan has not been altered in the process. Refer to the original plan for details on grading as quality is lost when importing the plan into the mapping software used to create the tree layer.
Note the location of tree 8 has been estimated

Prior to any site works, protective fencing should be installed around the trees as indicated in the attached Tree Information Map and maintained until all construction on site has been completed as per the **City of Ottawa Tree Protection Specifications (March 2021)**. Within the fenced area, the following tree protection guidelines should be applied:
