Tree Information Report v2.0

Submitted as part of Committee of Adjustment Application to the City of Ottawa

Address: 50 Rebecca
Date of Report: July 10, 2022
Date of Site Visit: November 11, 2022
Prepared by: Astrid Nielsen, RPF, ISA Certified Arborist ®
131 Smirle Ave, Ottawa, K1Y 0S4
Astrid.nielsen@dendronforestry.ca
Client: Michael Suh, micsuh@gmail.com

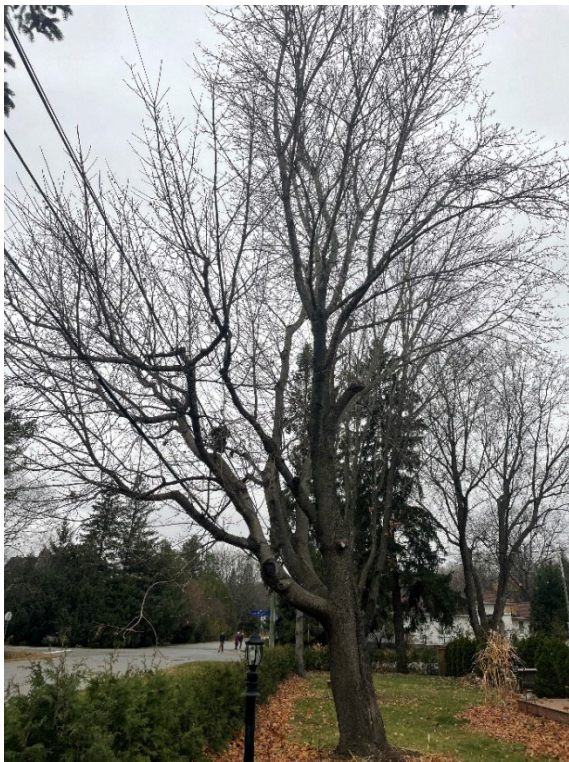
Tree ¹	Species	Diameter at breast height (cm)	Ownership ²	Condition	Arborist Recommendations
1	White spruce (<i>Picea glauca</i>)	45 cm	Private – 50 Rebecca	Fair/good; small twig dieback, especially at top of tree, thin crown	No action required
2	Norway maple (<i>Acer platanoides</i>)	45 cm	Private – 50 Rebecca	Fair/poor; lean towards road, seam on upper side of trunk, successive pruning for hydro clearance	Recommend removal based on health, tree has lean towards hydro lines and resident is concerned about safety
3	Sugar maple (<i>Acer saccharum</i>)	58 cm	Private – 50 Rebecca	Good/fair	No action required
4	White spruce (<i>Picea glauca</i>)	35 cm	Private – 50 Rebecca	Good/fair; some pruning for hydro clearance, thin crown	No action required
5	Colorado spruce (<i>Picea pungens</i>)	58 cm	City	Good	No action required
6	Silver maple (<i>Acer saccharinum</i>)	104 cm	City	Fair/good; 3 codominant stems, cavity at base	No action required; driveway and servicing for new home should be outside of critical root zone

Figure 1: tree 2, Norway maple, removal recommended due to poor health

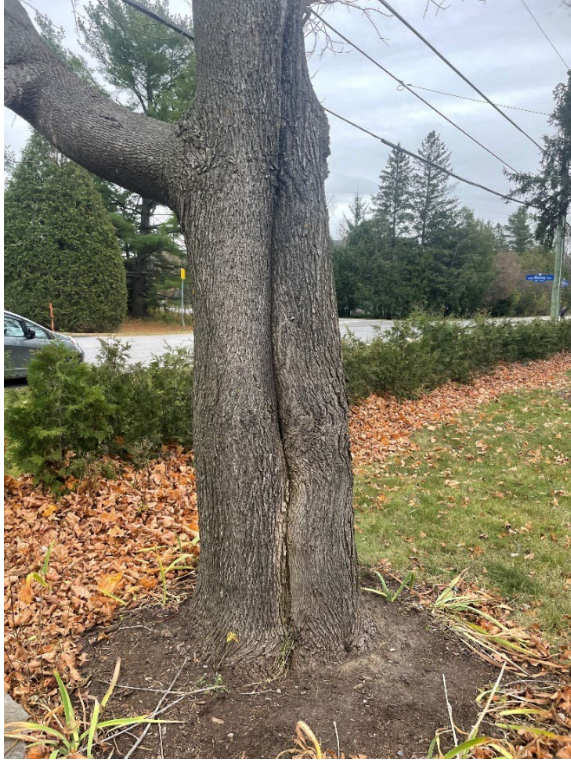
Figure 2: Seam in bark of Norway maple trunk (tree 2)

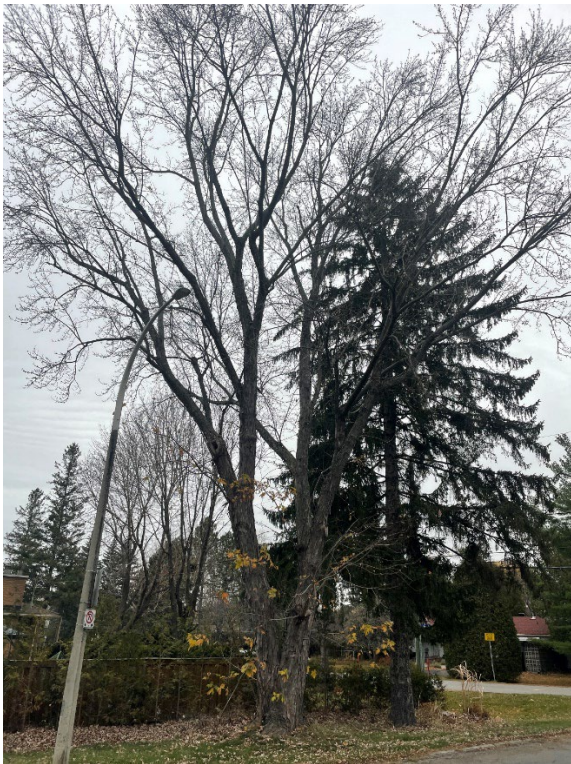
Figure 3: Tree 5 on right (Norway spruce) and tree 6 on left (Silver maple)

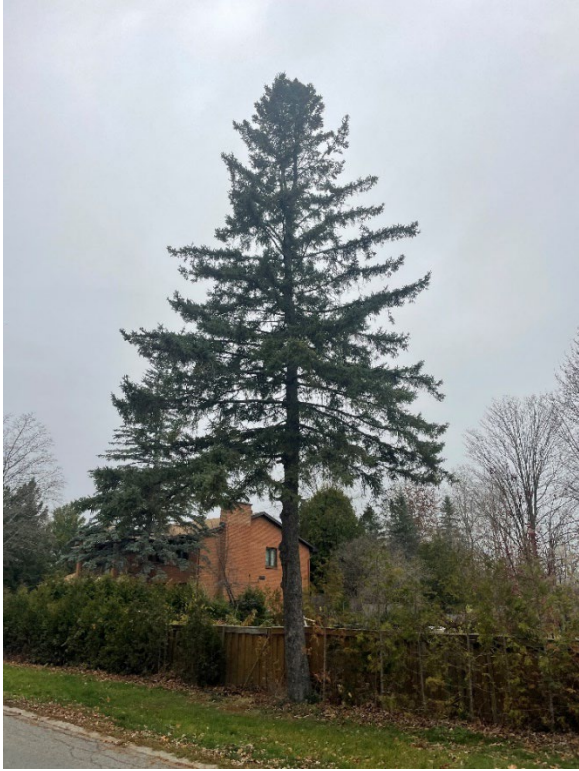
7	Norway spruce (<i>Picea abies</i>)	45 cm	City	Good	No action required; driveway and servicing for new home should be outside of critical root zone
8	Sugar maple (<i>Acer saccharum</i>)	57 cm	Private – 50 Rebecca	Fair; 2 codominant stems with included bark	Tree is in fair health and may not be a suitable candidate for retention if there is significant stresses due to construction. If

Figure 4: Colorado spruce, Tree 7

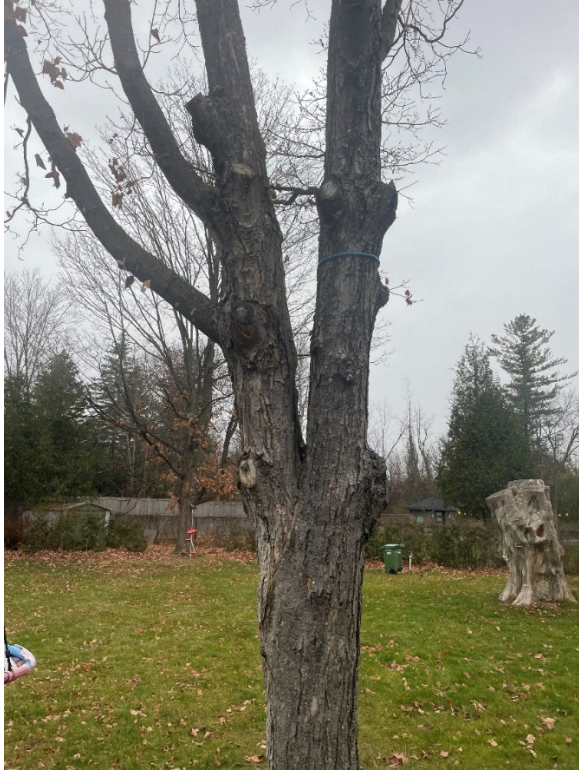
Figure 5: Tree 8, sugar maple in fair health

tree is retained, a structural support system is recommended to reduce risk of failure of the codominant stems
9	Sugar maple (<i>Acer saccharum</i>)	52 cm	Private – 50 Rebecca	Good	No action required; good potential for retention as tree is healthy and located in the rear corner, far from proposed home

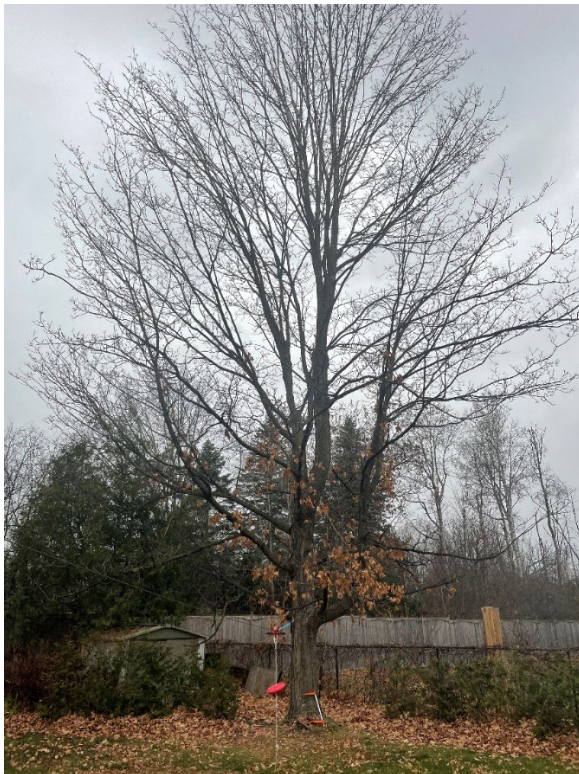
Figure 6: Tree 9, sugar maple in good health at the rear of the property
