# ARBORIST'S REPORT: 60 LEES AVENUE

TIM-O-TREE

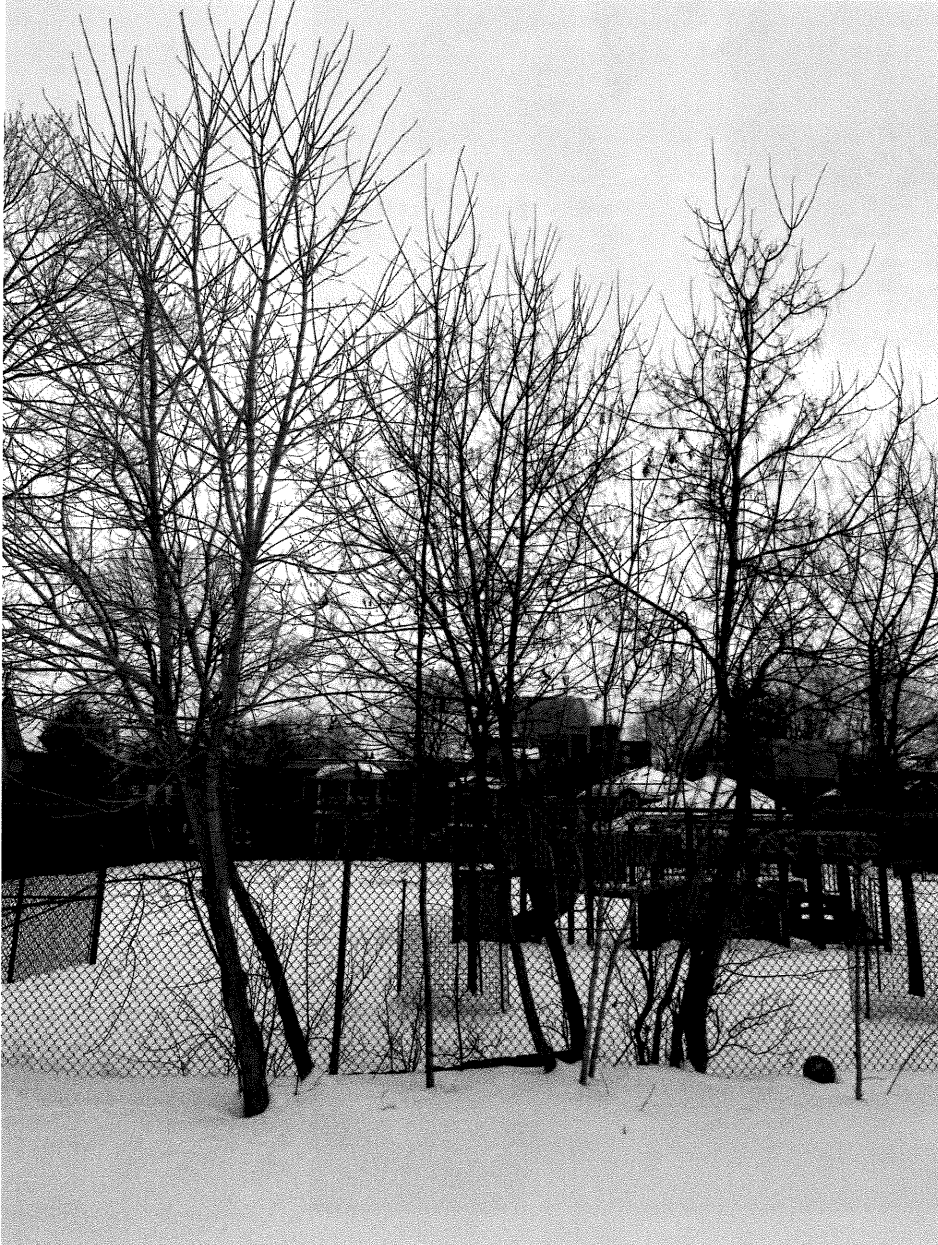
Several other trees on the property fall below 30cm DBH and therefore do not require any protections or compensation.

*Image 3. Manitoba Maples and Elm Tree.*

It is recommended that the Manitoba maples be removed as they are invasive and could suppress the replacement trees.
