Tree Information Report

Submitted as part of Committee of Adjustment Application to the City of Ottawa

Address: 884 Byron
Date of Report: August 22, 2022
Date of Site Visit: August 19, 2022
Prepared by: Astrid Nielsen, RPF, ISA Certified Arborist®
131 Smirle Ave, Ottawa, K1Y 0S4
Astrid.nielsen@dendronforestry.ca

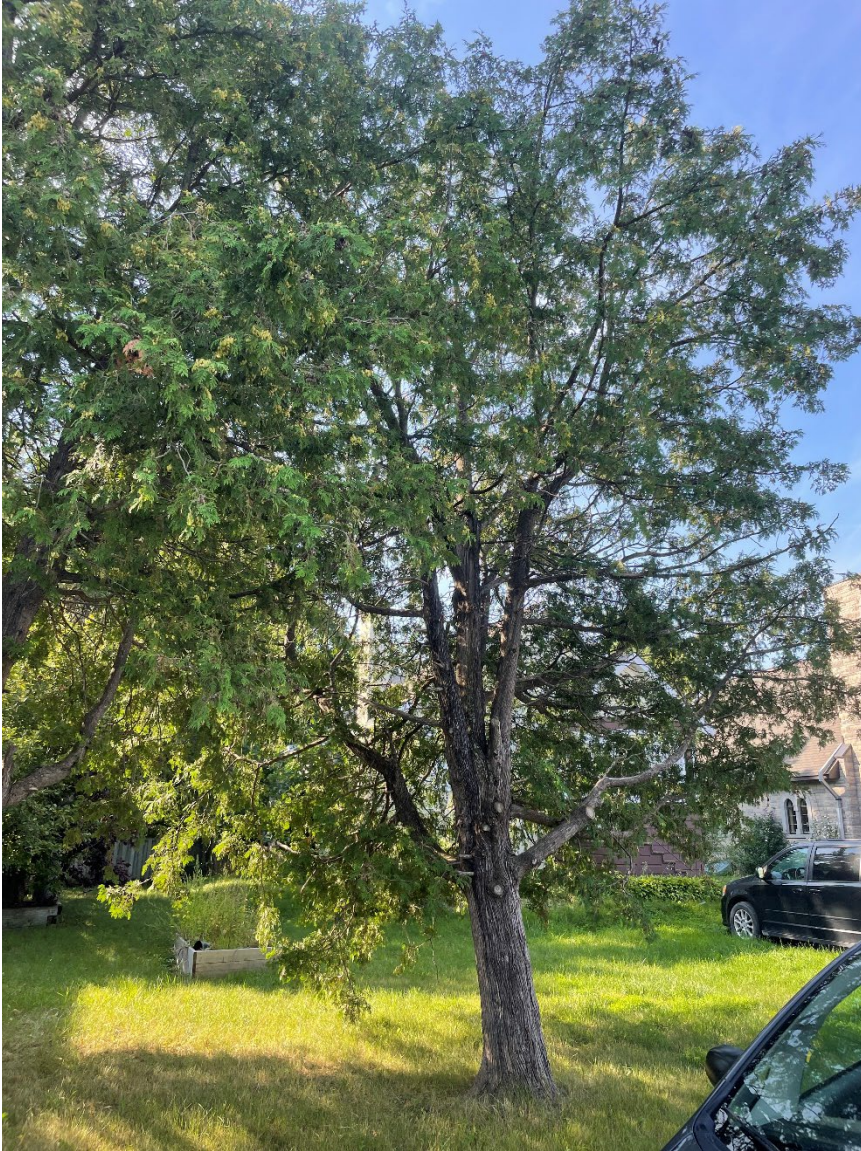
Tree 1 is a cedar tree that is mostly outside of the building footprint but will likely be damaged through construction via site access and the installation of new services. The increase in density from one to four units will result in significant site disturbance, making effective tree retention difficult. The recommended solution for tree 1 is remove and replacement with a large tree at maturity once construction is complete. Tree 2 has been marked for retention as it is in better condition, but this should be re-evaluated as more information is provided with regards to site construction plans. Tree 3 is not a protected tree but has been identified for retention as it is in good health and provides a good buffer. Furthermore, it is on the edge of the property, increasing the chance of successful retention.

Figure 1: Tree 1, eastern white cedar to be removed

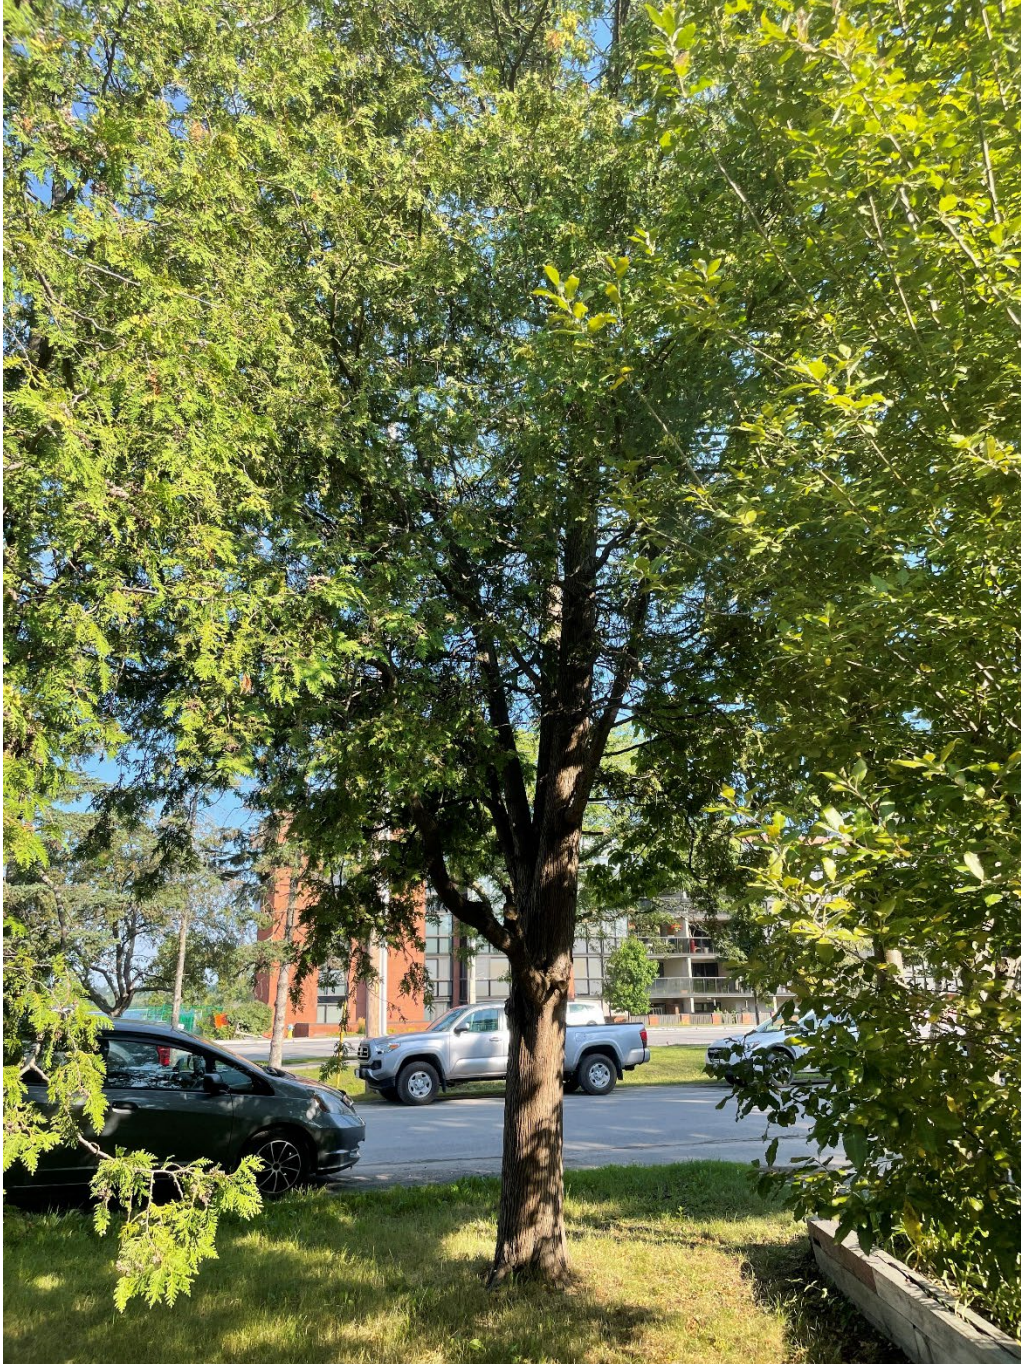
Figure 2: Tree 2, eastern white cedar to be retained

Prior to any site works, protective fencing should be installed around the trees as indicated in the attached Tree Information Map and maintained until all construction on site has been completed as per the **City of Ottawa Tree Protection Specifications (March 2021)**. Within the fenced area, the following tree protection guidelines should be applied:

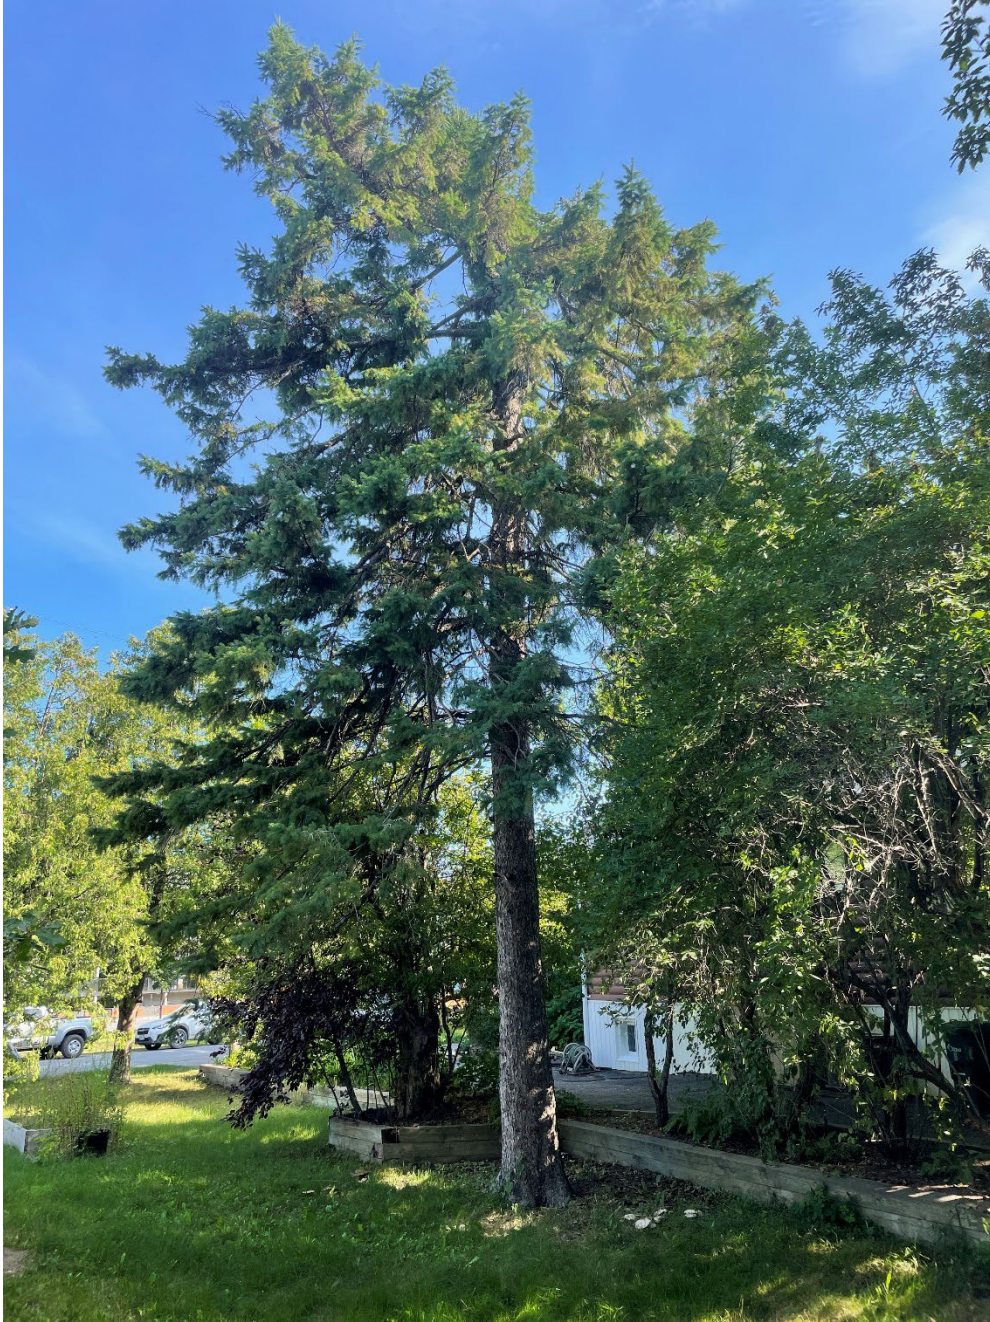
Figure 3: Tree 4, white spruce to be removed

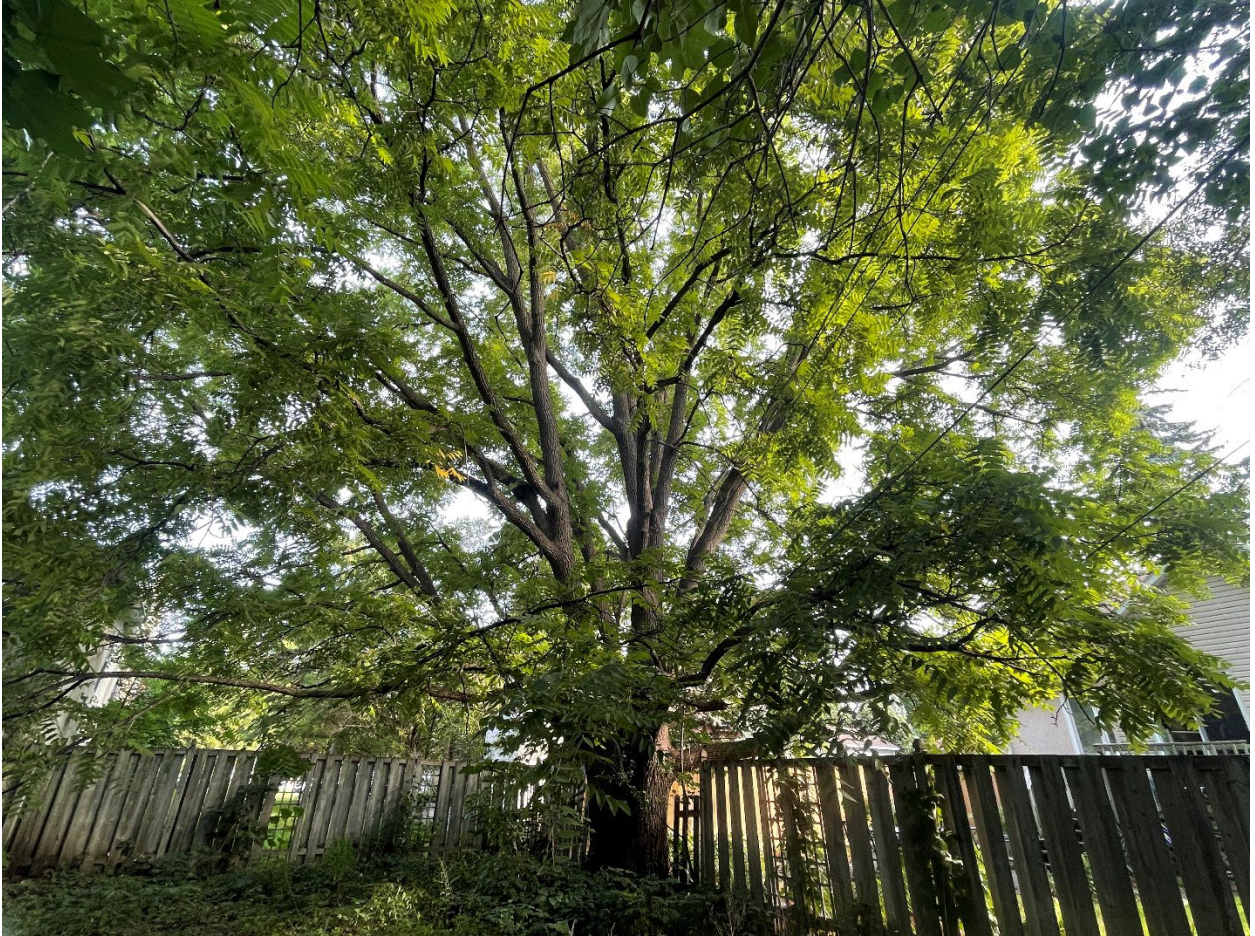
Tree 5 is a large, multi-stemmed, mature black walnut tree. With ample growing space, this tree has grown large branches that extend horizontally up to 9 m. The excavation for the new home will remove approximately 25% of the roots and be within a metre (or less) of the trunk. The rear parking area would remove another 15-20% of the roots. The new building would require the removal of approximately 25% of the crown on one side. Based on this level of impact, removal is recommended.

Figure 4: Tree 5, large black walnut to be removed

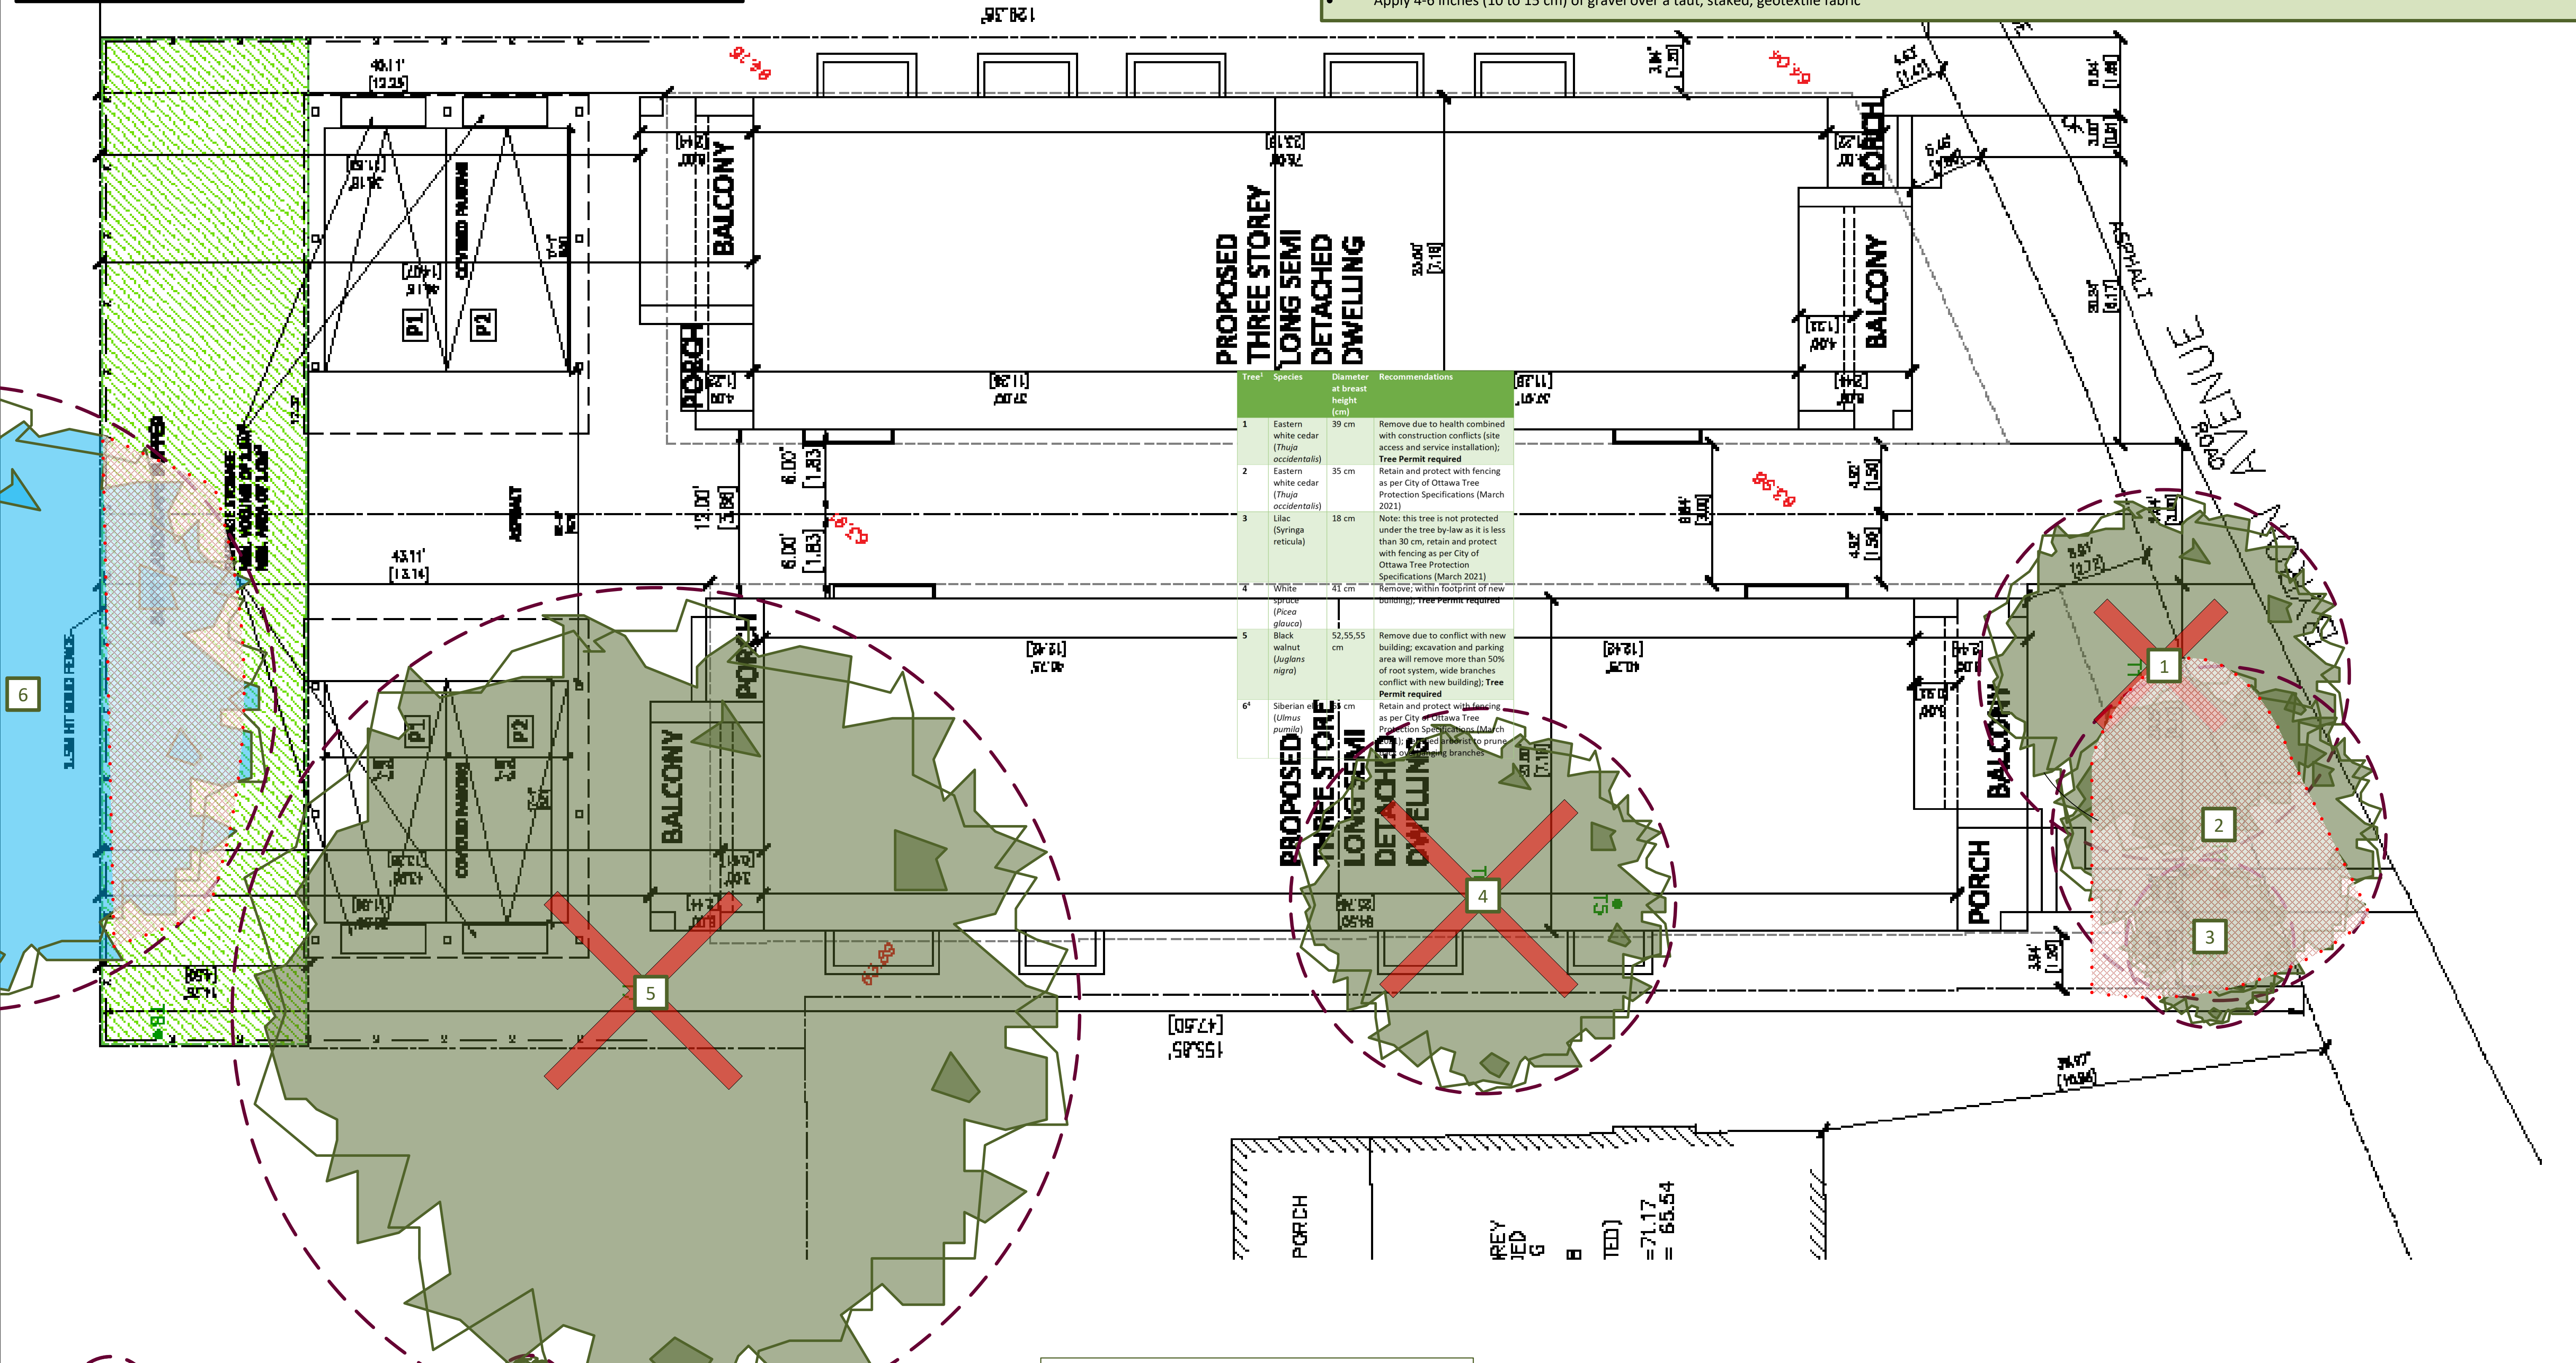
Tree Information Report – 884 Byron Ave.
 Tree layer prepared by Dendron Forestry Services
 Version 1.0, August 22, 2022
 For more information, please contact info@dendronforestry.ca

Tree#	Species	Diameter at breast height (cm)	Recommendations
1	Eastern white cedar (<i>Thuja occidentalis</i>)	39 cm	Remove due to health combined with construction conflicts (site access and service installation); Tree Permit required
2	Eastern white cedar (<i>Thuja occidentalis</i>)	35 cm	Retain and protect with fencing as per City of Ottawa Tree Protection Specifications (March 2021)
3	Lilac (<i>Syringa reticula</i>)	18 cm	Note: this tree is not protected under the tree by-law as it is less than 30 cm, retain and protect with fencing as per City of Ottawa Tree Protection Specifications (March 2021)
4	White spruce (<i>Picea glauca</i>)	41 cm	Remove; within footprint of new building; Tree Permit required
5	Black walnut (<i>Juglans nigra</i>)	52,55,55 cm	Remove due to conflict with new building; excavation and parking area will remove more than 50% of root system, wide branches conflict with new building; Tree Permit required

6 ⁴	Siberian elm (<i>Ulmus pumila</i>)	65 cm	Retain and protect with fencing as per City of Ottawa Tree Protection Specifications (March 2021); Certified arborist to prune back overhanging branches

Prior to any site works, protective fencing should be installed around the trees as indicated in Map and maintained until all construction on site has been completed as per the **City of Ottawa Tree Protection Specifications (March 2021)**. Within the fenced area, the following tree protection guidelines should be applied:
