# Tree Information Report v3.0

Submitted as part of Committee of Adjustment Consent Application

Address: 1558 Baseline Road

Date: June 21, 2023

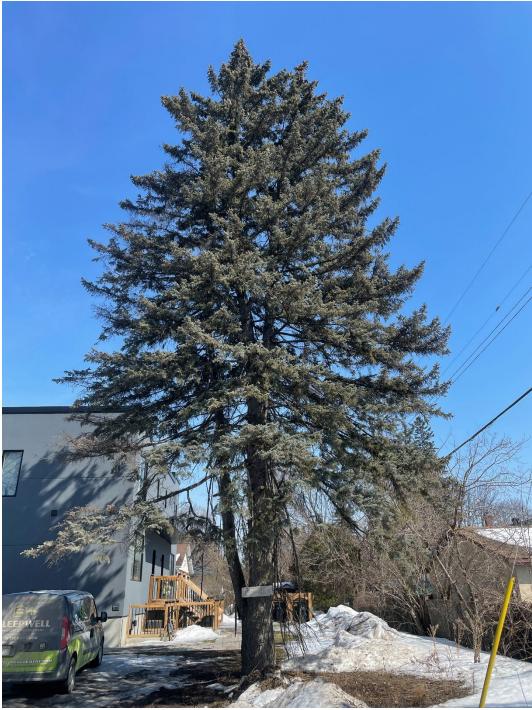
Tree <sup>1</sup>	Species	Diameter at breast height (cm)	Ownership <sup>2</sup>	Condition	Action	Arborist Recommendations
1	Colorado spruce ( <i>Picea</i> pungens)	74 cm	Private, 1558 Baseline	Fair; 2 codominant stems, 30 and 55 cm, significant wound on trunk 18 X 50 cm from recent construction due to lack of tree protection fencing, compacted soil due to creation of new parking	Retain	Retain and protect with fencing during all site works as per City of Ottawa Tree Protection Specifications (March 2021); limit excavation for new foundation to at least 2 m from edge of tree; trim excess bark around wound to speed up

Figure 1: Tree 1, Colorado spruce to be retained

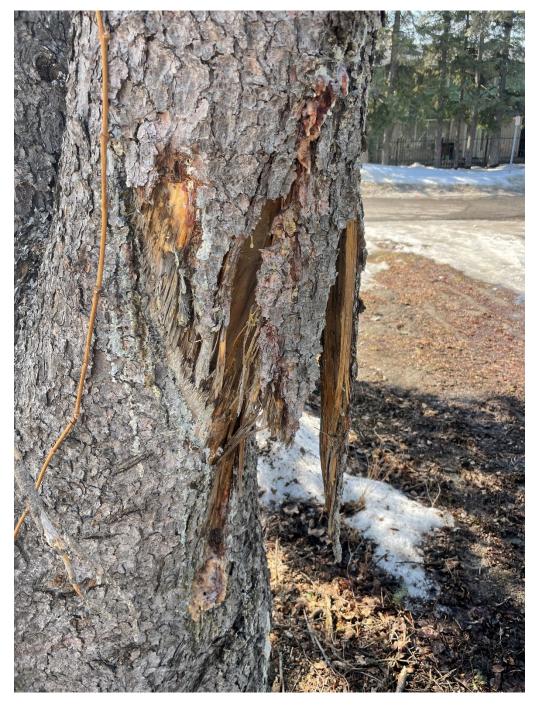
Figure 2: Mechanical damage on Colorado spruce from previous construction

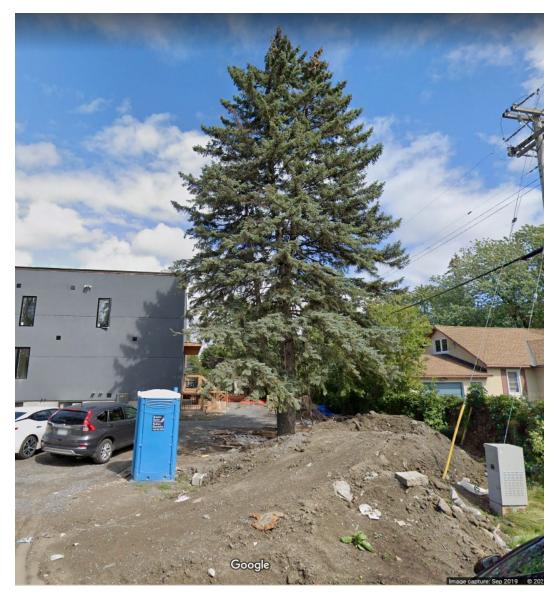
Figure 3: Image from Google Street View 2019 showing the lack of tree protection during construction

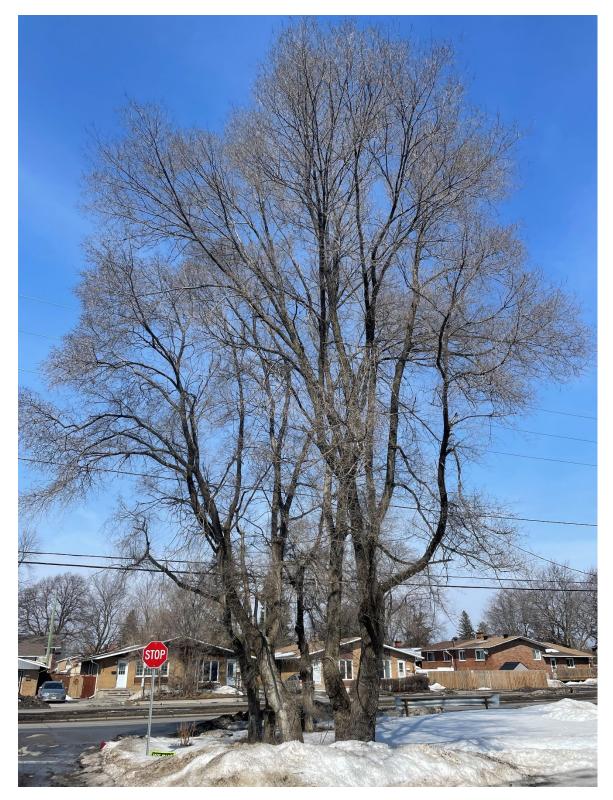
Figure 4: City Siberian elm (trees 2-6) along property line – view from southwestern corner, Baseline road in the back

3	Siberian elm ( <i>Ulmus</i> pumila)	54 cm	Fair; crown dieback 15%, wound at base 10X50 cm	Retain and protect with fencing during all site works as per City of Ottawa Tree Protection Specifications (March 2021); request that city forestry completes post construction assessment and appropriate follow up work
4	Siberian elm (Ulmus pumila)	31 cm	Fair; straight trunk, 15- 20% crown dieback, old mechanical wound on trunk	Retain and protect with fencing during all site works as per City of Ottawa Tree Protection Specifications (March 2021); request that city forestry completes post construction assessment and appropriate follow up work
5	Siberian elm ( <i>Ulmus</i> pumila)	36 cm	Fair; successive pruning for hydro clearance	Retain and protect with fencing during all site works as per City of Ottawa Tree Protection Specifications (March 2021); request that city forestry completes post construction assessment and appropriate follow up work

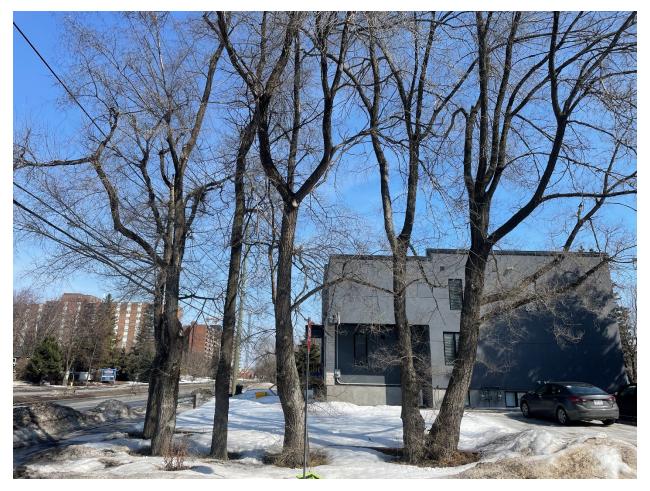
Figure 5: Trees 2 -6 (from right to left) – view from the west, Baseline road to the left
