# THOMSON WATSON CONSULTING ARBORISTS Inc

## **Re: Tree Conservation Report for Canadian Tire Centre at 2501 Greenbank Road, Nepean**

**TREE PHOTOGRAPHS – 2501 Greenbank Road, Nepean**

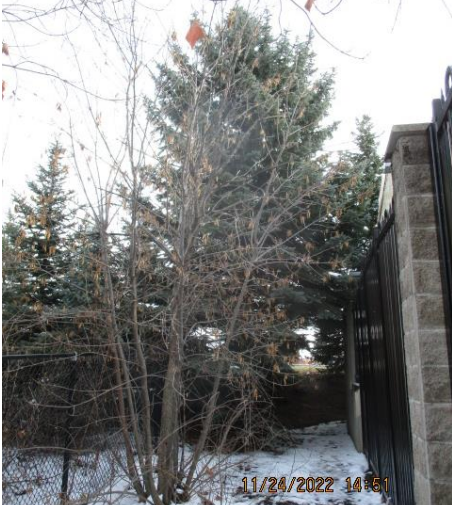
Tree 88 is a Green Ash which has been affected by Emerald Ash Borer, leaving stems with a maximum diameter of 7 cm. A permit should not be required for this tree.

Tree 88 – Green Ash with 87 to south

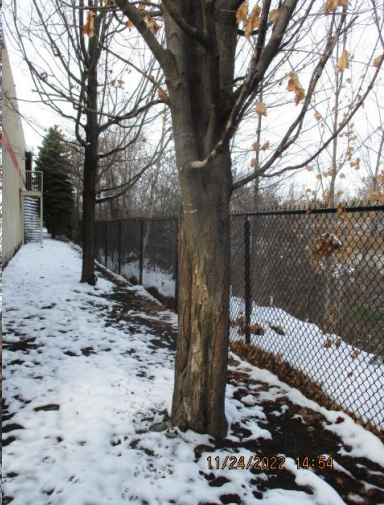
Tree 90 – trunk wound
