## Tree Information Report

Submitted as part of Committee of Adjustment Application to the City of Ottawa

**Address:** 290 Holmwood  
**Date of Report:** November 8, 2022  
**Date of Site Visit:** November 3, 2022  
**Prepared by:** Astrid Nielsen, RPF, ISA Certified Arborist®  
131 Smirle Ave, Ottawa, K1Y 0S4  
[Astrid.nielsen@dendronforestry.ca](mailto:Astrid.nielsen@dendronforestry.ca)

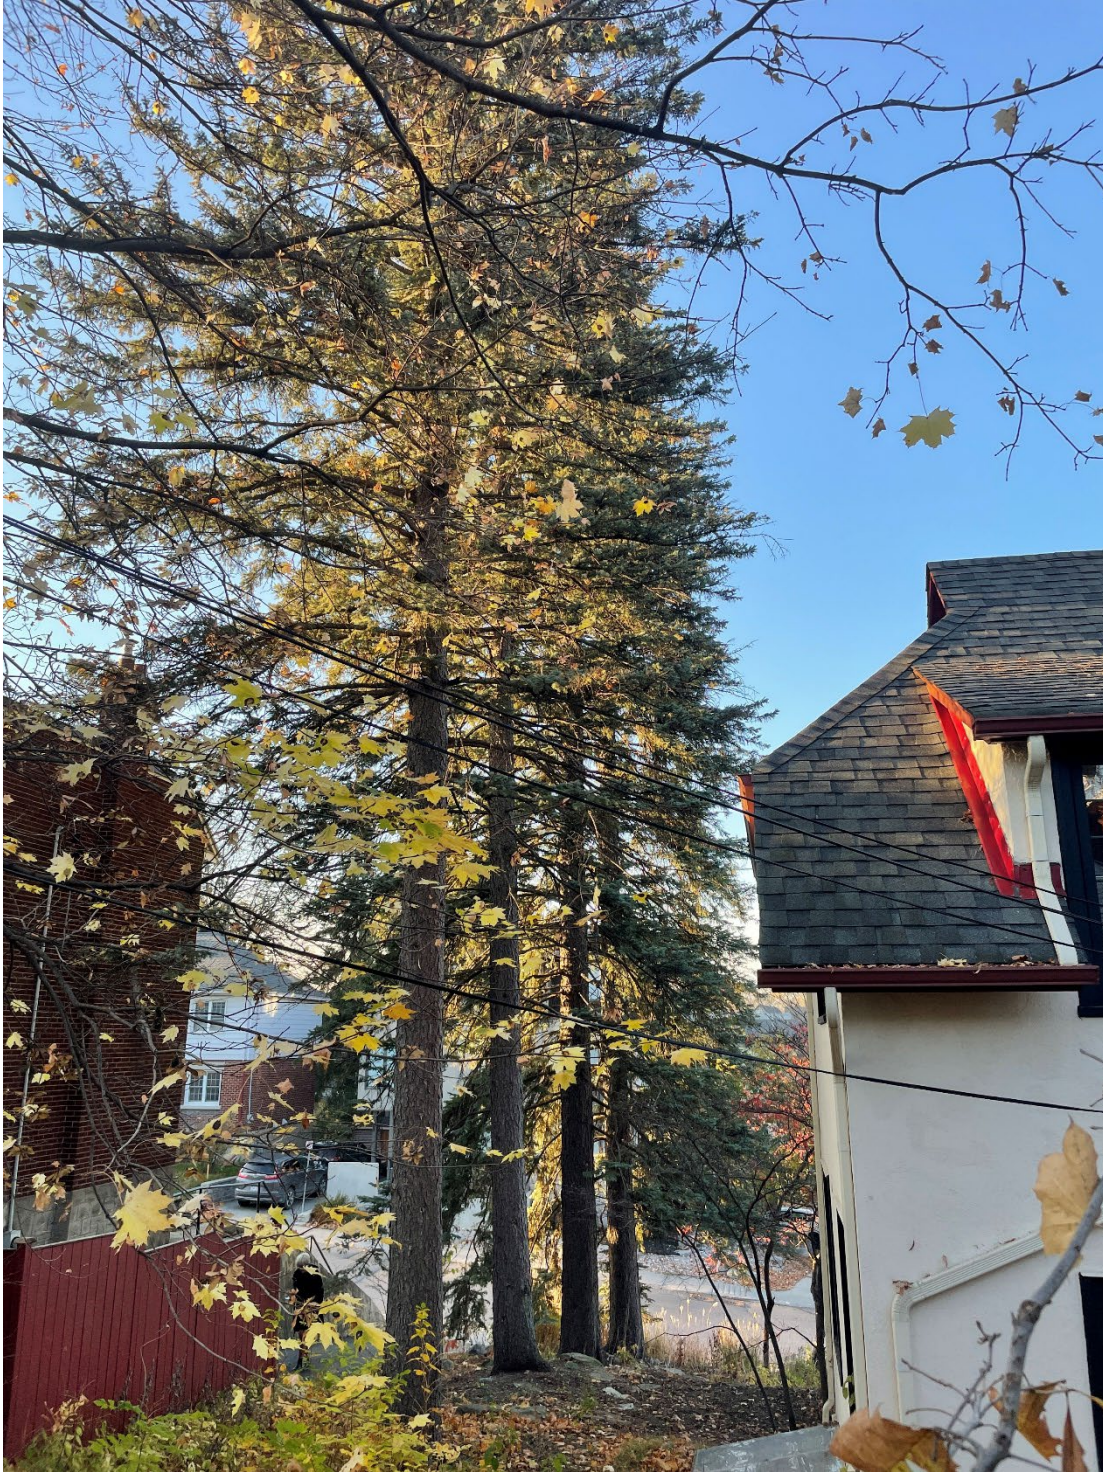
Tree <sup>1</sup>	Species	Diameter at breast height (cm)	Ownership <sup>2,3</sup>	Condition	Action	Arborist Recommendations
1	Colorado spruce ( <i>Picea pungens</i> )	57	Private	Good	Remove	Remove based on conflict with proposed home; <b>Tree Permit from city required for removal</b>
2	Colorado spruce ( <i>Picea pungens</i> )	56	Private	Good	Remove	Remove based on conflict with proposed home; <b>Tree Permit from city required for removal</b>
3	Colorado spruce ( <i>Picea pungens</i> )	45	Private	Good	Remove	Remove based on conflict with proposed home; <b>Tree Permit from city required for removal</b>
4	Colorado spruce ( <i>Picea pungens</i> )	49	Private	Good	Remove	Remove based on conflict with proposed home; <b>Tree Permit from city required for removal</b>
5	Norway maple ( <i>Acer platanoides</i> )	35	Private	Good; slight lean downhill	Retain	Retain and protect; recommend retaining grading in this area, if possible

*Figure 1: Photo taken from rear of property, Colorado spruce along the west property line, trees 1-4*

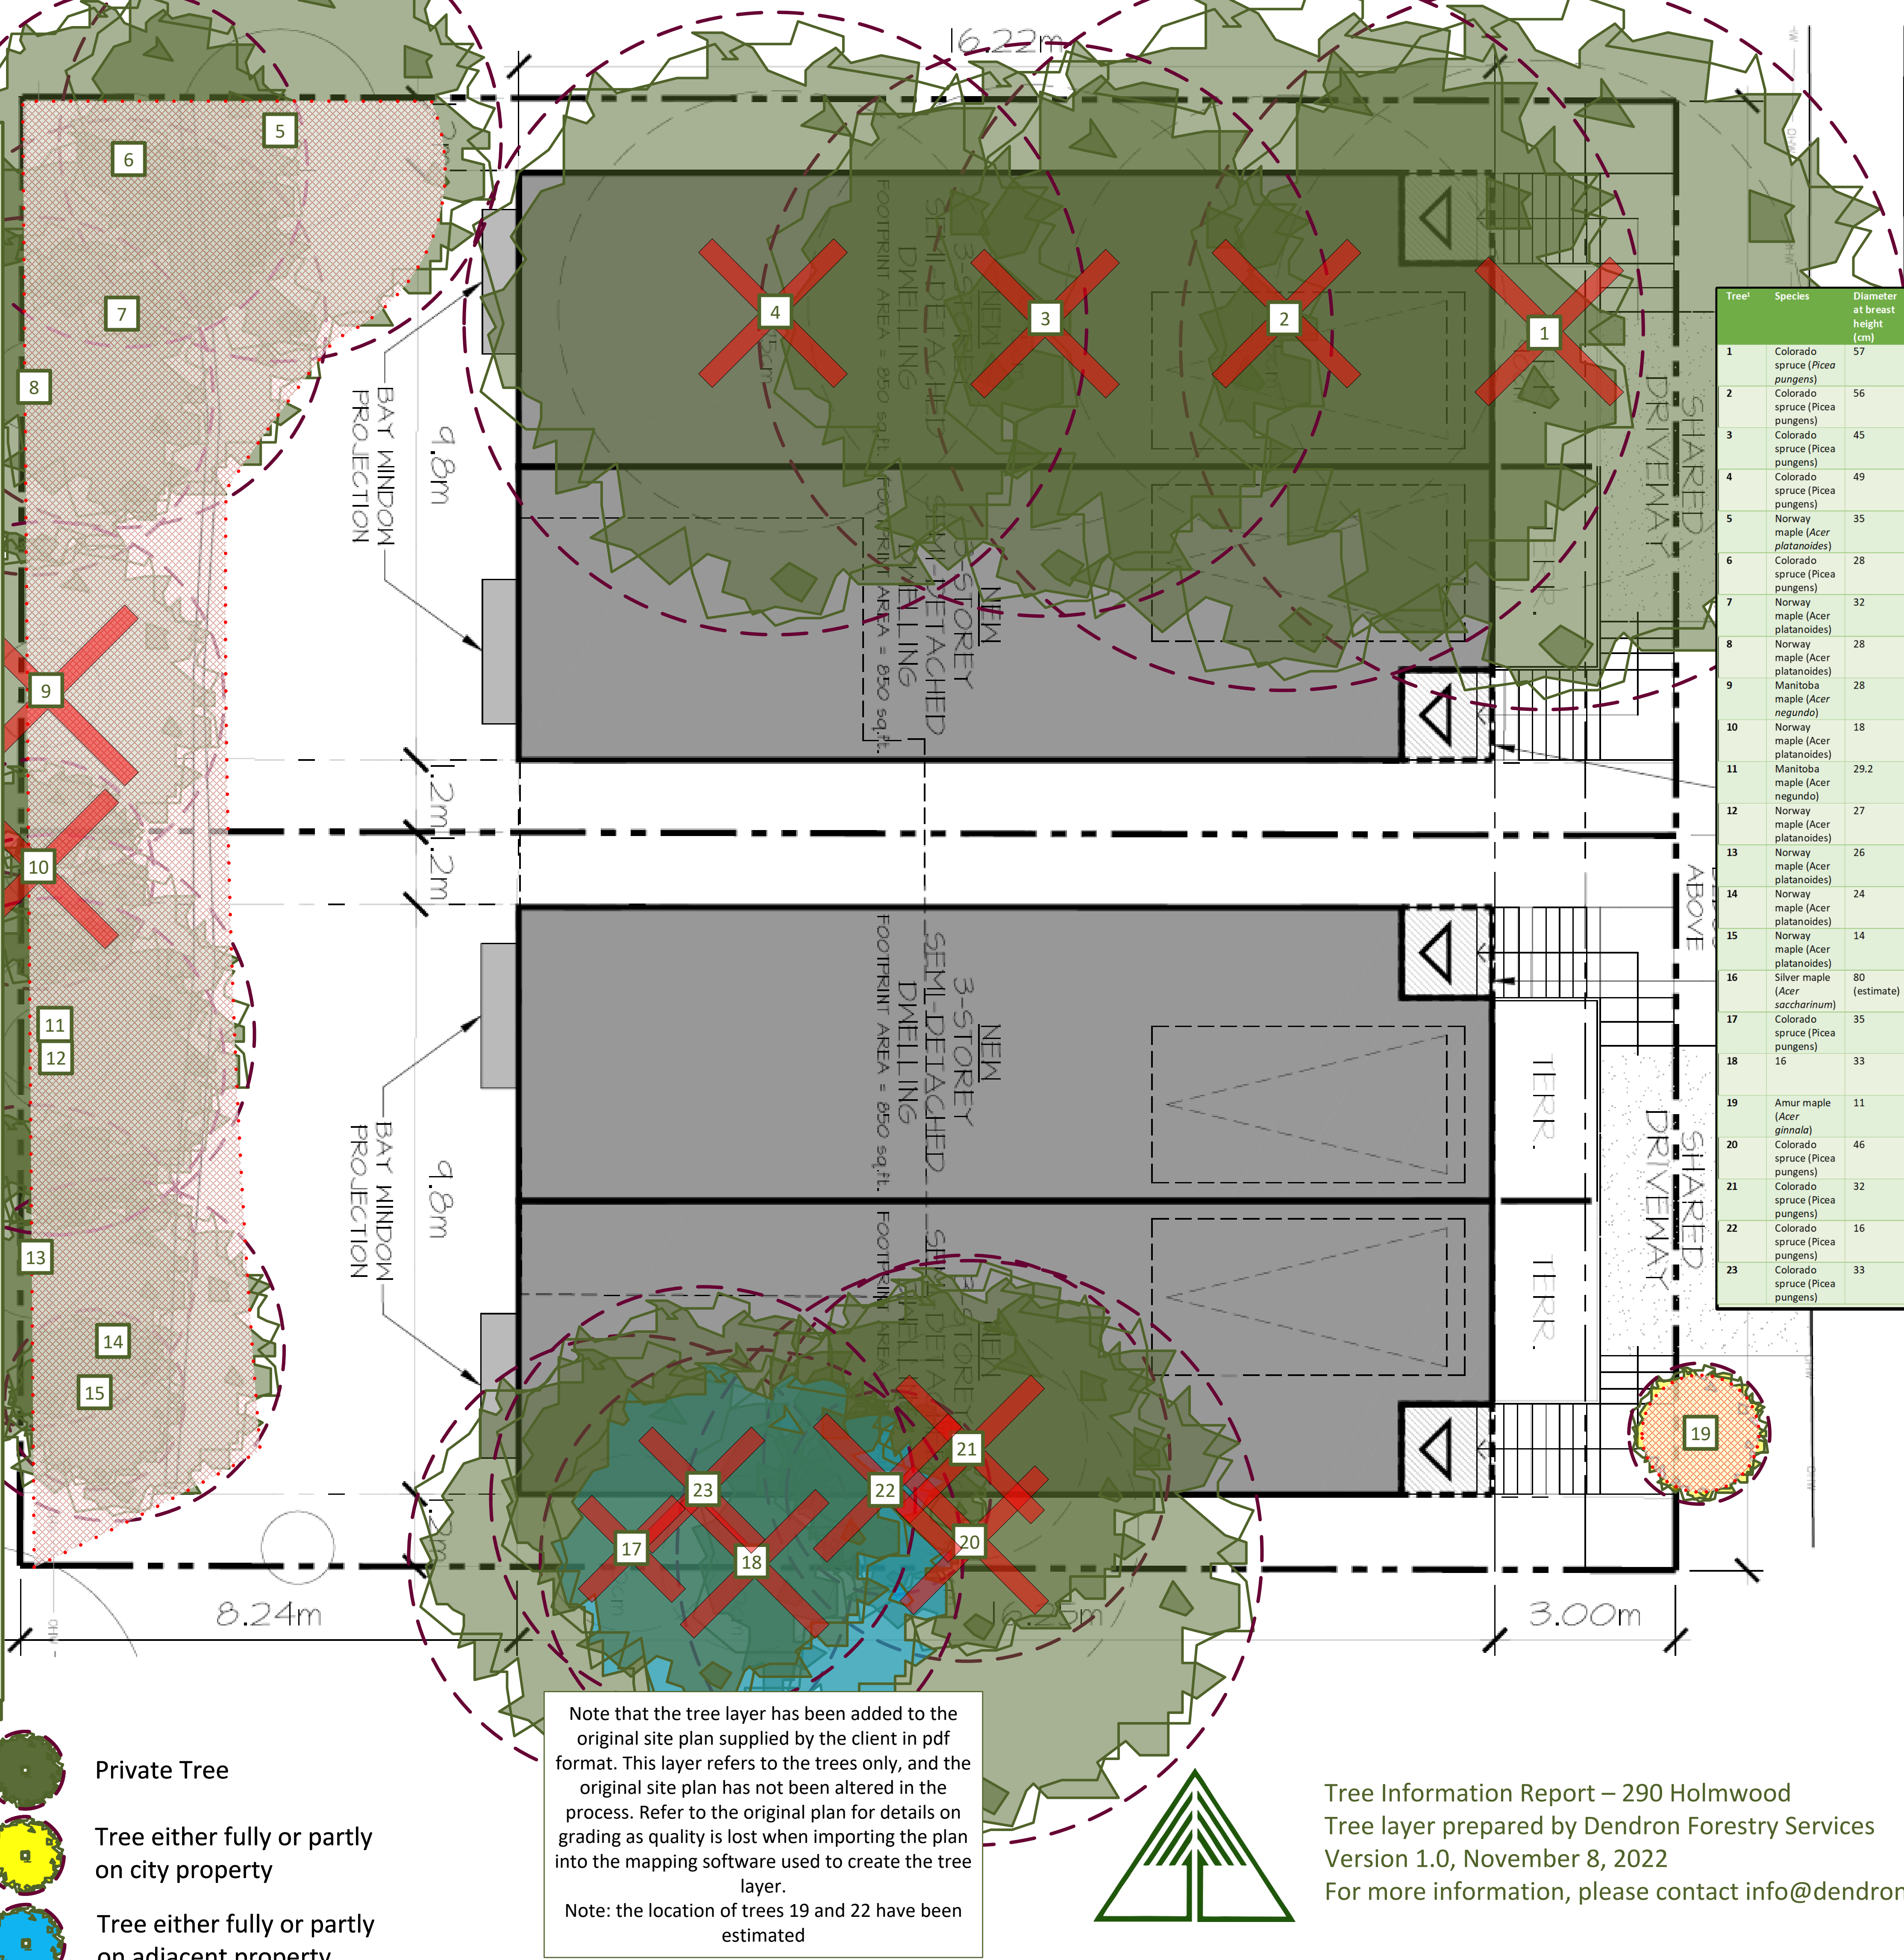
Tree Information Report – 290 Holmwood  
Tree layer prepared by Dendron Forestry Services  
Version 1.0, November 8, 2022  
For more information, please contact [info@dendronforestry.ca](mailto:info@dendronforestry.ca)

Tree#	Species	Diameter at breast height (cm)	Arborist Recommendations
1	Colorado spruce ( <i>Picea pungens</i> )	57	Remove based on conflict with proposed home; <b>Tree Permit from city required for removal</b>
2	Colorado spruce ( <i>Picea pungens</i> )	56	Remove based on conflict with proposed home; <b>Tree Permit from city required for removal</b>
3	Colorado spruce ( <i>Picea pungens</i> )	45	Remove based on conflict with proposed home; <b>Tree Permit from city required for removal</b>
4	Colorado spruce ( <i>Picea pungens</i> )	49	Remove based on conflict with proposed home; <b>Tree Permit from city required for removal</b>
5	Norway maple ( <i>Acer platanoides</i> )	35	Retain and protect; recommend retaining grading in this area, if possible
6	Colorado spruce ( <i>Picea pungens</i> )	28	Retain and protect; recommend retaining grading in this area, if possible
7	Norway maple ( <i>Acer platanoides</i> )	32	Retain and protect; recommend retaining grading in this area, if possible

8	Norway maple ( <i>Acer platanoides</i> )	28	Retain and protect; recommend retaining grading in this area, if possible
9	Manitoba maple ( <i>Acer negundo</i> )	28	Remove based on poor health; <b>no permit required for removal</b>
10	Norway maple ( <i>Acer platanoides</i> )	18	Remove based on poor health; <b>no permit required for removal</b>
11	Manitoba maple ( <i>Acer negundo</i> )	29.2	Retain and protect; recommend retaining grading in this area, if possible
12	Norway maple ( <i>Acer platanoides</i> )	27	Retain and protect; recommend retaining grading in this area, if possible
13	Norway maple ( <i>Acer platanoides</i> )	26	Retain and protect; recommend retaining grading in this area, if possible
14	Norway maple ( <i>Acer platanoides</i> )	24	Retain and protect; recommend retaining grading in this area, if possible
15	Norway maple ( <i>Acer platanoides</i> )	14	Retain and protect; recommend retaining grading in this area, if possible

16	Silver maple ( <i>Acer saccharinum</i> )	80 (estimate)	Retain and protect; recommend retaining grading in this area, if possible
17	Colorado spruce ( <i>Picea pungens</i> )	35	Remove based on conflict with proposed home; <b>Tree Permit from city required for removal</b>
18	16	33	Remove based on conflict with proposed home; <b>Tree Permit from city required for removal</b>
19	Amur maple ( <i>Acer ginnala</i> )	11	Retain and protect as per City of Ottawa Tree Protection Specifications (March 2021)
20	Colorado spruce ( <i>Picea pungens</i> )	46	Remove based on conflict with proposed home; <b>Tree Permit from city required for removal</b>
21	Colorado spruce ( <i>Picea pungens</i> )	32	Remove based on conflict with proposed home; <b>Tree Permit from city required for removal</b>
22	Colorado spruce ( <i>Picea pungens</i> )	16	Remove based on conflict with proposed home; <b>no permit required for removal</b>

23	Colorado spruce ( <i>Picea pungens</i> )	33	Remove based on conflict with proposed home; <b>Tree Permit from city required for removal</b>

Prior to any site works, protective fencing should be installed around the trees as indicated in Map and maintained until all construction on site has been completed as per the **City of Ottawa Tree Protection Specifications (March 2021)**. Within the fenced area, the following tree protection guidelines should be applied:
