Tree Information Report

Date of Report: February 22, 2024
Property Address: 282 Loretta Avenue
Prepared for: Justin Mastromattei; theboulevardottawa@gmail.com
Prepared by: Kevin Myers, ISA Certified Arborist®; kevin.myers@dendronforestry.ca
Date of Site Visit: February 21, 2024

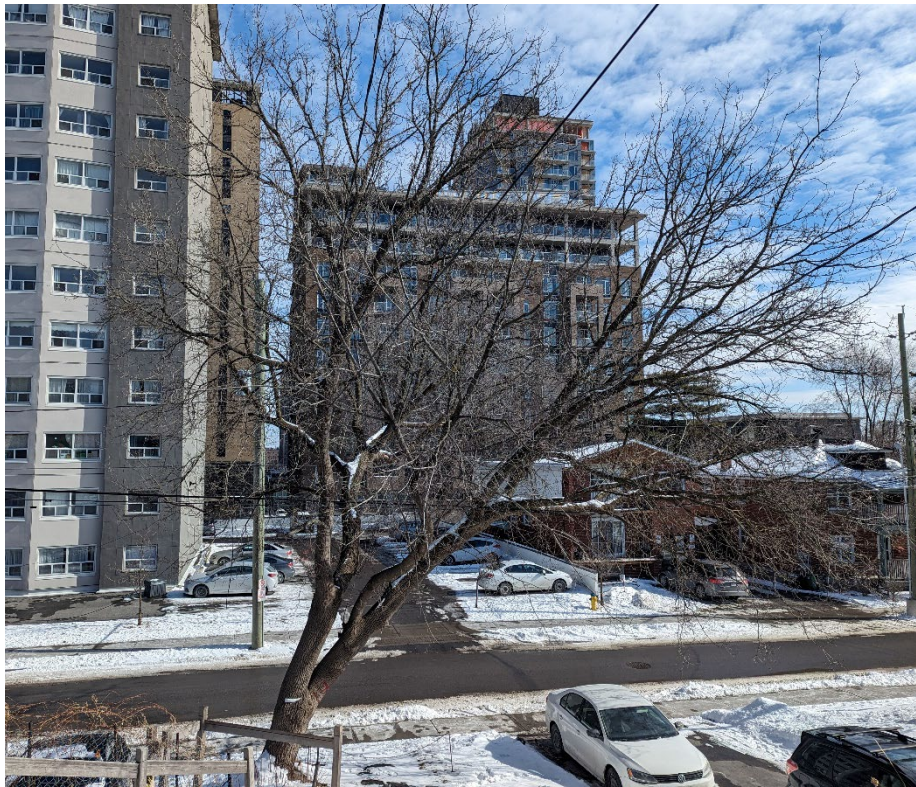
Tree 1 has a stem marked for removal by hydro. Once this limb is removed the tree will be in poor condition – with a large wound and very limited rooting space, it is likely the tree will decline. **Tree 6** is growing on the edge of a stone retaining wall, and once this is removed, the tree’s rooting space will be greatly disrupted. The proposed development will allow for four new planting areas of between approximately 18-27m² – allowing for the planting of trees along the Loretta ROW to replace the removed trees. In the opinion of Dendron Forestry Services, the official plan’s direction to increase canopy will be better served by removing and replacing these trees.

*Above: Tree 1 (view from in front of existing house)
- city Manitoba maple to be removed.*

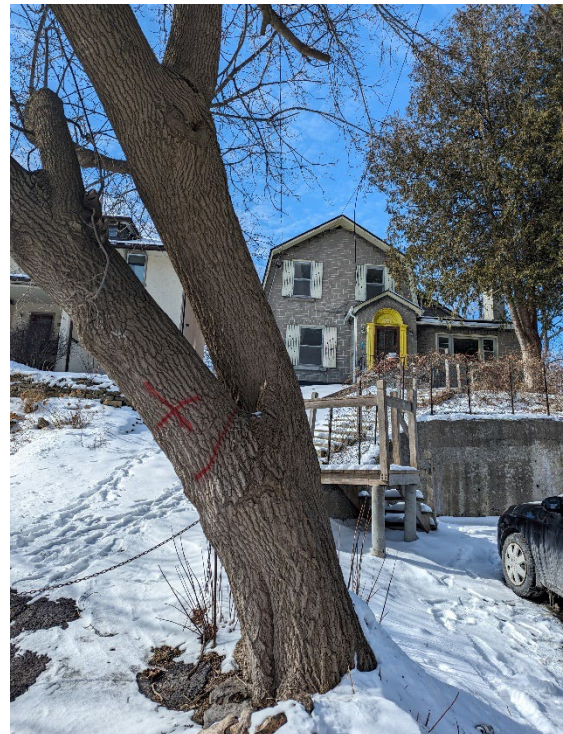
Right: trunks of Tree 1 - one marked for removal.

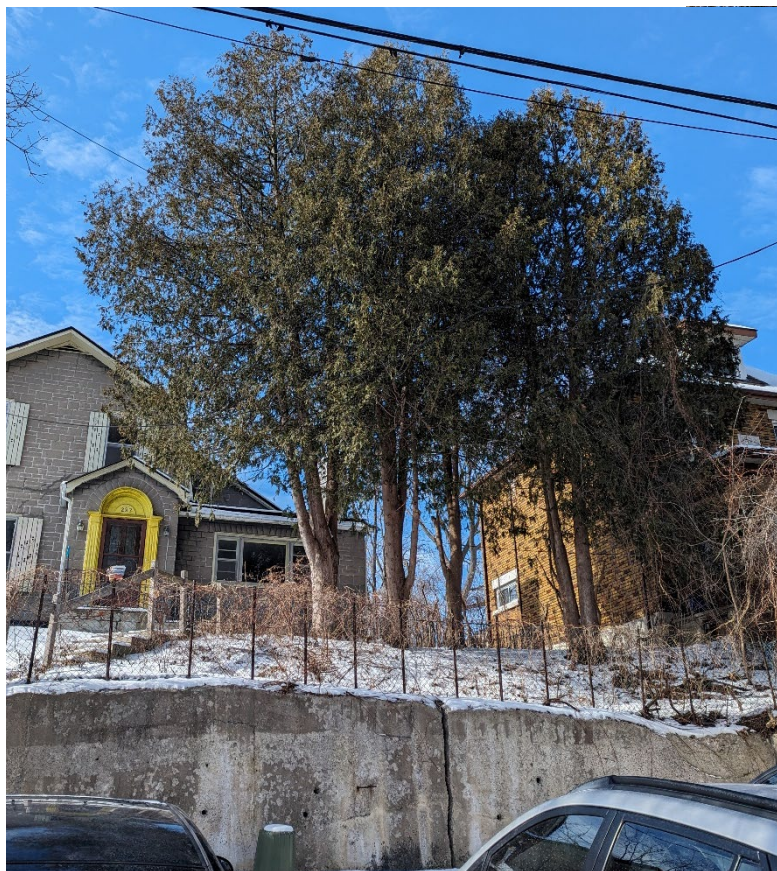
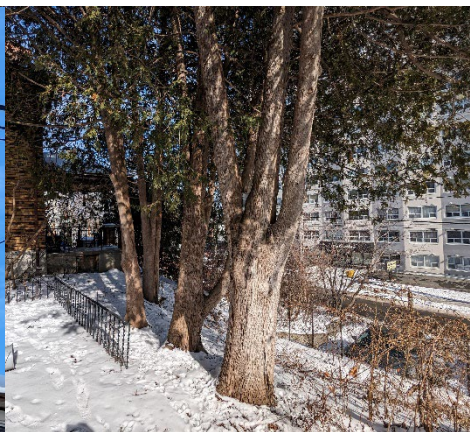
Above: Trunks of Trees 2-4

Left: Trees 2-4 - private cedars to be removed.

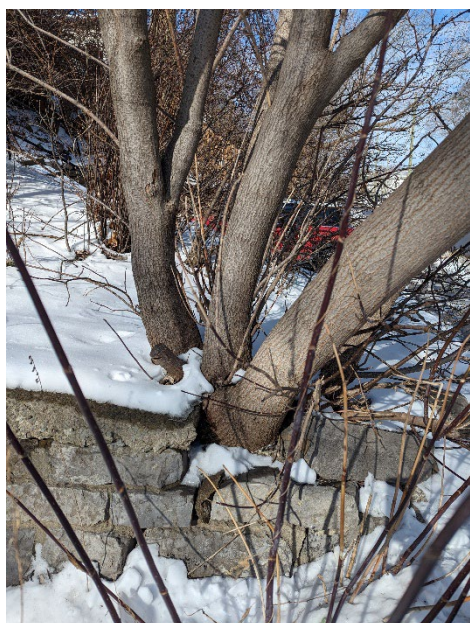
Below left: base of Tree 6

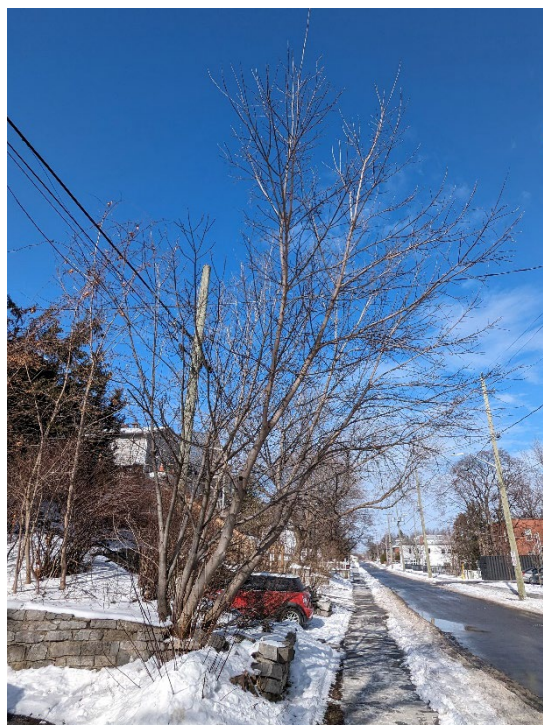
Below right: Tree 6 – city Manitoba maple to be removed.
