Tree Information Report

Date of Report: May 23, 2024
Property Address: 556 Mansfield Avenue
Prepared for: Frank Curcio; frank@bedrockdevelopments.ca
Prepared by: Kevin Myers, ISA Certified Arborist®; kevin.myers@dendronforestry.ca
Date of Site Visit: May 1, 2024

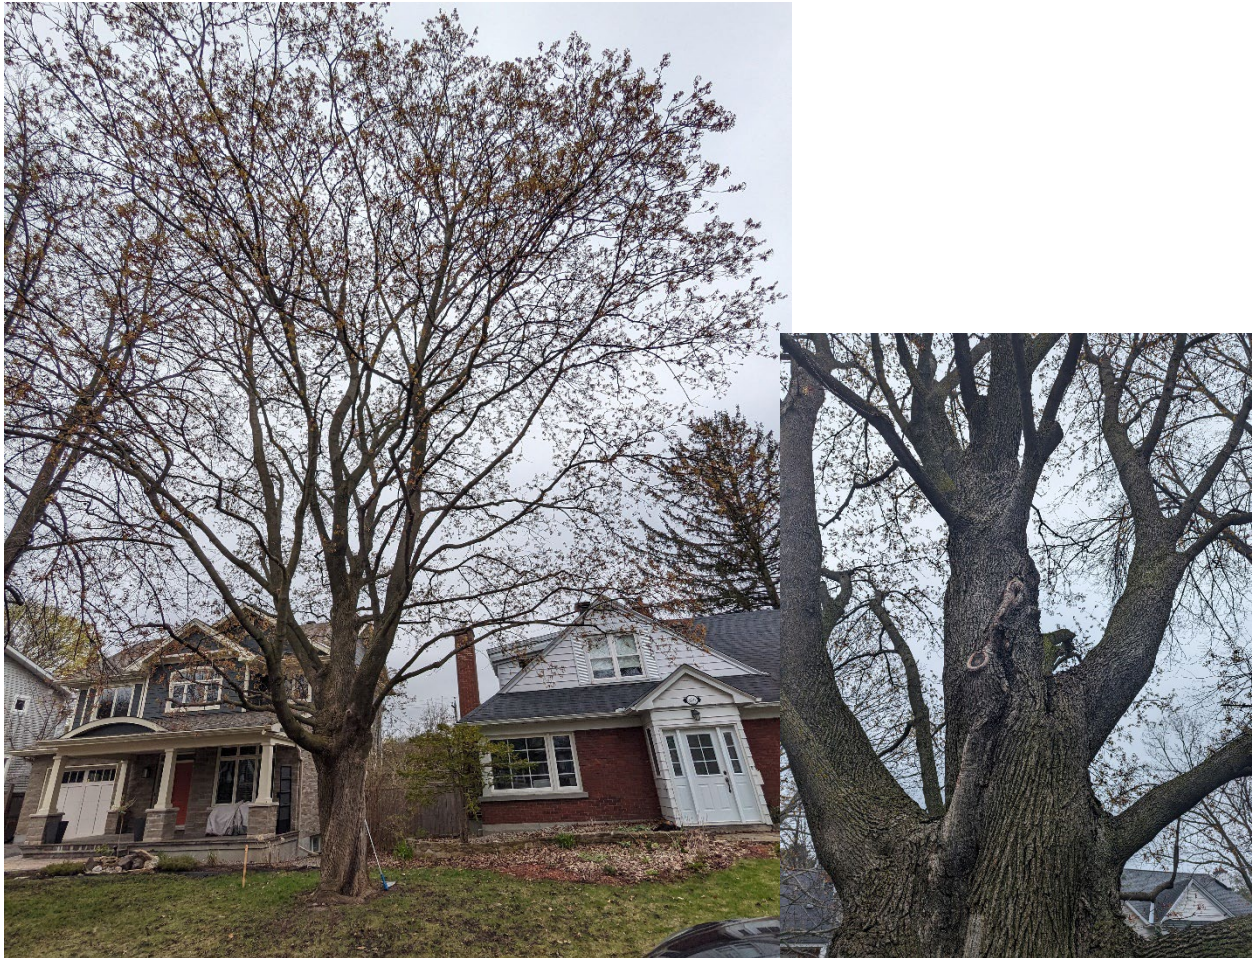
Above left: Tree 1 - City Norway maple to be retained.

Above right: small cavity with large seam on trunk of Tree 1

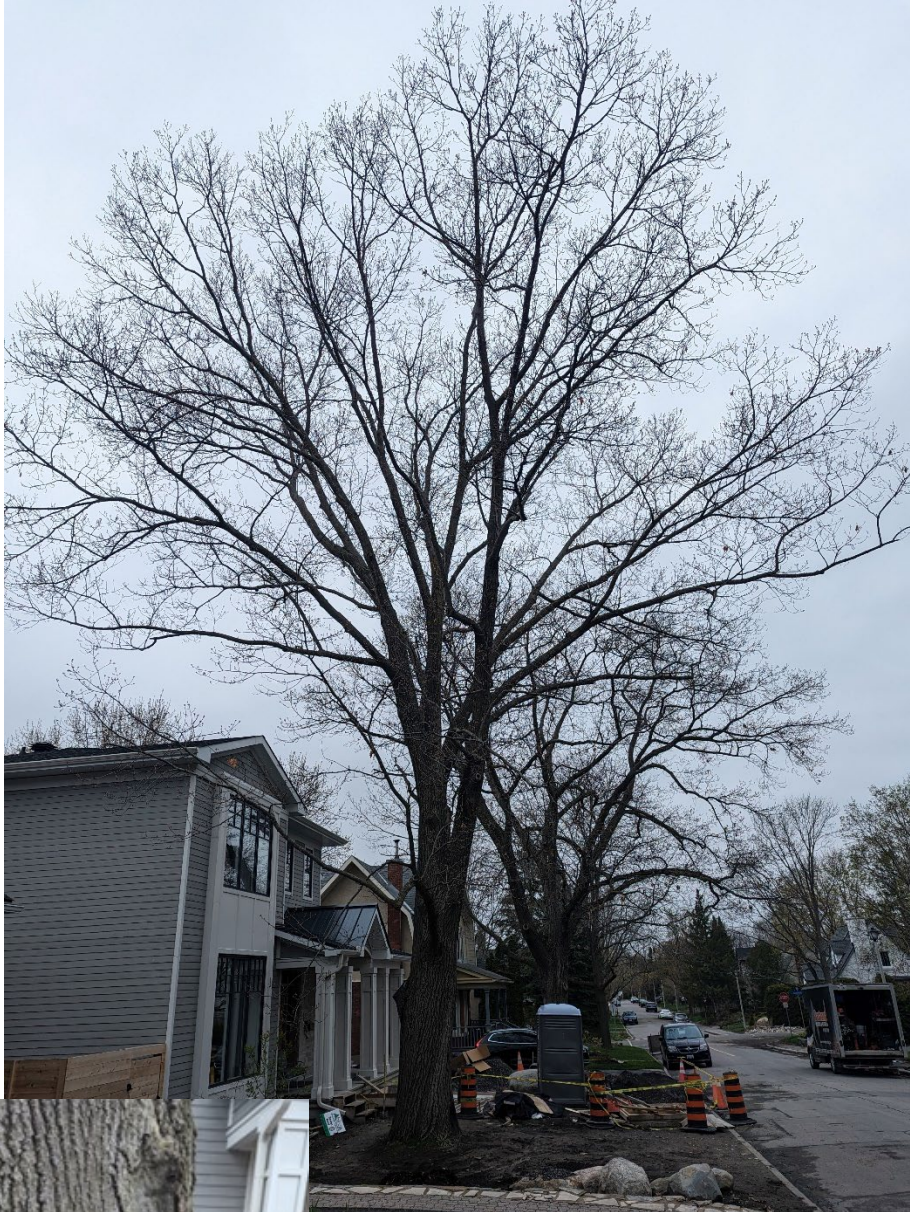
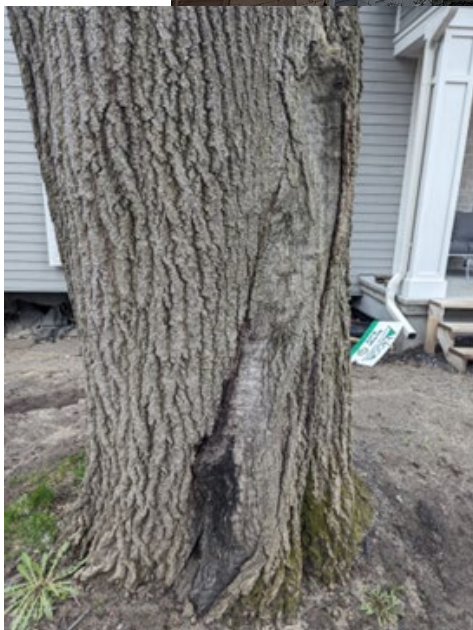
Tree 2 is on the front yard of the adjacent property, which is between 10-80cm lower than the subject property. It is unlikely the tree has grown many roots beyond the property line due to the differences in grade.

Above: Tree 2 - adjacent red oak to be retained.

Left: base of Tree 2 with small seam

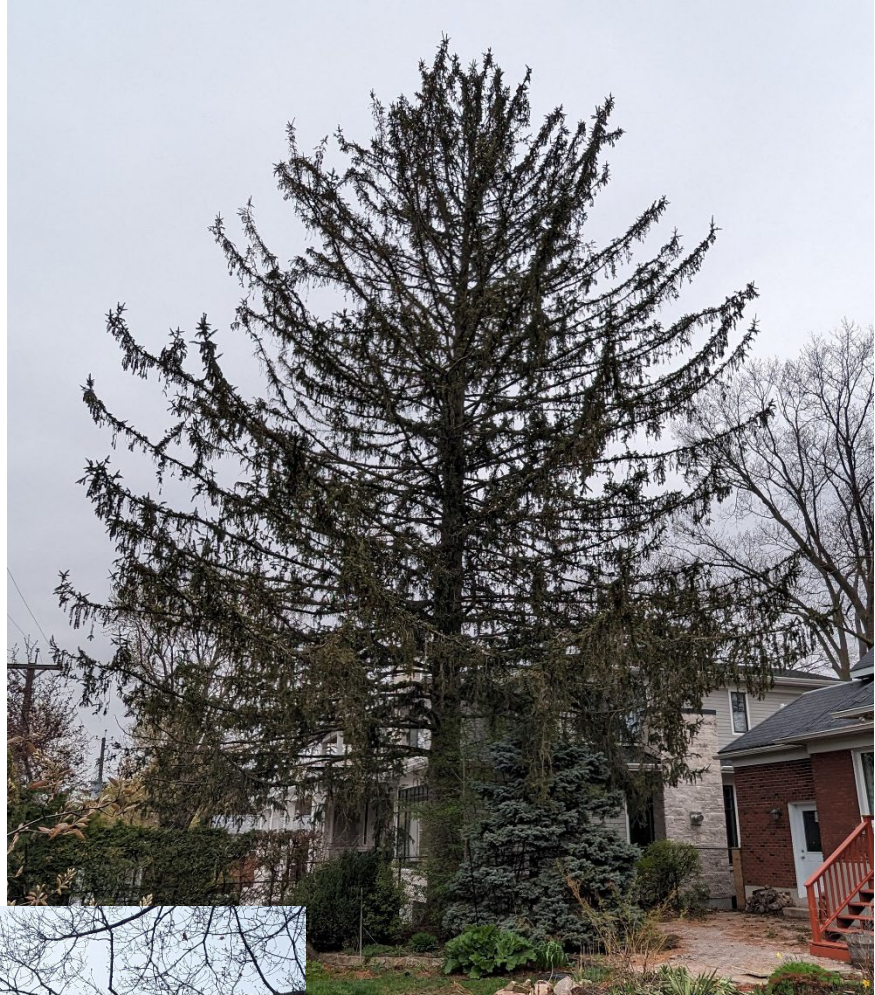
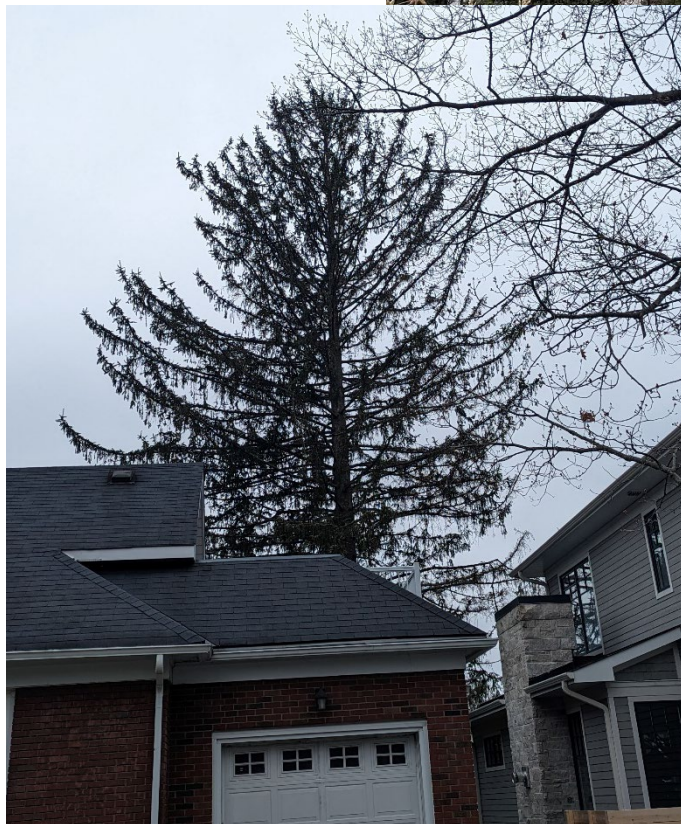
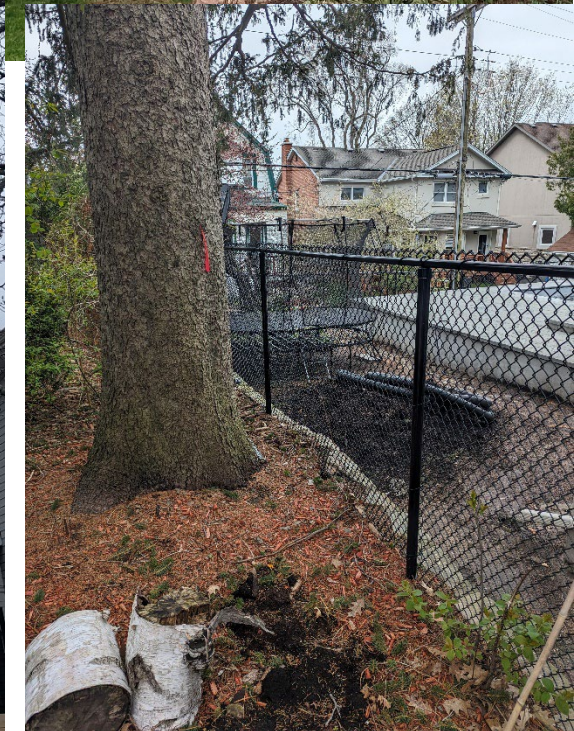
Tree 3 is a large Norway spruce (*Picea abies*). It is growing within 1m of a retaining wall on the north of the subject property. According to Google Streetview imagery, the retaining wall has been in place since at least 2007. Views of the tree from both Mansfield and Westminster (on Google Streetview) show the tree with full foliage from 2007 to 2019. This would indicate the defoliation the tree is experiencing has happened since 2019 - a relatively short time frame. It is hard to say what may have caused the defoliation but such acute defoliation has likely stressed the tree. Combined with the lack of rooting space along the entire north side of the property, and impacts from the proposed construction, it is recommended that this tree be removed.

Right: Tree 3 - private spruce to be removed.

Below right: base and trunk of Tree 3 beside adjacent retaining wall.

Below left: Canopy of Tree 3 – view from Mansfield
