Tree Information Report

Submitted as part of Committee of Adjustment Application to the City of Ottawa

Date of Report: August 30, 2023
Property Address: 2272 Lawn Avenue
Prepared for: Cailey Dunlap and Teddy Markey; cailey.dunlap@gmail.com
Prepared by: Kevin Myers, ISA Certified Arborist; kevin.myers@dendronforestry.ca
Date of Site Visit: August 28, 2023

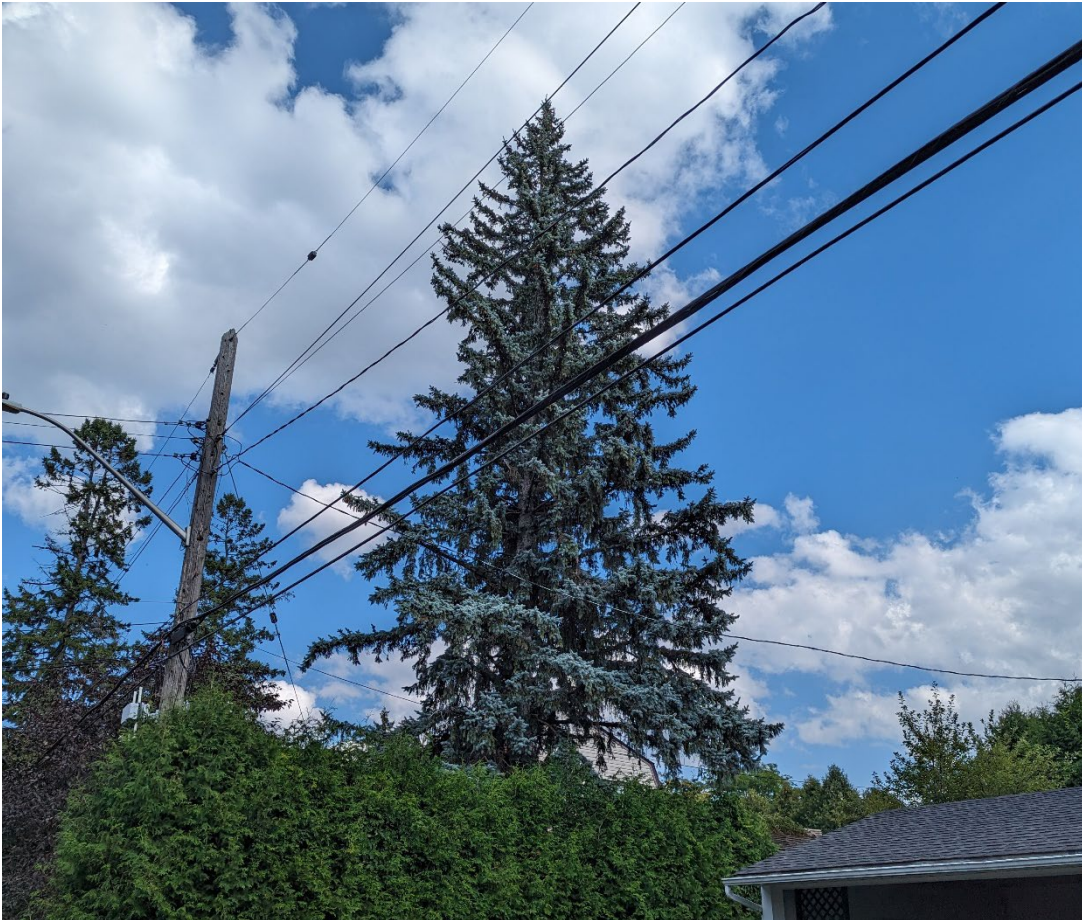
The only protected tree at this site is on the adjacent property. It is a mature Colorado spruce in good condition. The tree is approximately 2m from the property line; the most impacted area of its CRZ falls under the existing driveway and garage, where there are potentially fewer roots. Care is to be taken to not tear roots when removing the driveway; any roots encountered should be cleanly severed by hand to promote faster healing after construction. Care is also to be taken to not damage the tree while removing the cedar hedge. A line of fencing should be erected along the property line after the cedar hedge is removed to protect the tree's trunk from mechanical damage.

Tree 1 - Adjacent spruce to be retained.

Tree ¹	Species	DBH (cm)	Ownership ²	Tree health			Approximate distance to excavation (m)	Action	Forester recommendation
				Roots/Root collar	Trunk	Crown			
1	Colorado Spruce	50 (estimate)	Adjacent – 2266 Lawn	Unknown	Good	Good/Fair	5.5	Retain	Retain and protect. Care to be taken to not tear roots during removal of the driveway. Any roots encountered are to be cleanly severed by hand and covered with a moist organic material. Fencing to be erected along property line to protect trunk from mechanical damage.

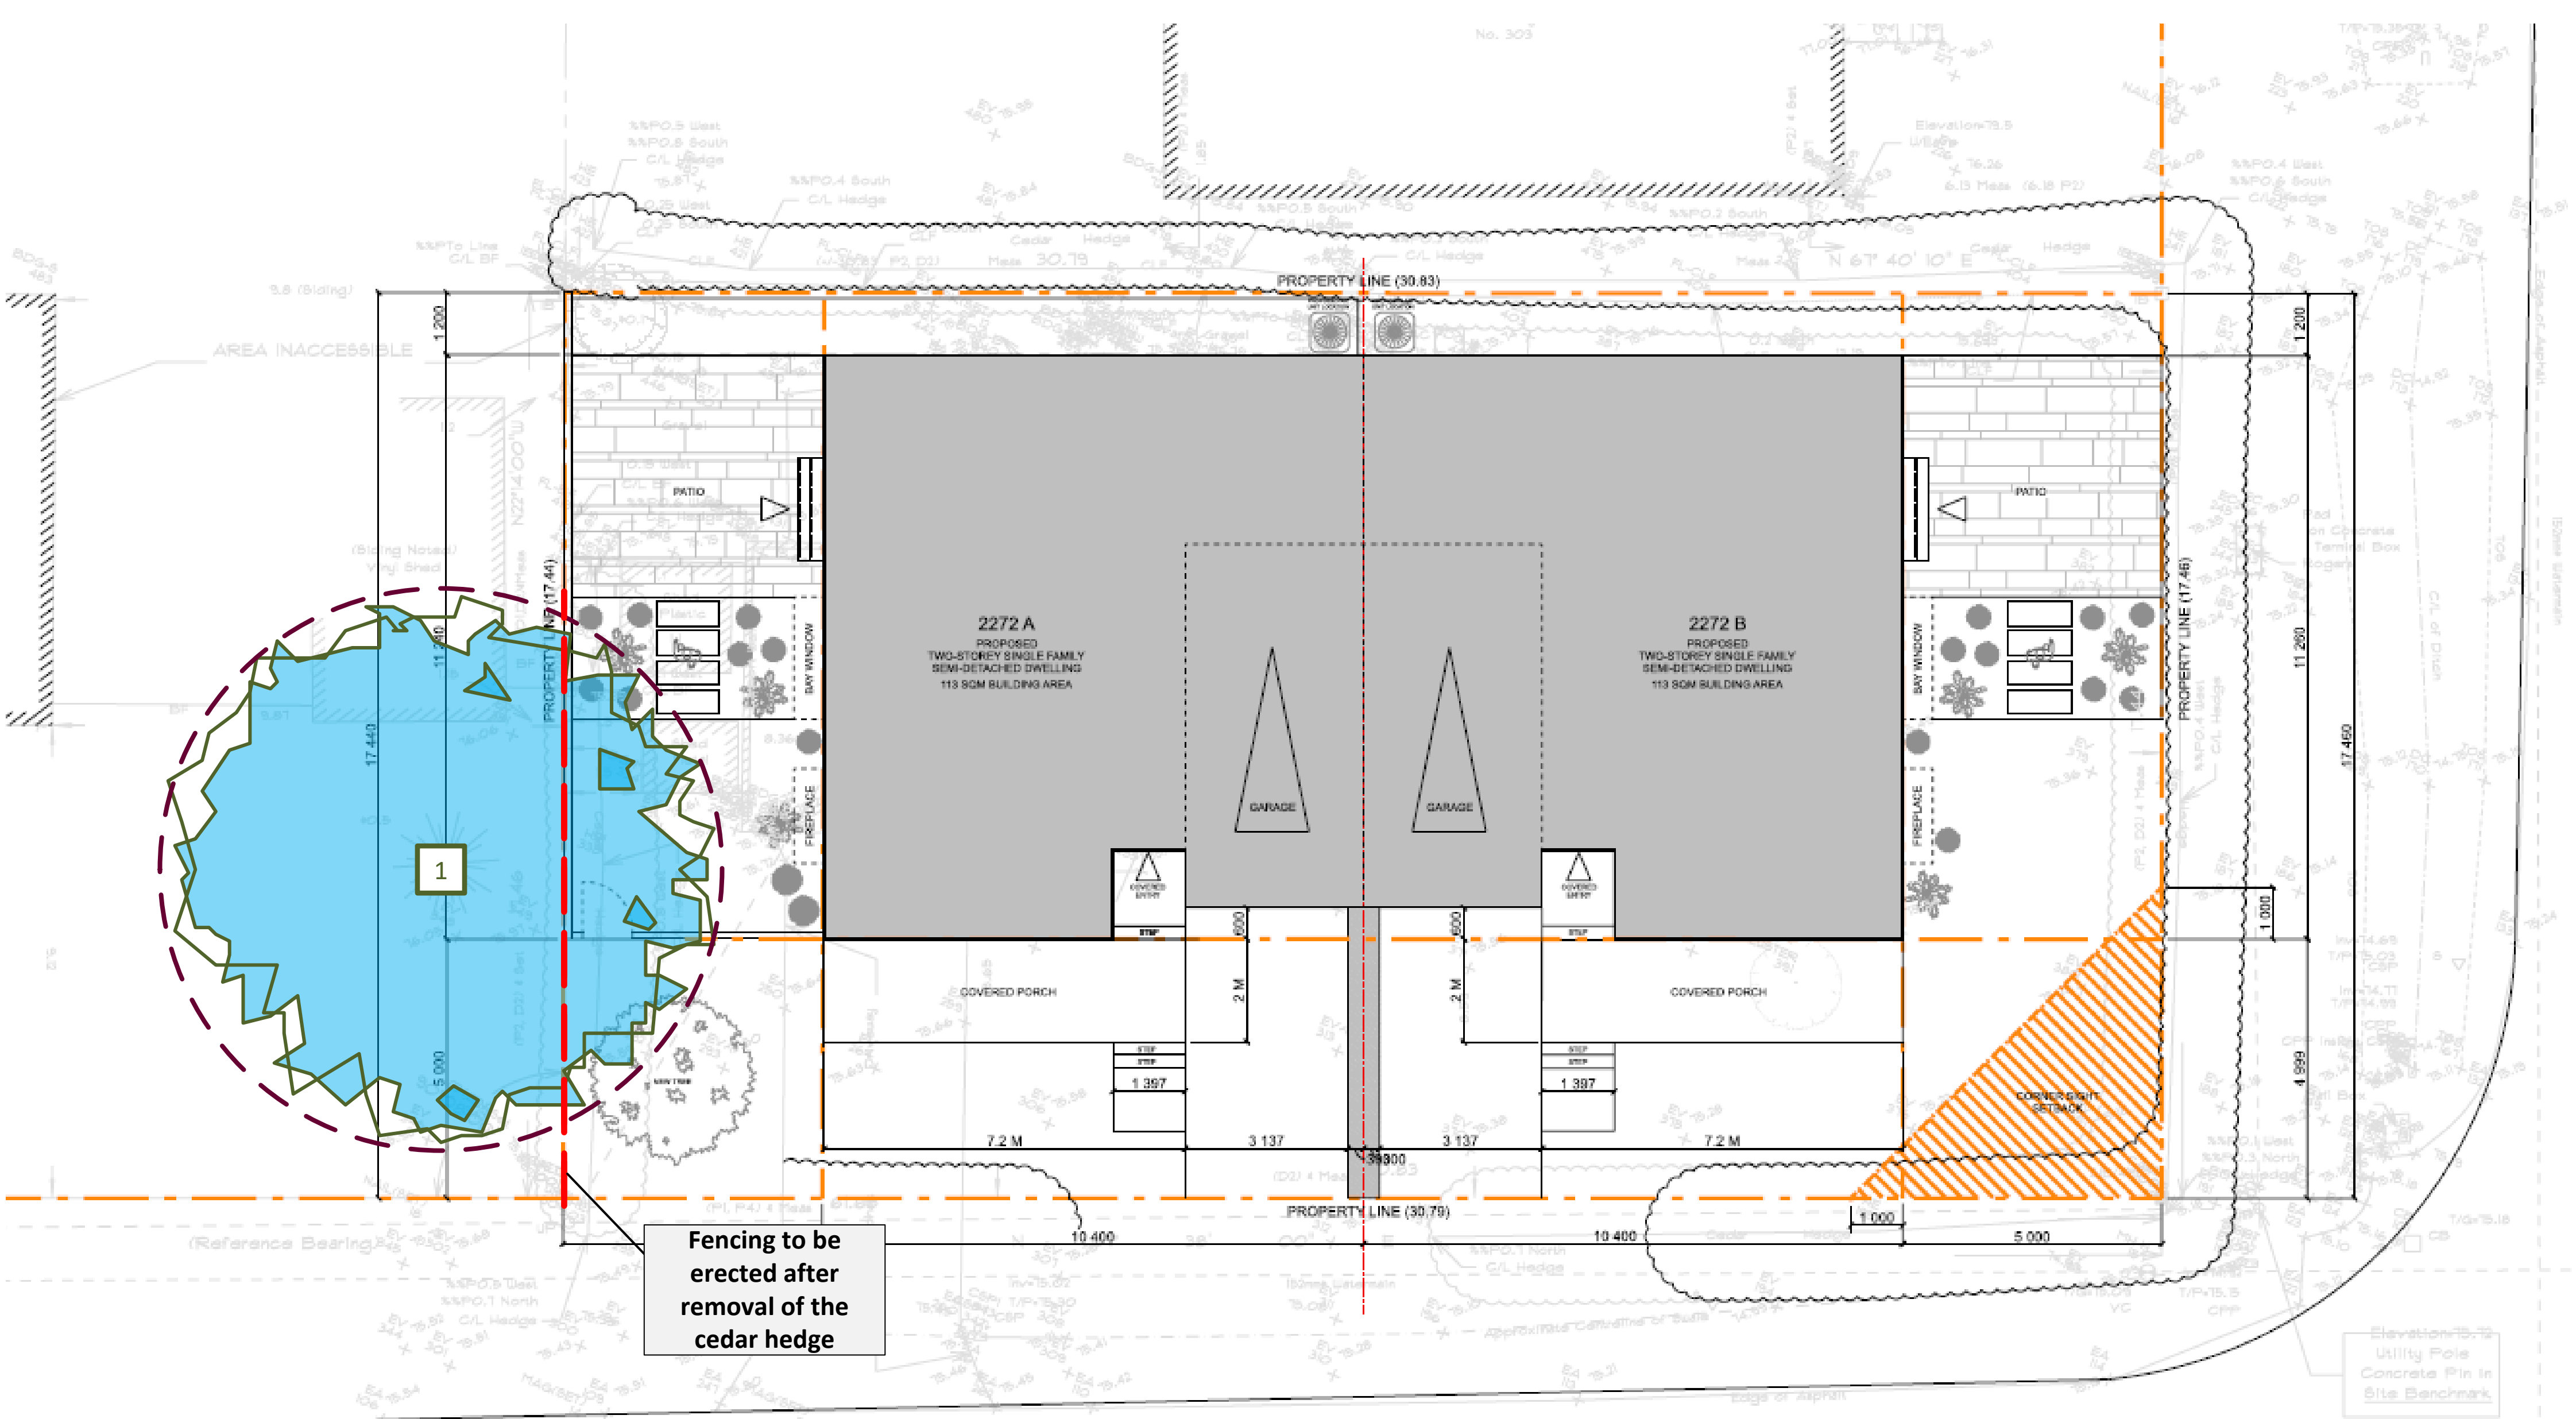
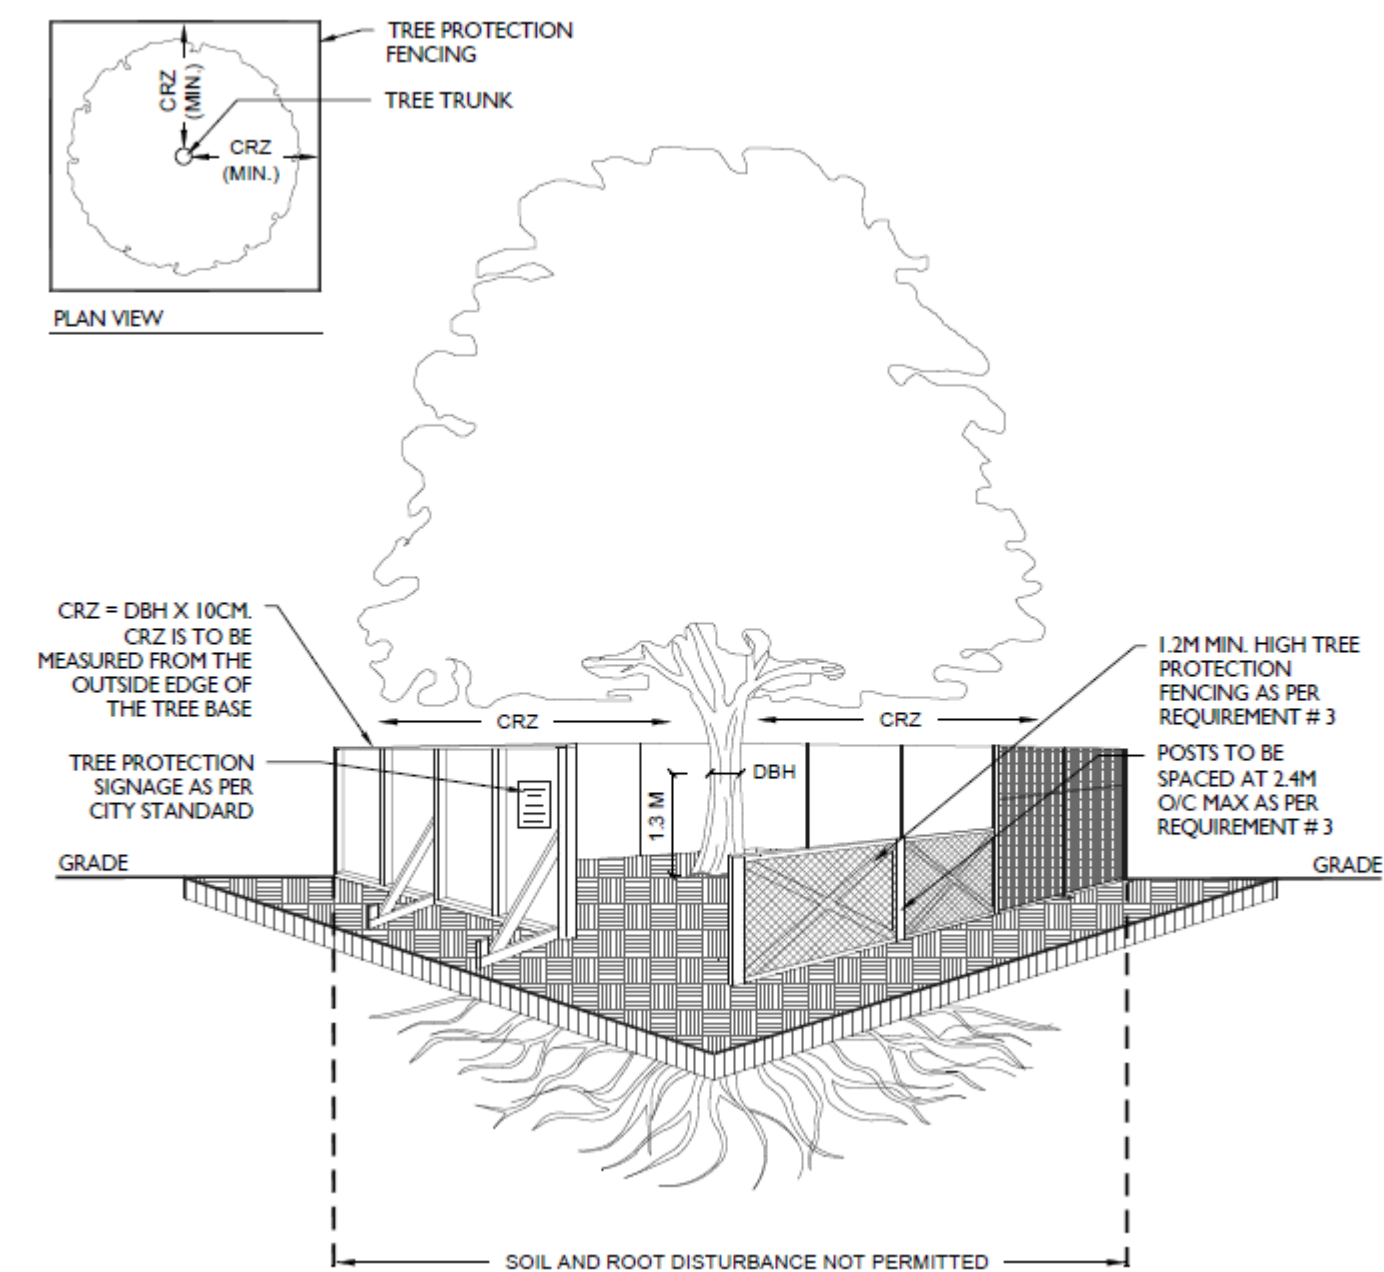
TIR Map – 2272 Lawn Avenue
 Tree layer prepared by
 Dendron Forestry Services
 Version 1.0, August 30, 2023
 For more information, please contact: info@dendronforestry.ca

Tree ¹	Species	DBH (cm)	Tree health			Approximate distance to excavation (m)	Forester recommendation
			Roots	Trunk	Canopy		
1	Colorado Spruce	50 (estimate)	Unknown	Good	Good/Fair	5.5	Retain and protect. Care to be taken to not tear roots during removal of the driveway. Any roots encountered are to be cleanly severed by hand and covered with a moist organic material. Fencing to be erected along property line to protect trunk from mechanical damage.

Prior to any site works, protective fencing should be installed around the Tree Protection Area as indicated in the attached Tree Information Map and maintained until all construction on site has been completed as per the City of Ottawa Tree Protection Specifications (March 2021).
