TREE CONSERVATION REPORT

1983 Carling Ave

Tree Conservation Report submitted as Partial
Requirements for a Site Plan Control Application

January 28, 2022

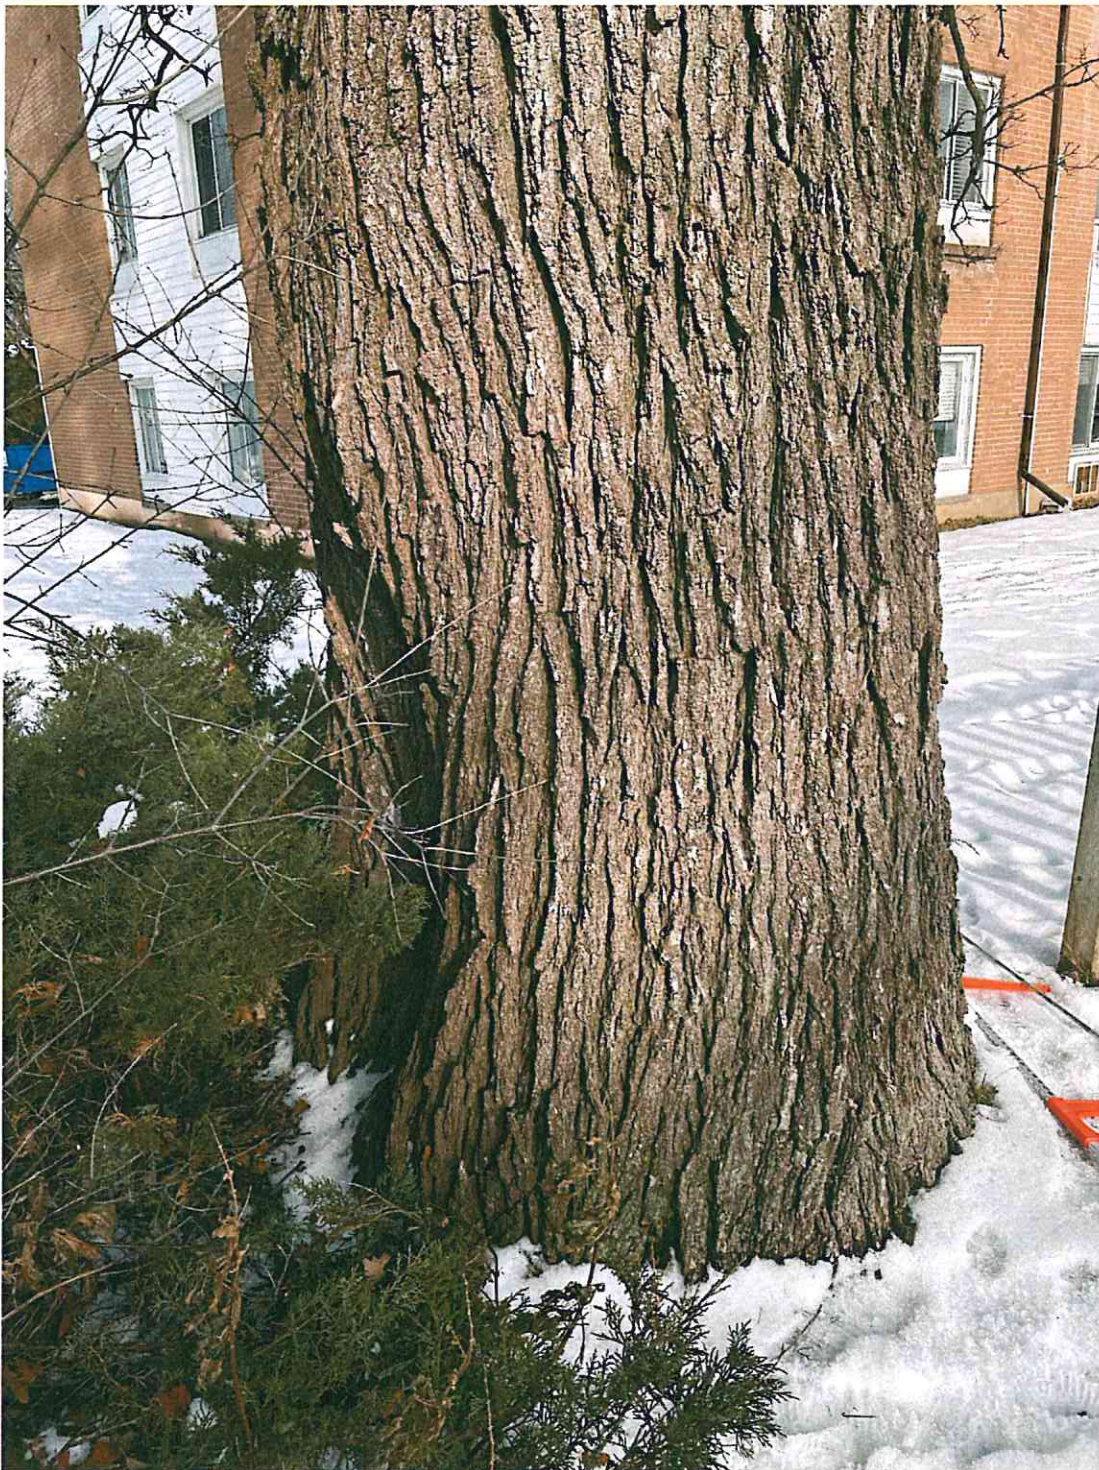
Figure 2: Wound at base of trunk along the west side
