Tree Information Report

Submitted as part of Committee of Adjustment Application to the City of Ottawa

Date of Report: February 6, 2024
Property Address: 304 Fairmont Avenue
Prepared for: Jim Cocks; jim.co@sympatico.ca
Prepared by: Kevin Myers, ISA Certified Arborist®; kevin.myers@dendronforestry.ca
Date of Site Visit: February 5, 2024

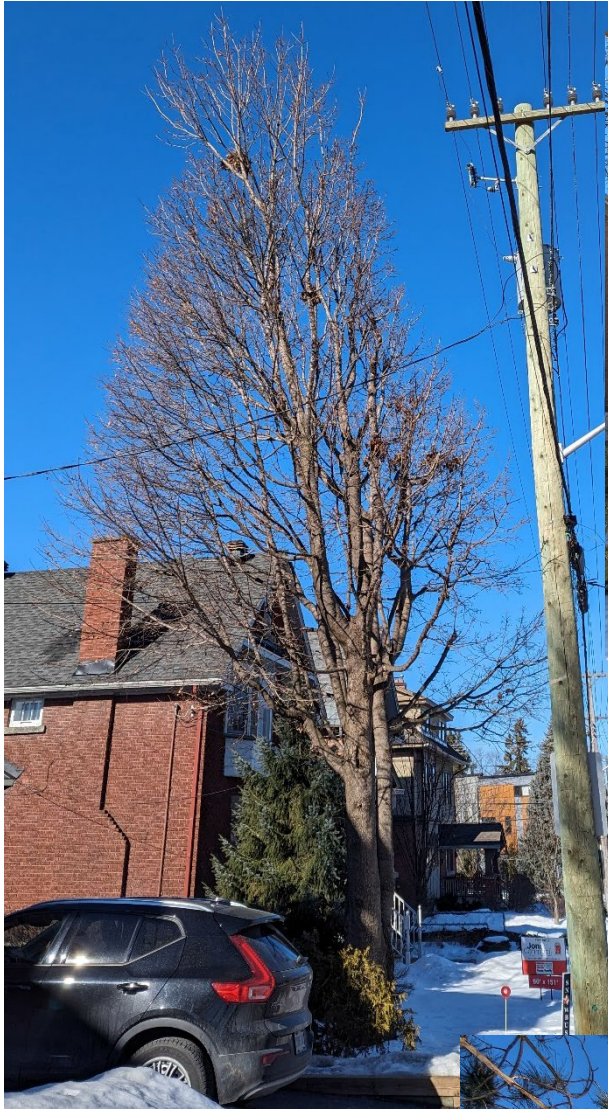
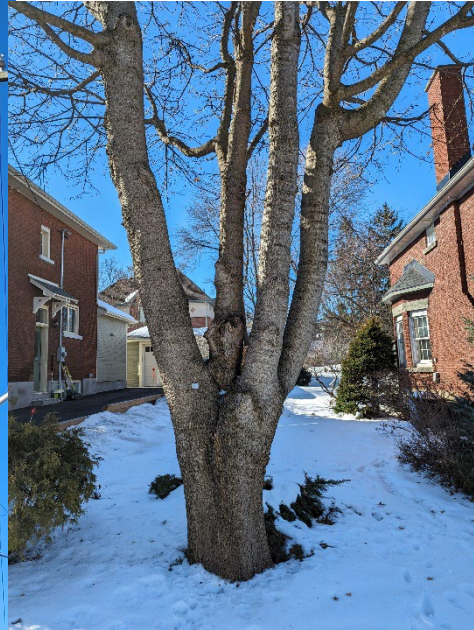
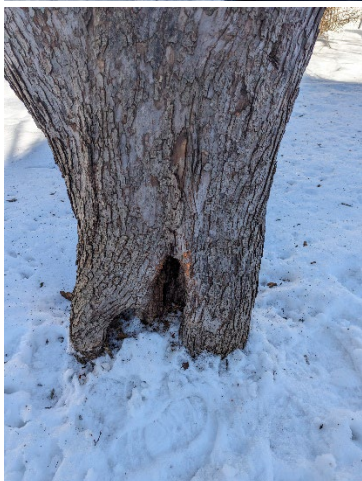
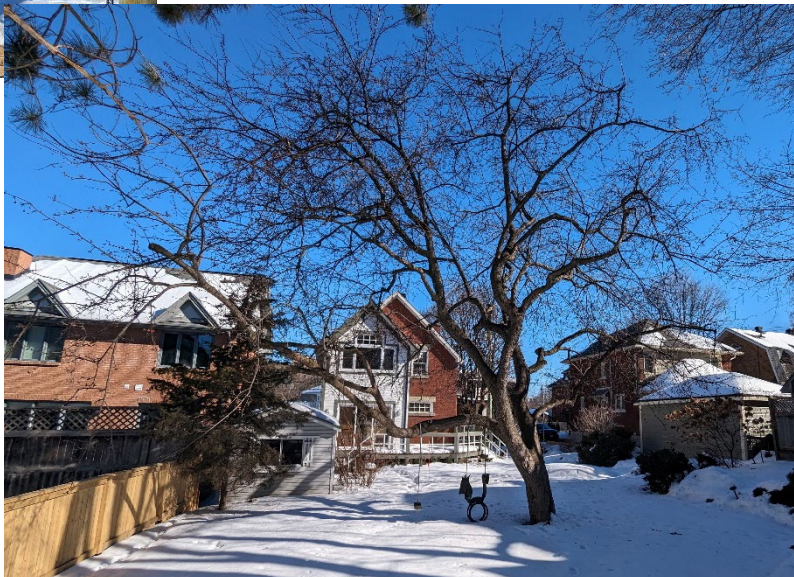
| Tree ¹ | Species | DBH (cm) | Ownership ² | Tree condition | Approximate distance to excavation (m) | Action | Forester recommendation |
|---|--|---|---|---|--|---|---|
| 1 | Norway maple (<i>Acer platanoides</i>) | 79 | City | Fair: included bark at main union; asymmetrical crown due to pruning around wires; canker and decay beginning | N/A | Retain | Retain during severance. |
| 2 | Crab apple (<i>Malus spp.</i>) | 36, 34, 24 | Subject property | Fair: cavity at base with decay present; slight lean to the W | N/A | Retain | Retain during severance. |

Tree 1 - City maple to be retained.

Main union of Tree 1.

Tree 2 - crab apple to be retained.

Cavity at base of Tree 2.

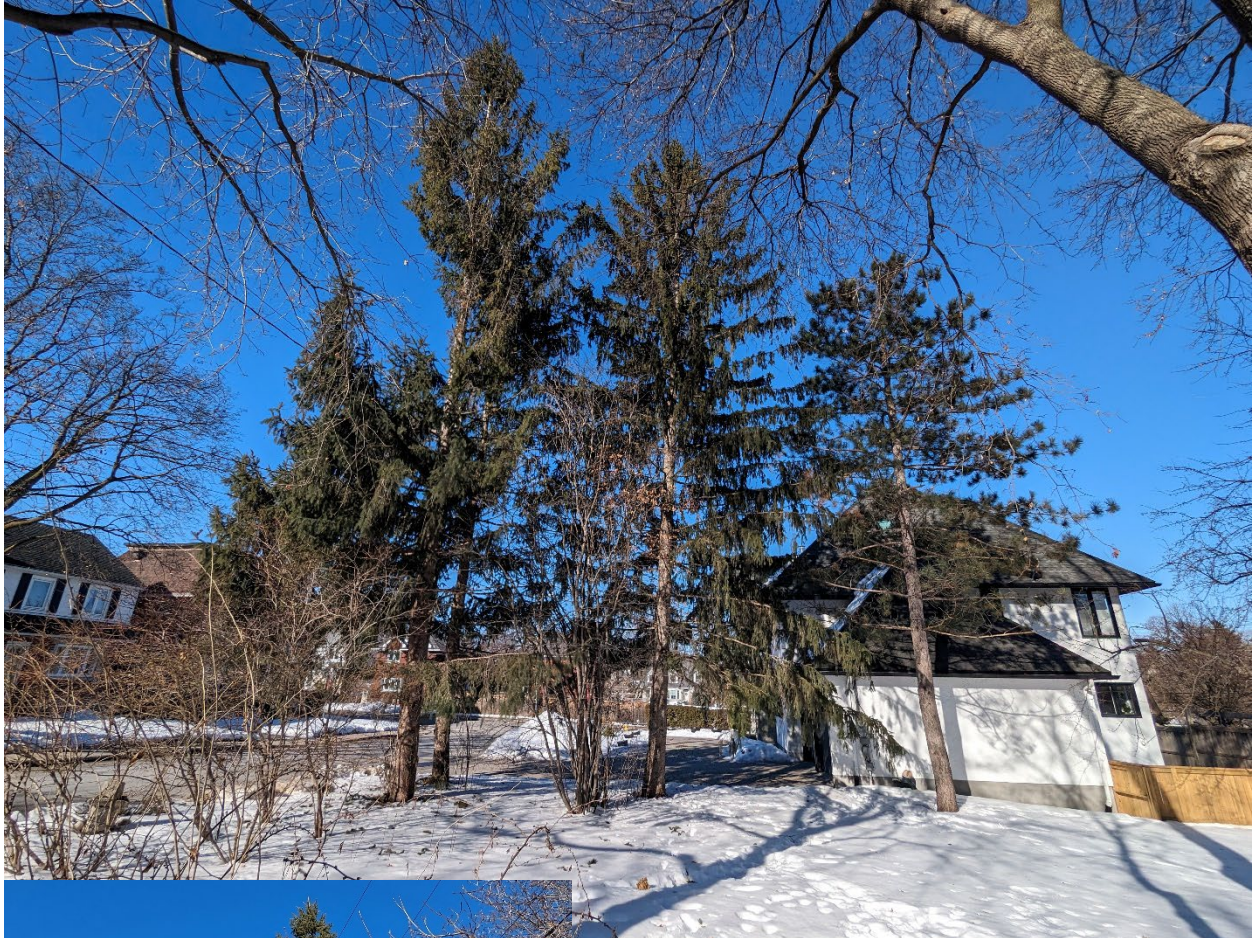
| Tree ¹ | Species | DBH (cm) | Ownership ² | Tree condition | Approximate distance to excavation (m) | Action | Forester recommendation |
|---|--|---|---|---|--|---|---|
| 3 | Red pine (<i>Pinus resinosa</i>) | 33 | Subject property | Good | N/A | Retain | Retain during severance. |
| 4 | Norway spruce (<i>Picea abies</i>) | 38 | Subject property | Good/Fair: slight lean to N; slight defoliation (~5%) | N/A | Retain | Retain during severance. |

Above: (Right to left) Tree 3 - red pine, 4, 5 and 6 - Norway spruce to be retained.

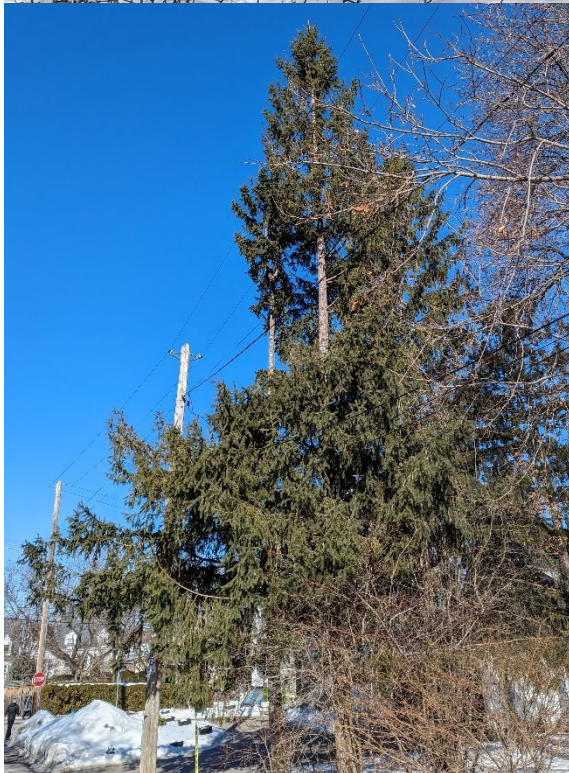
| Tree ¹ | Species | DBH (cm) | Ownership ² | Tree condition | Approximate distance to excavation (m) | Action | Forester recommendation |
|---|--|---|---|---|--|---|---|
| 5 | Norway spruce (<i>Picea abies</i>) | 32 | City | Fair: double leader at top; pruned around wires (15% canopy missing); defoliation (~15%) | N/A | Retain | Retain during severance. |
| 6 | Norway spruce (<i>Picea abies</i>) | 35 | City | Fair: pruned around wires (15% canopy missing); defoliation (~15%) | N/A | Retain | Retain during severance. |

Left: missing canopy segments of Tree 5 and 6

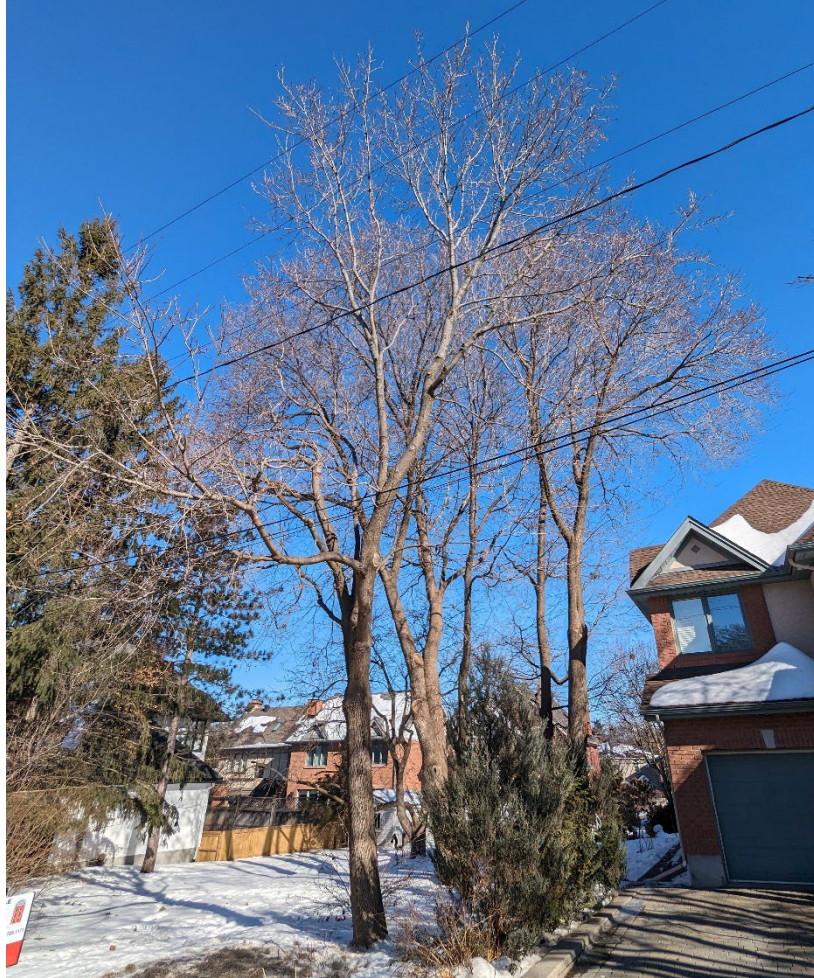
Above: Trees 7-11 - Norway maples to be retained.

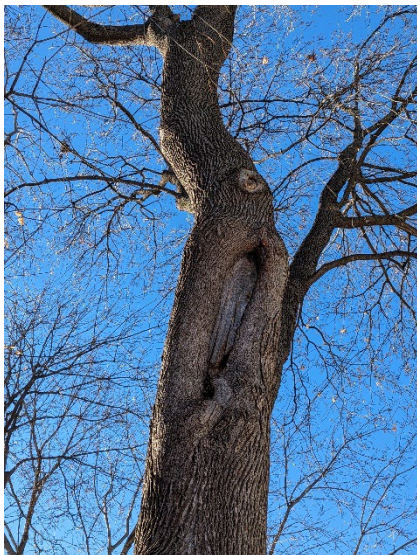
| Tree ¹ | Species | DBH (cm) | Ownership ² | Tree condition | Approximate distance to excavation (m) | Action | Forester recommendation |
|---|--|---|---|---|--|---|---|
| 10 | Norway maple (<i>Acer platanoides</i>) | 53 | Subject property | Fair: large wound at 3.5m with decay | N/A | Retain | Retain during severance. |

Left: wound on the stem of Tree 10.

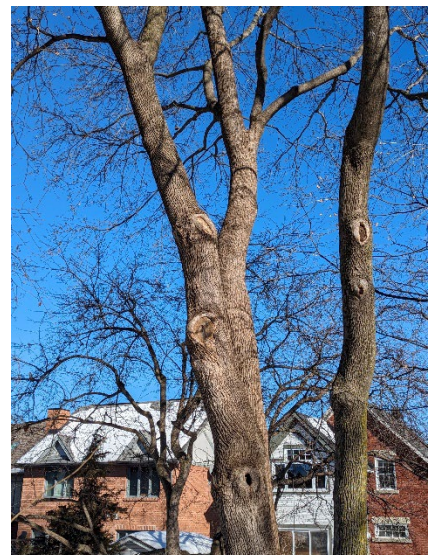
| Tree ¹ | Species | DBH (cm) | Ownership ² | Tree condition | Approximate distance to excavation (m) | Action | Forester recommendation |
|---|--|---|---|---|--|---|---|
| 11 | Norway maple (<i>Acer platanoides</i>) | 54 | Subject property | Poor/Fair: cavities with decay probable; large pruning wounds with decay beginning; moderate lean to N | N/A | Retain | Retain during severance. |

Right: Pruning wounds on Tree 11 (in foreground).
