May 14, 2024

RE: TREE CONSERVATION REPORT – 2140 BASELINE ROAD, OTTAWA

**APARTMENT
BUILDING**
2140 BASELINE ROAD

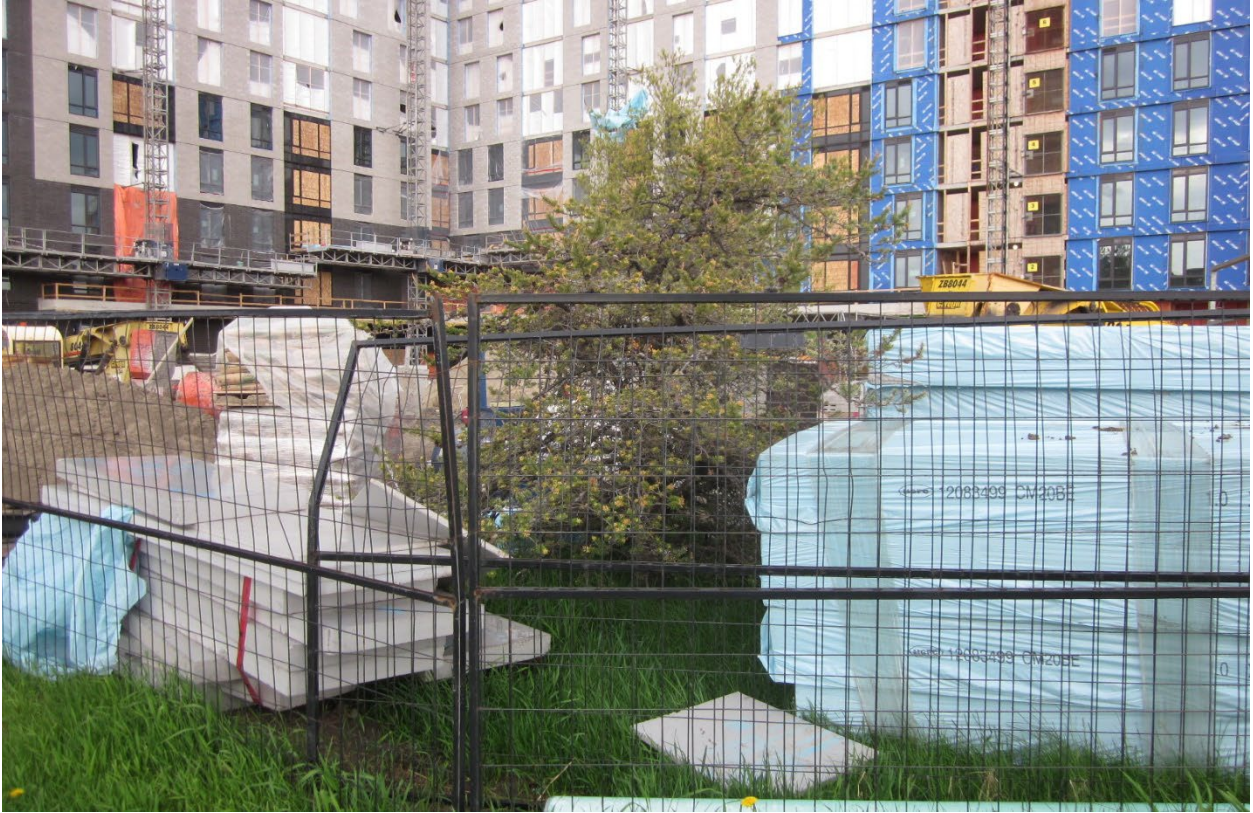
Tree No.	Tree Species	Ownership	DBH ¹ (cm)	Tree Condition, Age class & Preservation Status (to be removed or preserved and protected)
1	Jack pine (<i>Pinus banksiana</i>)	Fair	9	Fair; mature; stunted form; maturing; native species; to be removed (has been injured by construction related damage)
2	Red oak (<i>Quercus rubra</i>)	Good	24	Poor; maturing; broad crown; internal deadwood only; maturing; native species; to be removed (conflicts with construction)
3	Red oak (<i>Quercus rubra</i>)	Fair	23	Poor; maturing; moderate amount of dead, declining branches on north side of crown; maturing; native species; previously removed
4	Scots pine (<i>Pinus sylvestris</i>)	Fair	17	Fair; immature; co-dominant stems at 2m; maturing; introduced species; to be removed (has been injured by construction related damage)
5	Ash (<i>Fraxinus spp.</i>)	Very poor	-	Very poor; mature; in advanced decline due to Emerald ash borer (<i>Agilus planipennis</i>) – coppicing from base; native species; previously removed

Picture 1. Current condition of tree #1 at 2140 Baseline Road.

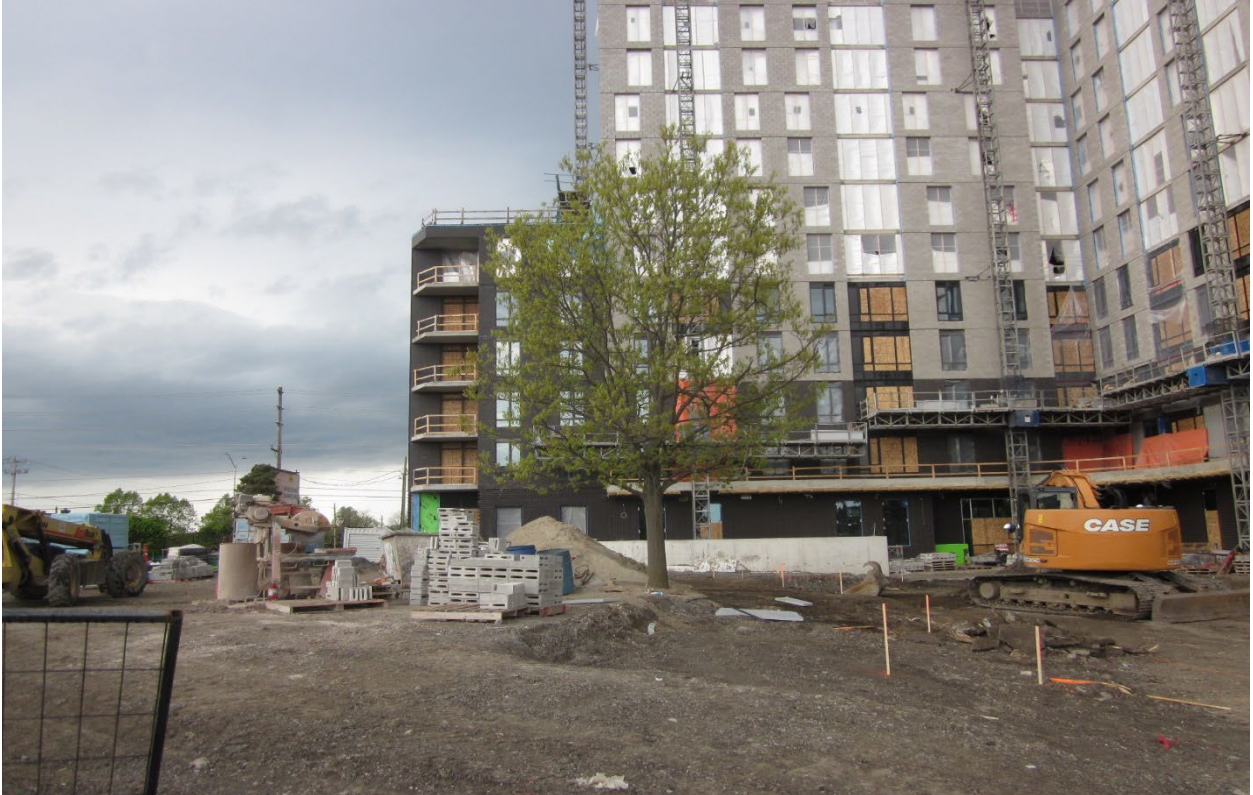
Picture 2. Current condition of tree #2 at 2140 Baseline Road.
