Committee of Adjustment

RE: TREE INFORMATION REPORT (FULL) FOR 185 KAMLOOPS AVENUE

Table 1. Tree information for 185 Kamloops Avenue

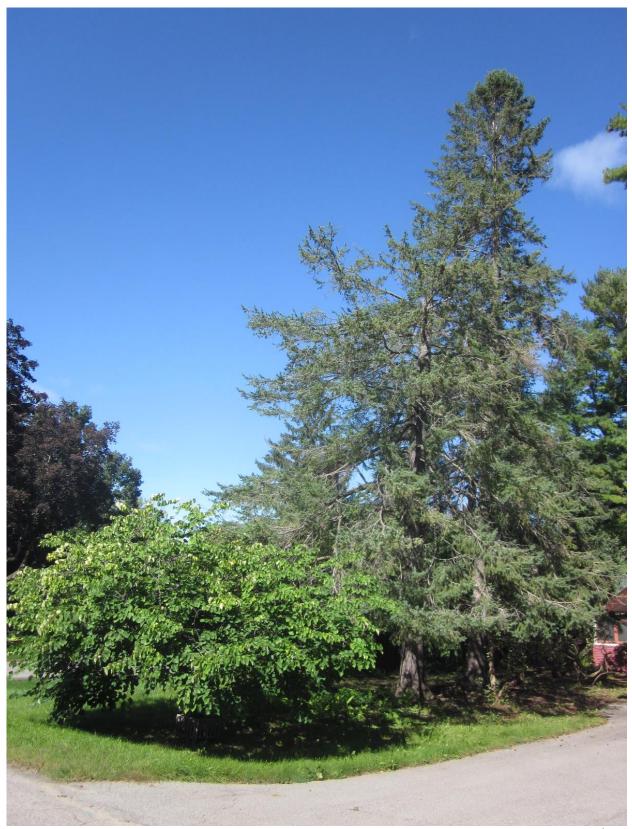
110.	Construction ¹	SIIIP	(6111)	(111)	$(m)^4$	removed or preserved and protected)	removal	Removal
1	Redbud	City	20.1	2.0	+/-2	Poor; mature; four competing stems at	Not	NA
	(Cercis		(at			1.3m and one suppressed lateral at 0.6m	applicable	
	canadensis) /		1m)			on southeast; very poor unions – all	– to be	
	Moderate		ĺ			failing; very broad crown; introduced	preserved	
						species to Eastern Ontario; to be	•	
						preserved and protected		
2	White spruce	Private	60.1	-	-	Very poor; mature; main stem broke off at	Very poor	Tree be
	(Picea					14m in May 2022 wind storm; native	condition	removed
	glauca) /					species; to be removed		
	Moderate-							
	Good							
3	White spruce	Private	53.5	-	-	Hazardous; mature; partially uplifted in	Hazardous	Tree be
	(Picea					May 2022 wind storm - now moderately		removed
	glauca) /					divergent towards northeast; native		
	Moderate-					species; to be removed

Picture 1. Trees #1, 2 and 3 (left to right), city redbud and private white spruces at 185 Kamloops Avenue

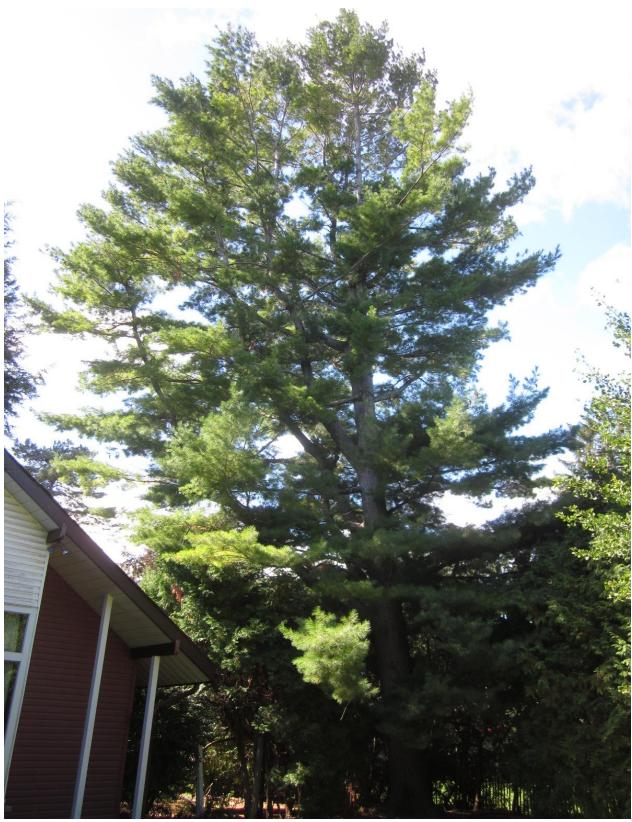
Picture 2. Tree #5, private white pine at 185 Kamloops Avenue

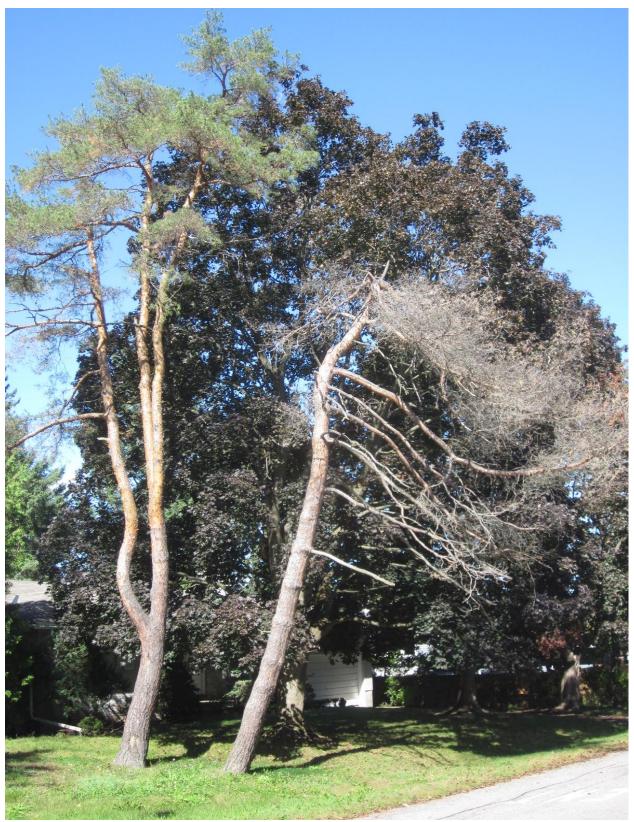
8	Norway	Neigh-	+/-60	+/6	+/-7	Fair; mature; co-dominant stems at 3.5m	Not	NA
	maple (Acer	bour				with suppressed lateral at 2m on north;	applicable	
	platanoides) /					broad crown; introduced invasive species;	– to be	
	Moderate-					to be preserved and protected	preserved	
	Good							
9	Scots pine	Private	49.5	5.0	+/-3	Poor; mature; central stem with competing	Will not	Tree be
	(Pinus					lateral at 3m on southwest; central stem	survive	removed
	sylvestris) /					bisects at 6m – poor form; poor crown	root loss	
	Moderate-					density (holding only 1 year of growth),	related to	
	Good					fair growth increment and needle colour;	driveway	
						introduced invasive species; to be	excavation	
						removed

T doic 1	. Con t							
Tree	Tree species	Owner	DBH ²	CRZ^3	Distance to	Tree Condition, Age Class, Condition	Reason	Forester's
No.	/Tolerance to	-ship	(cm)	(m)	excavation	Notes, and Species Origin	for	Opinion re.
	Construction ¹				$(m)^4$		removal	Removal
10	Scots pine (Pinus	City	35.3	-	1	Dead; introduced invasive species; to be removed	Dead	Tree be removed
	,					Temoveu		Tellioved
	sylvestris) /							
	Moderate-

Picture 3. Trees #8 (neighbouring Norway maple in background), Scots pines #9 and 10 at 185 Kamloops Avenue

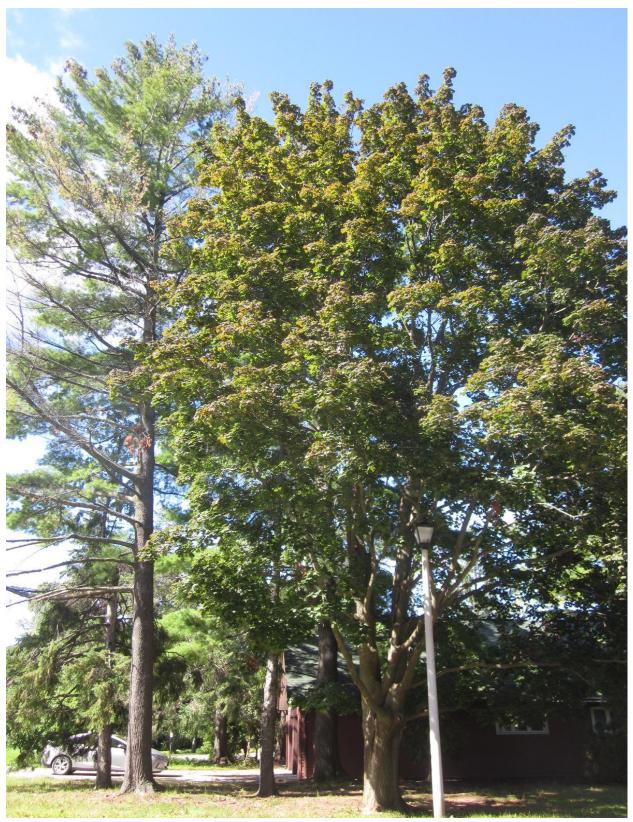
(Pinus					declining branches on south and east sides	condition	removed
	strobus) /					of crown; many others with chlorotic		
	Moderate-					foliage, including at crown apex; tree is in		
	Good					advanced decline; native species; to be		
						removed (due to poor condition)		
1						2		- 2

Picture 4. Tree #13 (city Norway maple, right) and #17 (private white pine, left) at 185 Kamloops Avenue

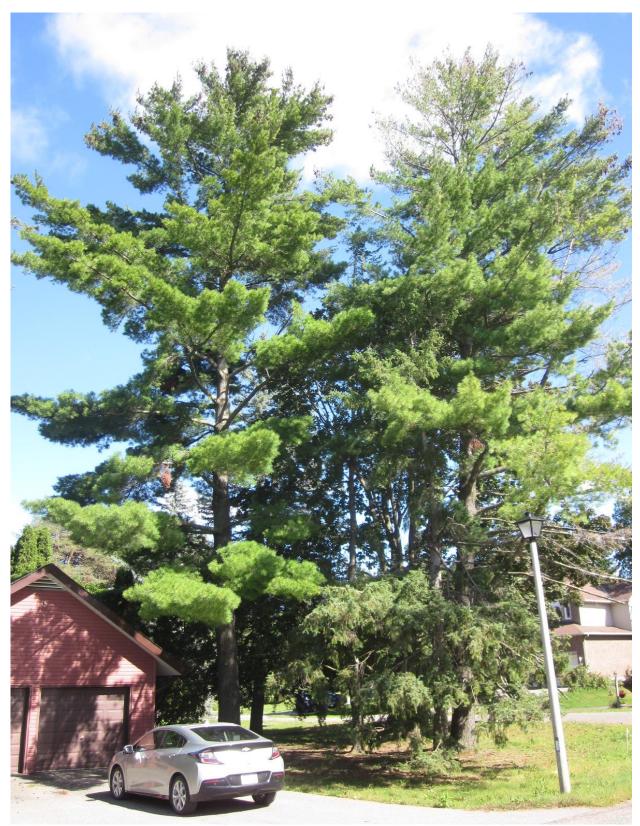
-	excavation	
15	White pine	Private	68.9	6.9	<1	Good; mature; single dominant stem for	Will not	Tree be
	(Pinus					most of height; crown asymmetric	survive	removed
	strobus) /					towards southwest due to trees #13 and	root loss	
	Moderate-					14; good crown density, annual increment	related to	
	Good					and needle colour; native species; to be	nearby	
						removed	excavation	
16	White spruce	Private	34.2	-	-	Poor; mature; main stem broken at 5.5m	Poor	Tree be
	(Picea					in distant past – single offset leader has	condition	removed
	glauca) /					regenerated; crown asymmetric towards		
	Moderate-					south/west due to influence of trees #14		
	Good					and 17; good crown density, annual		
						increment and needle colour where		
						exposed to sunlight; native species; to be		
						removed (due to poor condition)		
17	White pine	Private	62.1	-	-	Very poor; mature; multiple dead and	Very poor	Tree be

Picture 5. Trees #15, 16 and 17 (left to right), private white pines and white spruce (centre-right) at 185 Kamloops Avenue
