PROJECT
PROPOSED 17 UNIT RESIDENTIAL BUILDING
2458 CLEROUX CRESCENT, OTTAWA ON

DRAWING
TREE CONSERVATION REPORT &
LANDSCAPE PLAN

Addendum to Tree Conservation Report

Date of Report: November 22, 2023
Property Address: 2458 Cleroux Crescent
Prepared for: Melmar Group c/o Mark Nahkle; info@melmargroup.ca
Prepared by: Kevin Myers, ISA Certified Arborist; kevin.myers@dendronforestry.ca
Date of Site Visit: November 21, 2023

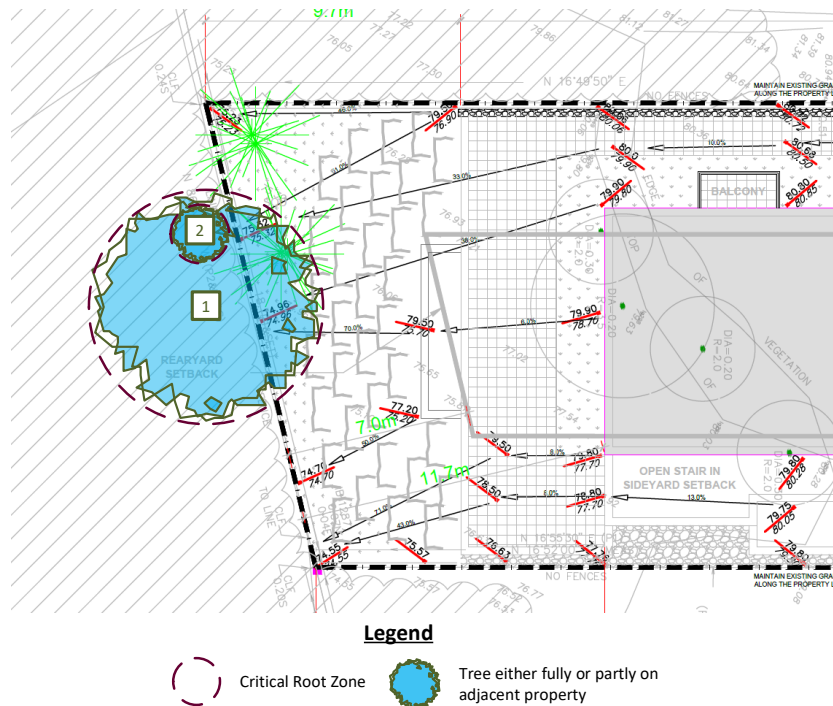
Please refer to the drawing below for tree positions. This drawing has been overlaid on the grading plan supplied by the client in pdf format. The Critical Root Zone is defined, as per the City of Ottawa Tree Protection By-law (no. 2020-340) as a circle around the trunk with a radius equal to 10x the tree’s diameter at breast height.

Tree 2 is not expected to be impacted by construction, as its CRZ does not extend into the subject property.

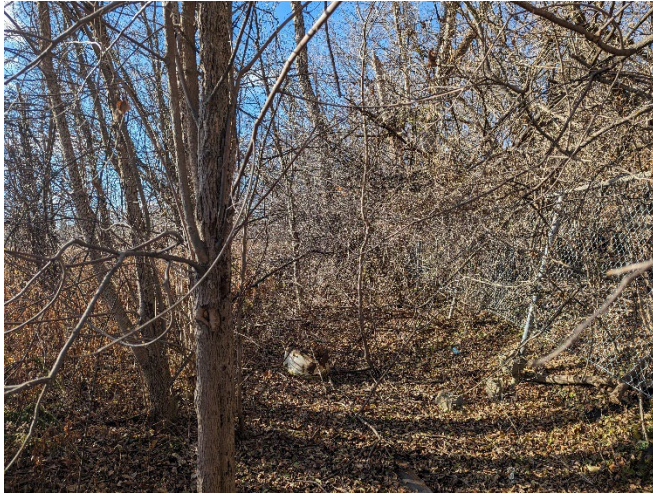
Immediately to the south of the fence was a small depression, approximately 40-75cm deep and 3.5m wide, sloping very gently west to east from beyond the subject property to beyond the scope of this report. Beyond this depression were many small trees, but they were far enough away that their CRZs would not be impacted. Within this depression the majority of the trees were ash (*Fraxinus spp.*), but these were all dead or very close to it. Two living trees were noted and are included in the table below:

Fence and the depression that run along the southern border of the subject property

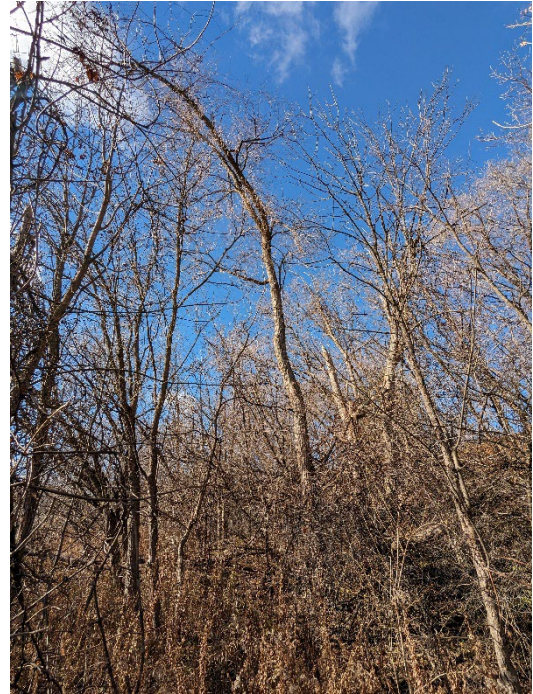
Tree ¹	Species	DBH (cm)	Ownership ²	Tree Condition
1	Willow (<i>Salix spp.</i>)	41	NCC	Fair/Good: asymmetrical crown; small mechanical wound (from falling branch) at 4m; slight lean (approx. 10°) to the SW
2	Manitoba maple (<i>Acer negundo</i>)	10	NCC	Fair/Poor: significant lean (approx. 25°) to the S; dead branches in canopy

Tree 1 - NCC willow with asymmetric crown

Tree 1 is 1.6m from the chain link fence and sits on the bottom of the depression where the soil is quite wet. The subject property directly north of the tree slopes upward and is much drier than the soil where the tree is growing. It is expected that the roots of Tree 1 may have extended into the subject property but are likely to prefer the rich wet soils on the NCC property. Adding fill on the subject property is unlikely to severely impact the CRZ of the tree.
