## Tree Information Report v4.0

Submitted as part of Committee of Adjustment Application to the City of Ottawa

**Address:** 290 Holmwood  
**Date of Report:** July 31, 2024  
**Date of Site Visit:** November 3, 2022, November 29, 2023 and April 16, 2024  
**Prepared by:** Astrid Nielsen, RPF, ISA Certified Arborist®; [astrid.nielsen@dendronforestry.ca](mailto:astrid.nielsen@dendronforestry.ca)  
**Client:** Allan Bateman, [prestwick24@gmail.com](mailto:prestwick24@gmail.com)

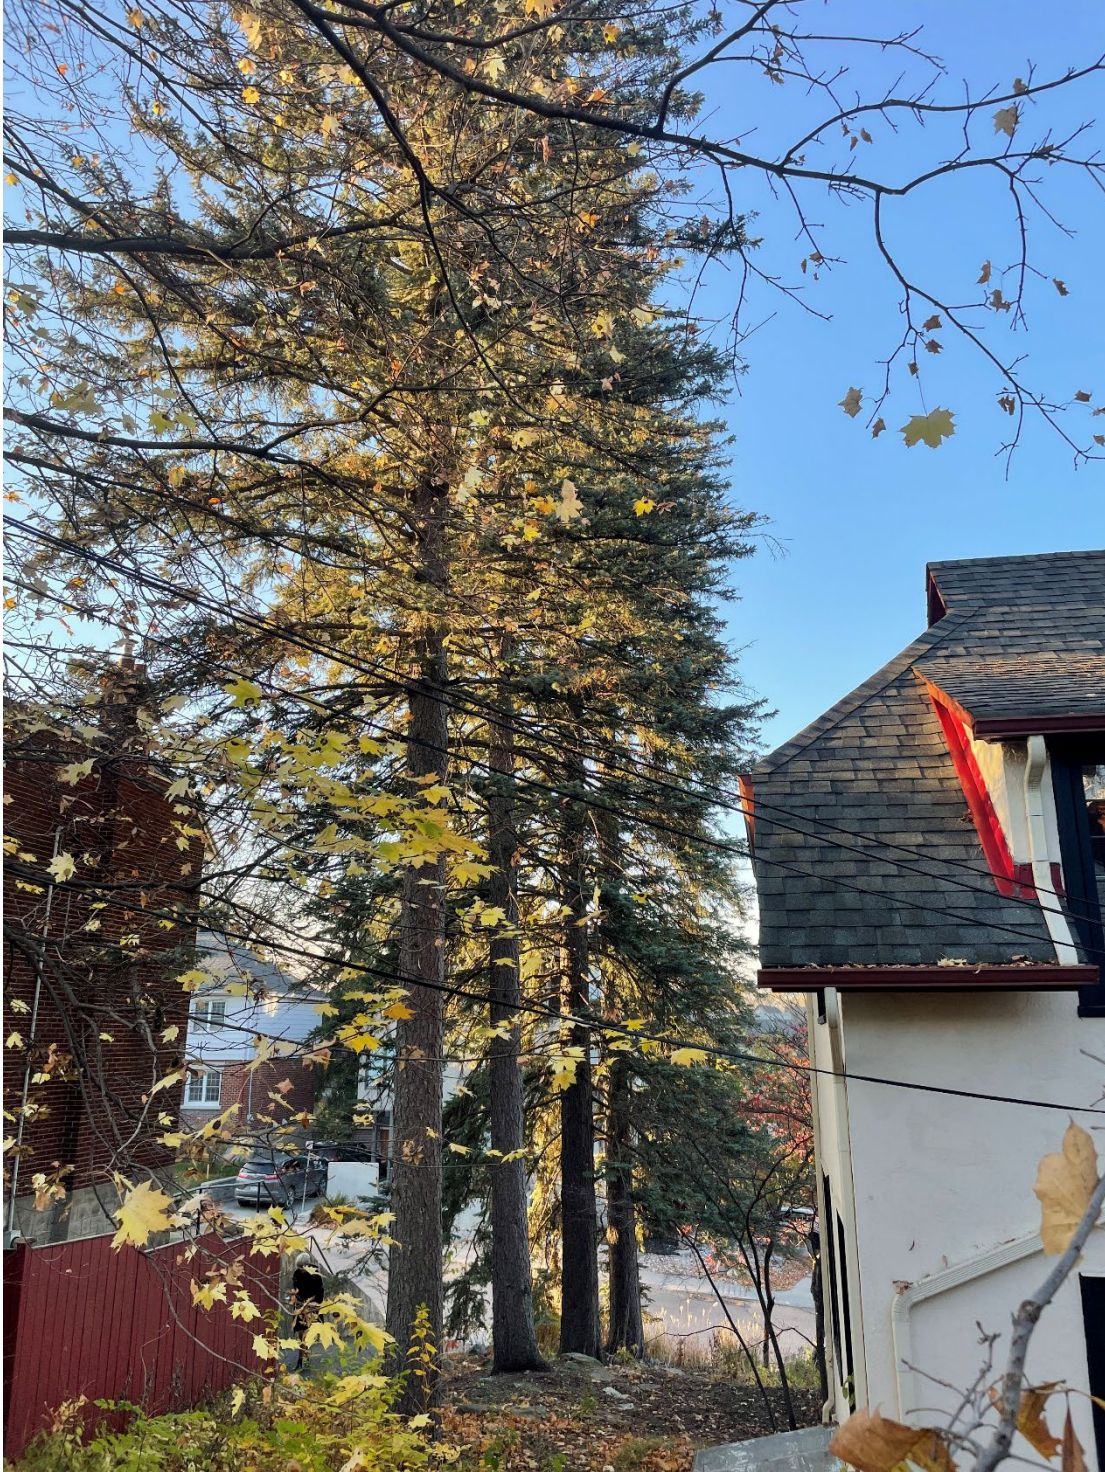
*Figure 1: Photo taken from rear of property, Colorado spruce along the west property line, trees 1-4*

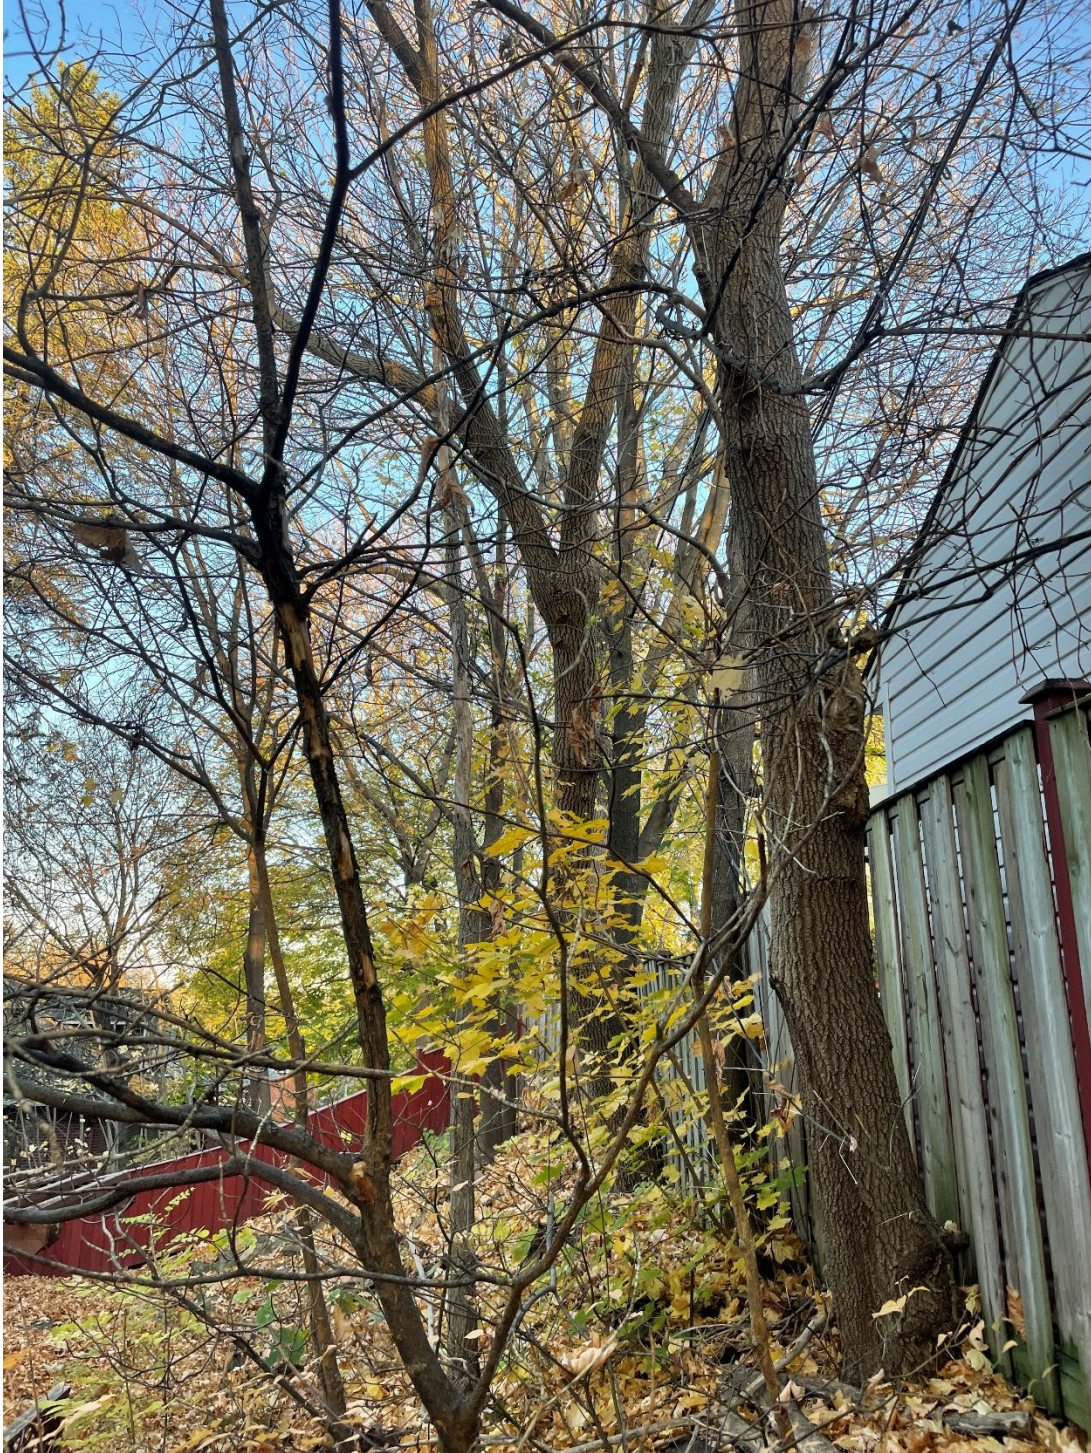
*Figure 2: Side view of trees along the rear property line*

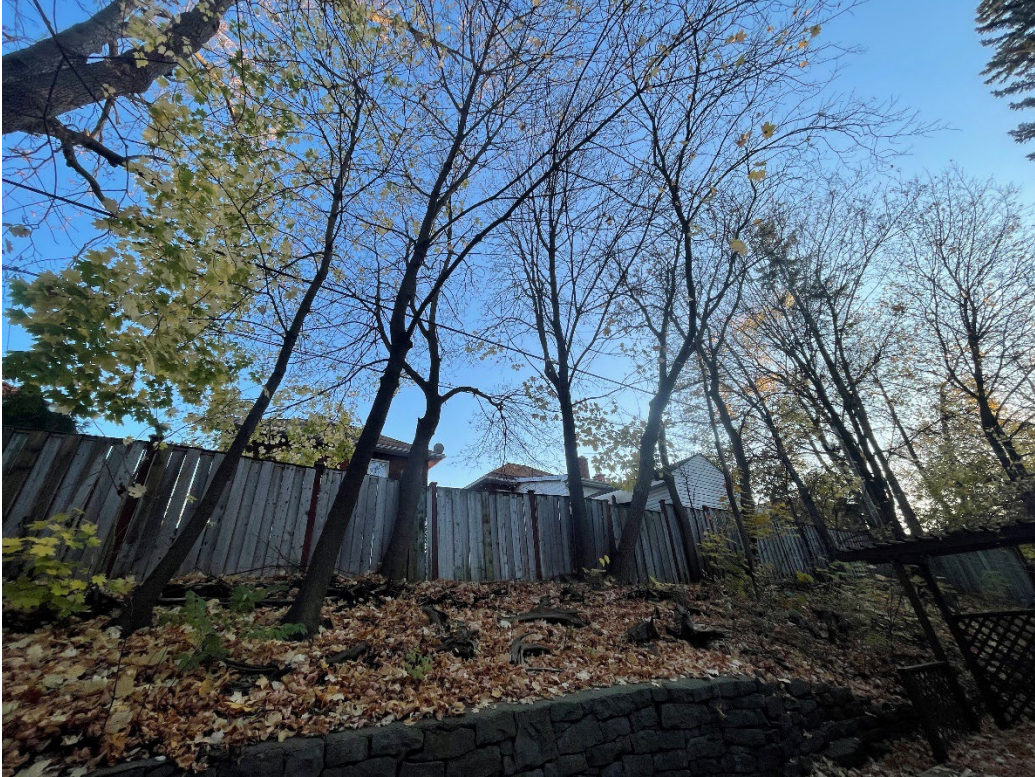
*Figure 3: Trees along the rear property line*

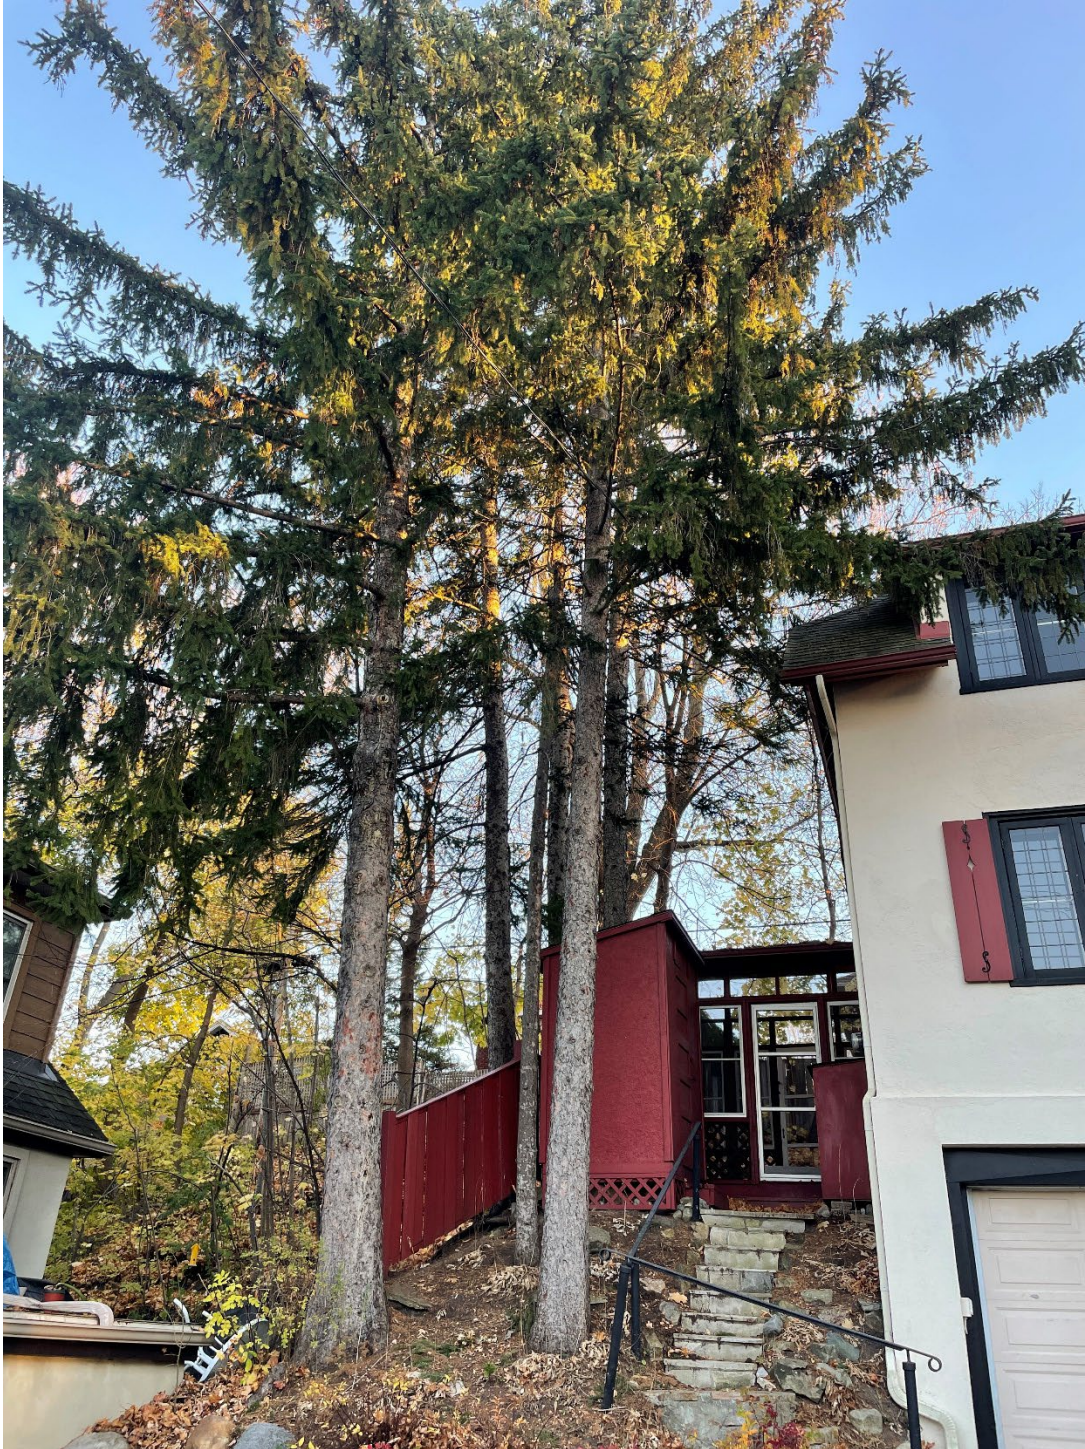
The property is heavily treed, and there is a significant grade change from the back to the front of the property. Many of the trees are located on the steep slope, especially the spruce trees along the east side. Since the first phase of development includes only the western lot, the spruce trees, 17-22 along the east side, will be retained at this time. They should be protected as indicated in the map during the demolition of the existing home.

*Figure 4: Spruce trees along the eastern property line, trees 17-22. Note the limited rooting space and steep slope.*
