October 12, 2021

**RE: TREE CONSERVATION REPORT FOR ST. THOMAS THE APOSTLE (2345 ALTA VISTA DRIVE)
AND ELLWOOD HOUSE (2270 BRAESIDE AVENUE), OTTAWA**

DRAWING: Tree Conservation Plan

PROJECT: ELWOOD HOUSE EXTENSION CITY OF OTTAWA

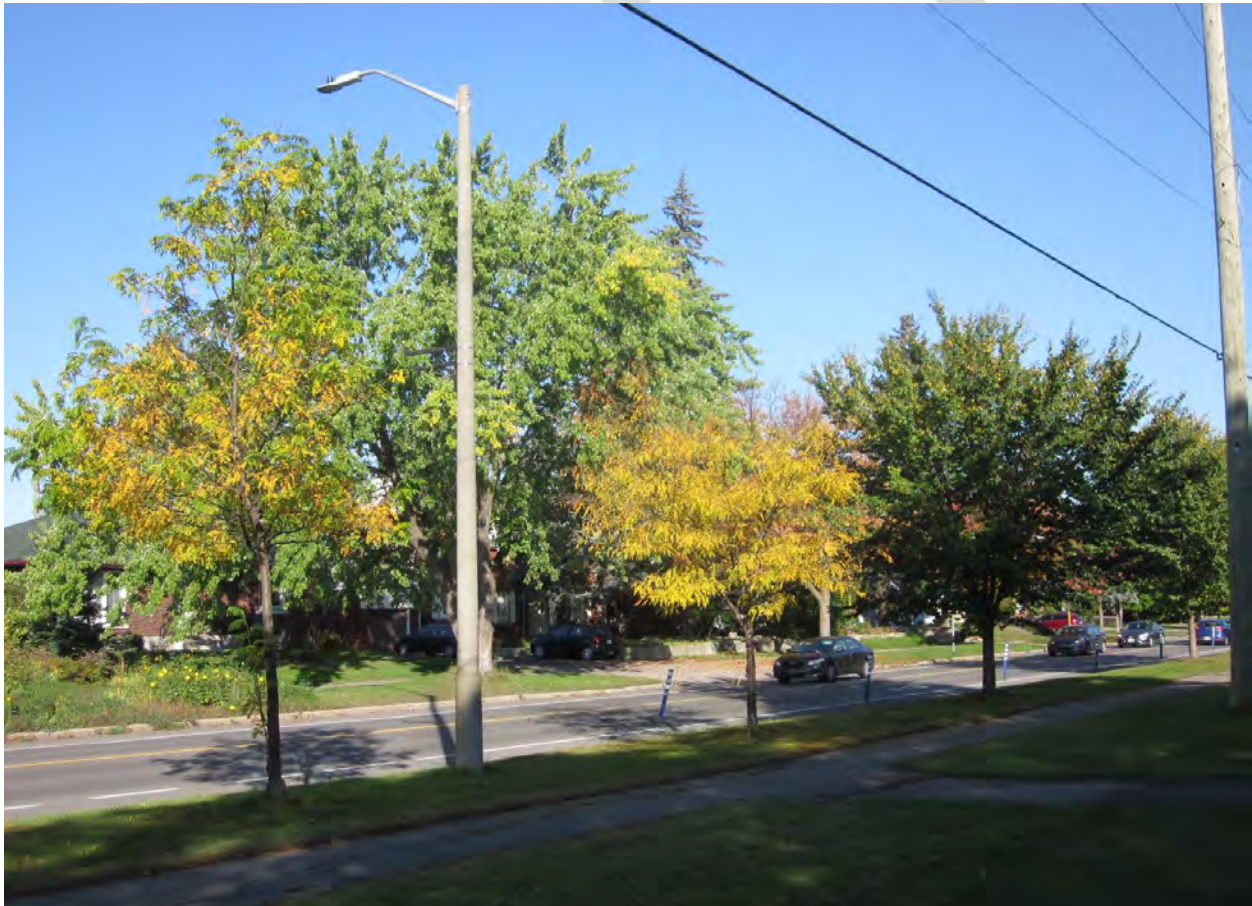
Picture 1. City trees #3, 4 and 5 (right to left) adjacent to 2345 Alta Vista Drive

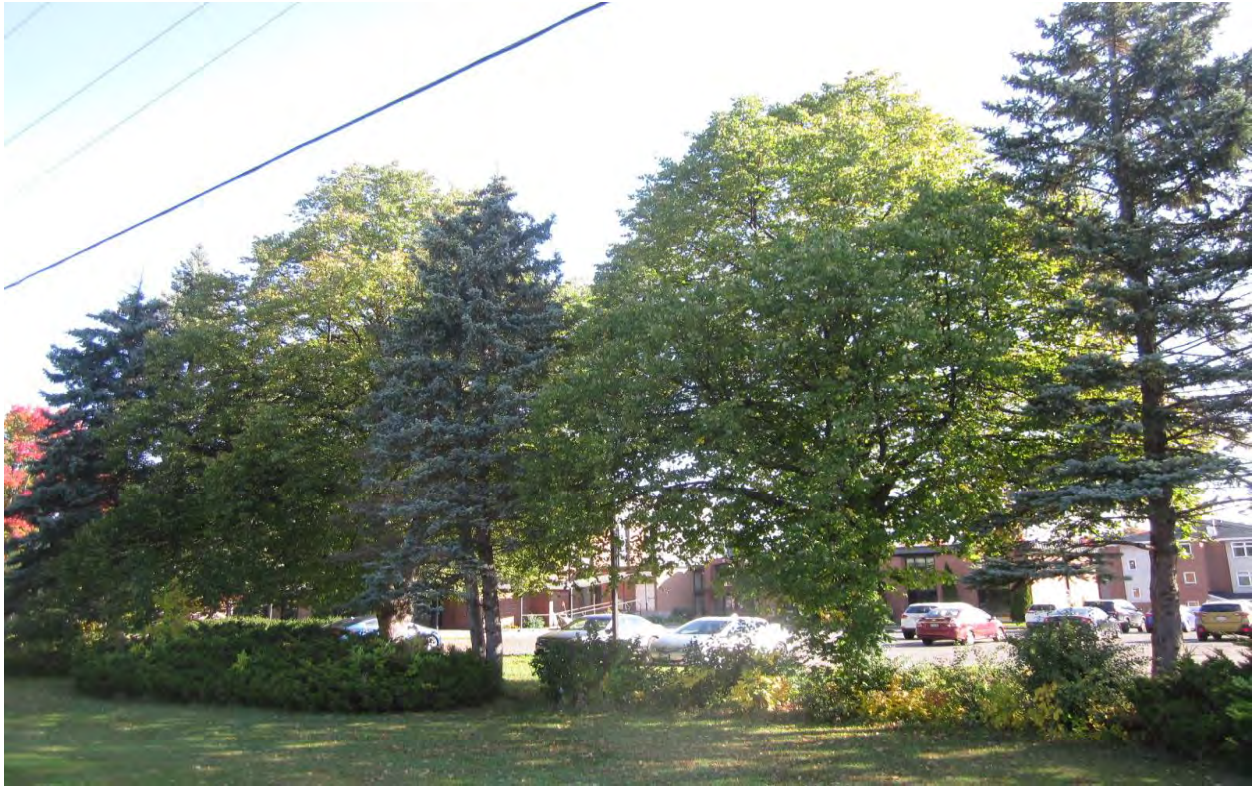
13	Colorado spruce	Poor	26.9	Private	Mature; leader missing; growth suppressed by adjacent trees – poor density, increment and colour; introduced species; to be preserved and protected
14	Little-leaf linden	Good	69.7 (at 1m)	Private	Very mature; competing stems 1.5m – mildly divergent; northwest stem dominant; very broad, dense crown with good leaf size; introduced species; to be preserved and protected
15	Colorado spruce	Fair	34.3	Private	Mature; leader dead; crown asymmetric towards west; good density, increment and colour where exposed to direct sunlight; introduced species; to be preserved and protected
16	Colorado spruce	Good	40.2	Private	Mature; crown asymmetric towards northwest; good density, increment and colour where exposed to direct sunlight; introduced species; to be preserved and protected

Picture 2. Private trees # 9 through 14 (right to left) at 2345 Alta Vista Drive (looking northward)

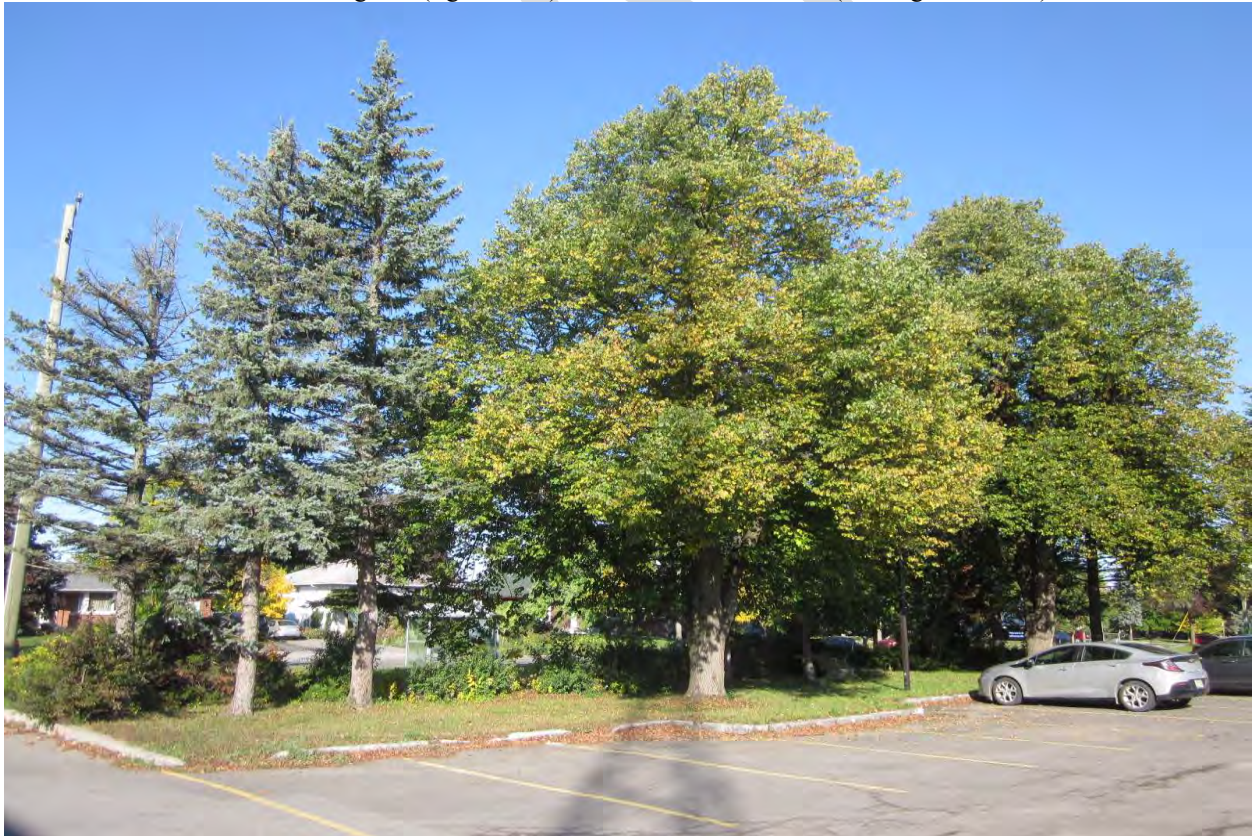
8	Colorado spruce (<i>Picea pungens</i>)	Poor	29.0	Private	Mature; three competing leaders – all dead; poor crown density and growth increment, fair needle colour on recent growth; introduced species; to be removed
9	Colorado spruce	Fair	30.5	Private	Mature; upright form due to influence of adjacent trees; leader dead; poor density, fair increment and colour; introduced species; to be removed
10	Colorado spruce	Good	36.5	Private	Mature; leader alive and intact; lower crown shaded by tree #11; good density, increment and colour; introduced species; to be removed
11	Little-leaf linden (<i>Tilia cordata</i>)	Good	61.7 (at 1m)	Private	Very mature; single dominant stem for most of height; suppressed laterals starting at 1.5m; very broad, dense crown with good leaf size; introduced species; to be preserved and protected
12	Colorado spruce	Good	28.6	Private	Mature; very asymmetric toward southwest due to influence of neighbouring trees; good density, increment and colour where exposed to direct sunlight; introduced species; to be preserved and protected

Picture 3. Private trees #8, 9, 10, 11 and 14 (left to right) at 2345 Alta Vista Drive (looking westward)

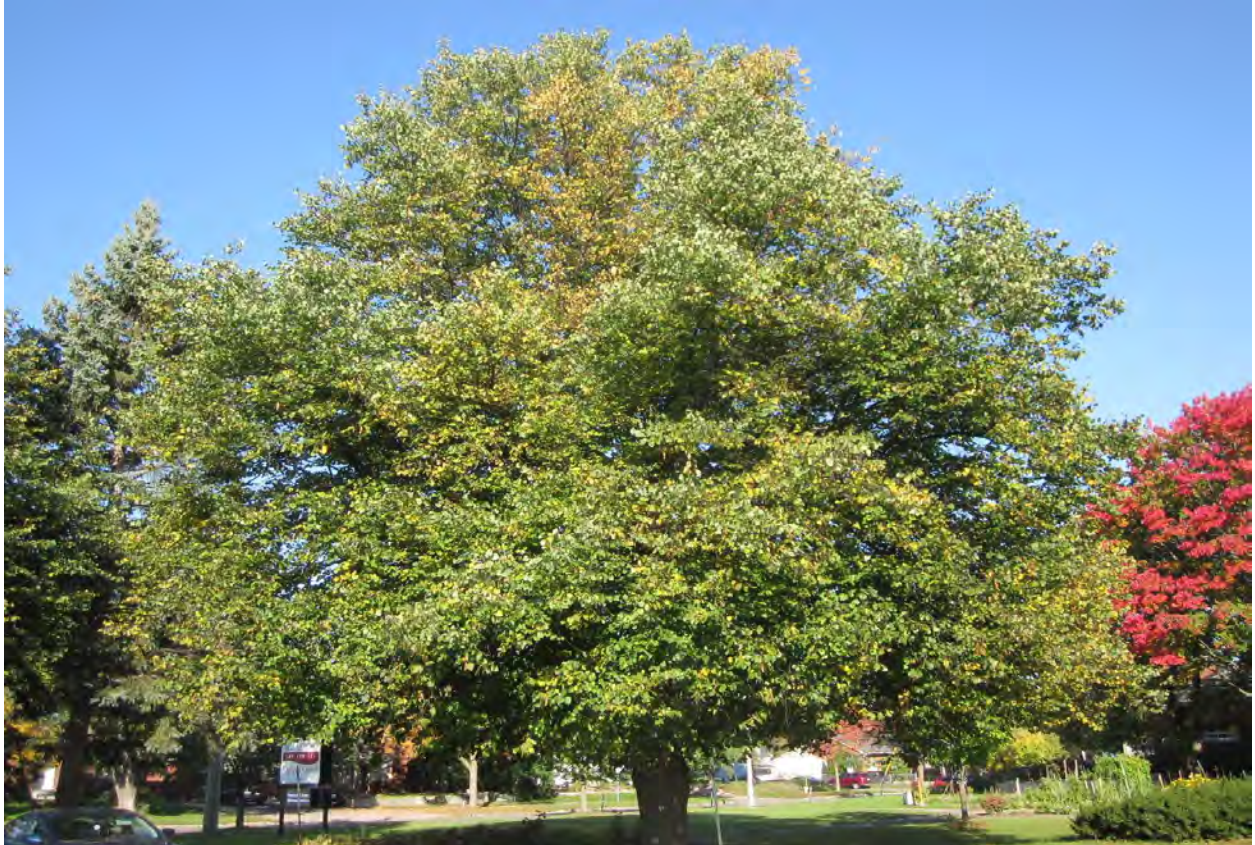
17	Little-leaf linden	Good	74.5	Private	Very mature; central stem to 7.5m with multiple leaders above (rounded crown apex); suppressed laterals starting at 2m – very broad, dense crown with good leaf size; good root collar; mildly restricted rooting area (parking median); introduced species; to be preserved and protected
18	Red maple (<i>Acer rubrum</i>)	Very good	12.5	Private	Maturing; central stem with competing leaders; lowest lateral at 1m; native species; to be removed (could possibly be transplanted for use elsewhere)
19	Hackberry (<i>Celtis occidentalis</i>)	Fair	10.4 (at 1m)	Private	Maturing; central stem with competing laterals at 1.3m on southeast and 2.25m on northwest; native species; to be removed (could possibly be transplanted for use elsewhere)
20	Red maple	Fair	81.2 (at 0.2m)	Private	Very mature; tri-stemmed at 0.5m from grade - moderately divergent; lower crown asymmetric towards south due to clearing from Hydro lines; good crown density and leaf size; native species; to be removed

Picture 4. Private tree #17 at 2345 Alta Vista Drive

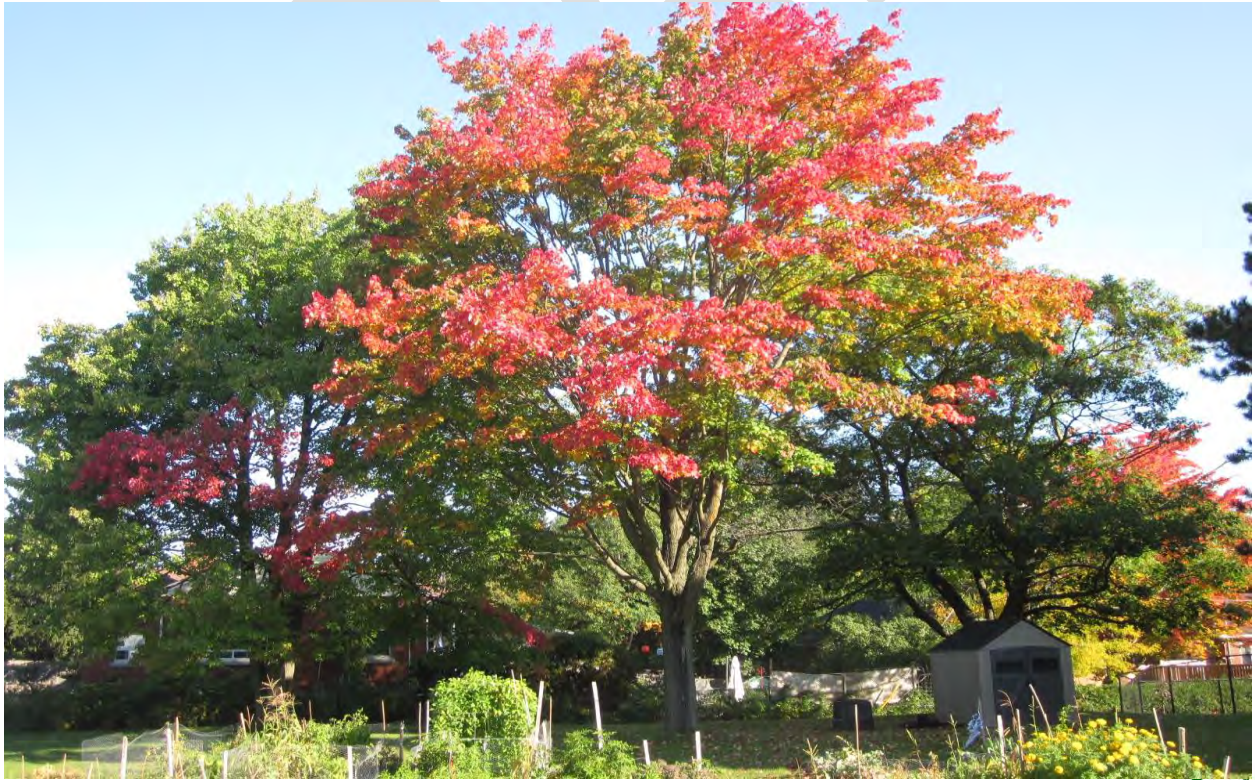
21	Red maple	Good	60.2	Private	Mature; central stem with competing lateral at 2.25m on south and co-dominant leaders at 5m; crown asymmetric towards southwest due to influence of tree #22; native species; to be removed
22	Red oak (<i>Quercus rubra</i>)	Fair	95.2	Private	Very mature; tri-stemmed at 2m – dominant stem towards east with suppressed stem on west and heavily suppressed stem on north (strongly divergent); heavy buttressing in lower bole with opposing basal wounds (one with advanced decay); polypore fruiting body on ground near base present in October; native species; to be preserved and protected (must be decay tested to ensure integrity of bole)

Picture 5. Private tree #20, 21 and 22 (left to right) at 2345 Alta Vista Drive

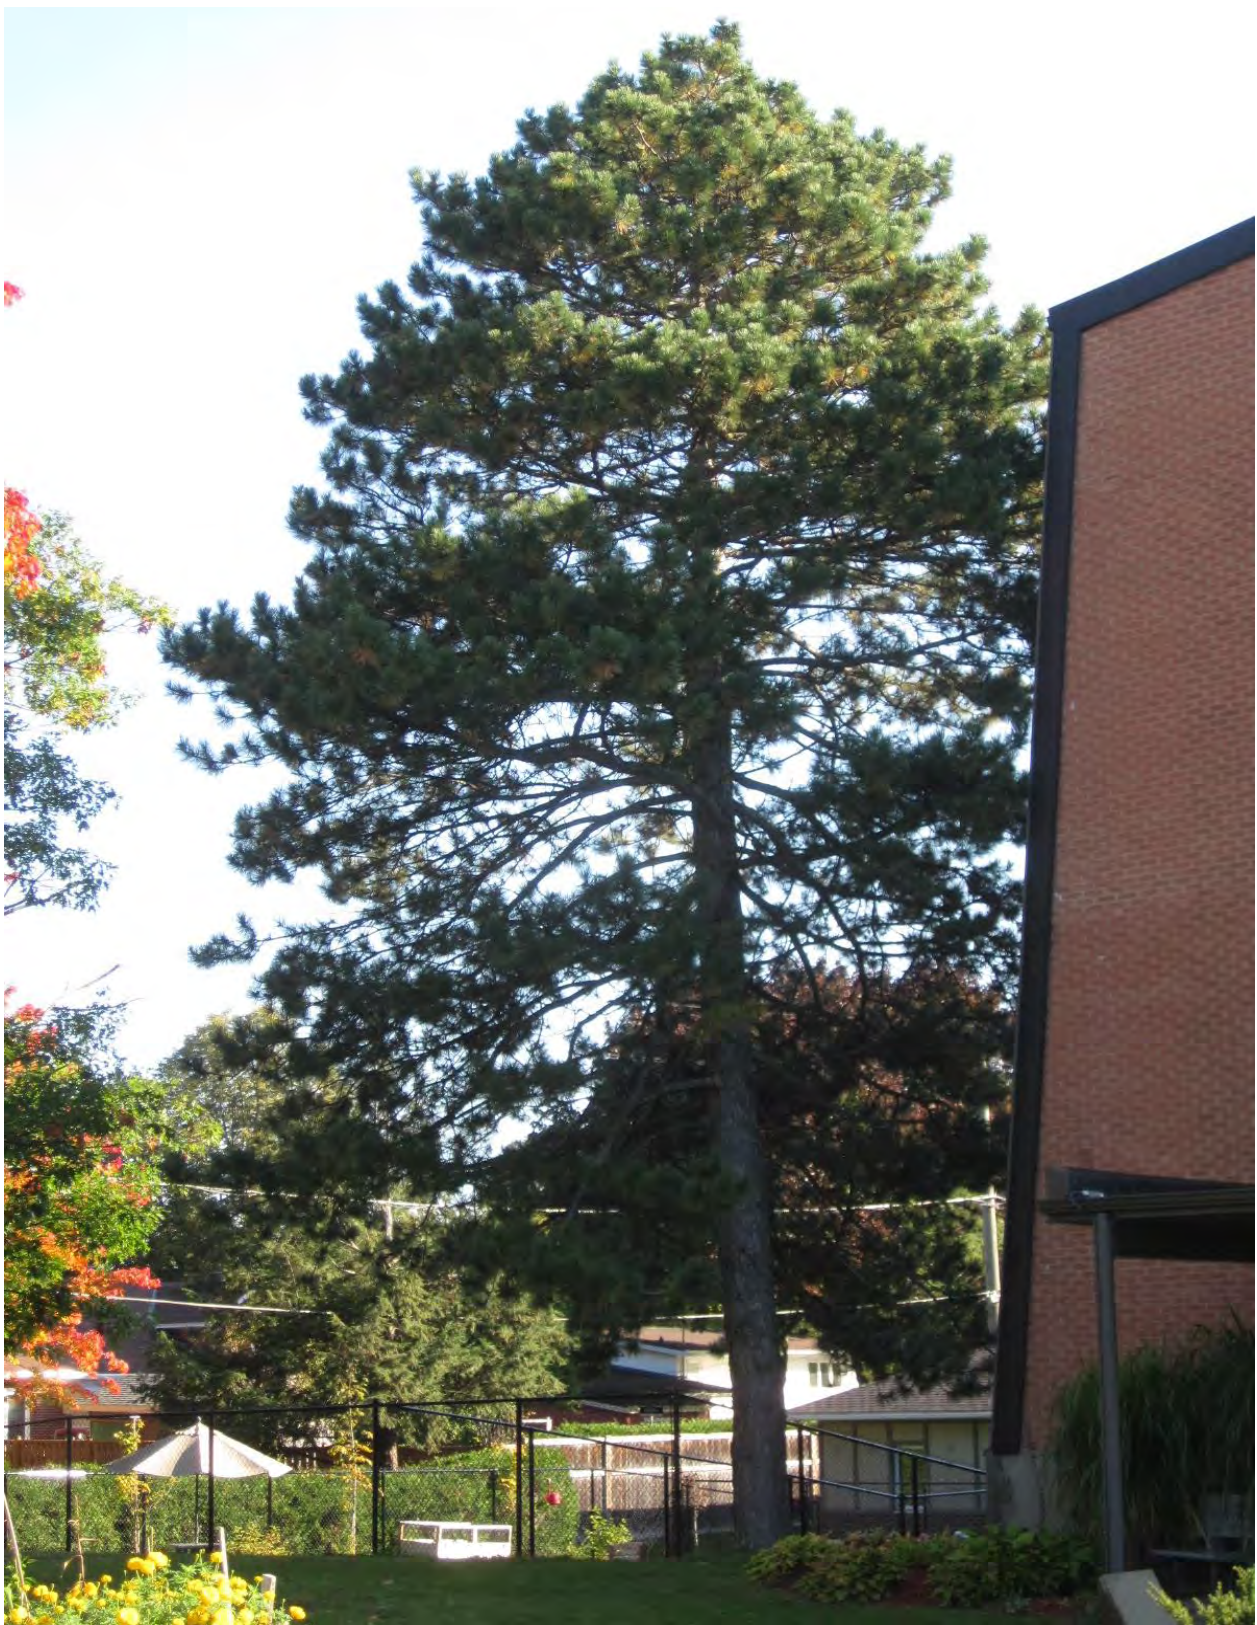
23	Austrian pine (<i>Pinus nigra</i>)	Good	55.9	Private	Very mature; central dominant stem mildly divergent towards northwest due to proximity of building; co-dominant leaders at 12m; crown generally symmetric; deep crown - held at 2m from grade; good density; increment and colour for age; introduced species; to be preserved and protected
24	Pin oak (<i>Quercus palustris</i>)	Good	+/15	Private	Maturing; within fence playground; introduced species to Eastern Ontario; to be preserved and protected
25	Norway maple	Good	27.2	Private	Mature; lower stem divergent towards northwest, crown asymmetric in same direction due to influence of adjacent trees; likely originated from seed; introduced invasive species; to be removed
26	White cedar (<i>Thuja occidentalis</i>)	Fair	15 avg.	Private	Mature hedge with 11 stems in total; west section divergent with stem damage from snow piling - poor density, increment and colour with heavy cone crop in 2021; east section with fair density, increment and colour; located within a mildly restricted rooting area; native species; to be removed

Picture 6. Private tree #23 at 2345 Alta Vista Drive

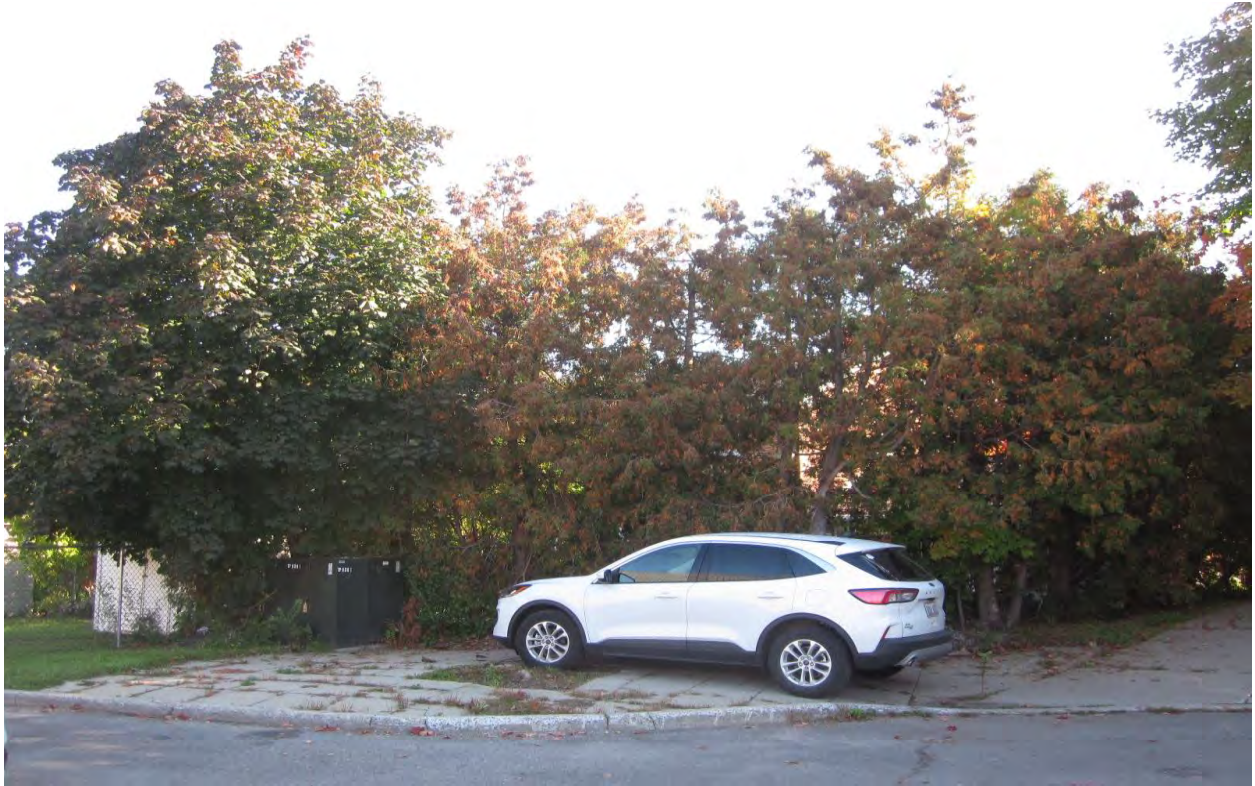
Picture 7. Private trees #25 and 26 (left to right) at 2270 Braeside Avenue

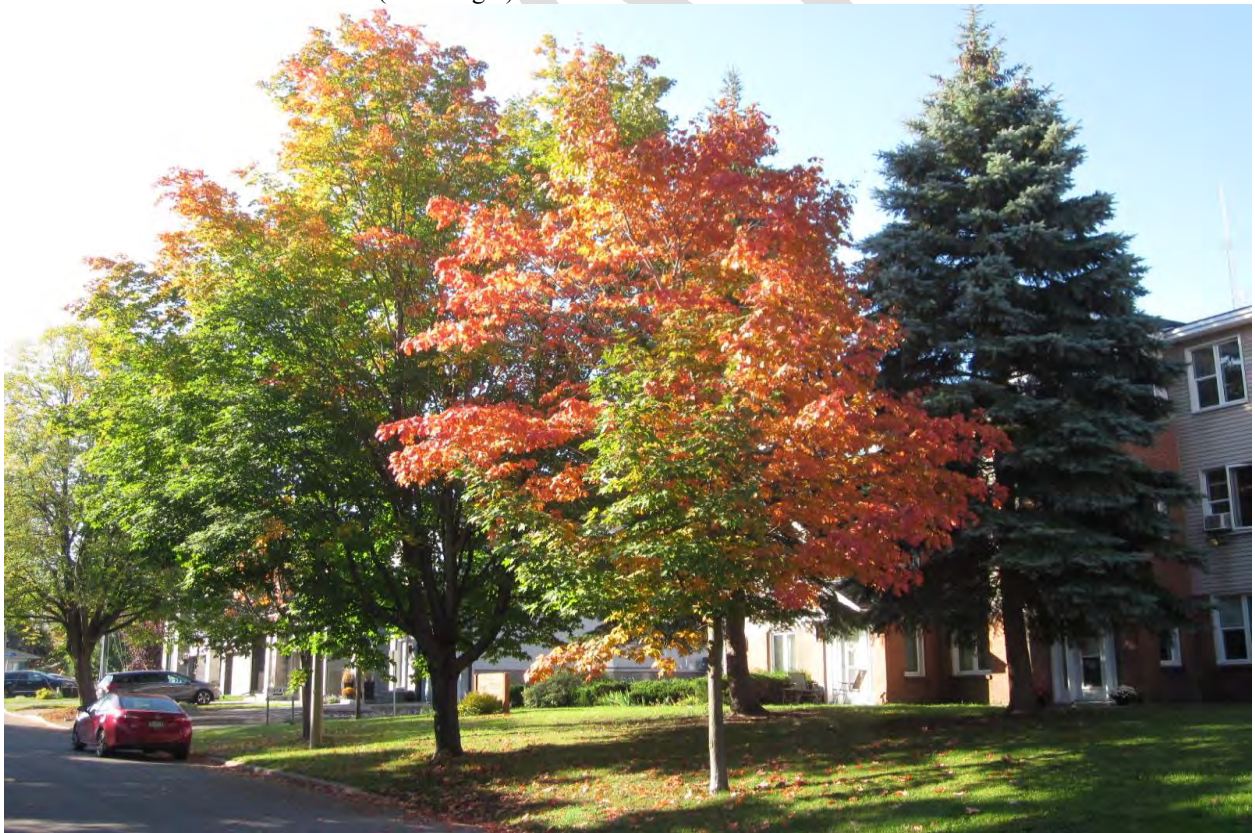
Picture 8. City trees #30 and 33 and private tree #32 (left to right) at 2270 Braeside Avenue

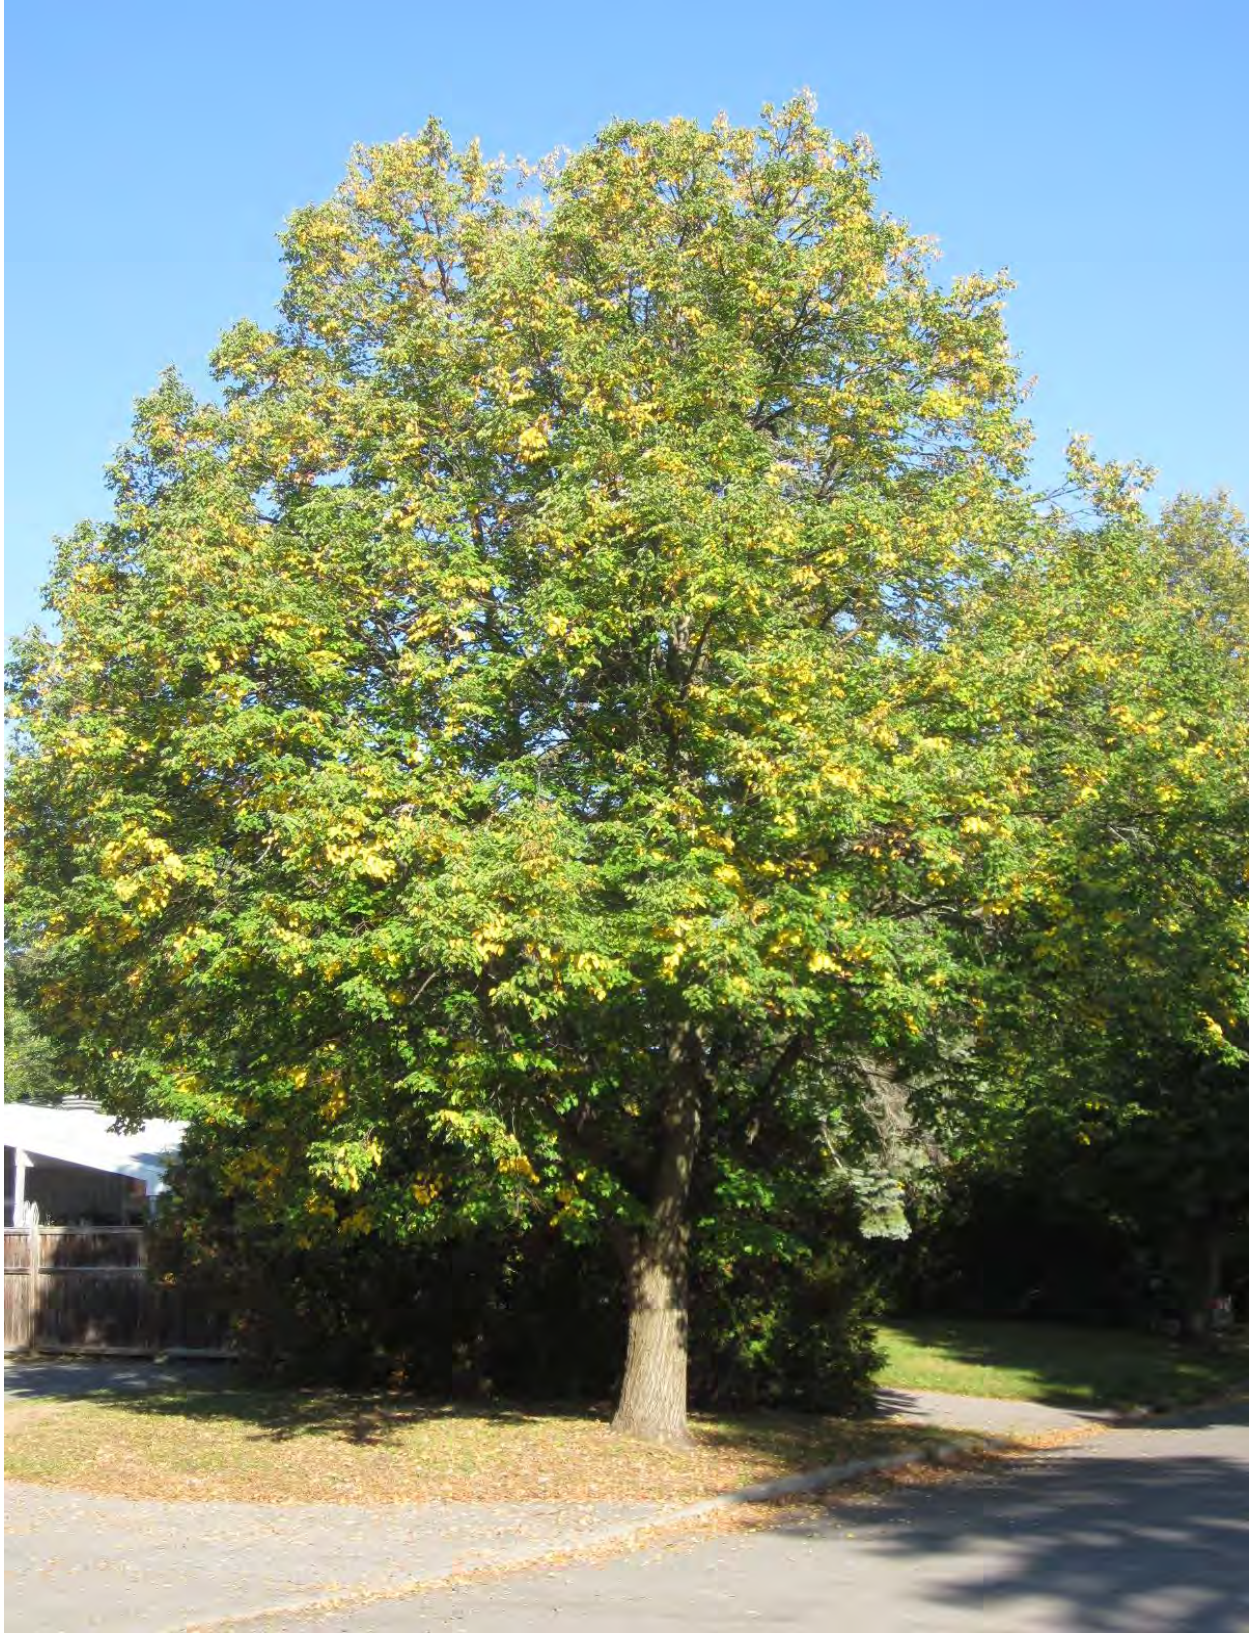
In terms of existing vegetation, there is a mixture of planted amenity trees and cedar hedges. Under the current site plan the majority of existing trees can be retained as the proposed layout of the extension is relatively small in relation to the overall property. The one area where tree retention will not be possible is the proposed new entranceway from Braeside Avenue. A mature city tree will be lost as a result of this conflict.

Picture 9. City tree #36 adjacent to 2270 Braeside Avenue (tree is to be removed for new driveway)

New trees are shown on the site plan for planting in the new landscape. Additional planting may be required to achieve parity with trees lost as a result of the proposed construction. Further planting or monetary compensation may be required for the loss of the one tree on City of Ottawa property.
