CUSTOMER:
ROBINSON RESIDENCE
 173 & 175 RIVERDALE AVE
 OTTAWA, ON

SHEET TITLE:
SITE PLAN

SHEET:
A-10

RE: TREE DISCLOSURE REPORT – 173 RIVERDALE AVENUE

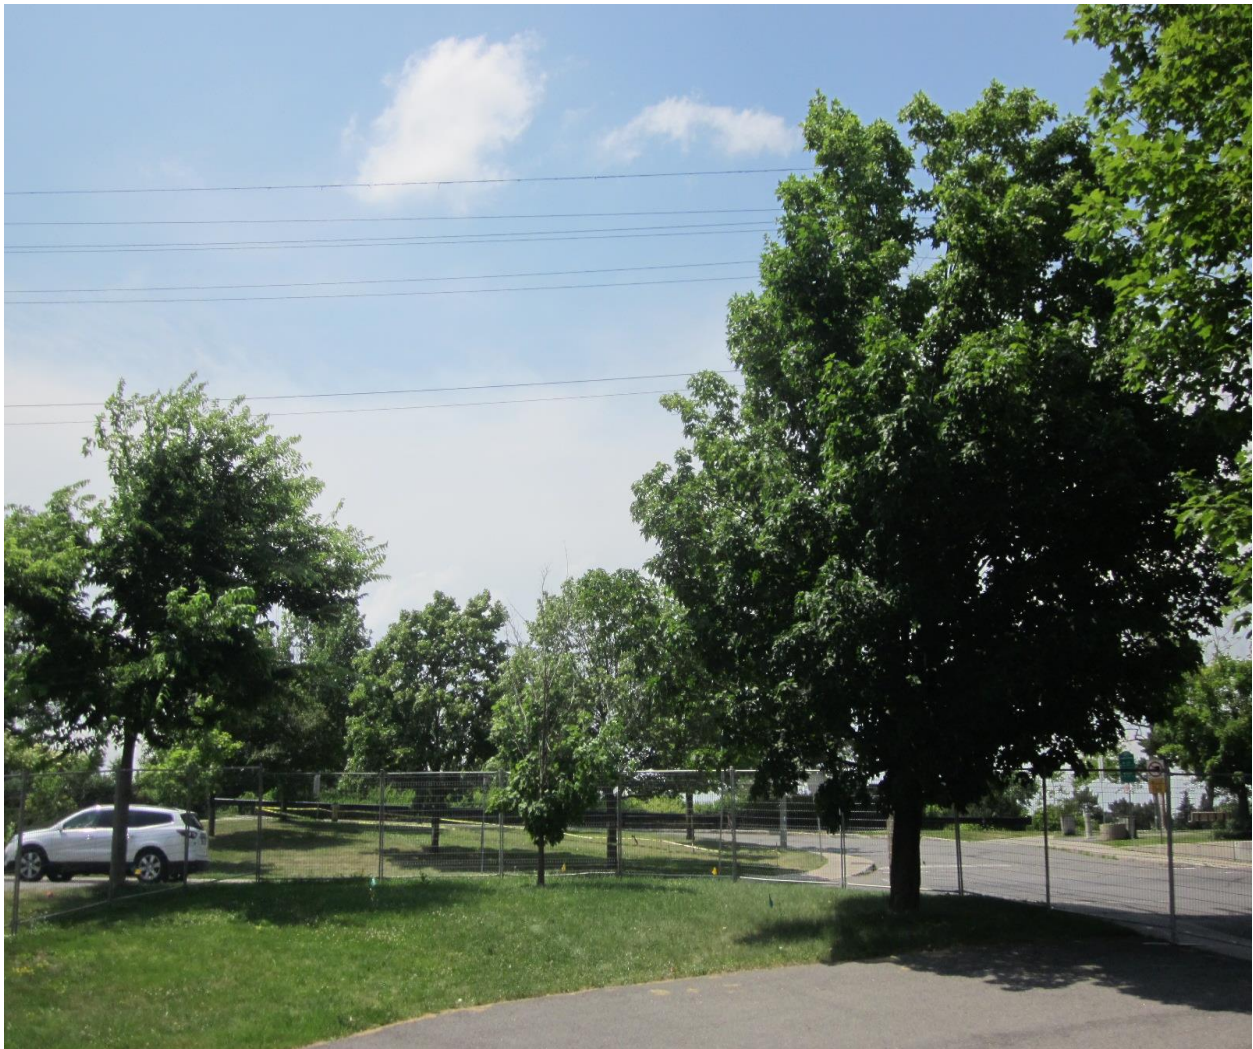
Tree No.	Tree Species	DBH ¹ (cm)	CRZ ² (m)	Ownership	Tree Condition, age class and Status (to be removed or preserved and protected)
2	Sugar maple (<i>Acer saccharum</i>)	24.2	2.4	City	Good; mature; co-dominant stems at 4m from grade with weak union; dense crown of deeply-coloured leaves; native species; to be preserved and protected
3	Sugar maple	40.2	4.0	City	Fair; mature; multiple competing stems arising at 2m – broad, dense crown; primary union weak; native species; to be preserved and protected
4	Sugar maple	9.7	1.0	City	Poor; juvenile; tree is half dead; native species; to be preserved and protected
5	Hackberry (<i>Celtis occidentalis</i>)	20.6	2.0		Fair; maturing; co-dominant stems at 2.5m from grade with strong union; previously topped by Hydro; native species; to be preserved and protected (although a red 'X' on trunk indicates planned future removal by City)

Picture 1. Trees #3, 4 and 5 (right to left) adjacent to 173 Riverdale Ave.

1. Erect a fence as close as possible to the CRZ of the tree. At a minimum this fence should be constructed of plastic snow fencing supported by metal t-bars and wooden top rails (see City of Ottawa tree protection specifications for more detail).

2. Attach signs to the fence indicating the area within is a protected space (do not attach any signs, notices or posters to the tree).
3. Do not place any material or equipment within the CRZ of the tree.

4. When possible do not raise or lower the existing grade within the CRZ.
5. Tunnel or bore instead of digging or trenching within the CRZ.
6. Do not damage the root system, trunk or branches of the tree – if damage does occur cut the wound cleanly and, especially in the case of roots, seal the wound with bees wax or sealing paint before reburial.

7. Ensure that exhaust fumes from all equipment are not directed towards the tree's crown.
8. To ensure the future subgrade remains viable for root growth and development, the material used as backfill should either be CU-structural soil (if supporting a weight-bearing surface) or a good quality topsoil. This will replace the rooting volume lost through soil excavation and will serve as a future rooting medium allowing the trees to recover from the loss of roots.

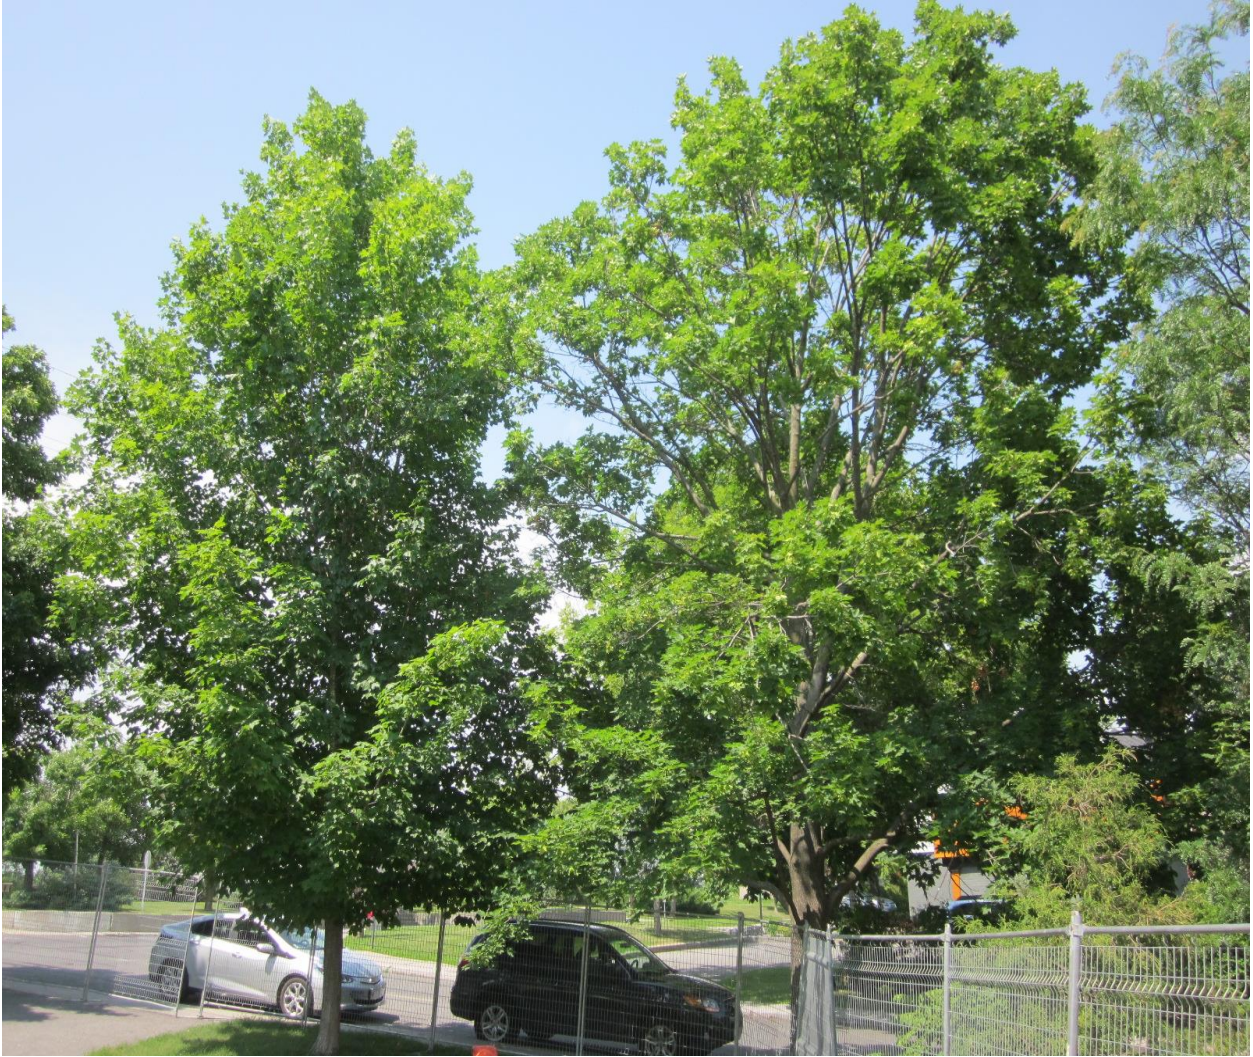
Tree No.	Tree Species	DBH ¹ (cm)	CRZ ² (m)	Ownership	Tree Condition, age class and Status (to be removed or preserved and protected)
1	Norway maple (<i>Acer platanoides</i>)	39.3	3.9	City	Fair; mature; multiple girdling and bindings roots; crown thinning – in early decline; introduced invasive species; to be preserved and protected

Picture 2. Trees #1 and 2 (right to left) adjacent to 173 Riverdale Ave.
