# REVISED HERITAGE IMPACT ASSESSMENT & CONSERVATION PLAN FOR 211-231 BANK

**John Stewart**  
COMMONWEALTH  
Historic Resource  
Management

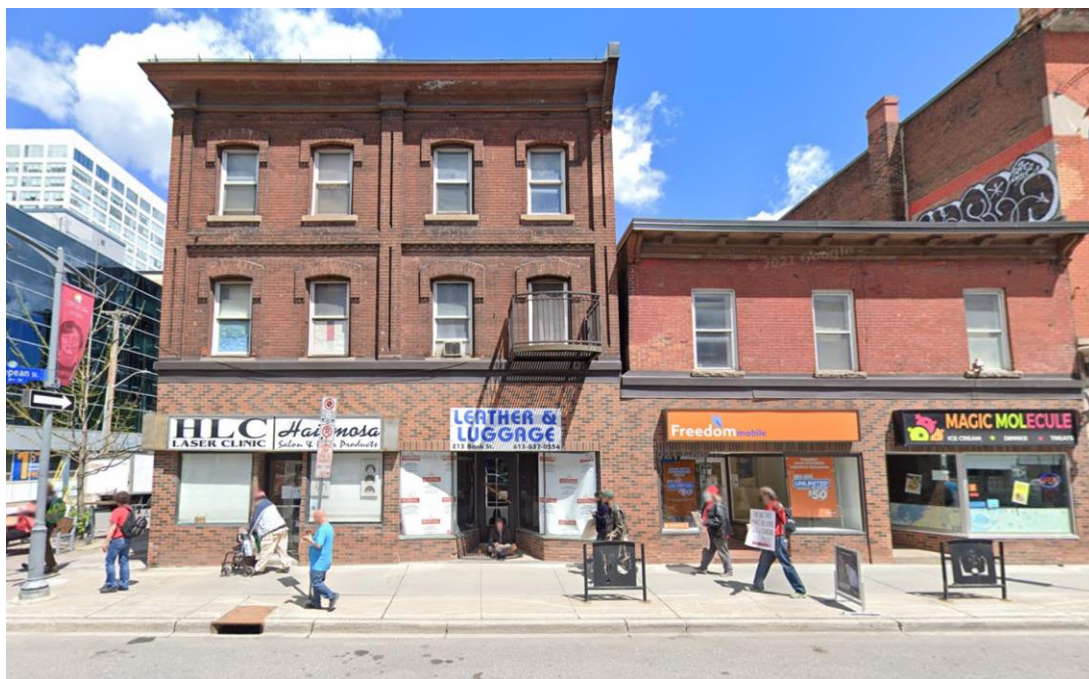
Figure 12: A view of 211 Bank Street with the two-storey unit.

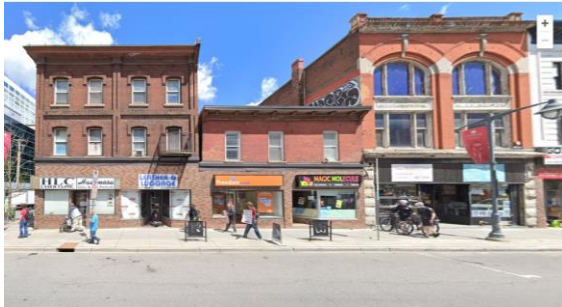
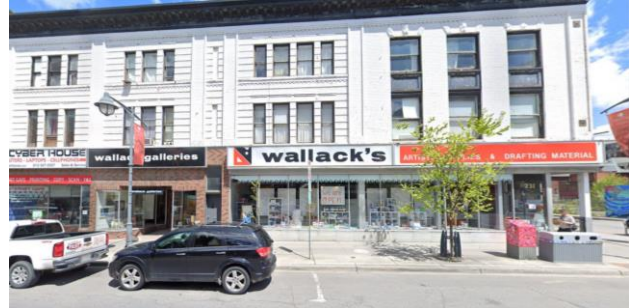
Figure 13: East elevation of buildings 211, 215, 219, 223 and 231 Bank Street.

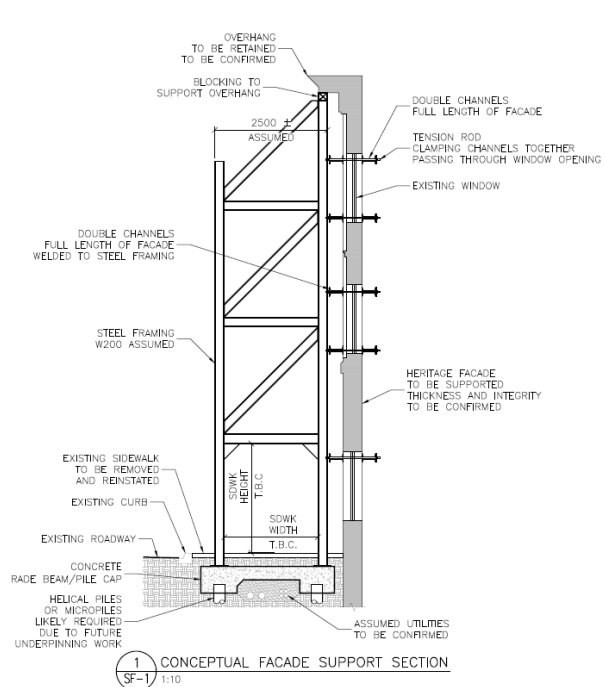
The temporary shoring plan and masonry restoration (in progress) addresses the existing exterior masonry on the first, second, and third storeys of the existing buildings at 211, 215, 219 223, and 231 Bank Street as well as the extensions along 178 Nepean and Lisgar Streets. Portions of the rear façade are being demolished and brick will be salvaged for use in repairs and infill with matching material.

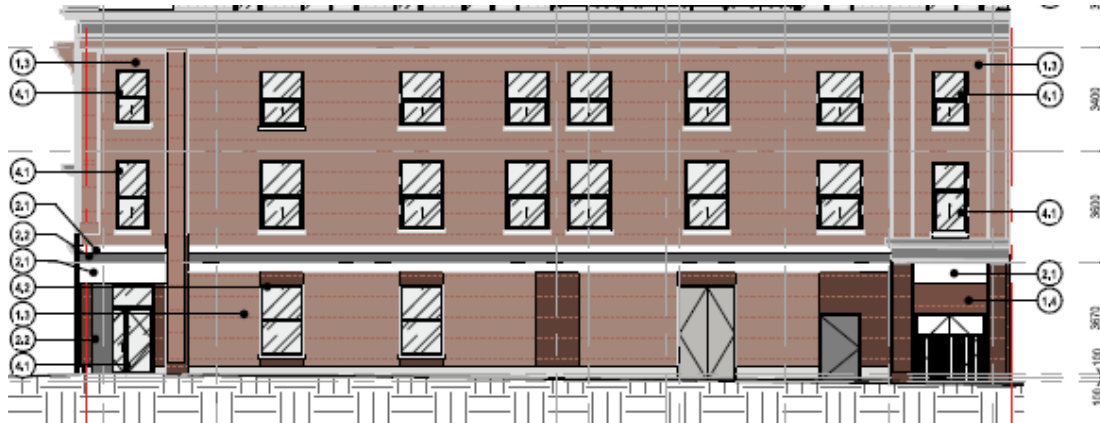
Please update or provide the following to complete the heritage application:

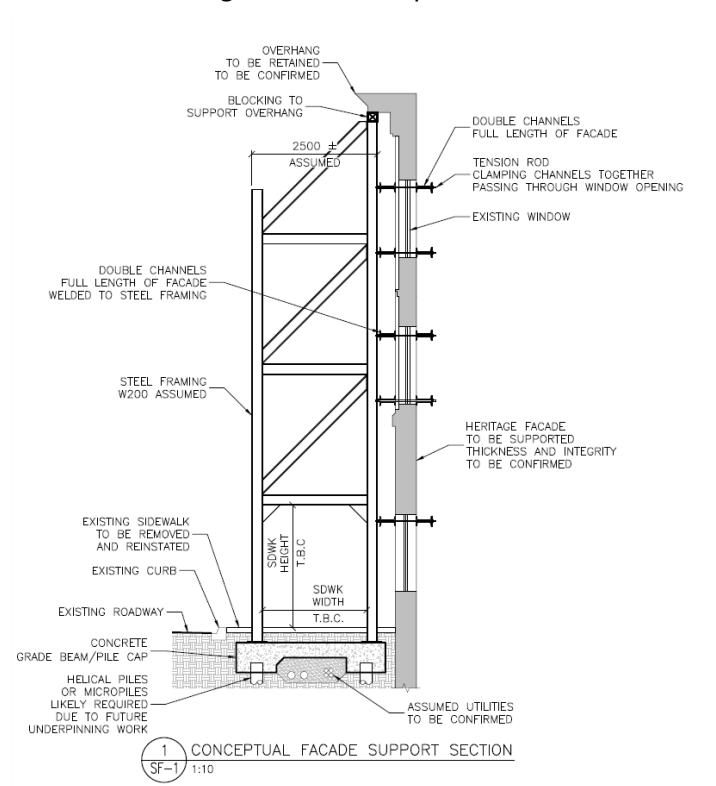
Figure 2: SF-1 Conceptual façade support section. Source, Art Engineering Inc. August 24.

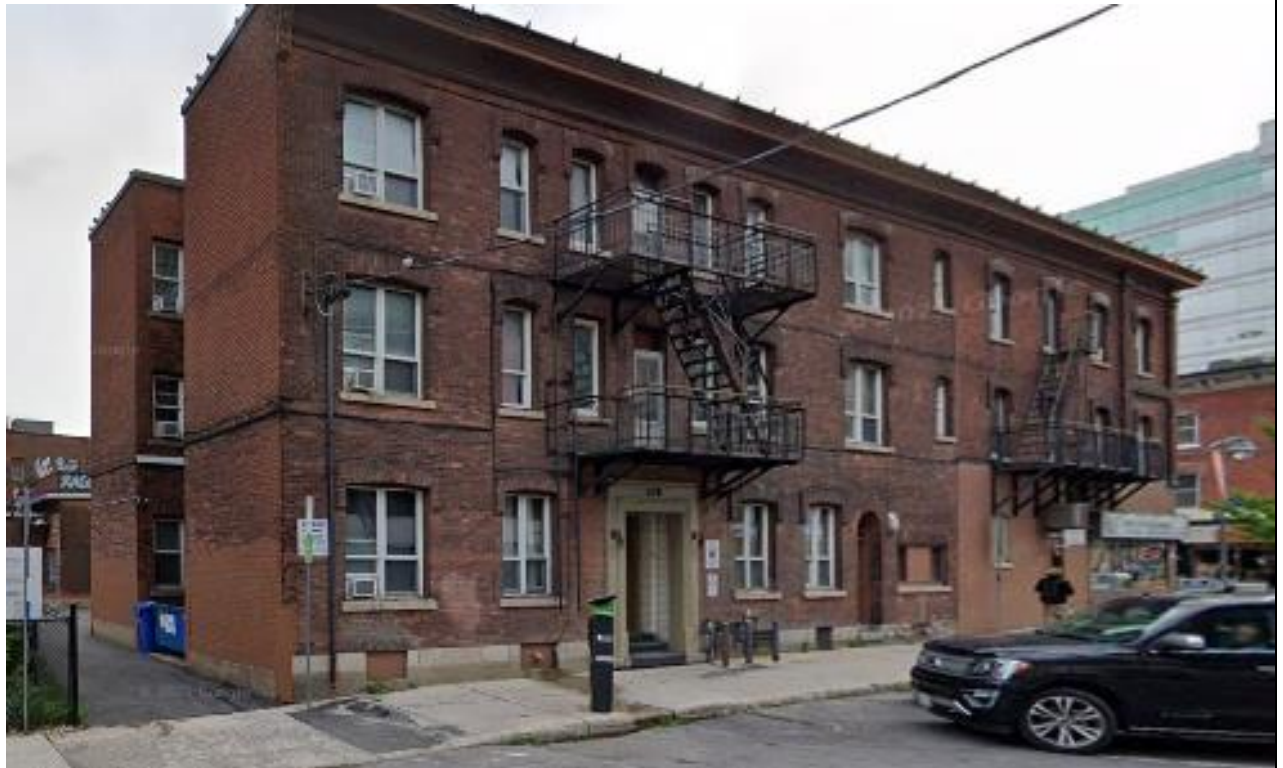
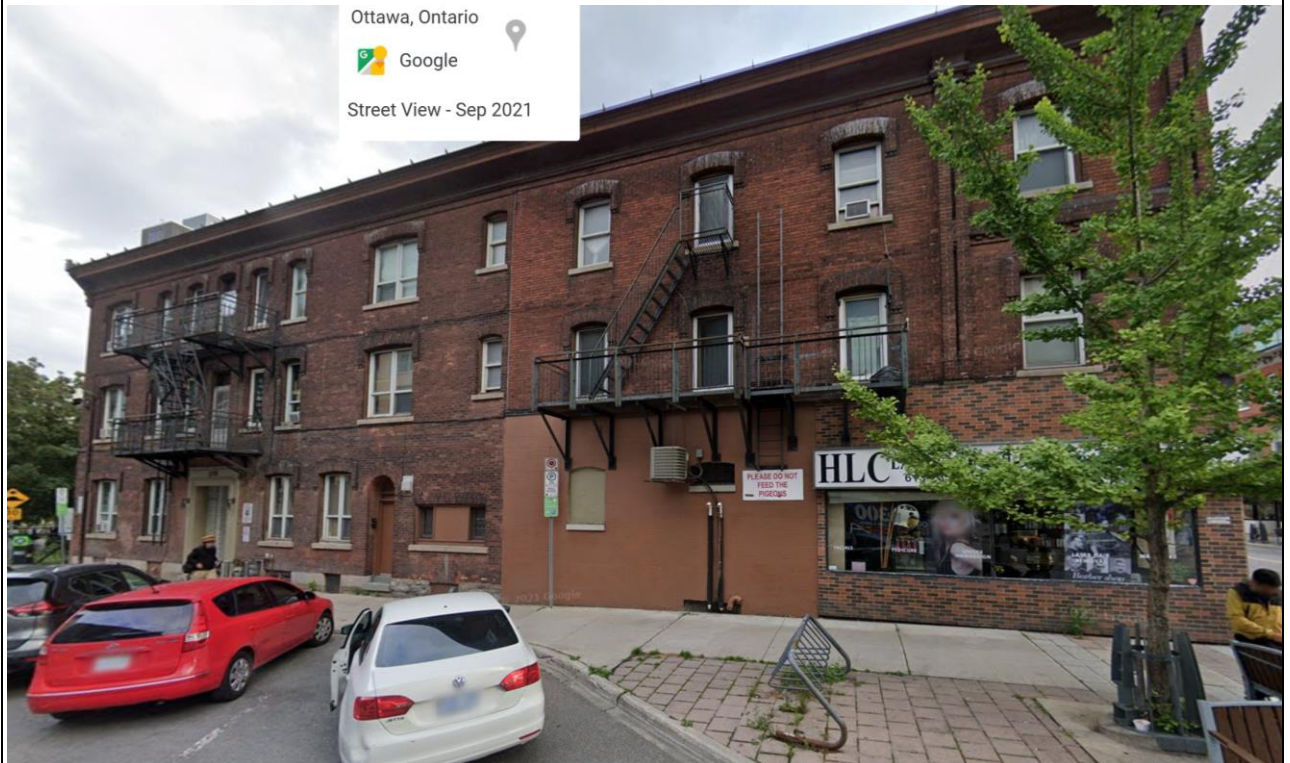
Figure 6. West Elevation

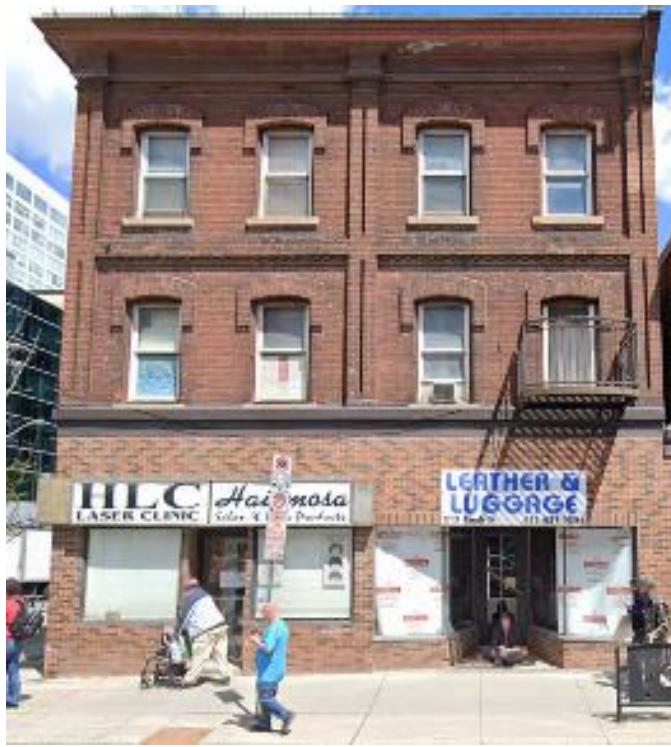
### CHARACTER DEFINING FEATURES

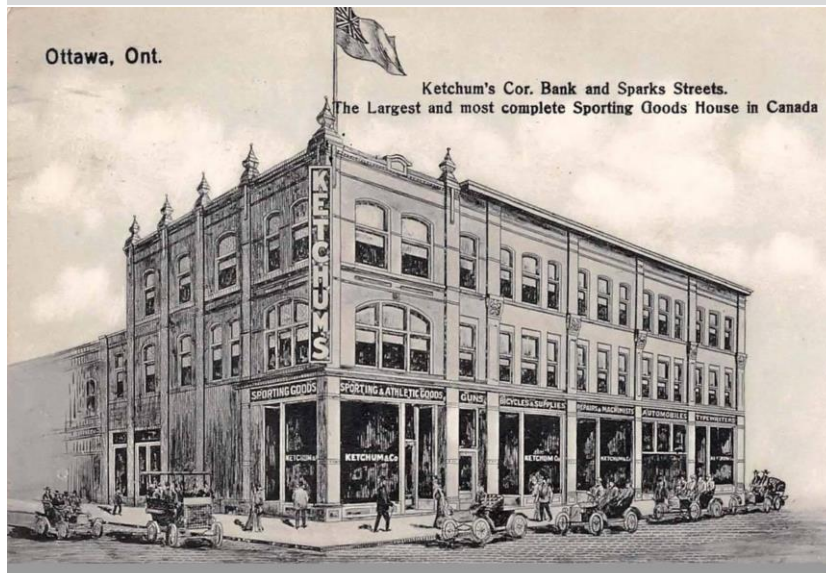
This sketch of Ketchum's Bank at the corner of Bank & Sparks Streets provides an excellent example to model the replacement shopfront with the raised pilasters framing, commercial units, cornice, and signboard wrapping around the corner.

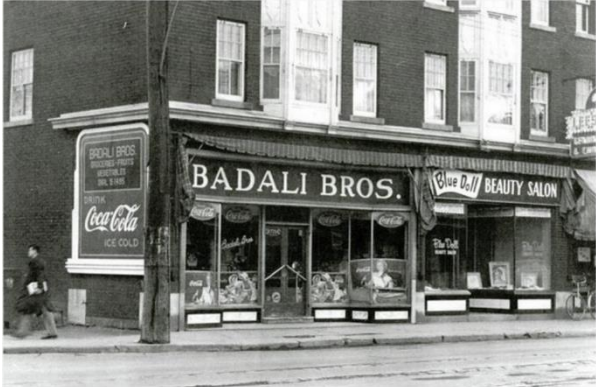
This Bank Street corner building provides a good model comparative example with the large fascia signage and the awning set below the metal cornice, the double door entrances with the recessed flared display windows and brightly accented knee wall. The cornice carries around the corner, with a large signage taking advantage of the corner location.

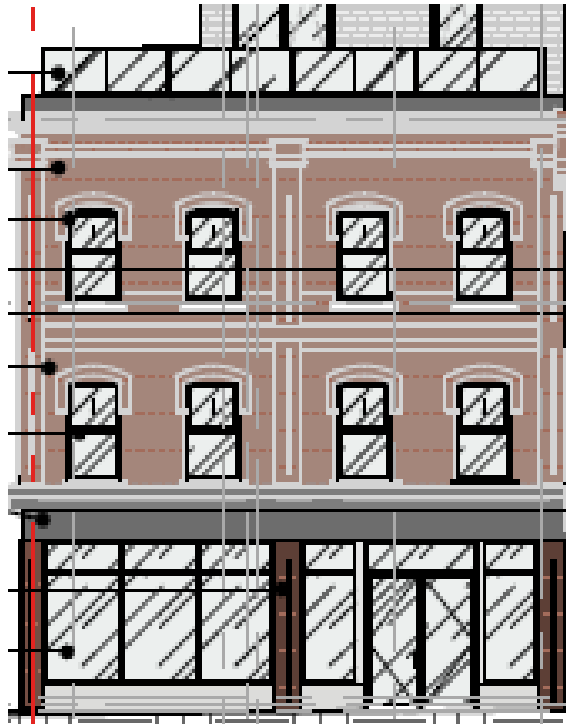
**Conservation Work**

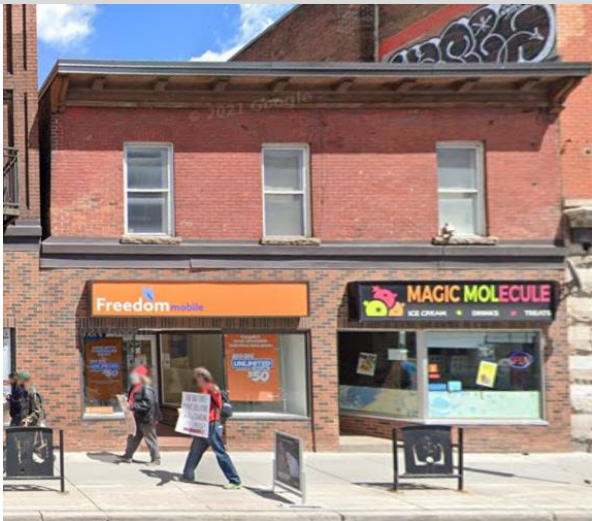
#### CHARACTER DEFINING FEATURES

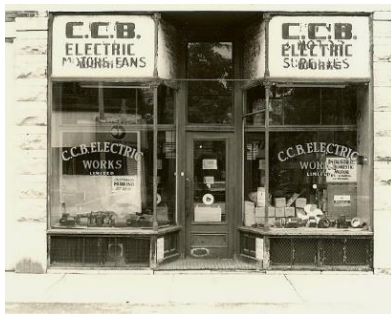
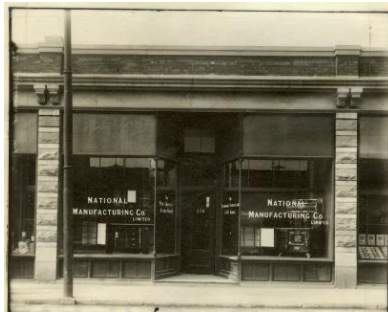
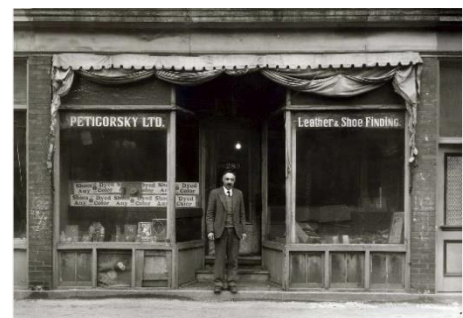
Three Storefronts along Bank Street dating from the turn of the century are models for the modest 2-storey building at 213-215 Bank Street. Note the flared recessed entrances, single entrance door, knee wall, and masonry piers framing the retail units.

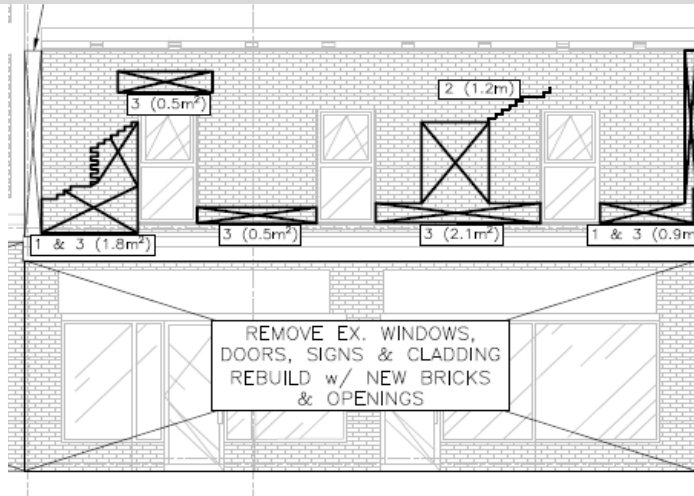
#### Removals, Interventions

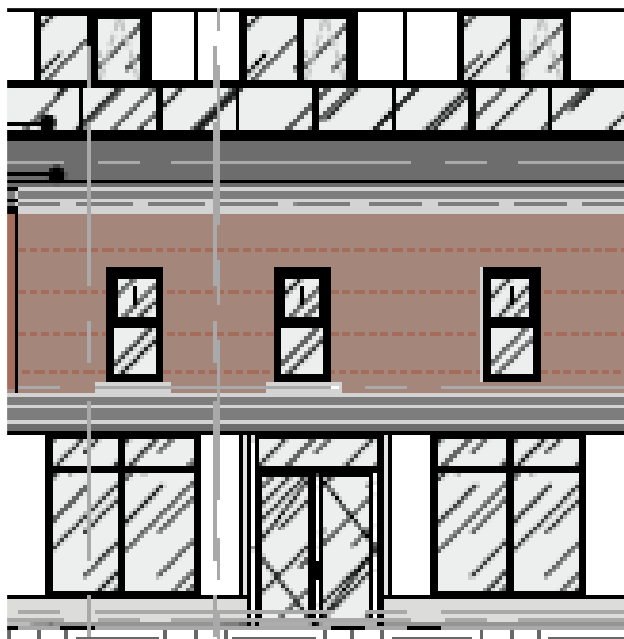
#### Conservation Work

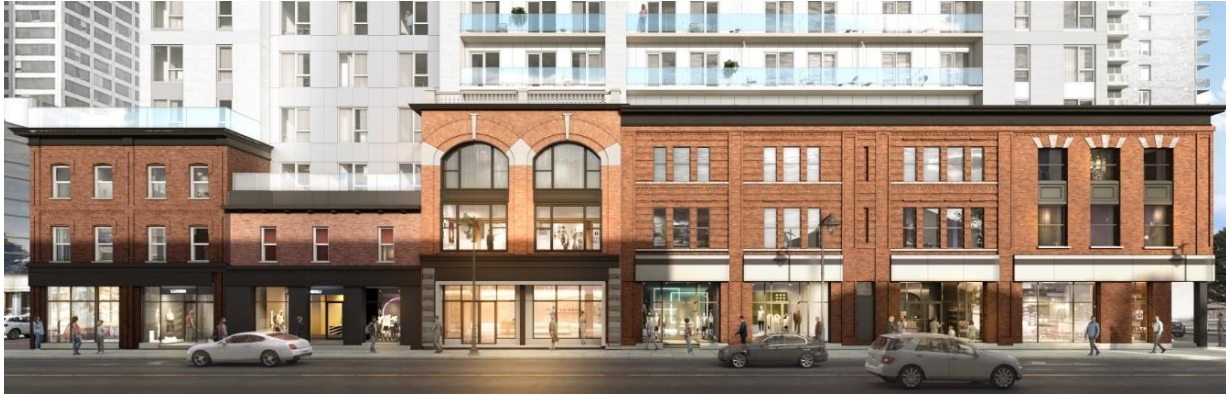
Figure 4: 115-117 As part of the Bank Street range.

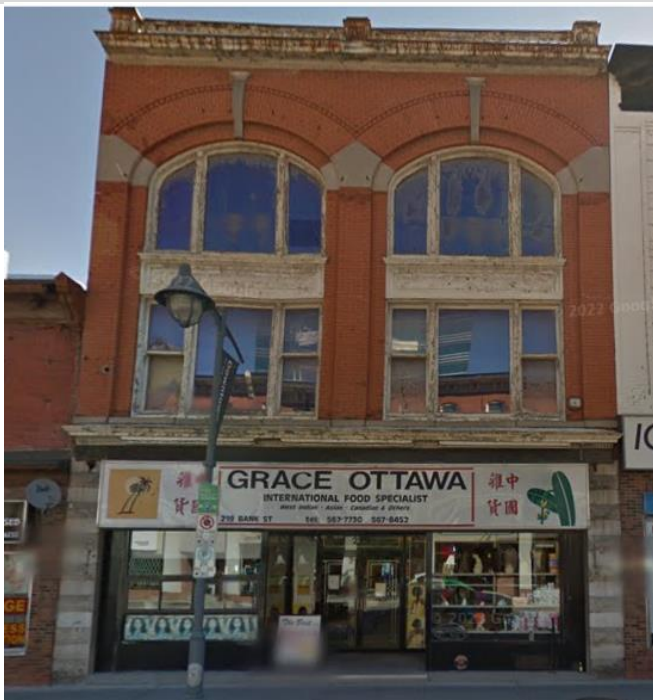
### CHARACTER FEATURES

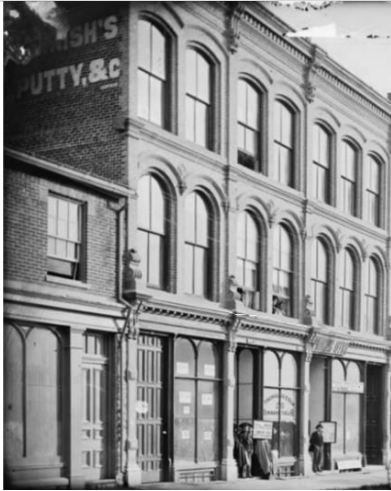
two examples of Ottawa commercial buildings illustrating features comparable to the 219 Bank St.

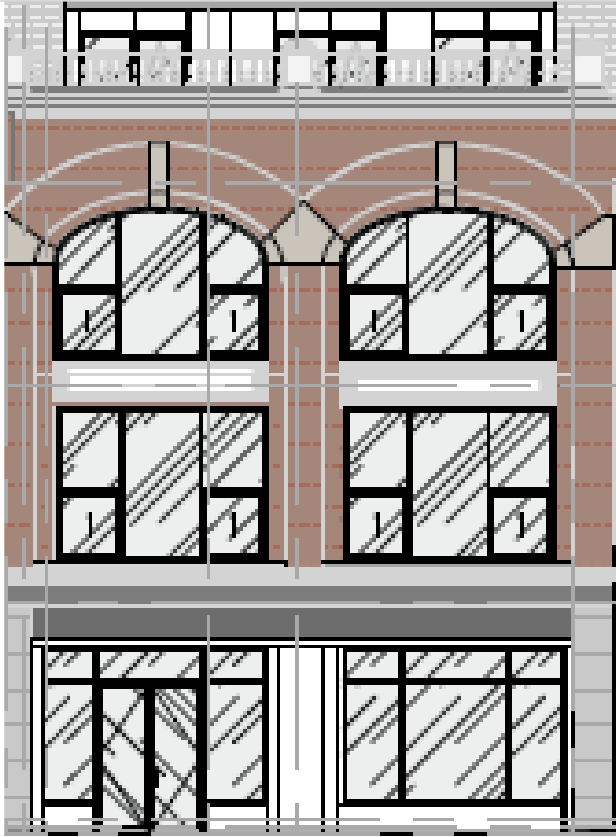
### Conservation Guidelines

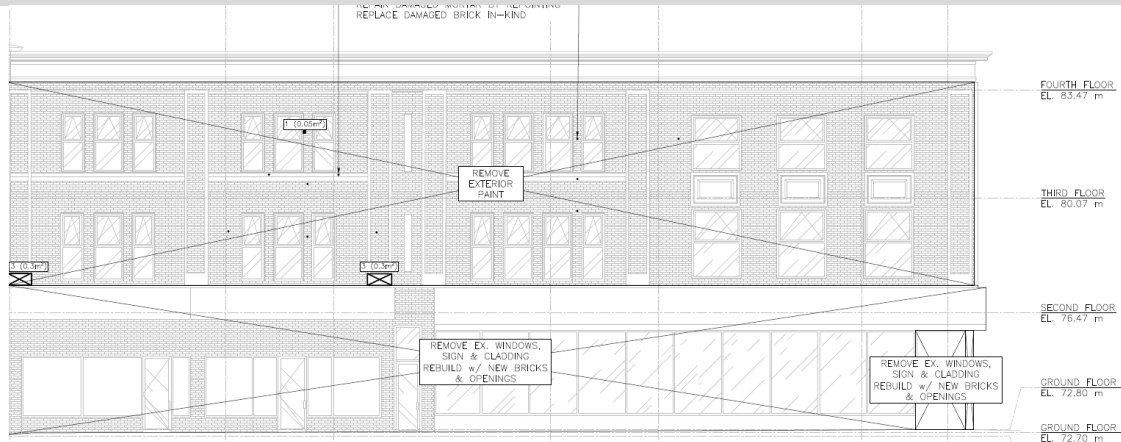
## REMOVALS AND INTERVENTIONS OF THE EXISTING BANK & LISGAR STREET FACADES

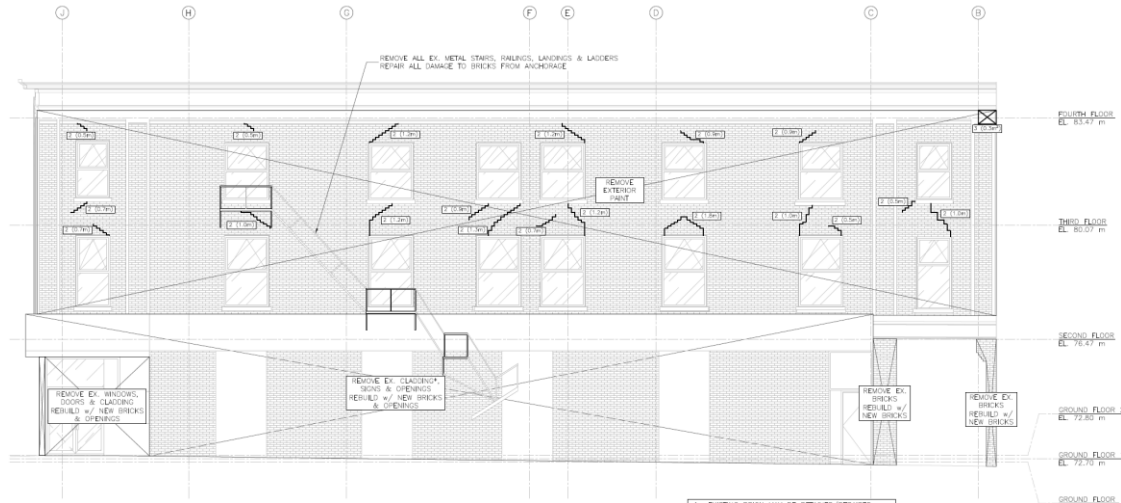
*The façade of the Wallack’s Building has been painted. In the detailed view, the spalling of the paint is extensive, suggesting that the removal of paint will not be too difficult. The extent of damage to the brick needs to be assessed. Along the face there is step cracking of the brick below third floor windows. There is some bulging in places. The pilasters at either end of the facade will have to be replaced at the street level. The large black panels at grade were originally windows that have been boarded over.*

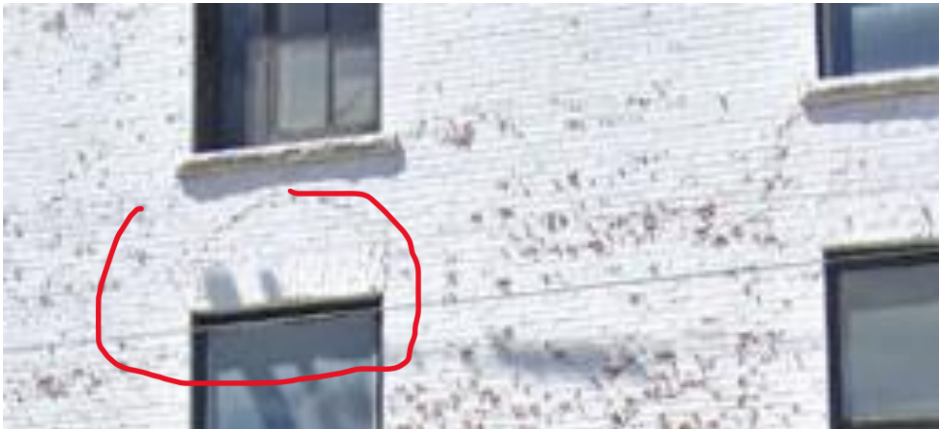
### Removals, Interventions

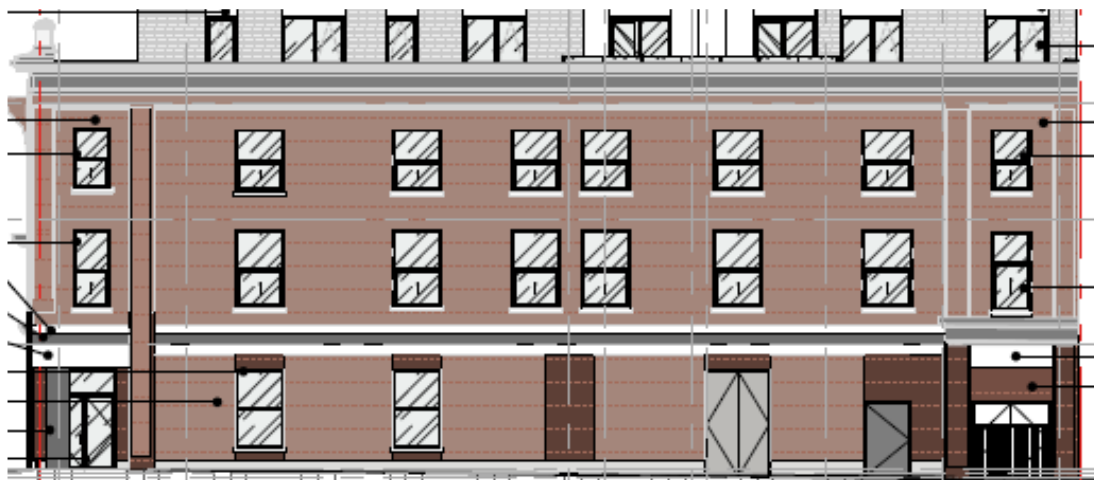
### Conservation Work
