Tree Information Report

| Date of Report: | October 8, 2024 |

| Property Address: | 1299 Dorchester Avenue | City of Ottawa Ville d'Ottawa Comité de dérogation | |
| Prepared by: | Kevin Myers, ISA Certified Arborist [®] ; <u>kevin.myers@dendronforestry.ca</u> | | |

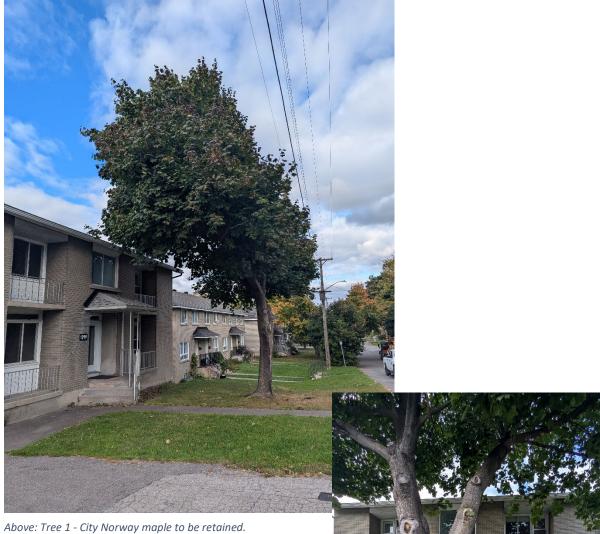
| Tree ¹ | Species | DBH (cm) | Ownership ² | Tree condition ³ | Approximate distance to excavation (m) | Action | Forester recommendation |
|---|--|---|---|--|--|---|---|
| 1 | Norway maple (<i>Acer</i> platanoides) | 47 | City | Fair: heavily asymmetrical crown – pruned away from wires; decay beginning in pruning wounds; 2m long seam along trunk; exposed roots with damage | Laneway: 1.8 | Retain | Retain and protect as per the City of Ottawa Tree Protection Specifications (March 2021). |

Right: Trunk of Tree 1 with pruning wounds, exposed roots.

Tree 1 has been considered in designing the site: the intent is to retain this tree. The future services are proposed to be installed outside the tree's CRZ and excavation for the permeable laneway is to be reduced to a minimum. Any roots encountered during installation of the laneway are to be cleanly severed by hand and covered with a moist organic material to prevent the wounds from drying out.

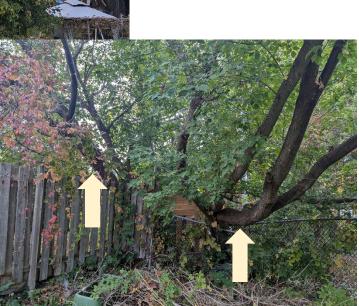
| Tree ¹ | Species | DBH (cm) | Ownership ² | Tree condition ³ | Approximate distance to excavation (m) | Action | Forester recommendation |
|---|--|---|---|--|--|---|---|
| 2 | Manitoba maple (<i>Acer</i> <i>negundo</i>) | 50 (estimate) | Subject property | Fair/Poor: trunk growing horizontally – stems fusing; growing around fence; branch stubs with decay; decay possible at base (vision obscured by fence) | Rear parking: 4 | Remove | Remove due to health status and expected conflict with proposed bike and car parking in the rear. Tree permit required for removal. |

Above: Trunks of Tree 2.

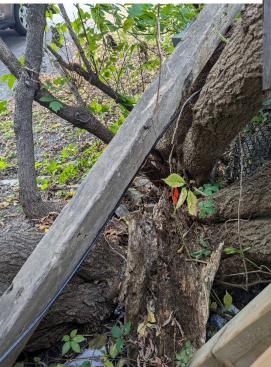
Tree 2 and 3 appear to originate from the same base – although it is hard to determine precisely as vision is obscured by the existing fence. Often these stems would be called one tree – however, because Tree 2 is recommended for removal, and the removal of that stem is not expected to severely impact the other, it has been decided to call them separate trees.

Left above: Tree 2 (right) – Manitoba maple stem to be removed, and Tree 3 (left) - Manitoba maple stem to be retained.

Left below: base of Tree 2 and Tree 3.
