Scoped Tree Information Report

Submitted as part of Committee of Adjustment Application to the City of Ottawa | Ville d'Ottawa

Date of Report: November 18, 2024

Property Address: 30 Mayo Avenue

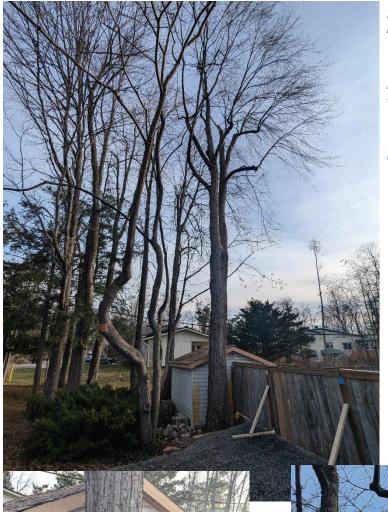
Tree ¹	Species	DBH (cm)	Ownership ²	Tree condition	Approximate distance to excavation (m)	Action	Forester recommendation
14	Red maple (<i>Acer rubrum</i>)	61	Subject property	Fair/Poor: included bark and bulge at main union (@6m); poor form in canopy – weak attachments; broken branch with decay	N/A	Retain	Retain – tree has opportunity to receive water and nutrients from the surrounding area. Care is to be taken when removing the shed not to damage the trunk.

Left: Tree 1 and other red maples - private maples to be retained.

Below right: decay in a branch attachment wound and poor form in canopy.

Below left: base of Tree 1

During the site visit, a gravel driveway extension and a poured concrete pad were in place. The driveway is approximately 40cm higher than the base of **Tree 1**, but the tree has ample opportunity to receive water and nutrients from the unaffected areas of the yard. Care is to be taken not to damage the tree's trunk during the removal of the existing vinyl shed and wooden fence. The client has indicated that the trees are to be retained, and it is expected this is feasible given the plans. Fencing as described below and shown in the map is to be erected along the edge of the driveway extension to protect the treed area from soil compaction and the trunks from mechanical damage.

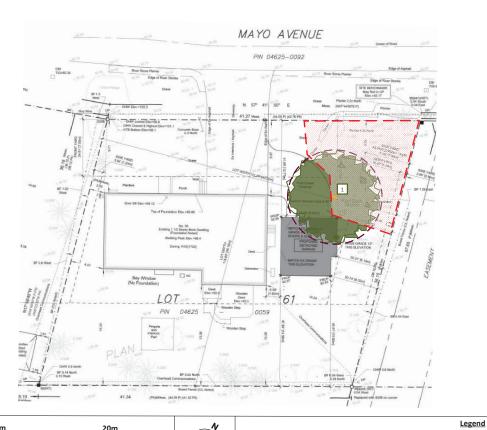
TIR Map – 30 Mayo Avenue						
Date	Version	Prepared By				
18/11/2024	1	KM

Tree ¹	Species	DBH (cm)	Tree condition	Forester recommendation
14	Red maple (Acer rubrum)	61	Fair/Poor: included bark and bulge at main union (@6m); poor form in canopy – weak attachments; broken branch with decay	Retain – tree has opportunity to receive water and nutrients from the surrounding area. Care is to be taken when removing the shed not to damage the trunk.

Protective fencing should be installed around the Tree Protection Area as indicated in the attached Tree Information Map and maintained until all construction on site has been completed as per the City of Ottawa Tree Protection Specifications (March 2021).
