Tree Information Report

Date: September 23, 2024

Site Address: 346 Roosevelt, Ottawa ON, K2A 1Y9

Infill / Development: Client is requesting to build a 4 storey triplex.

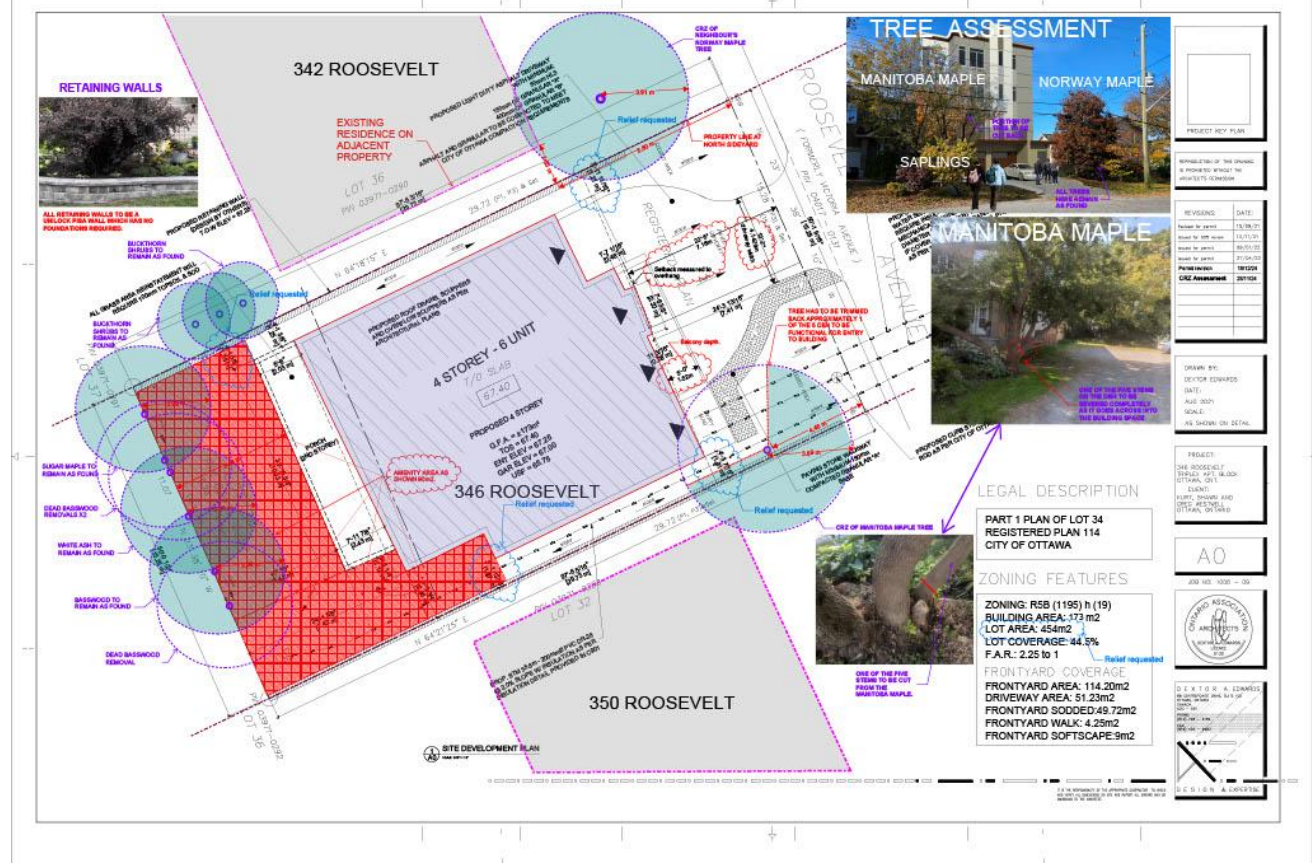
(The image above shows none of the proposed excavation will have any impact on the CRZ of any trees on the property or neighboring properties.)

1. The cluster of Trees 1,2 ,3 ,4 and 5, will require protection from activities that may disturb the CRZ or compact the soil around the tree. The Critical root zone of this tree is a radius of **3.9 meters** from the base of the cluster. A temporary jobsite fence should be erected between the worksite and the tree no closer than 3.9 meters to the tree. If this is not possible, then work in this area must not exceed the allowable 30% disturbance of the crz.

2. Trees 7, 8, 9, 12 and 14 should be protected and impact to crz should be no greater than 30%, measurements should be taken on site to determine where a temporary jobsite fence should be erected between the tree and the jobsite.

3. Tree #16 is the neighbors Crimson King Maple tree; much care should be taken to protect this tree's crown and roots. Any activities that require pruning the crown or roots should be discussed with the homeowner before hand and written consent should be taken and signed. A protective barrier (jobsite fence) should be erected between the tree and the jobsite no nearer than 3.5 meters from the bole of the tree

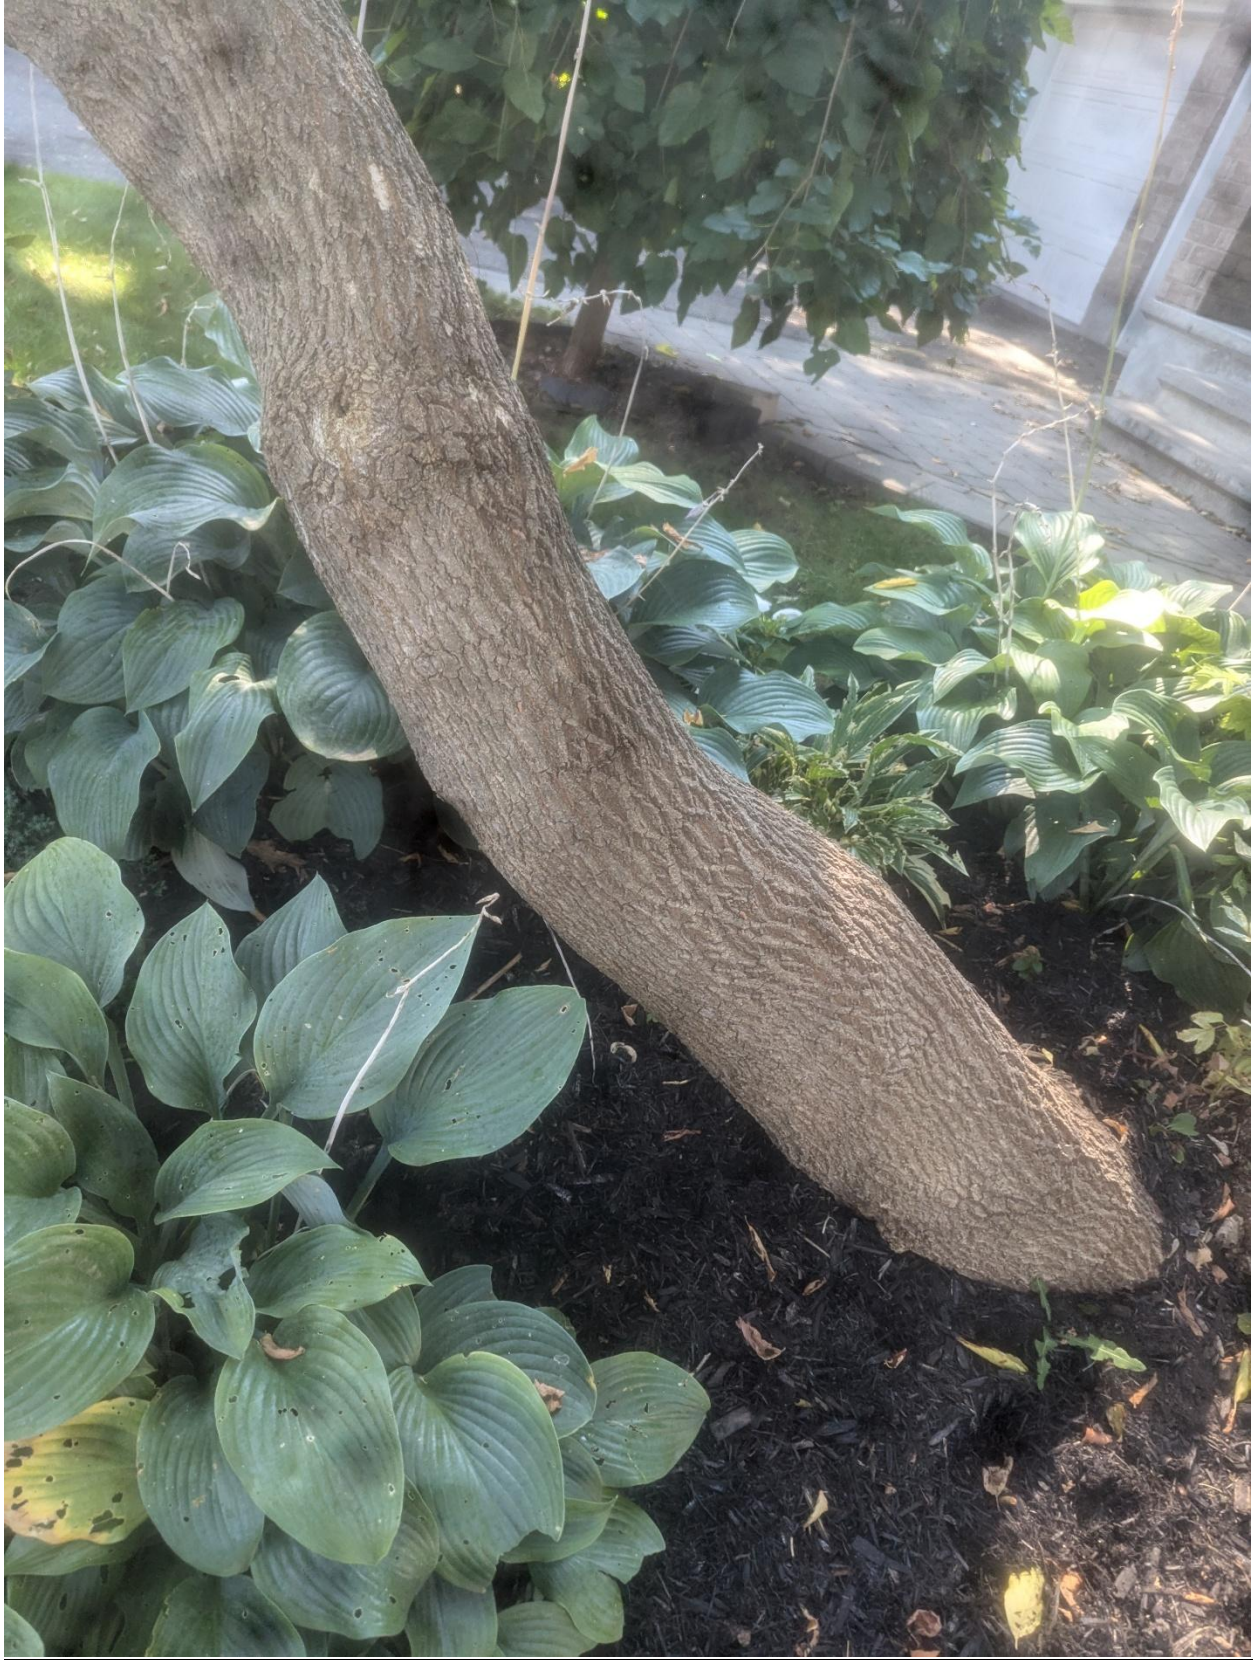
Tree # 1 (Manitoba maple stem, part of cluster of 5 stems separating from ground level)

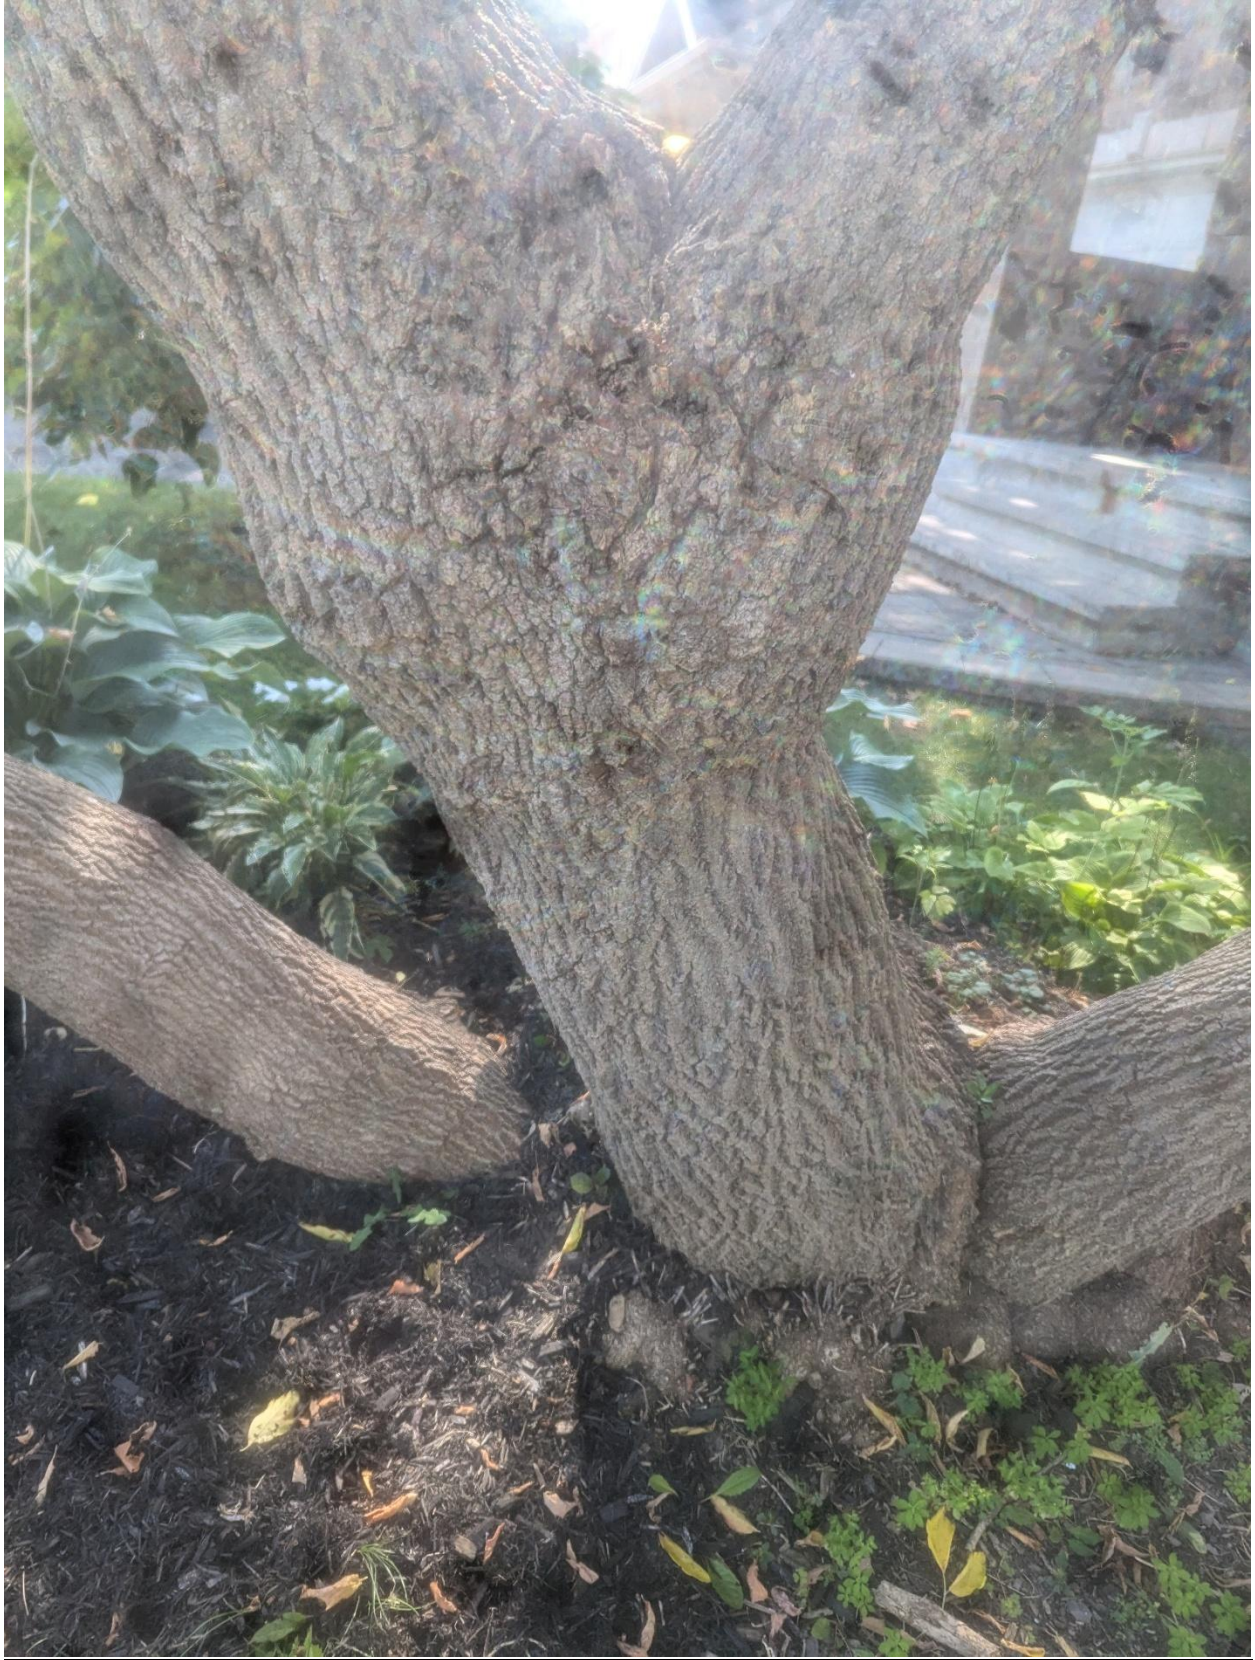
Tree # 2 (Manitoba maple stem, part of cluster of 5 stems separating from ground level)

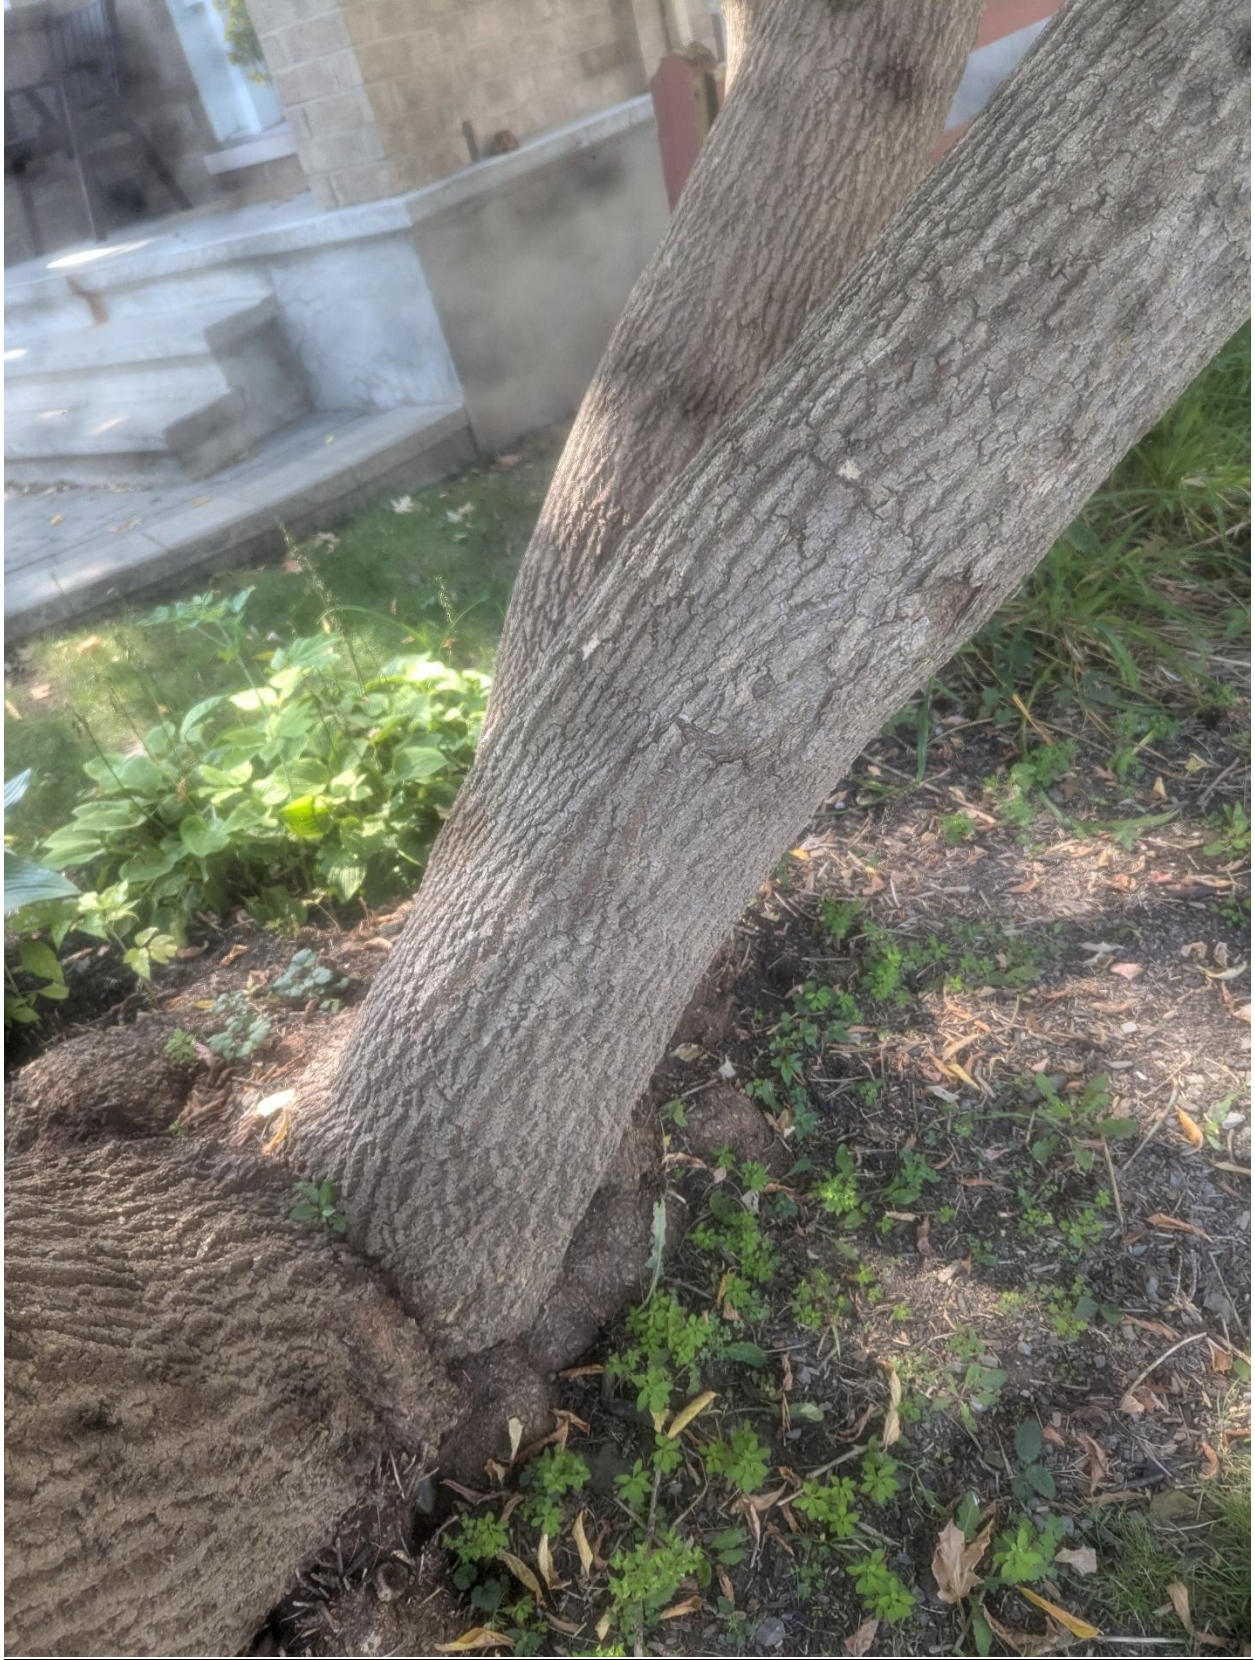
Tree # 3 (Manitoba maple stem, part of cluster of 5 stems separating from ground level)

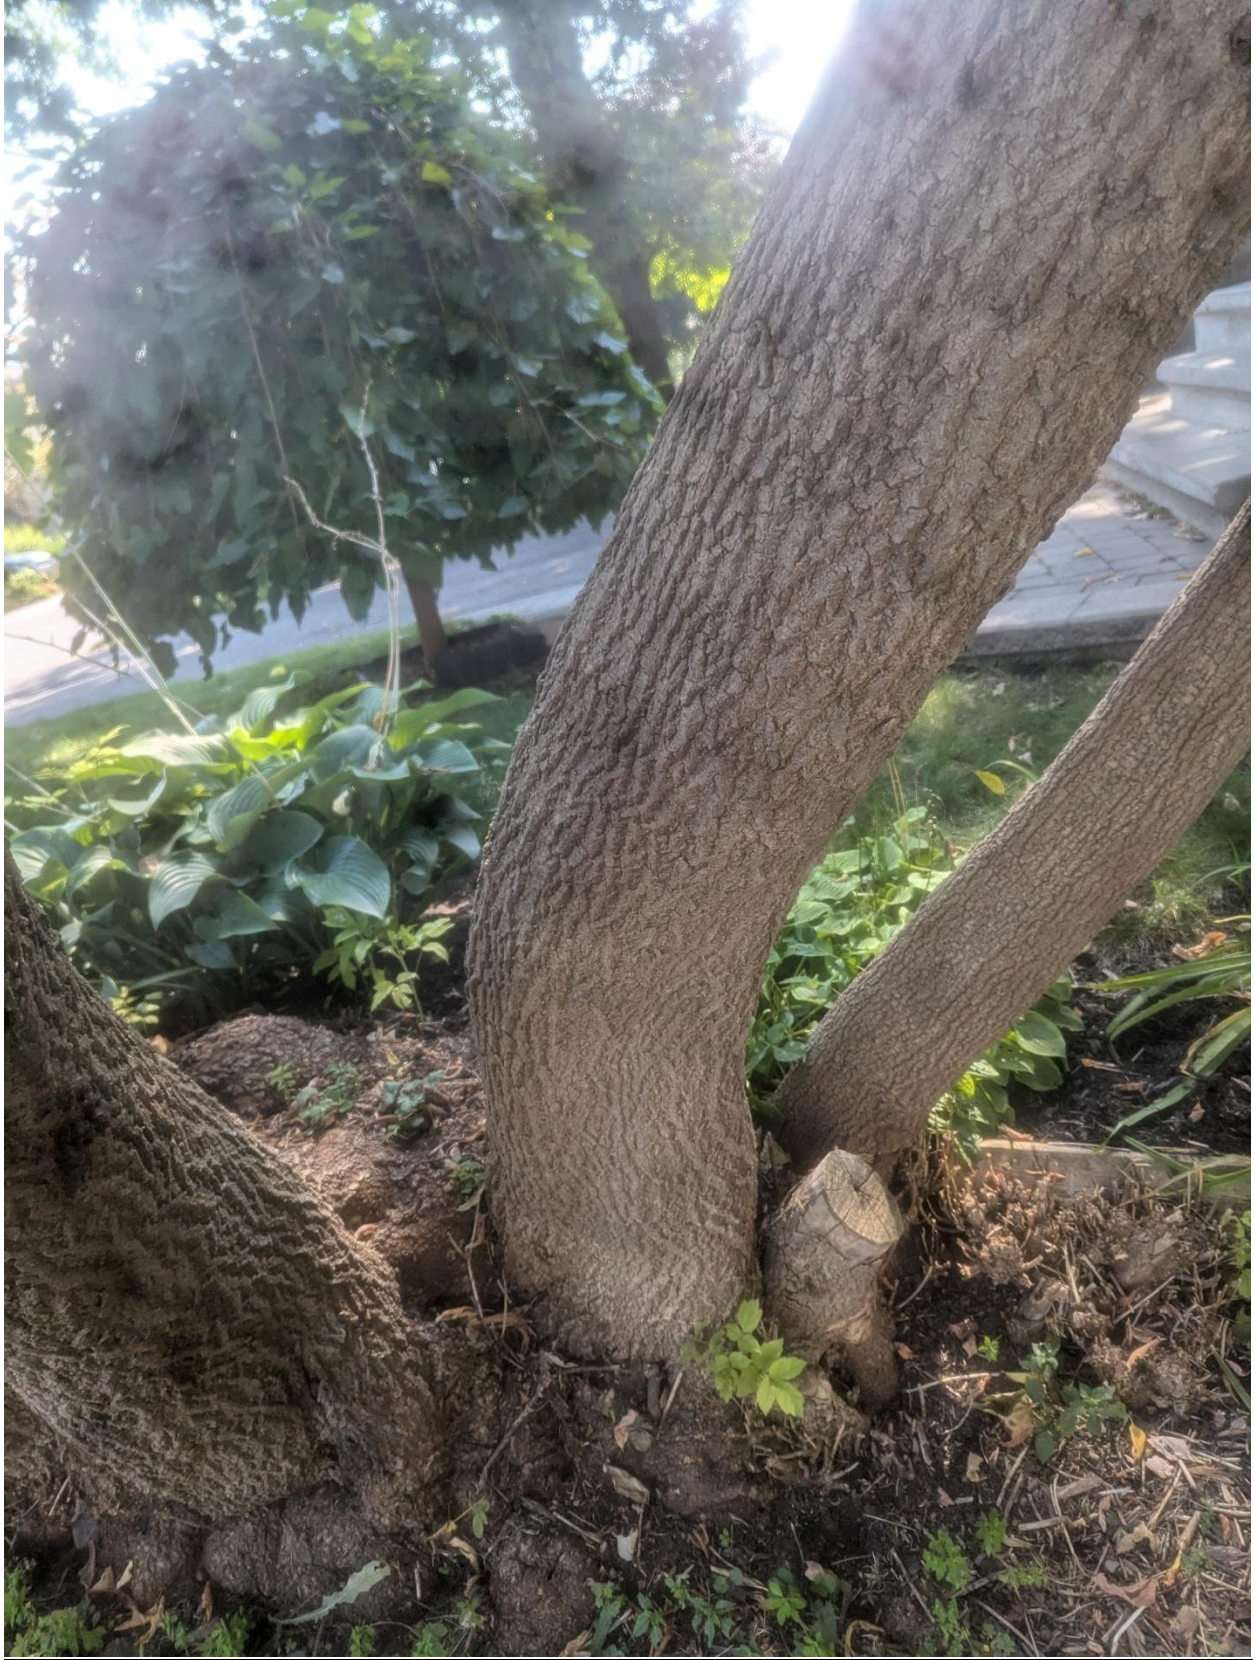
Tree # 4 (Manitoba maple stem, part of cluster of 5 stems separating from ground level)

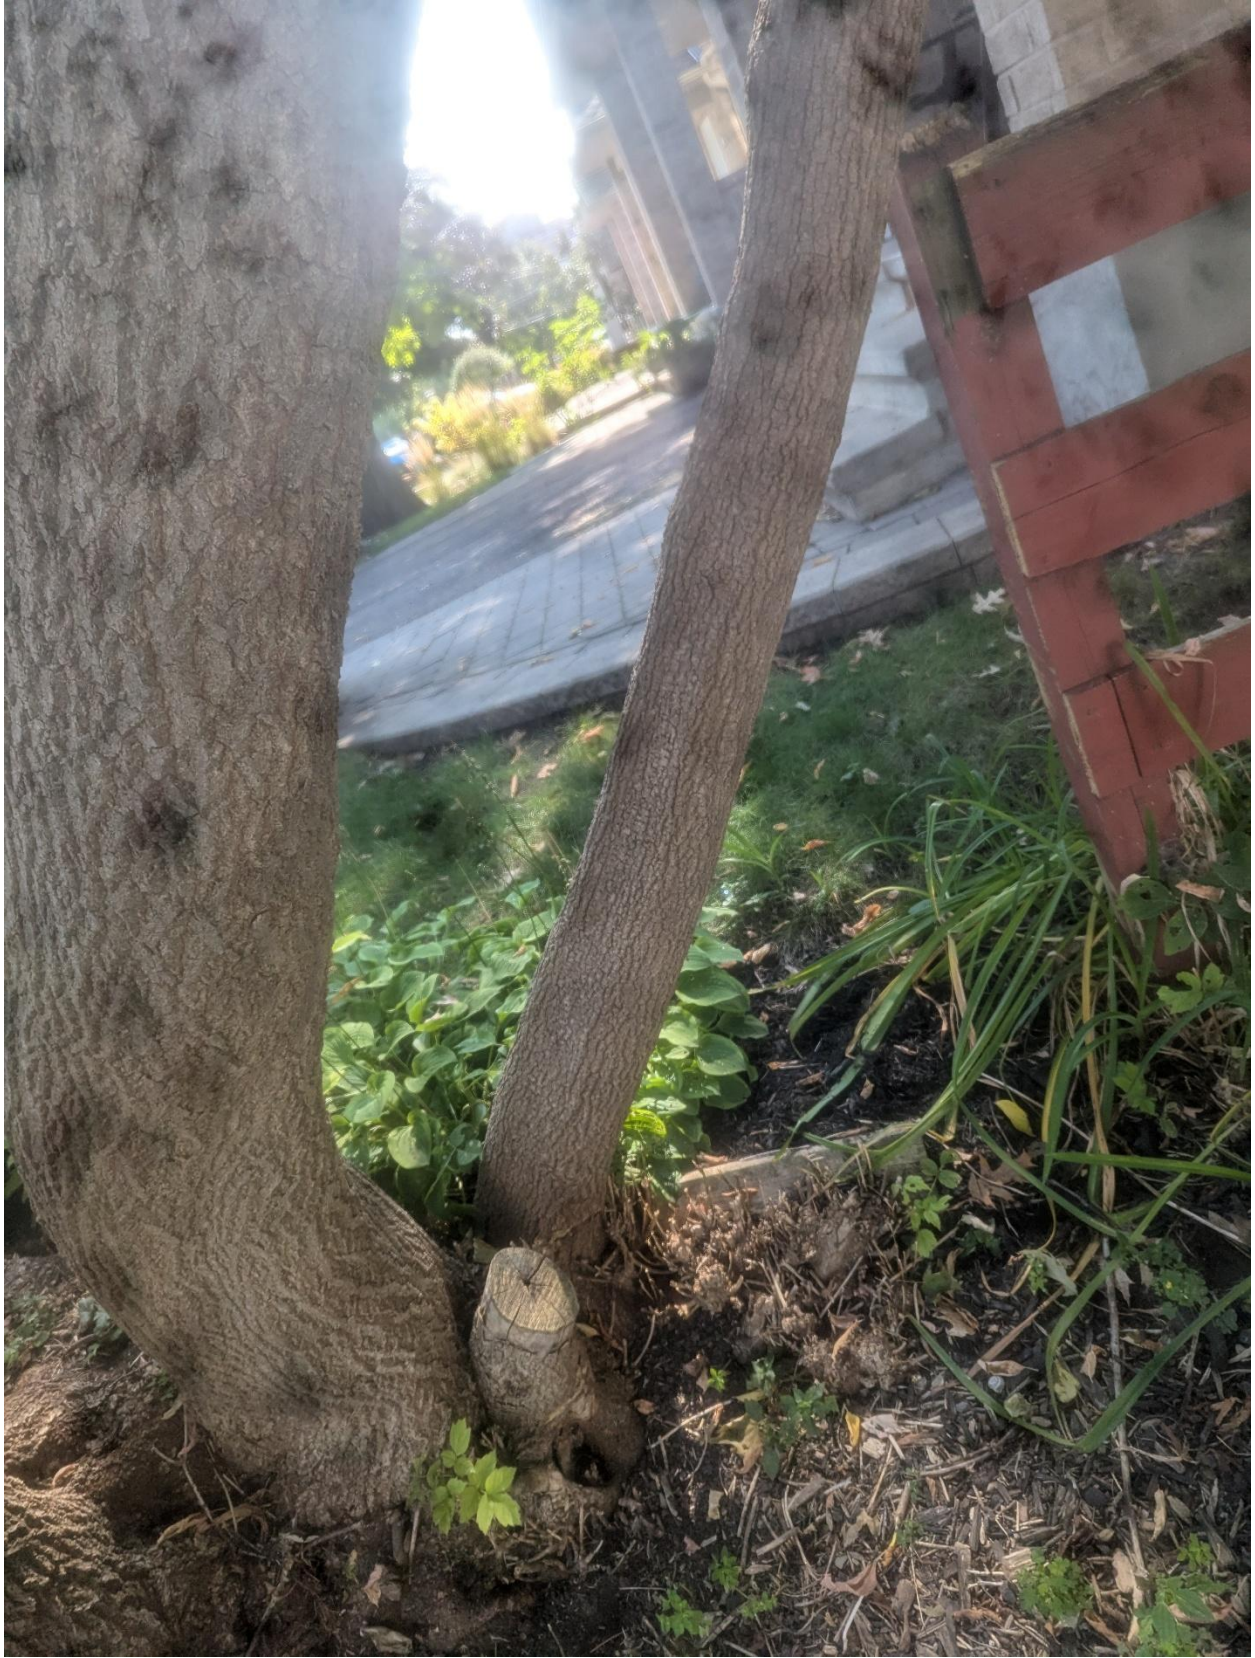
Tree # 5 (Manitoba maple stem, part of cluster of 5 stems separating from ground level)

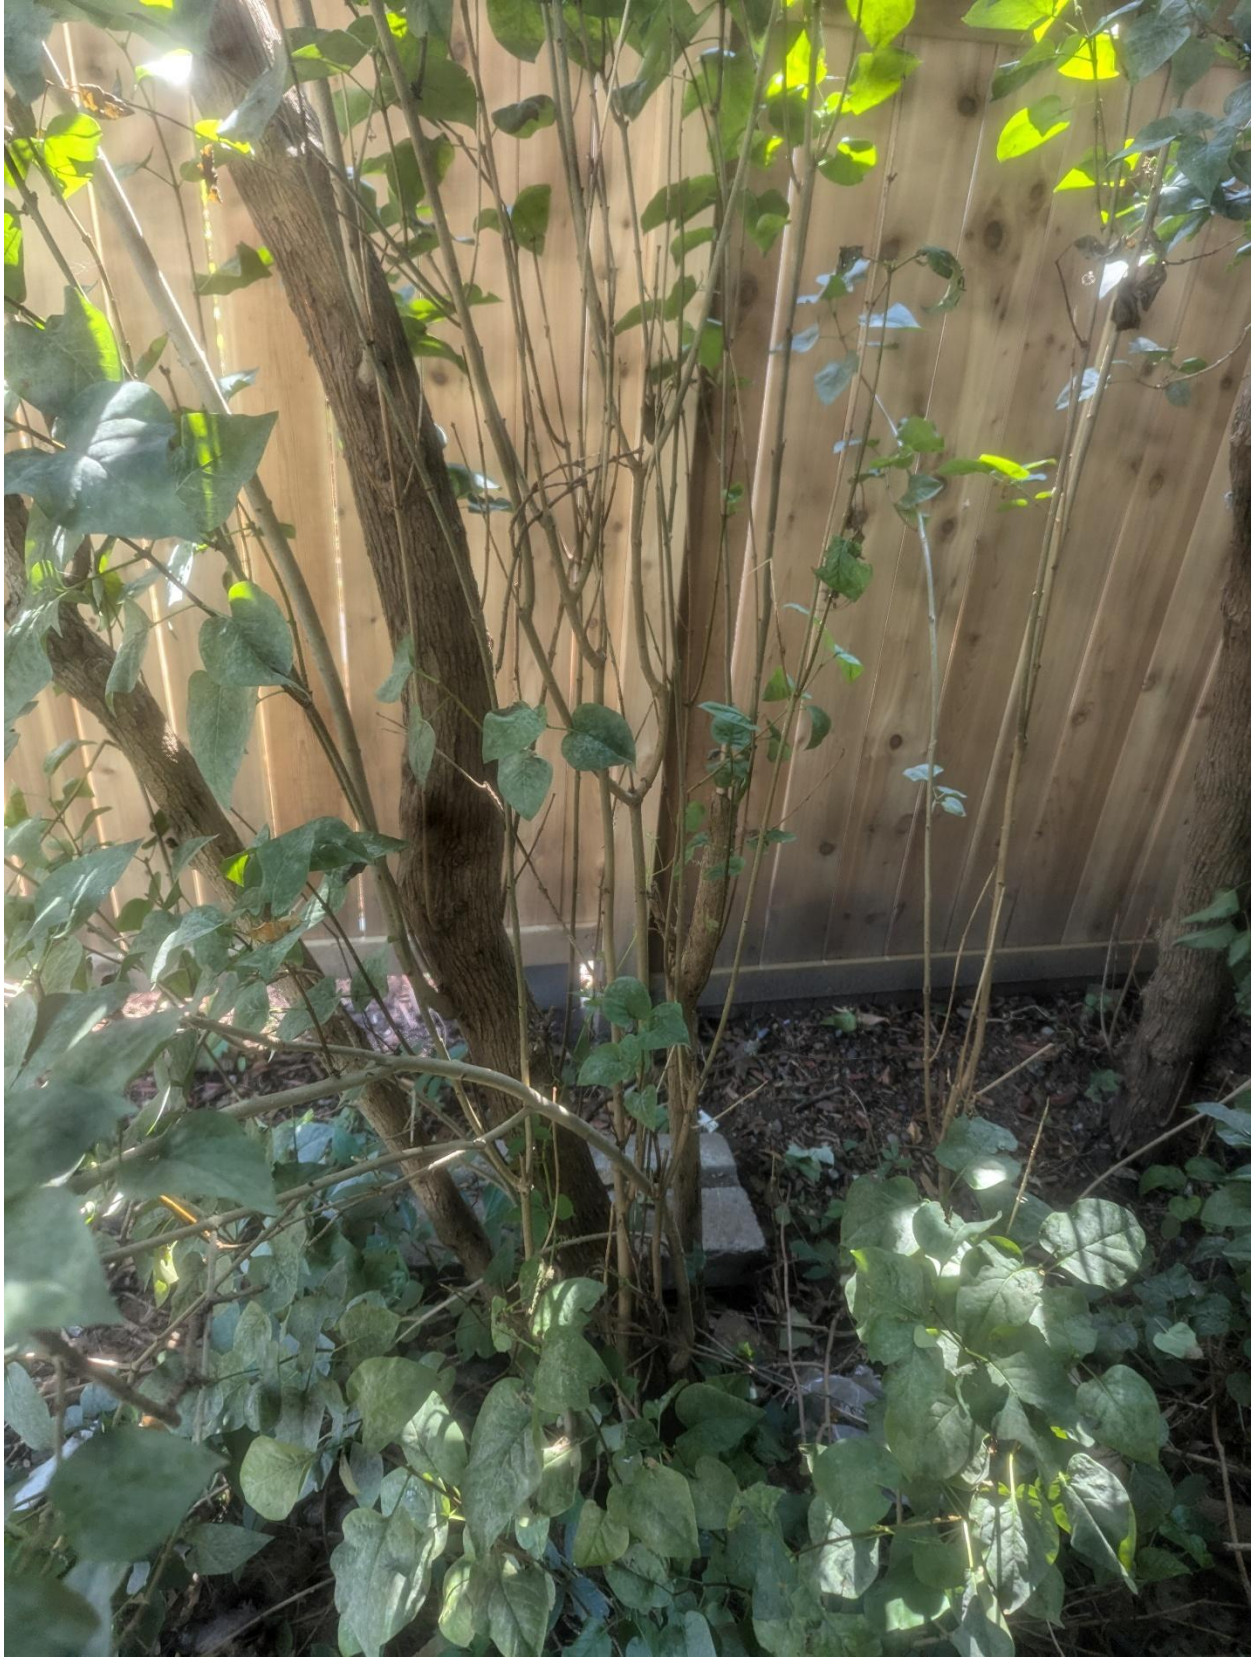
Tree # 6 (1) (Lilac stem, part of larger cluster)

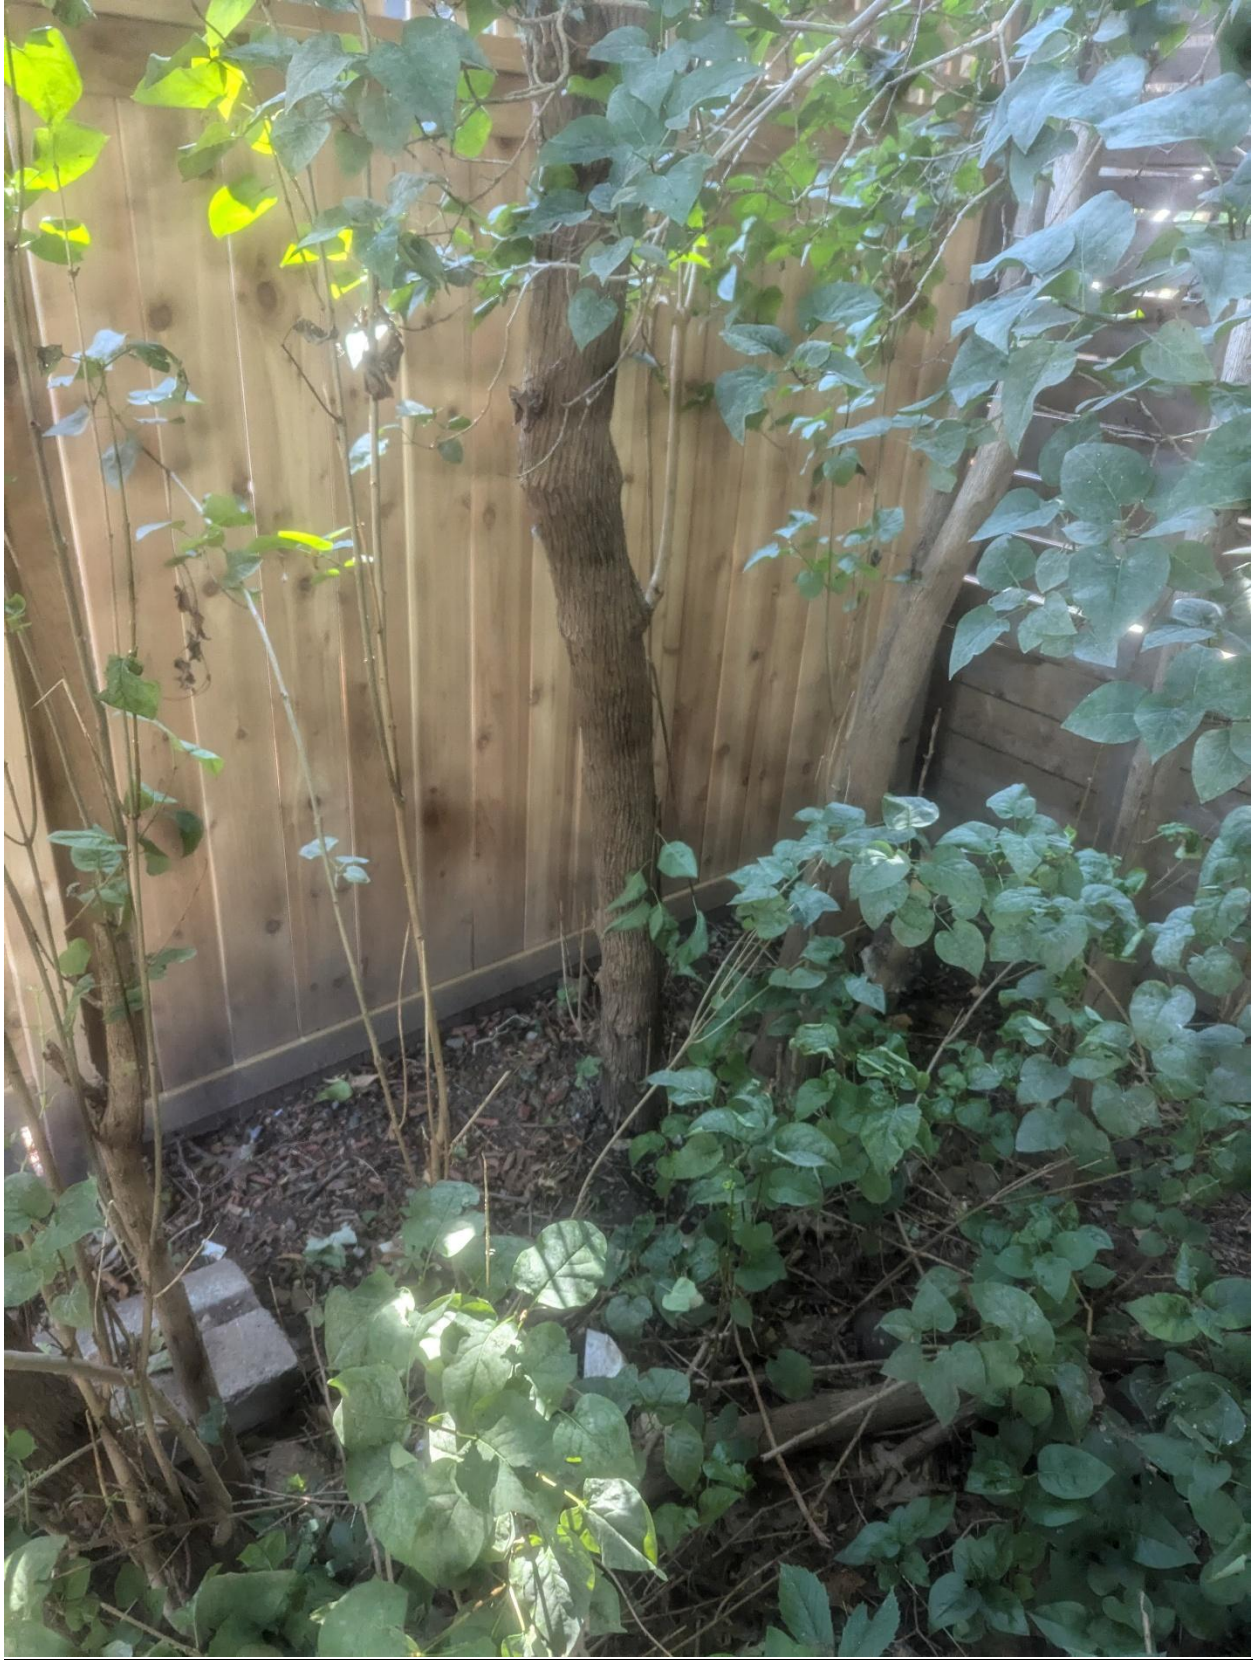
Tree # 6 (2) (Lilac stem, part of larger cluster)

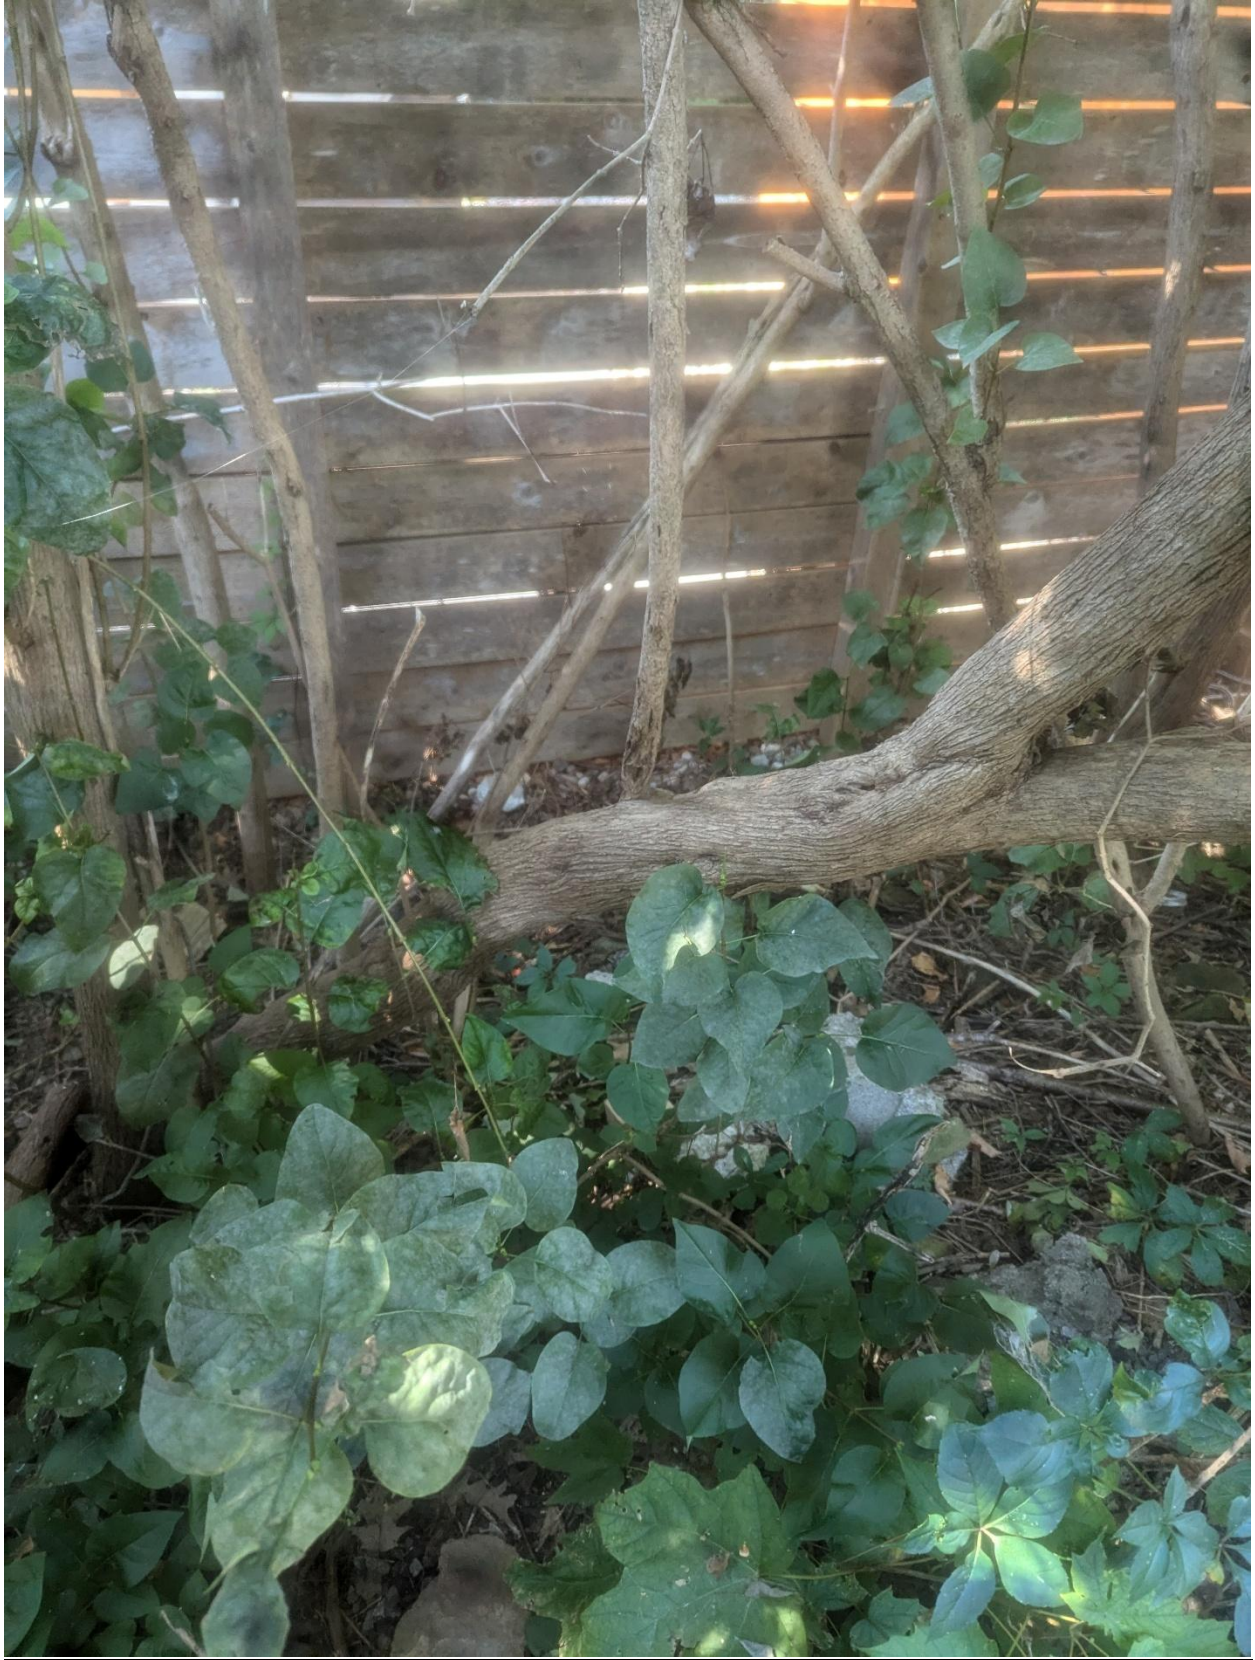
Tree # 6 (3) (Lilac stem, part of larger cluster)

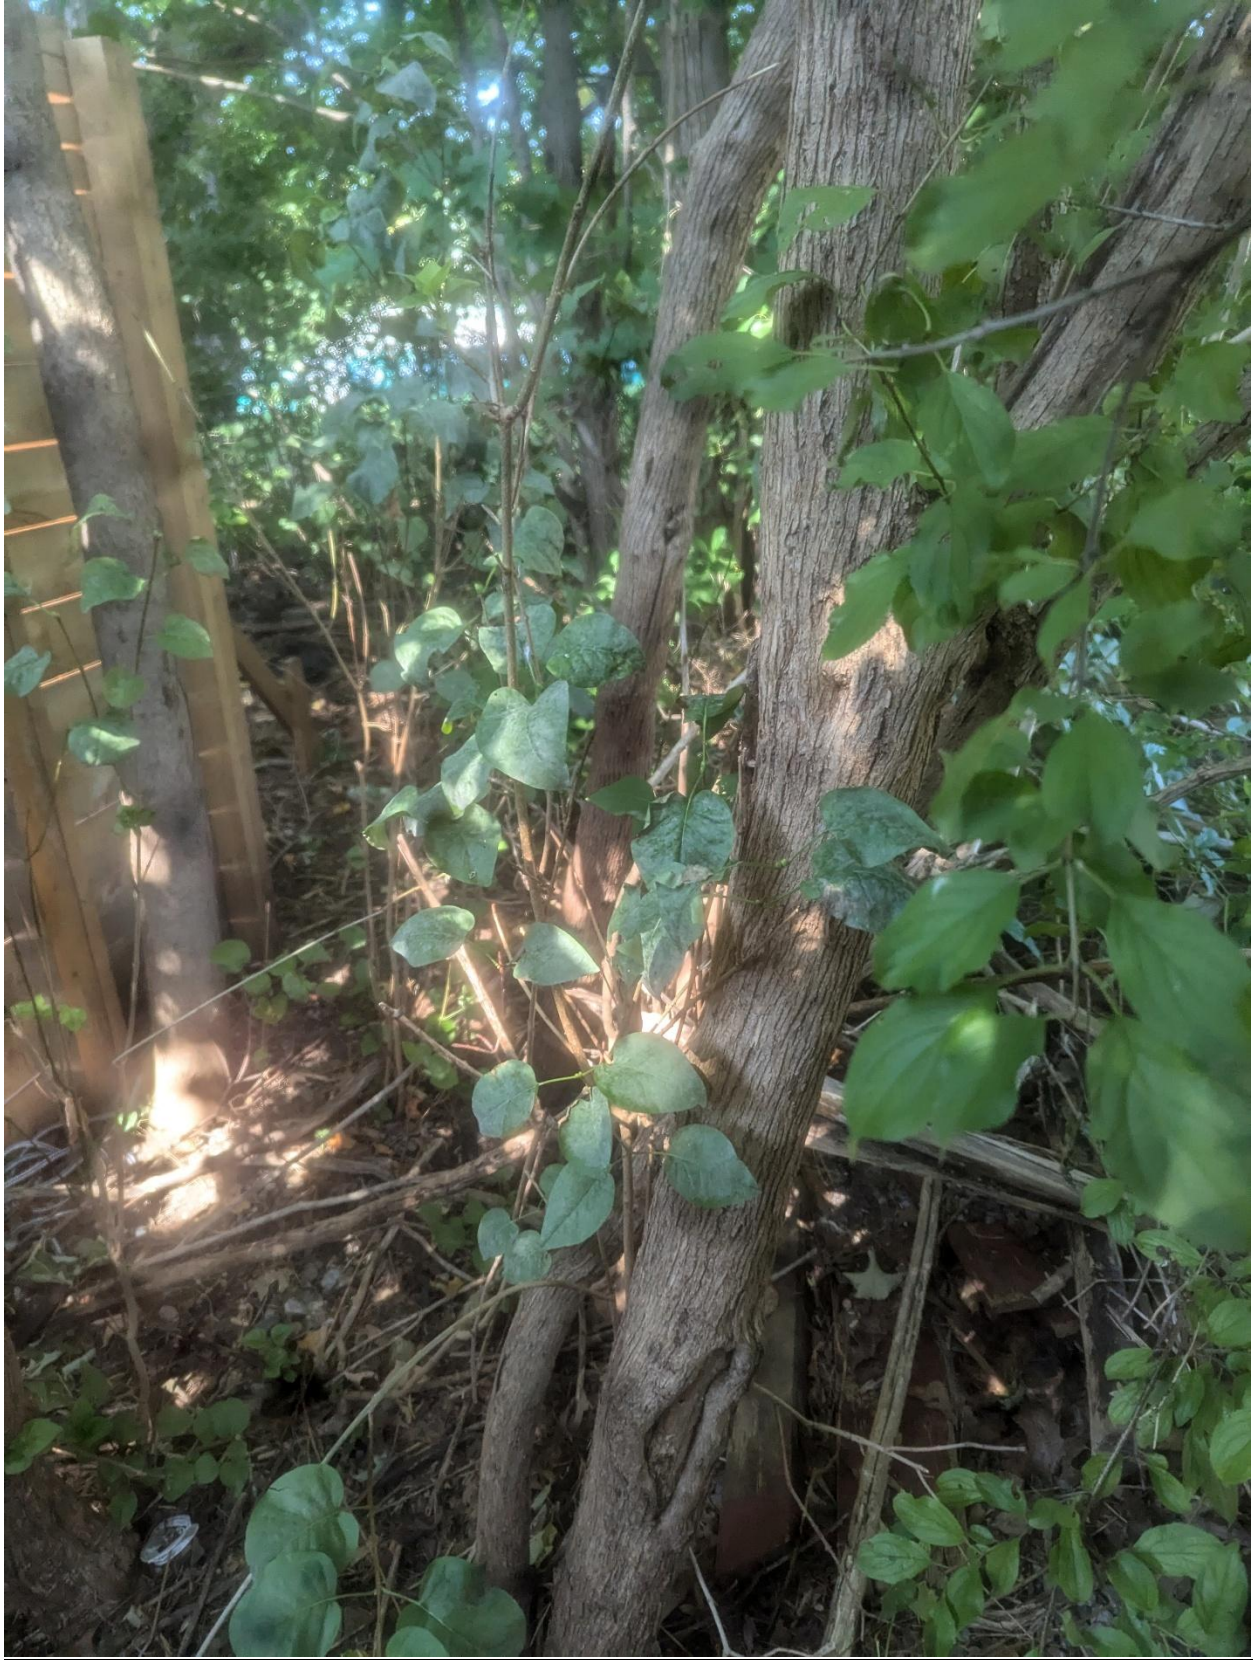
Tree # 6 (4) (Lilac stem, part of larger cluster)

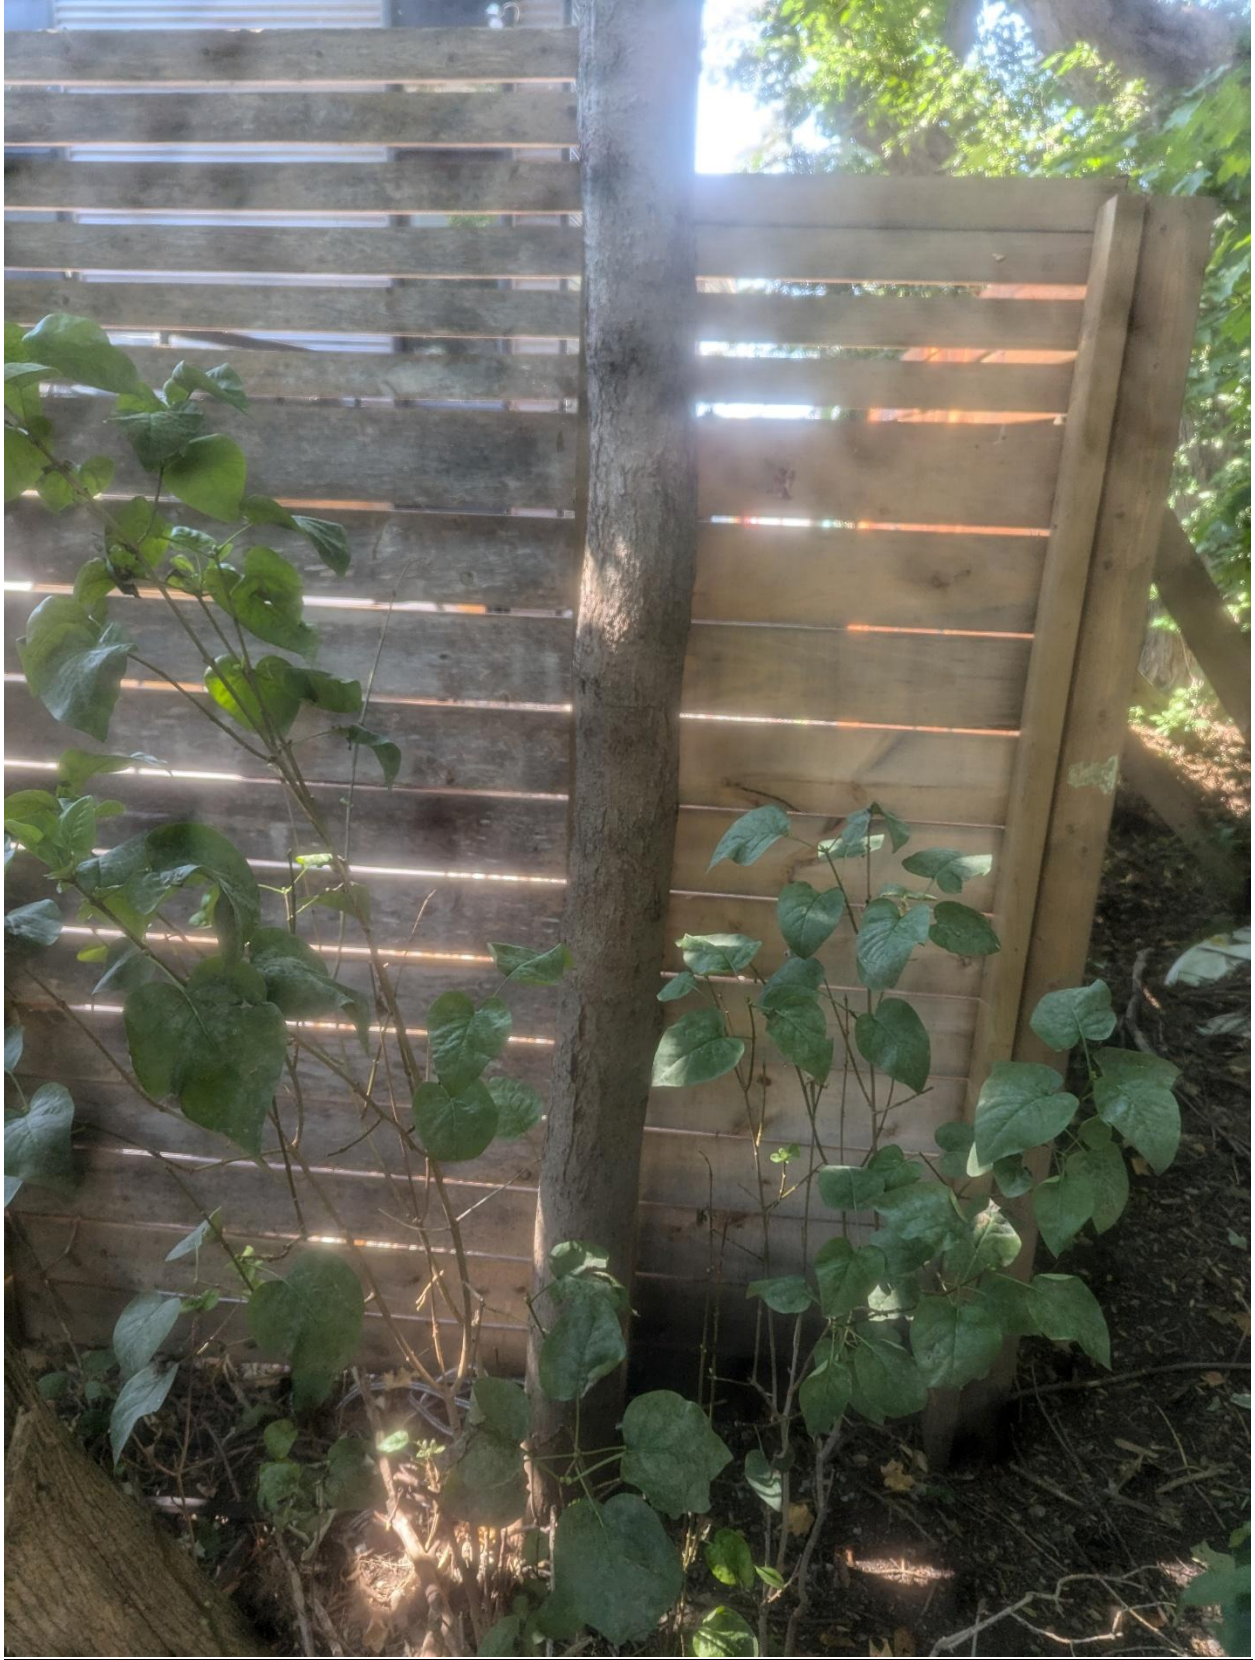
7	Norway Maple (Acer Platanoides)	13.5	rear fenceline (west fenceline)	Healthy, no defects, crowded crown	Retain	346 Roosevelt

Tree # 7 (Healthy Norway Maple)
