Tree Information Report

Date: September 23, 2024

Site Address: 346 Roosevelt, Ottawa ON, K2A 1Y9

Infill / Development: Client is requesting to build a 4 storey triplex.

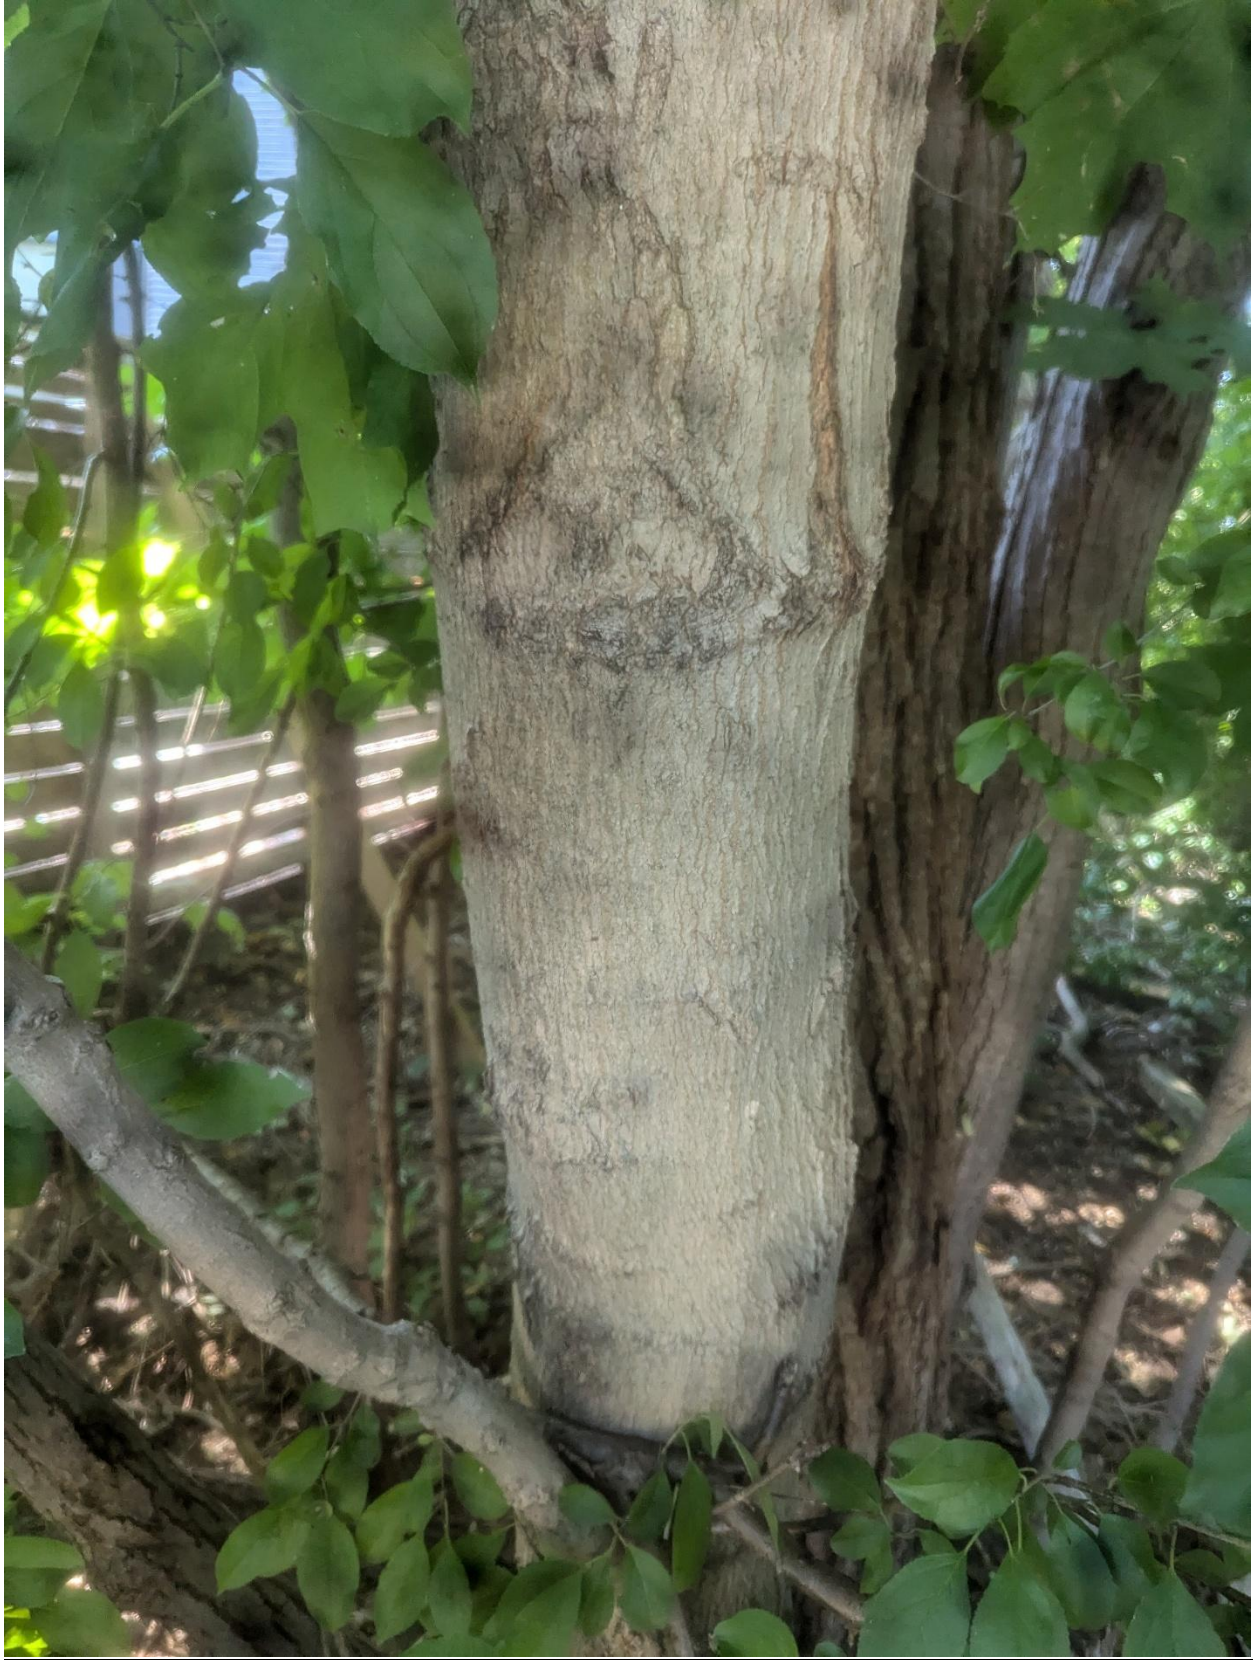
Tree # 8 (Healthy Sugar Maple)

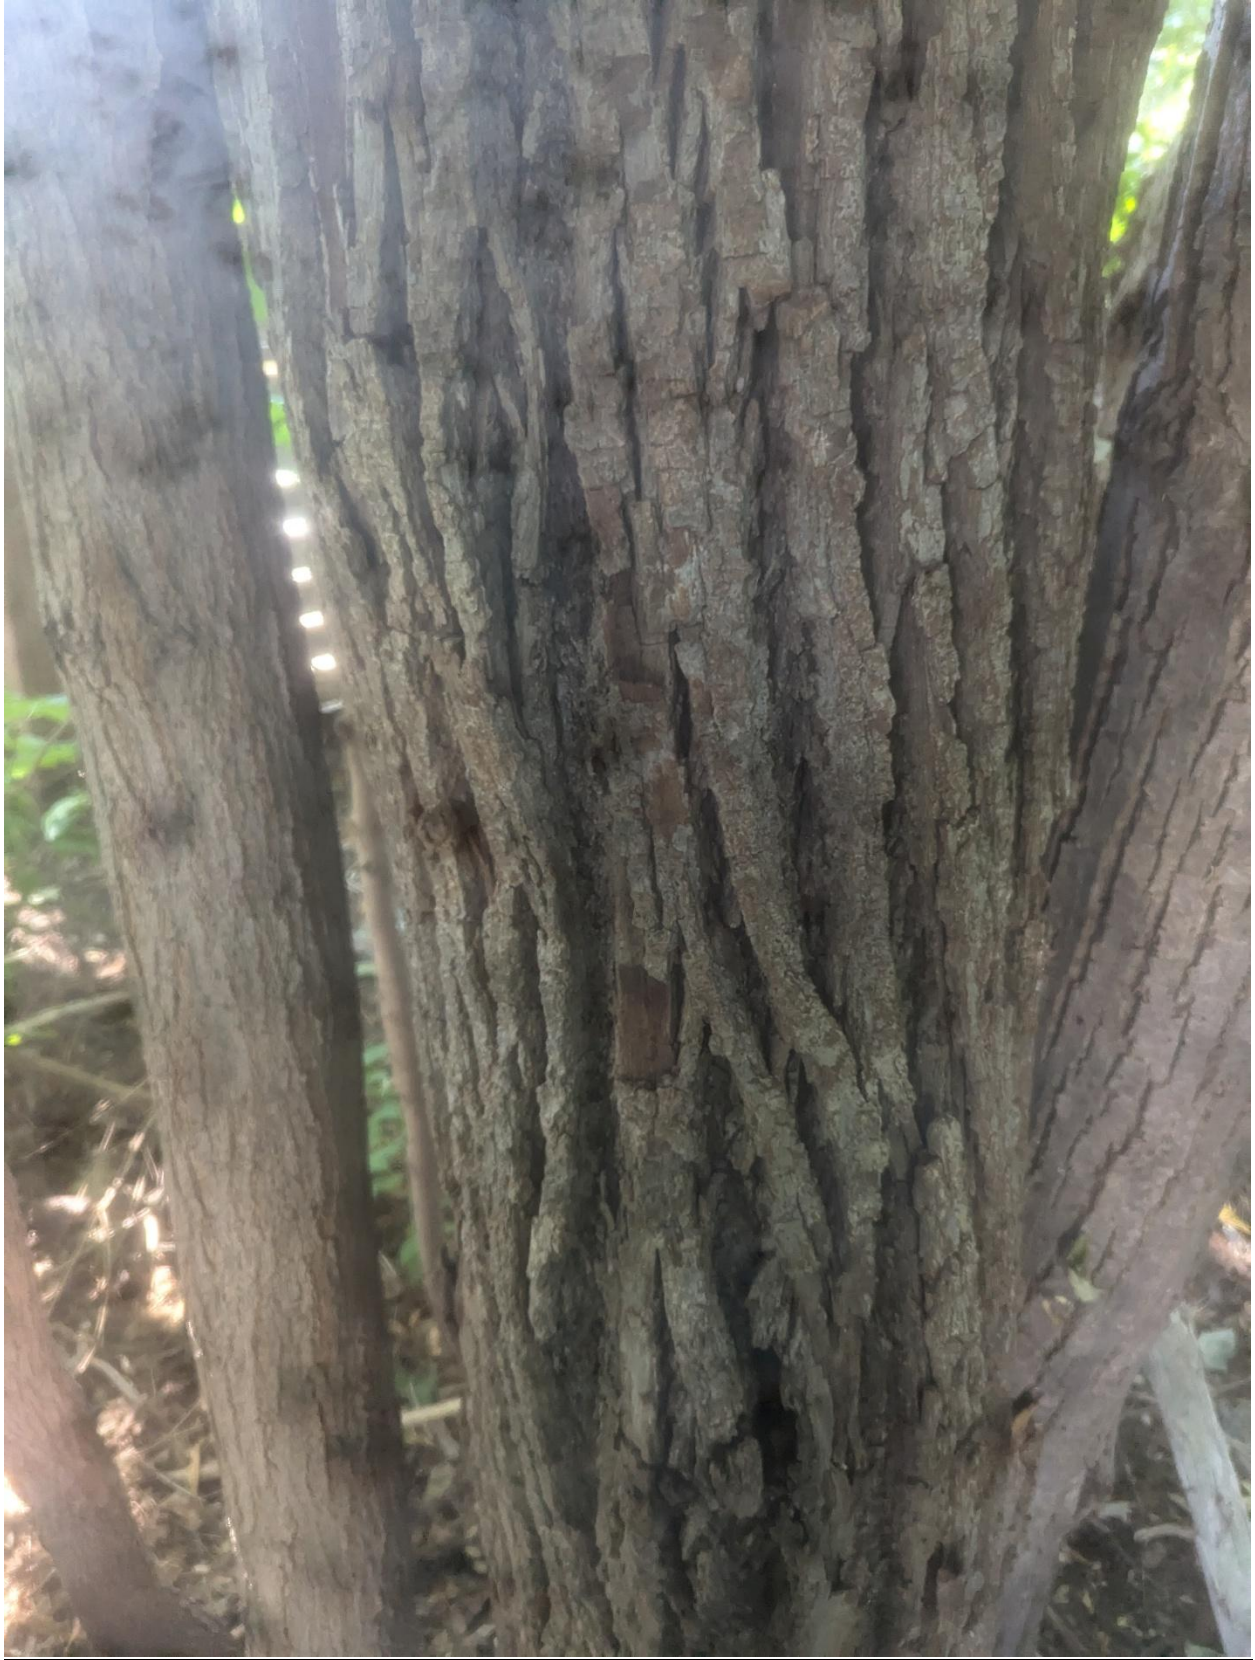
Tree # 9 (Healthy Basswood)

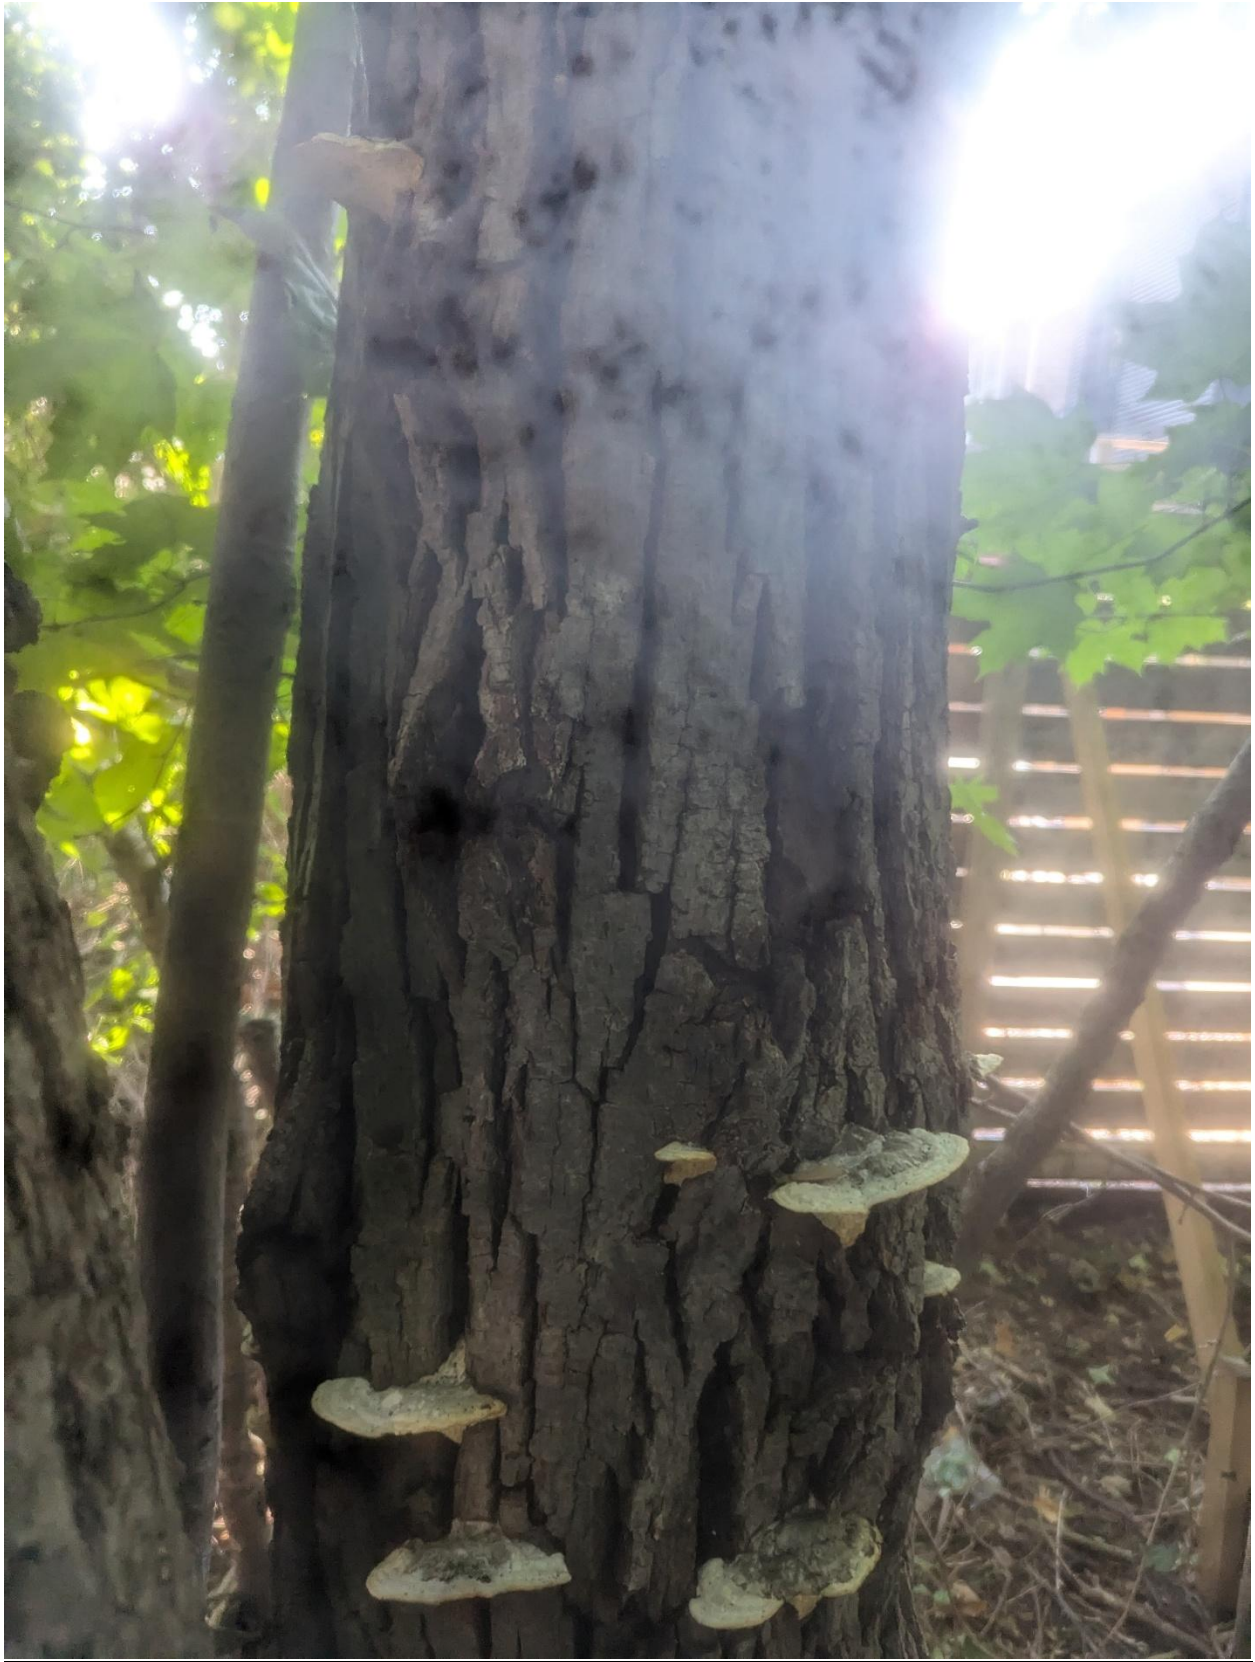
Tree # 10 (Dead Basswood)

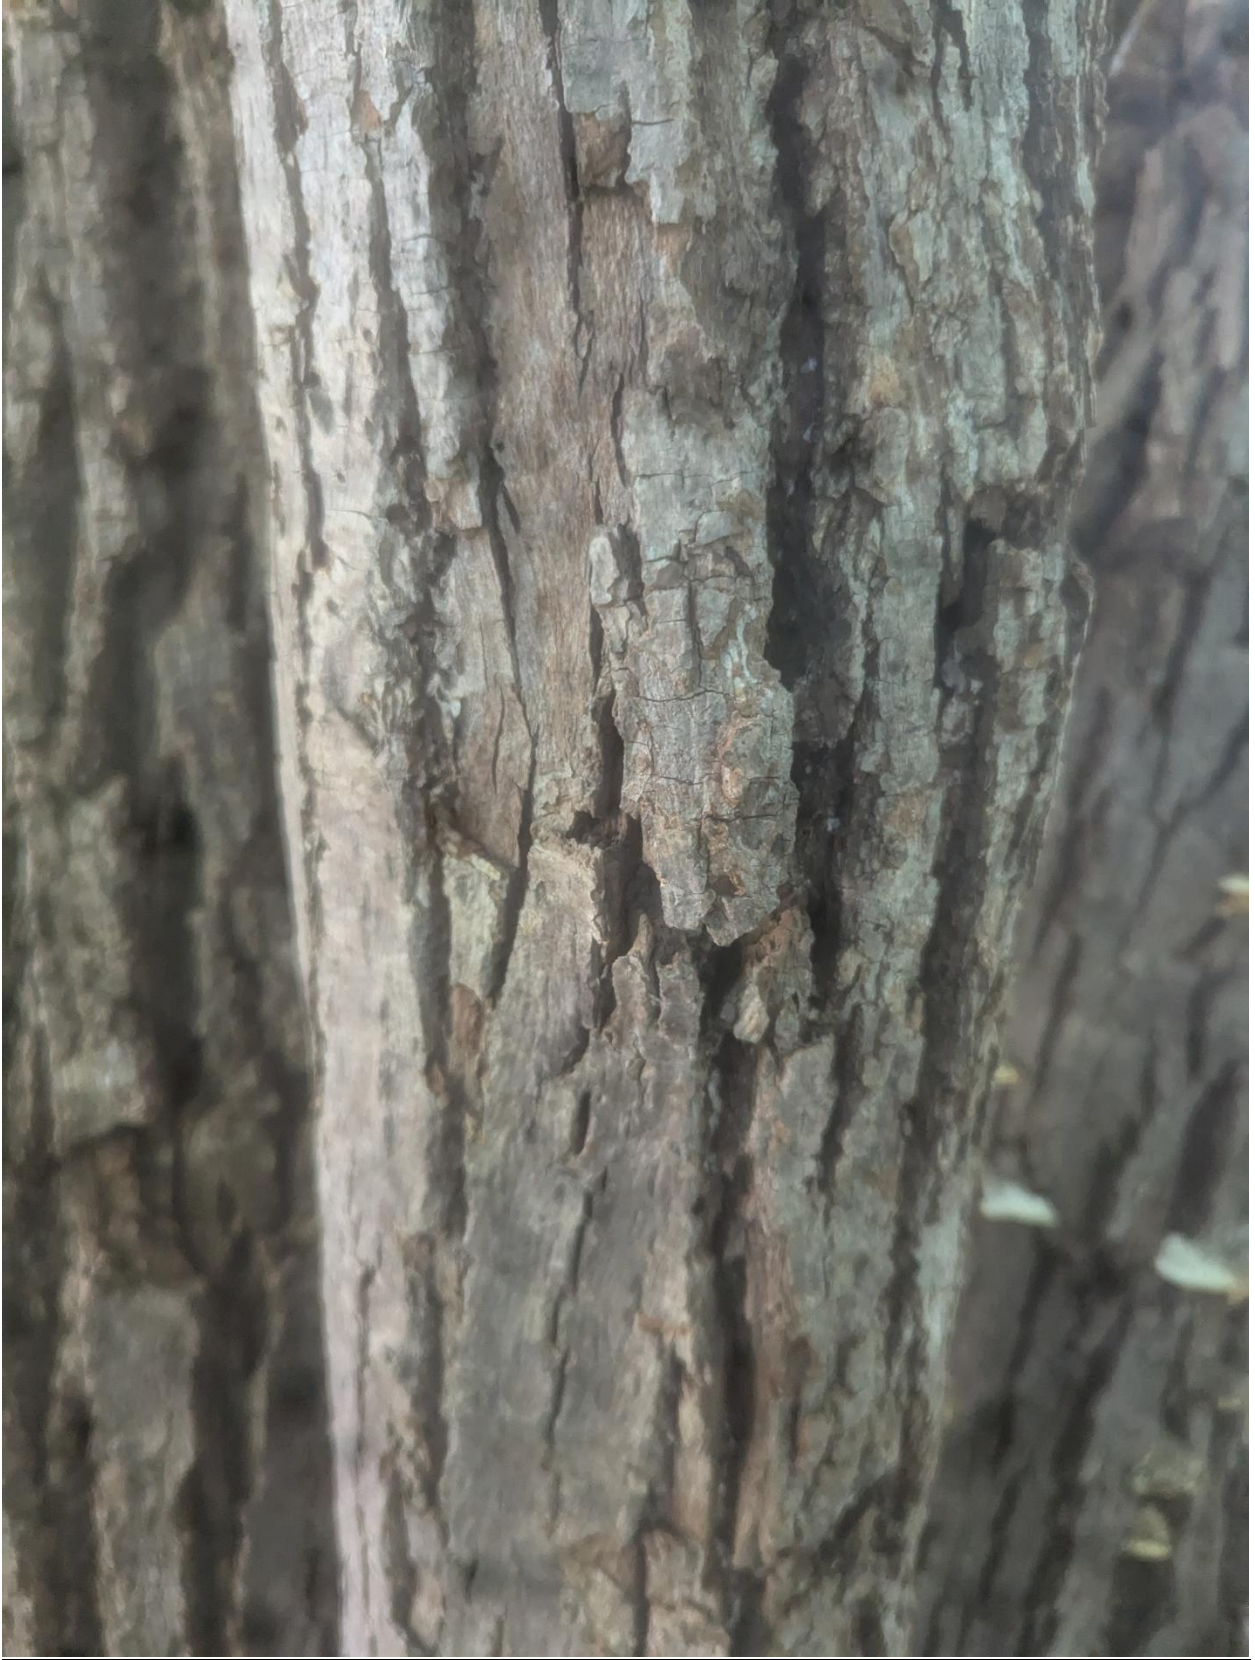
Tree # 11 (Dead Basswood)

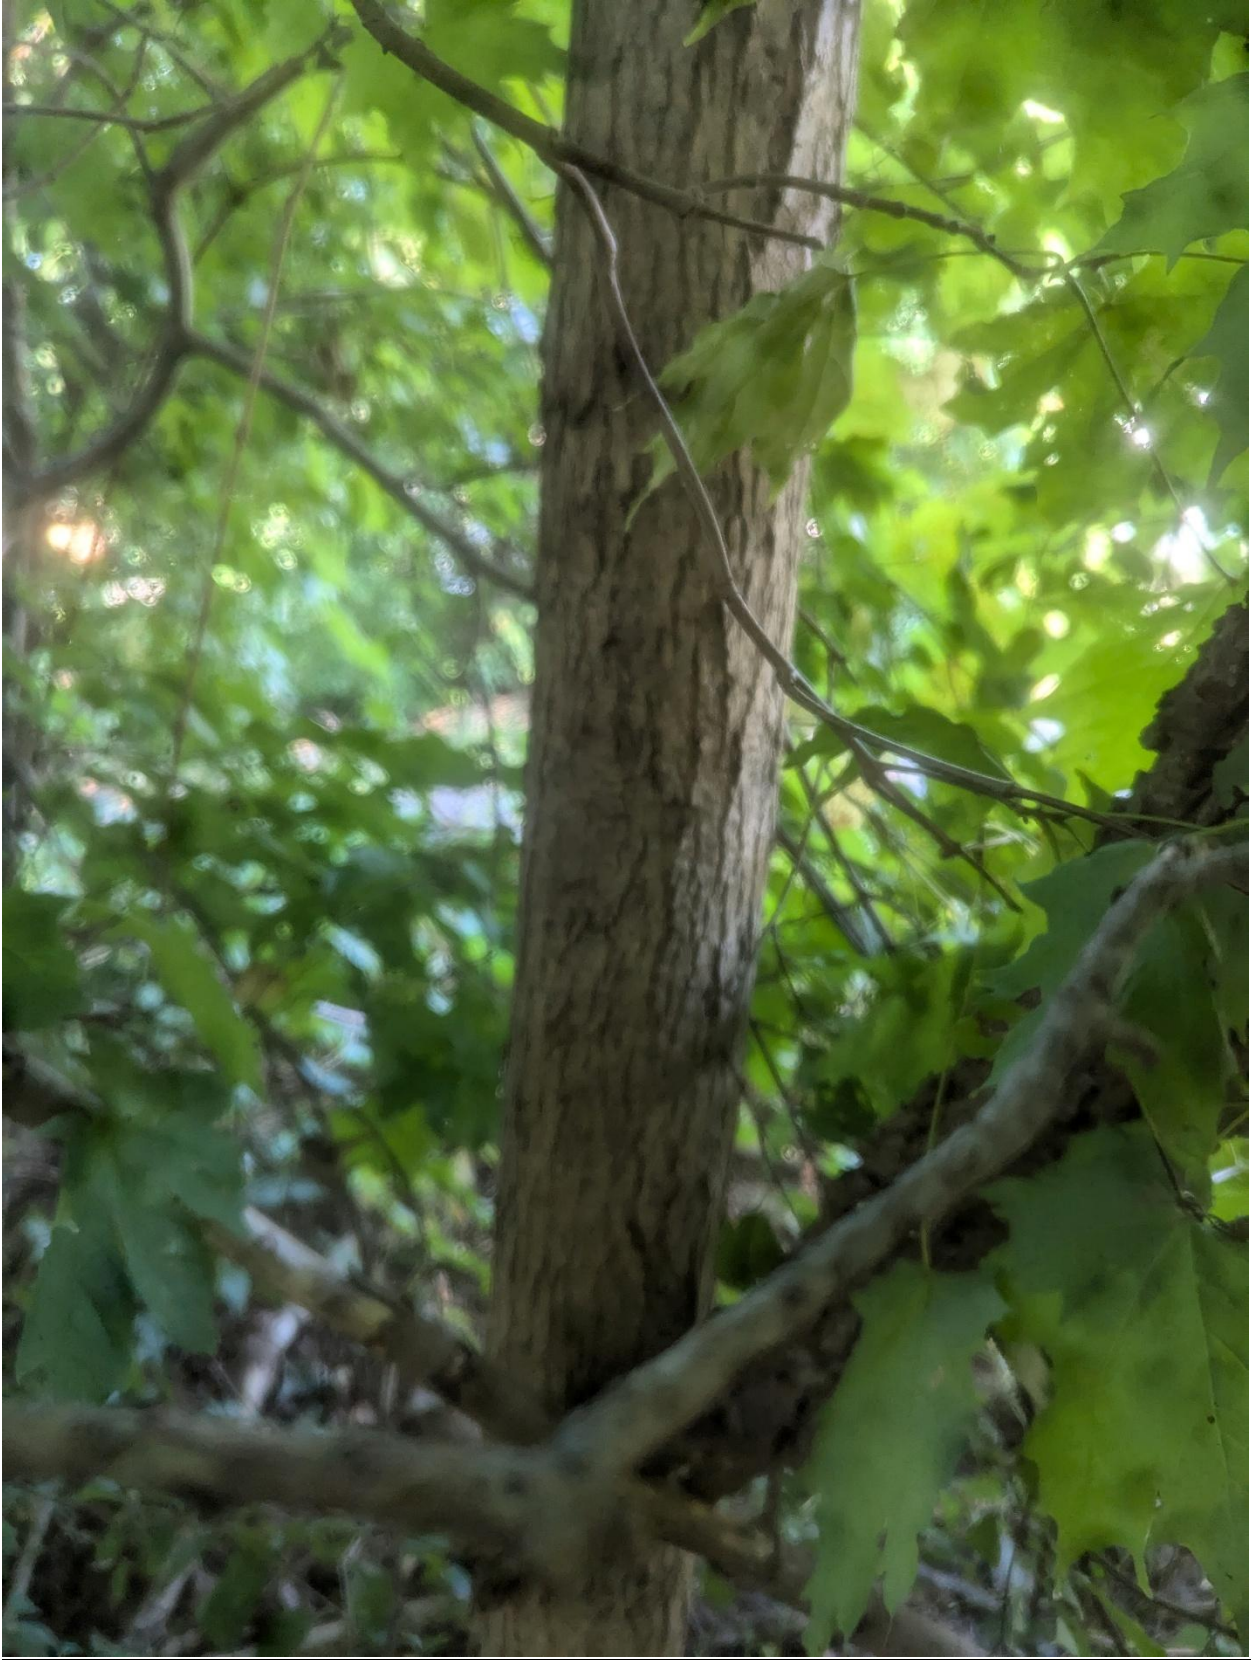
Tree # 12 (Healthy Ash tree)

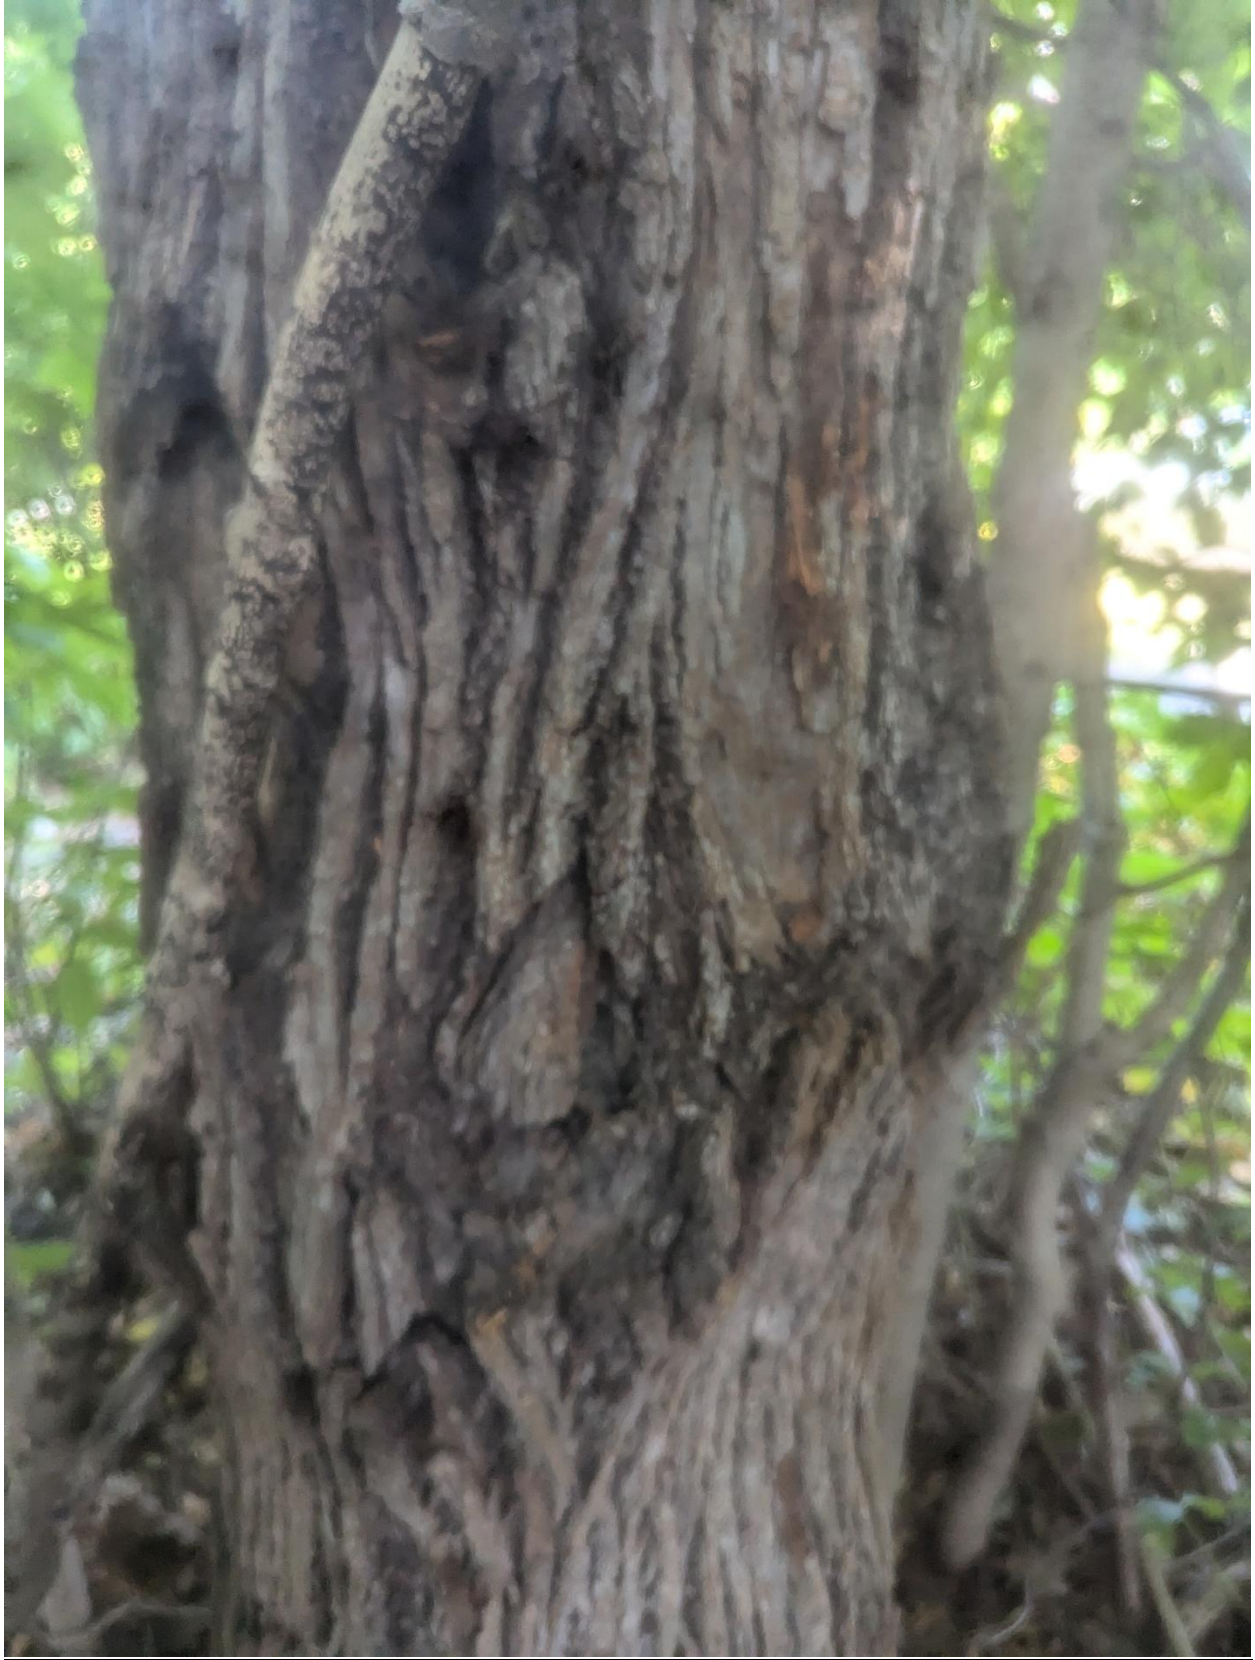
Tree # 13 (dead basswood)

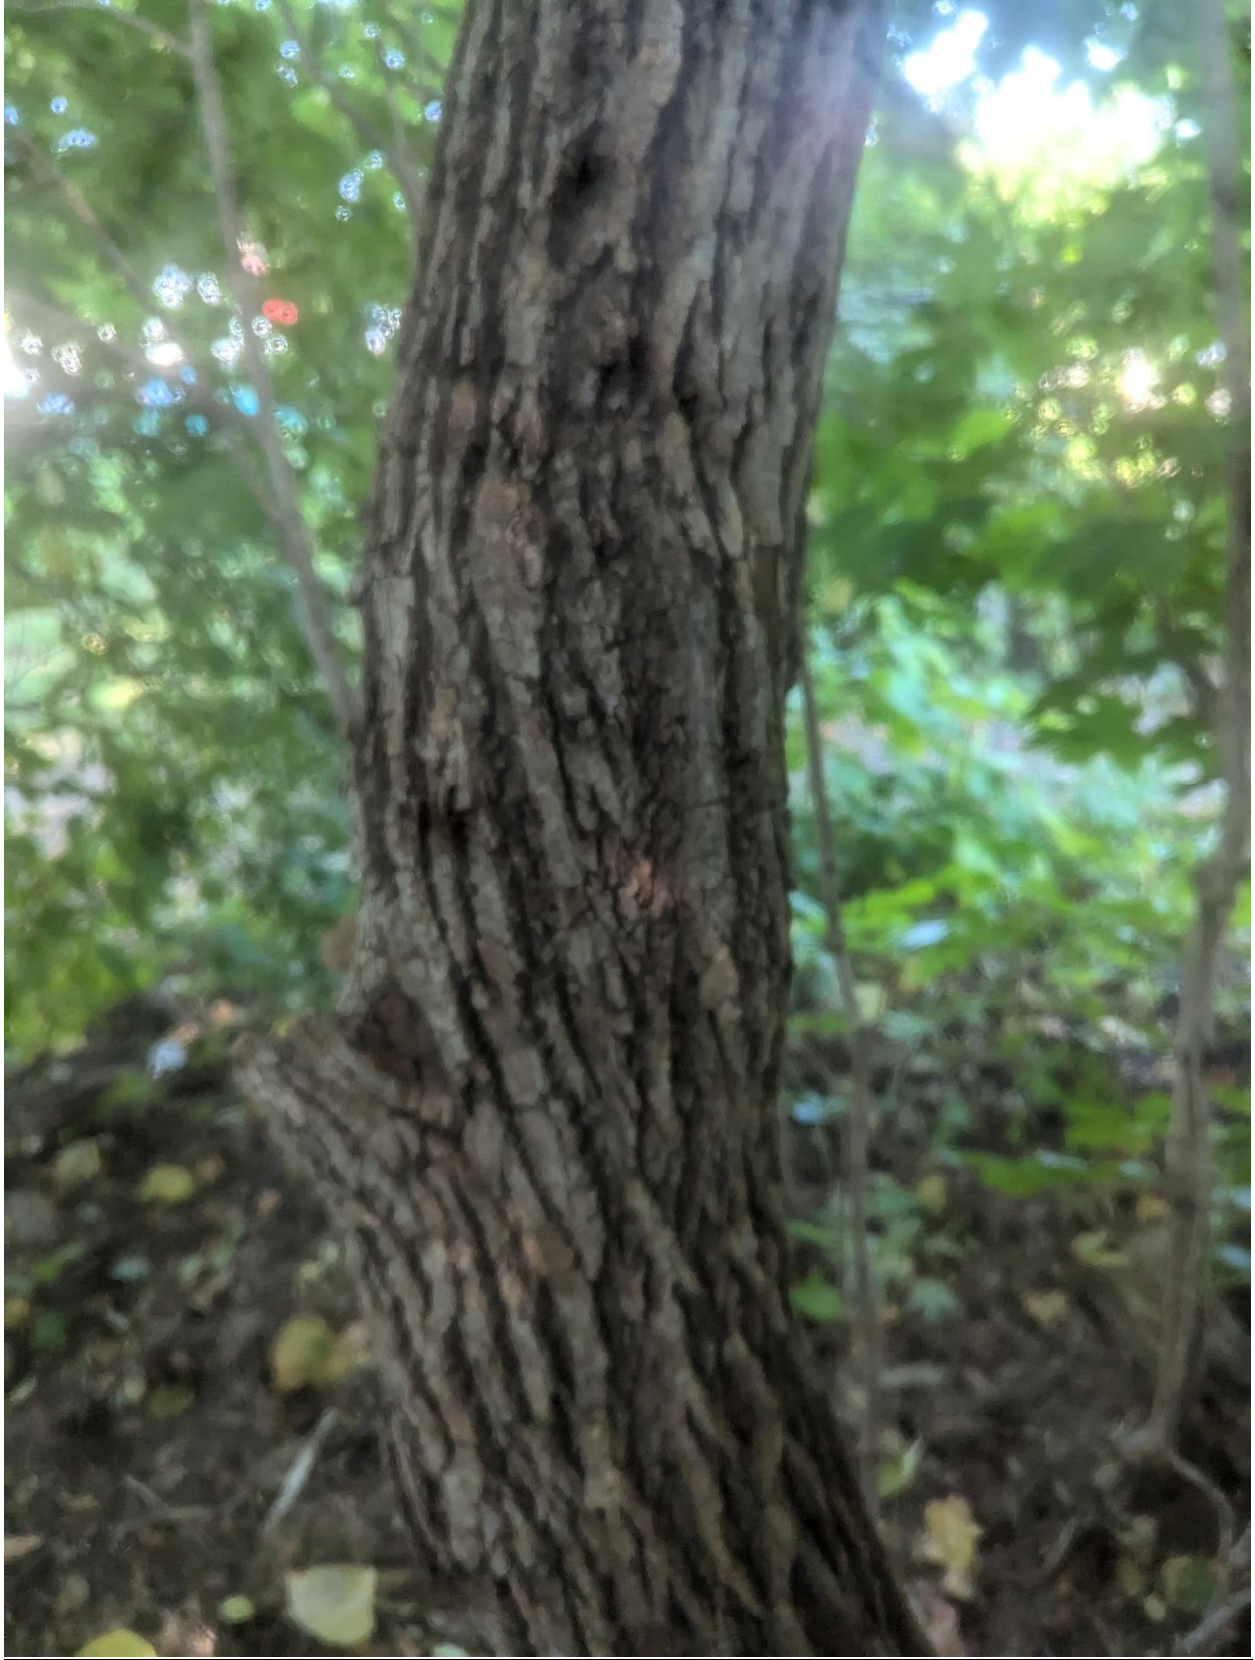
Tree # 14 (Healthy Basswood)

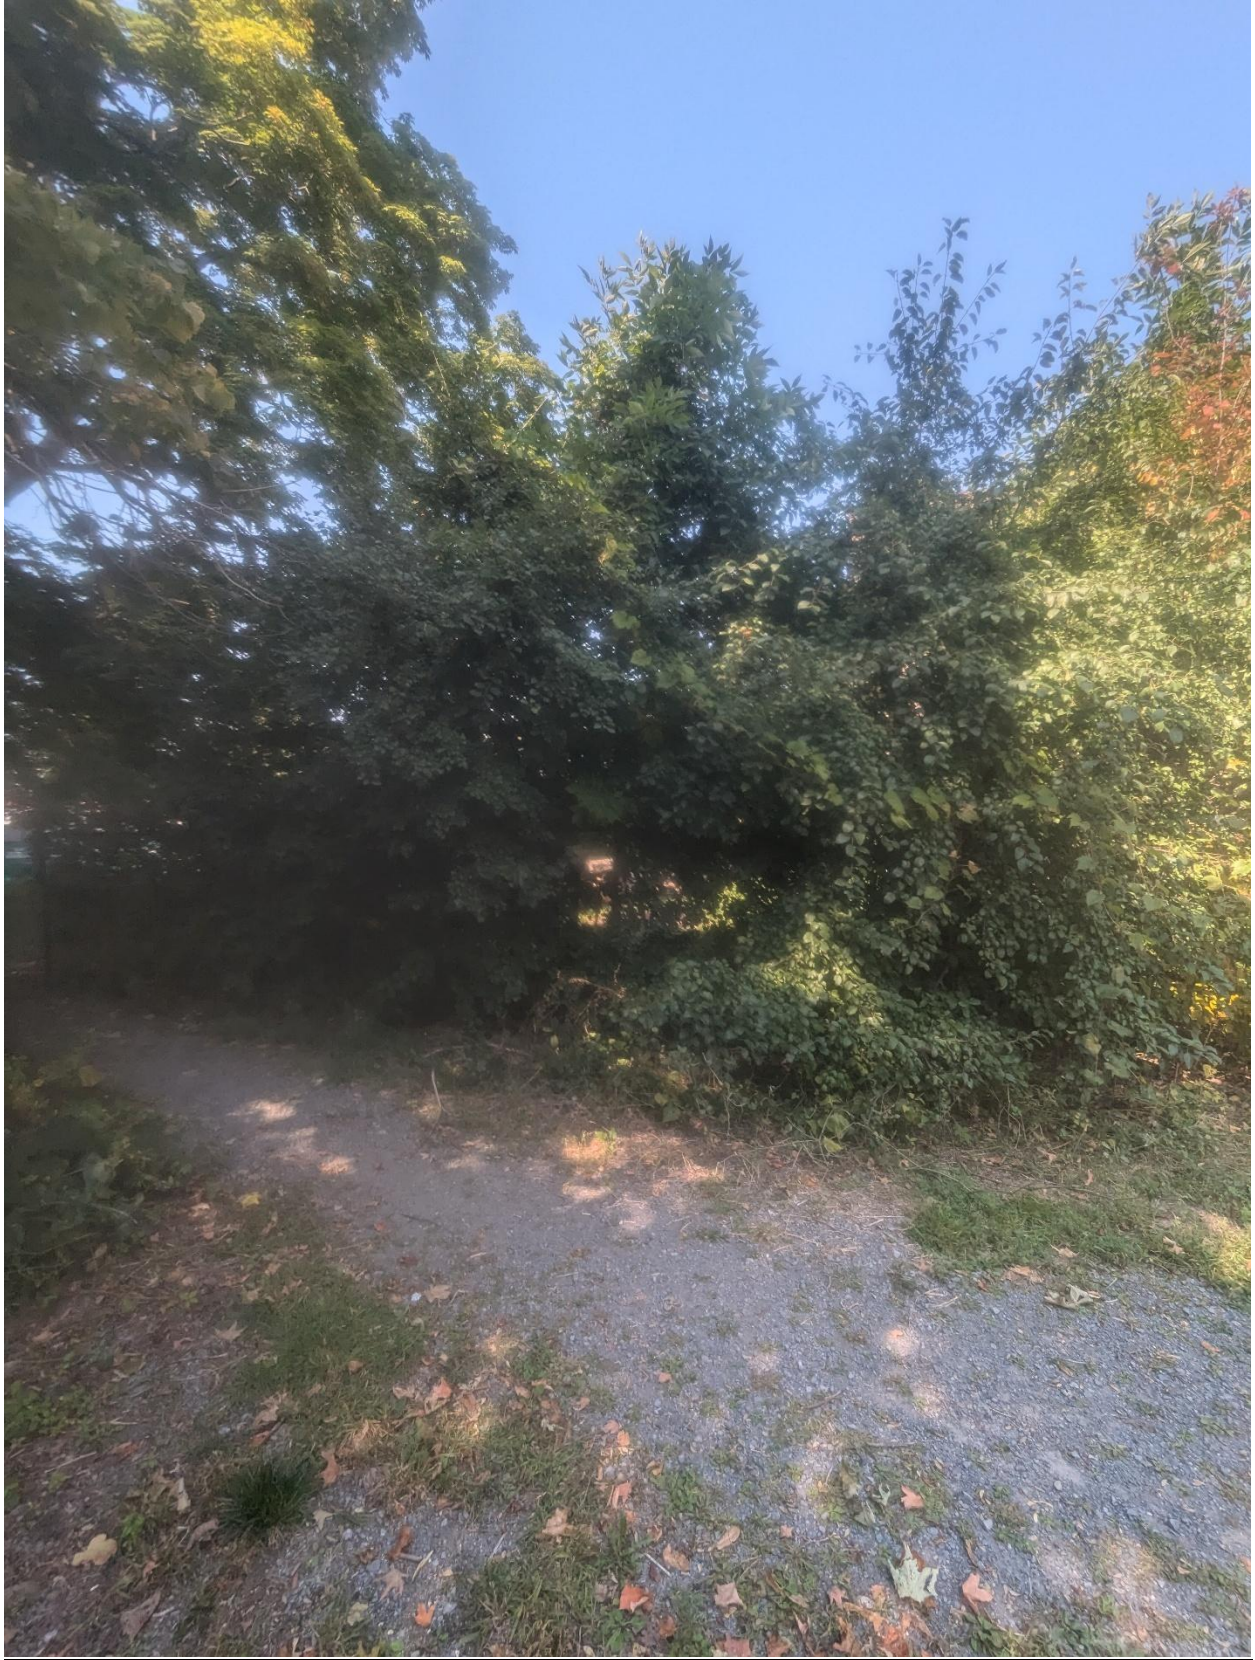
Tree # 15 (Buckthorne shrubs)

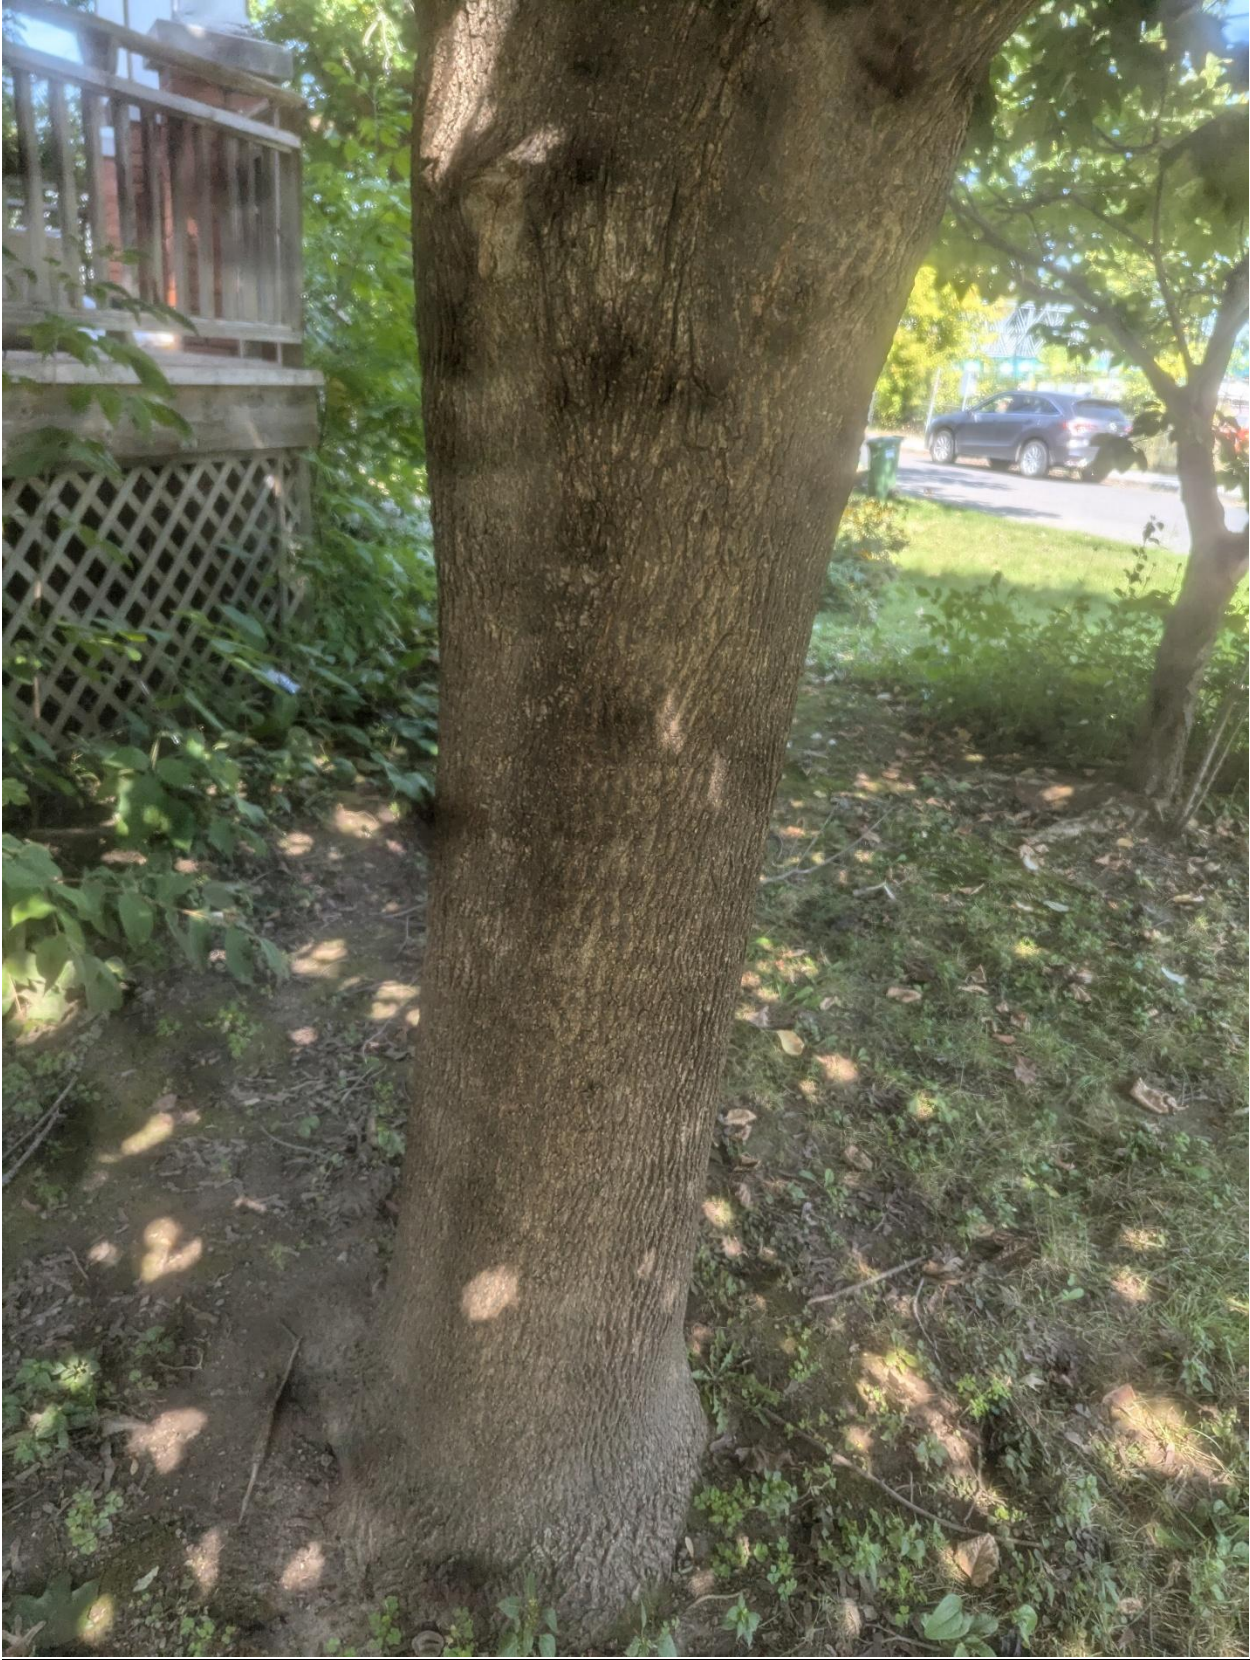
16	Noray Maple (Acer Platanoides) "Crimson King"	35 cm	North neighbors front yard tree.	Healthy, virile, good form, no dieback and no observable signs of decay or disease.	Retain	342 Roosevelt (North Neighbor)

Tree # 16 (Norway Maple, bole of tree)

3. Tree #16 is the neighbors Crimson King Maple tree; much care should be taken to protect this tree's crown and roots. Any activities that require pruning the crown or roots should be discussed with the homeowner before hand and written consent should be taken and signed. A protective barrier (jobsite fence) should be erected between the tree and the jobsite no nearer than 3.5 meters from the bole of the tree

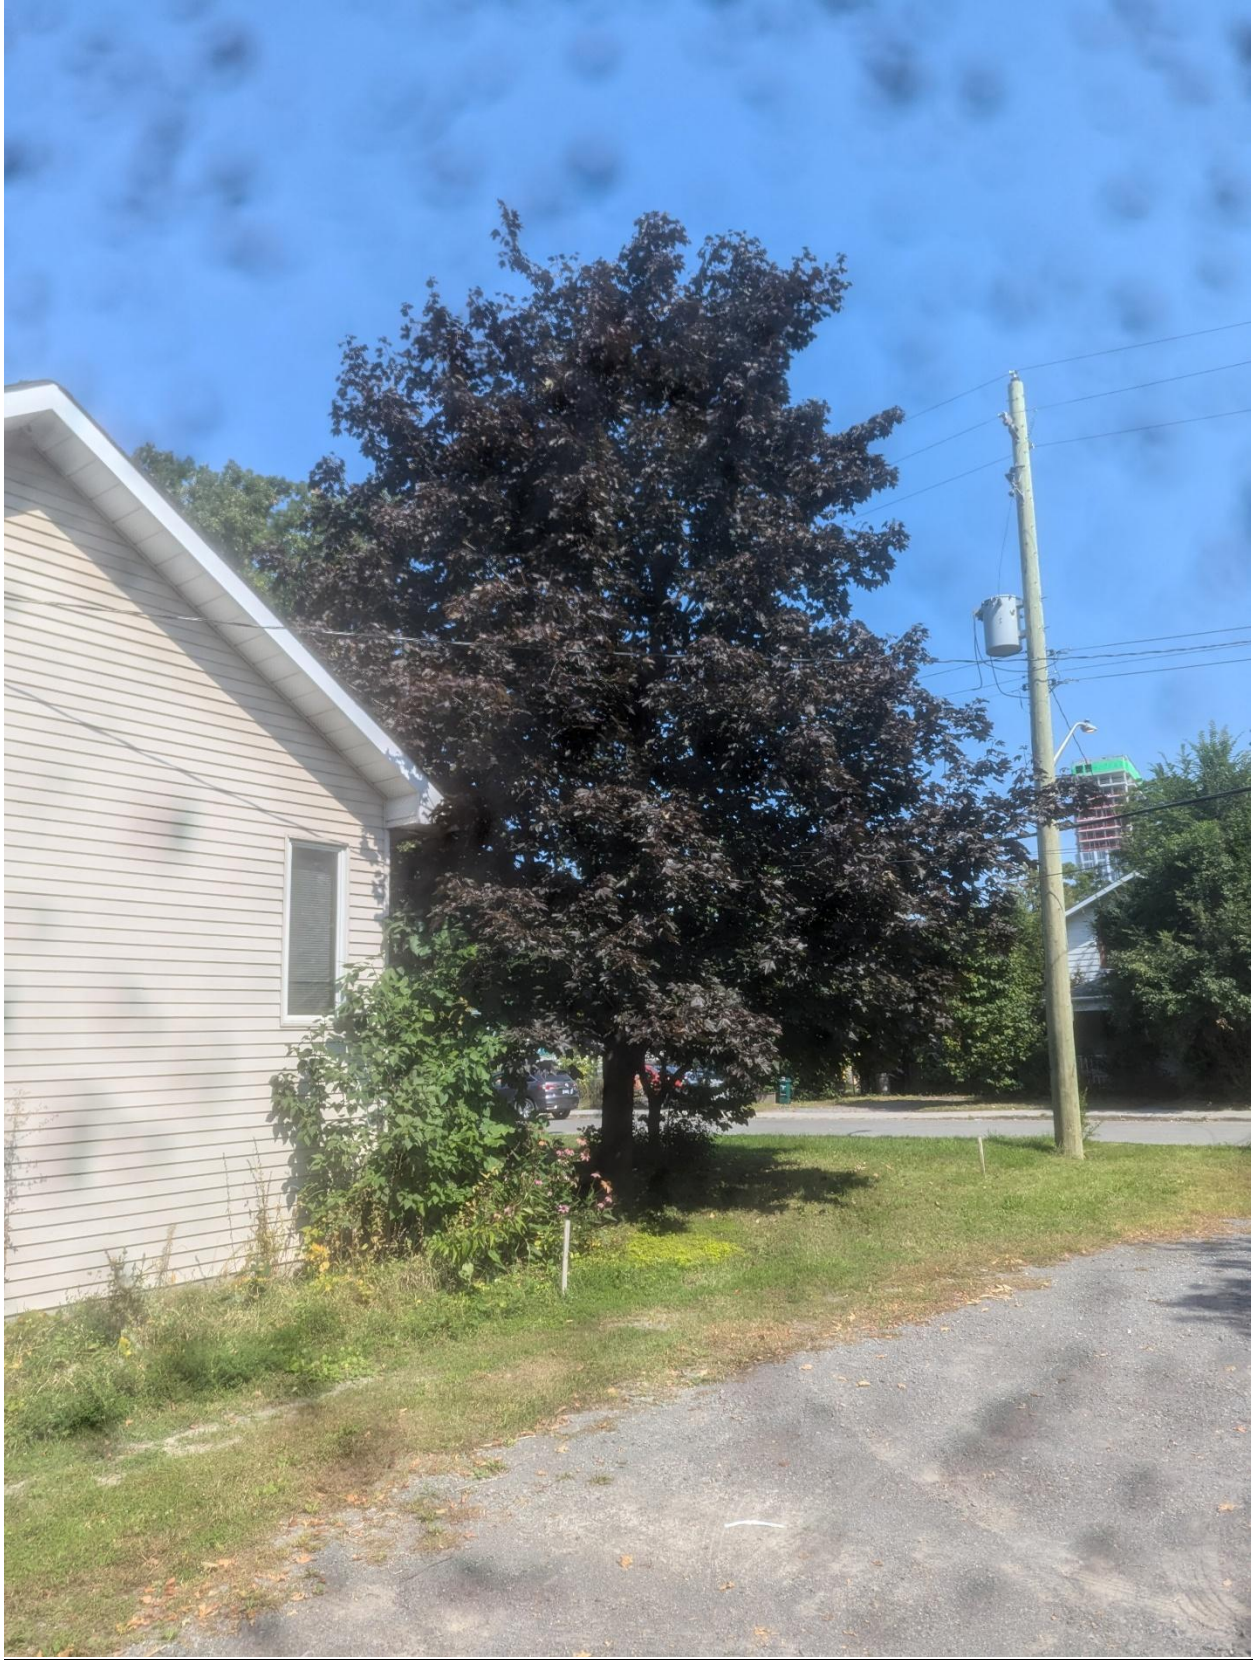
Tree # 16 (Norway Maple, full tree)
