RE: Dickie Moore OHQ- 1547 Lagan Way, Ottawa ON Tree Information Report

PROJECT
DICKIE MOORE OHQ
1457 LAGAN WAY, OTTAWA ON

DRAWING
TREE CONSERVATION REPORT &
LANDSCAPE PLAN

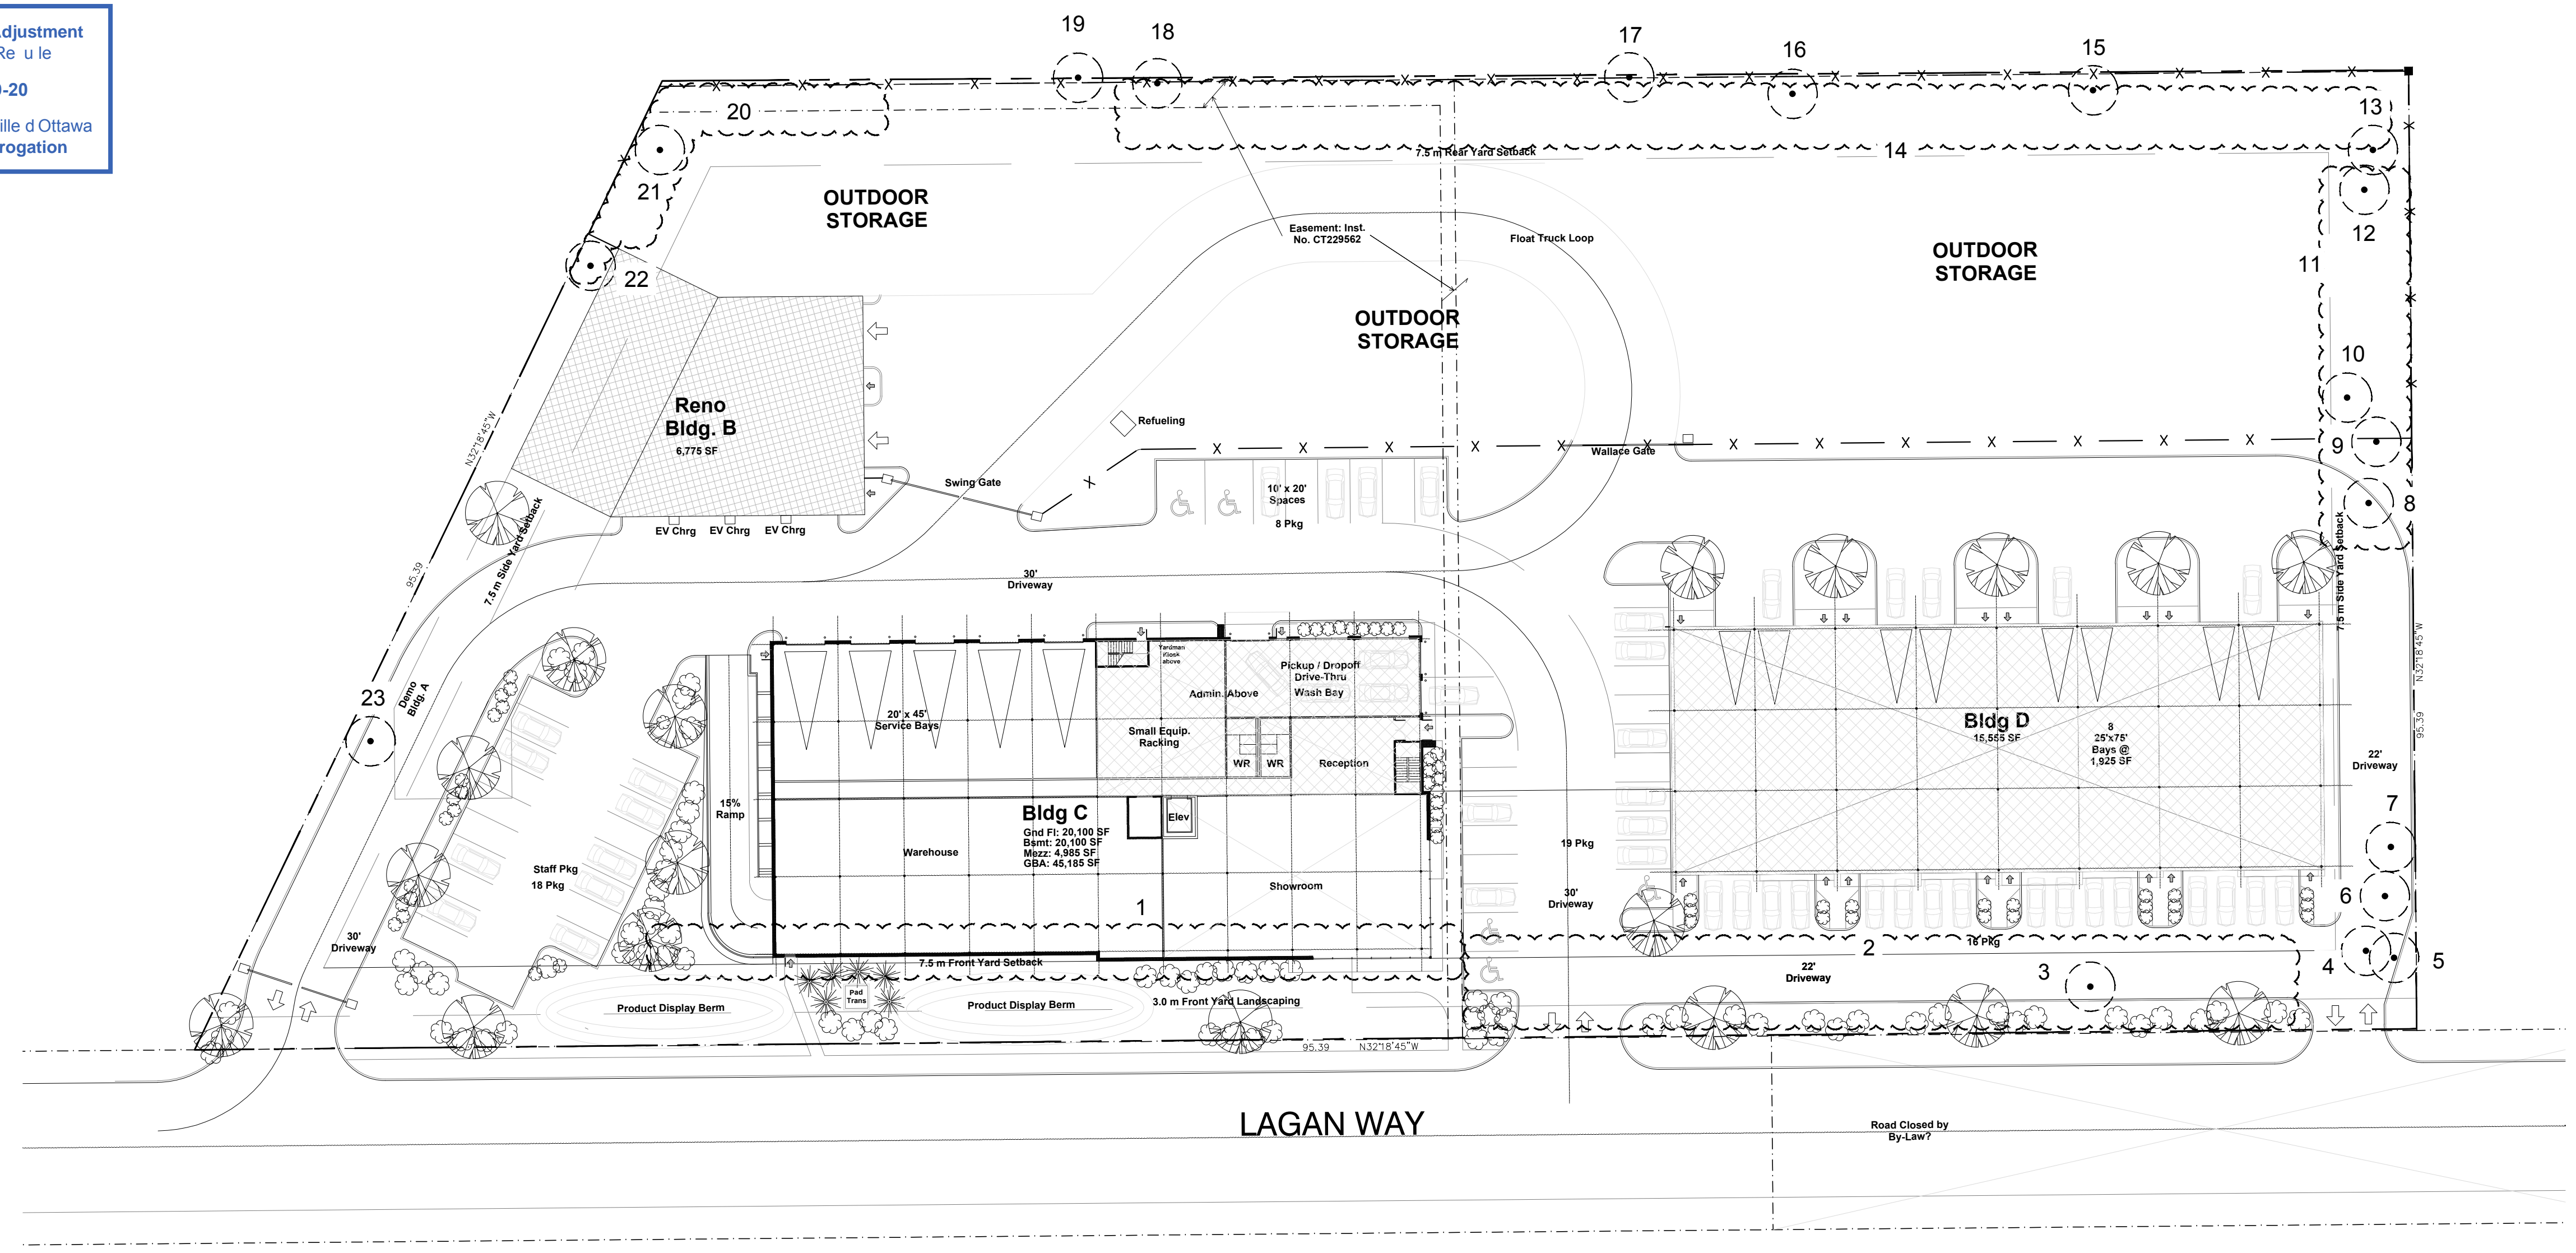
1 TREE INFORMATION REPORT
TIR SCALE 1:400

The vegetation on site is typical of many of the industrial sites within the City of Ottawa. Unmaintained hedgerows have been established in areas along the property boundaries where there is ample soil for volunteer seedlings to grow. We have identified a total of eighteen 18 individual trees as well as five 5 deciduous hedgerows with multiple smaller deciduous trees. Based on the extensiveness of the site development we have concluded that all of the existing trees are to be removed.

While some of the species on site are native to Ottawa, most have invasive characteristics and the potential to be ha rdous in storm events due to their fast growth and weak wood. Our intention is to replace these less desirable potentially ha rdous trees with more desirable large and medium canopy native deciduous trees that will eventually help shade the parking lot and contribute towards achieving the City of Ottawa's tree canopy
