Tree Information Report

Date of Report: August 9, 2024

Property Address: 55 Norway Spruce Street

Prepared by: Kevin Myers, ISA Certified Arborist®; kevin.myers@dendronforestry.ca

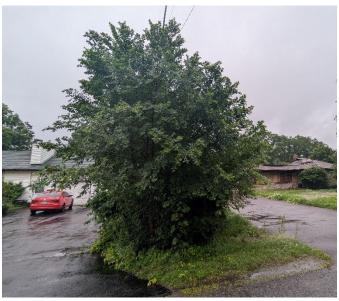
Below: Tree 3 and 4 – private cedars to be retained.

The trees in the rear yard are mostly far enough from construction to not require mitigation or protection. The three protected cedar trees (**Trees 3, 4 and 7**) will experience some increased water availability due to the grade changes around the new house. Cedars are adapted to wet conditions and this change is not expected to adversely impact the trees. They should be protected with fencing as described below and shown in the map during construction.

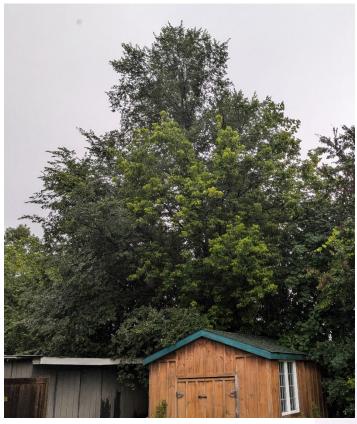
Right: Canopy of Tree 6 – adjacent elm to be retained.

6	Siberian elm (<i>Ulmus</i> pumila)	51, 45	Poor: 65% dieback in canopy – mostly on larger stem; included bark at main union	Retain. No mitigations required; far enough from construction.
7	Eastern white cedar (<i>Thuja</i> occidentalis)	34, 26, 21	Good/Fair: depression and included bark at main union	Retain and protect as per the City of Ottawa Tree Protection Specifications (March 2021).

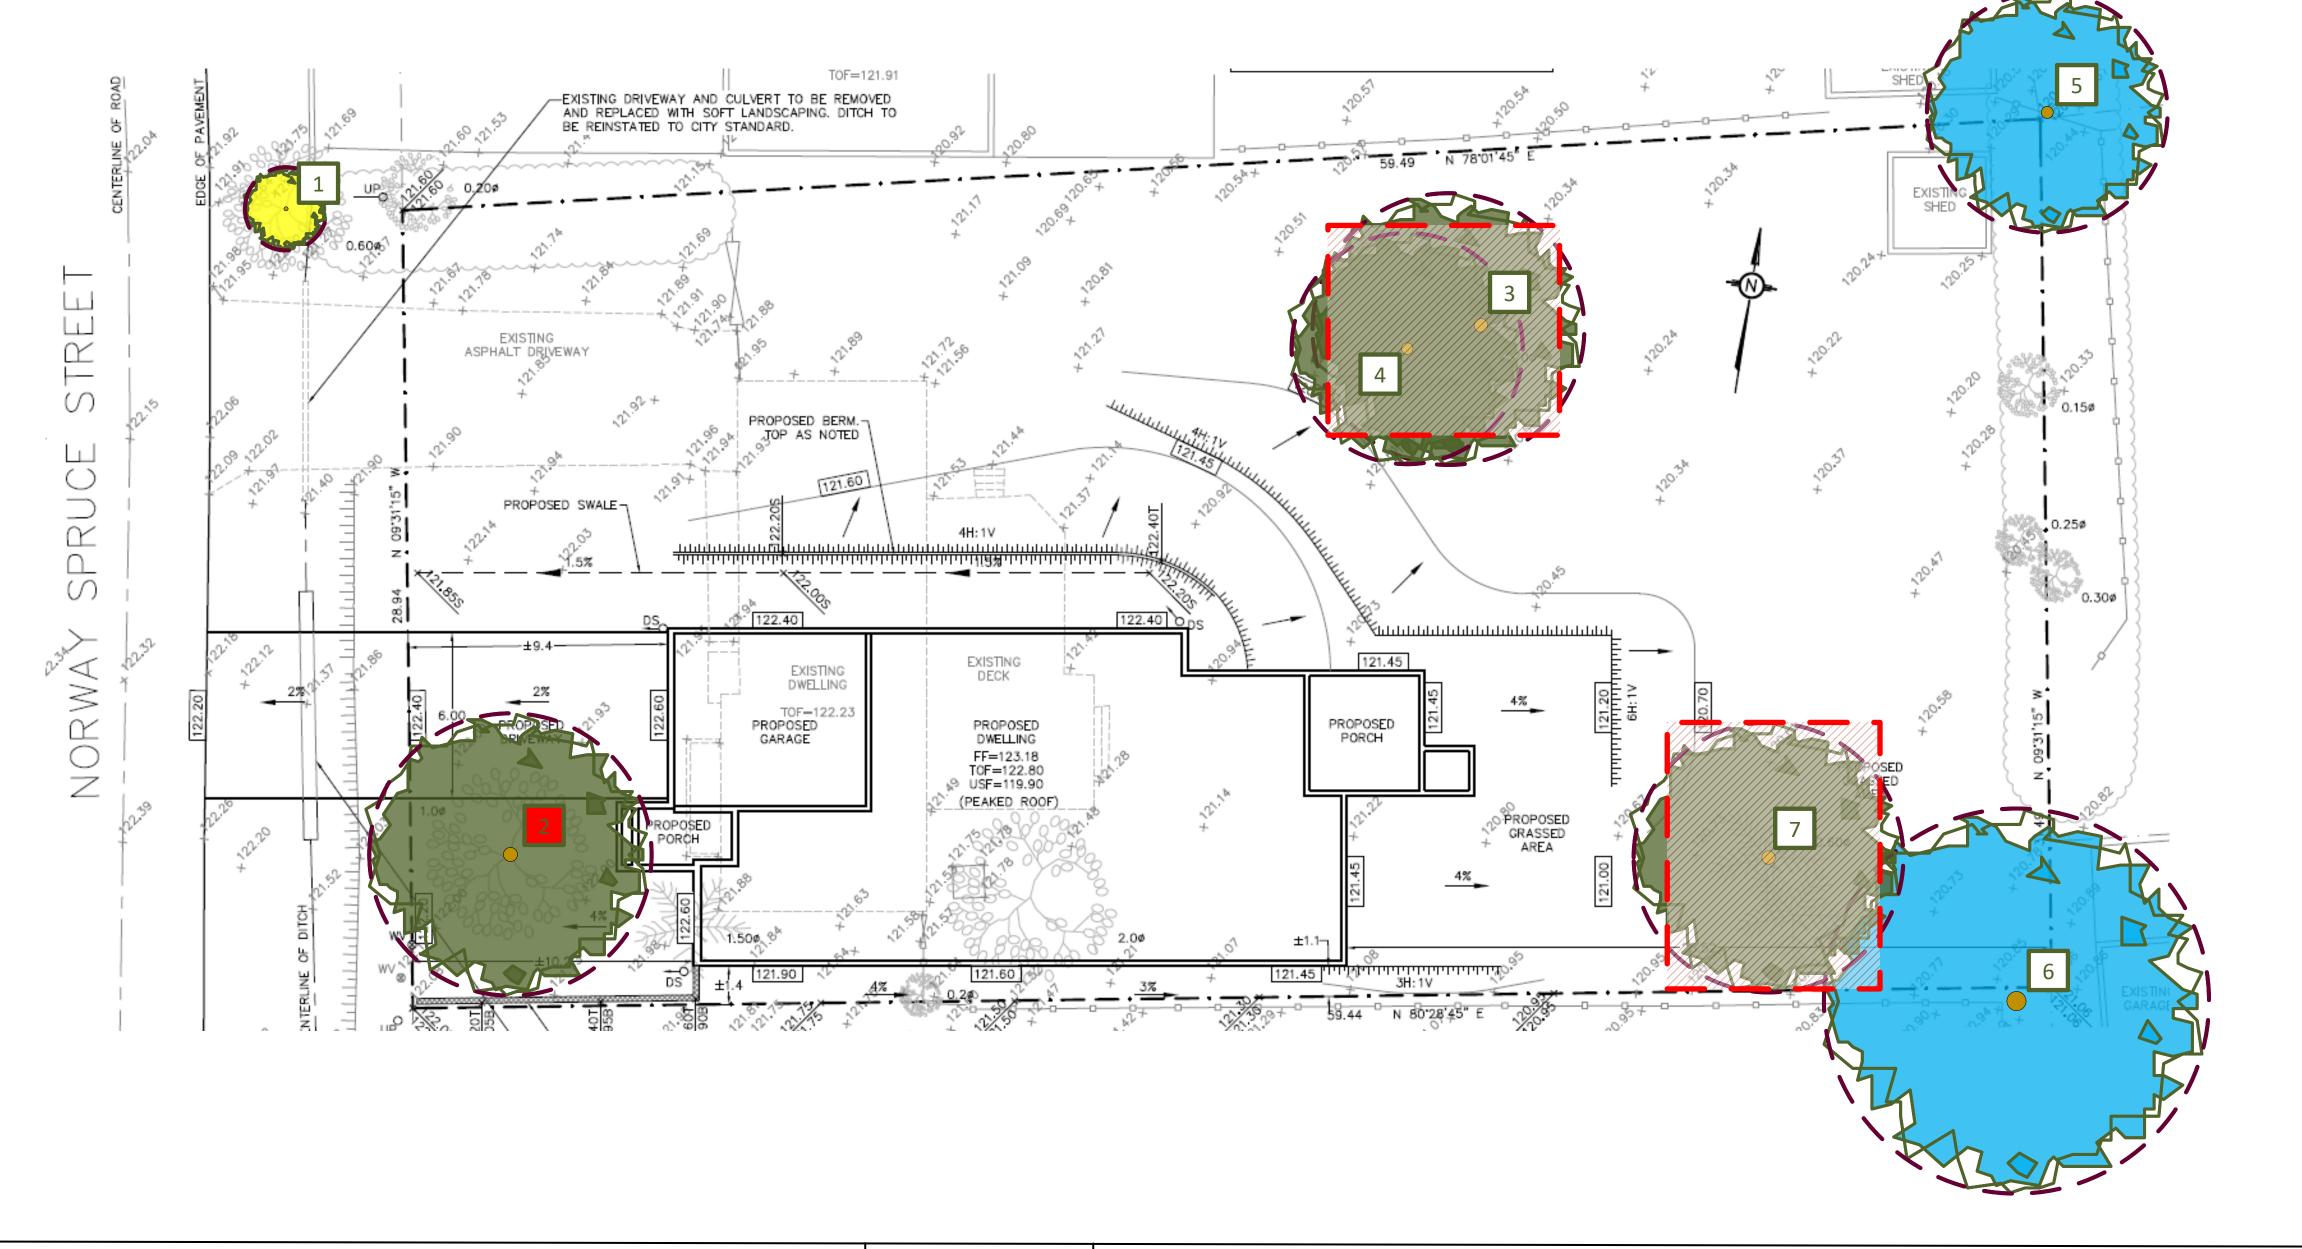
TIR Map – 55 Norway Spruce							
Date	Version	Prepared By					
12/07/2024	Preliminary – not for	KM					
	submission						
09/08/2024	1	KM

Tree 2 is an overmature white birch (*Betula papyrifera*) in declining health – it has cavities and likely decay throughout the canopy. There are grade changes of approximately 15-60cm proposed all around the tree, as well as excavation for the driveway, house and retaining wall. Due to the tree's health status and the impacts of these construction elements, it is recommended this tree be removed.

Tree ¹	Species	DBH (cm)	Tree Condition ³	Forester recommendation
1	Siberian elm (<i>Ulmus</i> pumila)	6 stems <8cm	Good/Fair: growing in ditch; multi-stem – poor form	Retain. No mitigations required; far enough from construction.
2	White birch (<i>Betula</i> papyrifera)	29, 31, 26	Fair/Poor: overmature; several broken branches; cavities in all stems – decay possible	Remove due to health condition and impacts from construction. Tree permit required for removal.
3	Eastern white cedar (<i>Thuja</i> occidentalis)	27, 24, 32	Good: some crossing branches and included bark on 31 and 27cm stems	Retain and protect as per the City of Ottawa Tree Protection Specifications (March 2021).
4	Eastern white cedar (<i>Thuja</i> occidentalis)	27, 31	Good	Retain and protect as per the City of Ottawa Tree Protection Specifications (March 2021).
5	Siberian elm (<i>Ulmus</i> pumila)	42	Good	Retain. No mitigations required; far enough from construction.

Prior to any site works, protective fencing should be installed around the Tree Protection Area as indicated in the attached Tree Information Map and maintained until all construction on site has been completed as per the City of Ottawa Tree Protection Specifications (March 2021).

The tree protection fencing must be 1.2 m in height and constructed of a rigid or framed material (e.g. modulus – steel, plywood hoarding, or snow fence on a 2"X4" wood frame) with posts 2.4 m apart such that the fence location cannot be altered. All supports must be placed outside of the CRZ and installation must minimize damage to existing roots.
