## Tree Information Report

Submitted as part of Committee of Adjustment Application to the City of Ottawa

**Date of Report:** January 21, 2025  
**Property Address:** 2544 Gravelle Crescent  
**Prepared for:** Chris Milburn, c/o Alison Clarke; [alison@tsgdi.ca](mailto:alison@tsgdi.ca)  
**Prepared by:** Kevin Myers, ISA Certified Arborist®; [kevin.myers@dendronforestry.ca](mailto:kevin.myers@dendronforestry.ca)  
**Date of Site Visit:** January 3, 2025

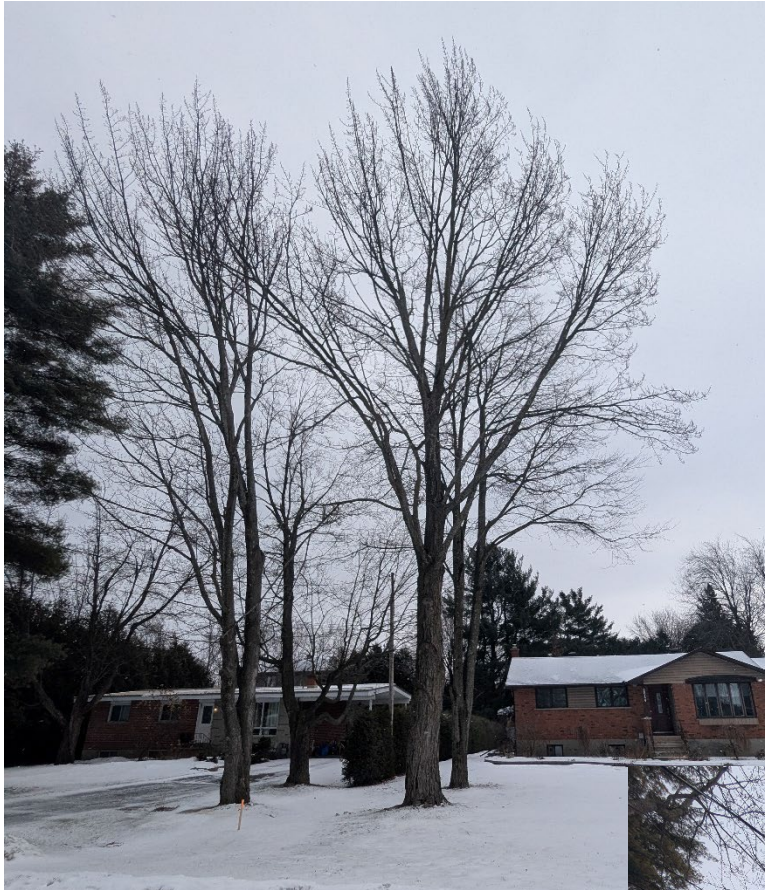
*Trees 2-5 - private red maples.*

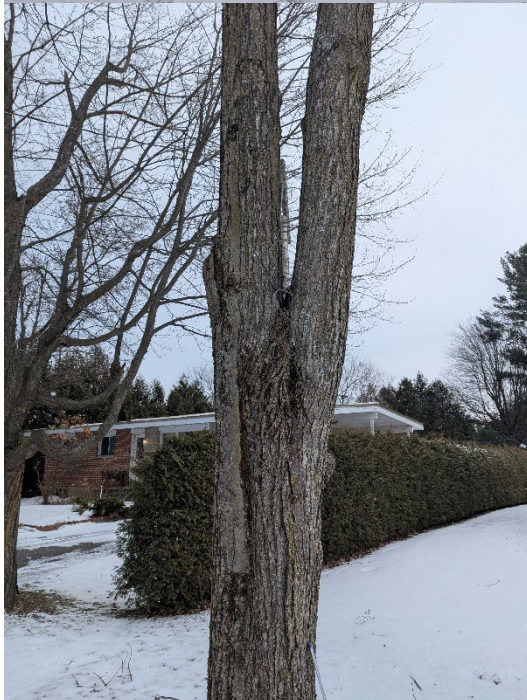
Excavation is expected to come to approximately 1m from the trunk of **Tree 4**. Effects of this excavation on the tree’s stability are expected to be lessened due to the fact that it will be a corner cut out of the CRZ and not straight across the tree’s trunk; the tree is also upright and well balanced, further reducing concerns around stability. Approximately 15% of the tree’s CRZ is expected to be removed.

4	Red maple ( <i>Acer rubrum</i> )	59	Adjacent – 2548 Gravelle	Fair/Poor: pruned around wires – poor structure; canker in canopy	Front stairs: 1	Retain	Retain. Roots encountered during excavation for the front stairs are to be cleanly severed by hand.
5	Red maple ( <i>Acer rubrum</i> )	68	Boundary – 2548 Gravelle	Fair: asymmetrical crown to the north; trunk is two large stems that have grown together – included bark and weak union very likely	6	Retain	Retain and protect as per the City of Ottawa Tree Protection Specifications (March 2021).
6	White pine ( <i>Pinus strobus</i> )	75 (estimate)	Boundary – 2548 Gravelle	Good: some smaller broken branches; crown is slightly asymmetrical to the west	Garbage area: 2.75	Retain	Retain and protect. Any roots encountered during installation of the rear yard garbage and bike storage area are to be cleanly severed by hand.

*Tree 4 - adjacent red maple to be retained.*

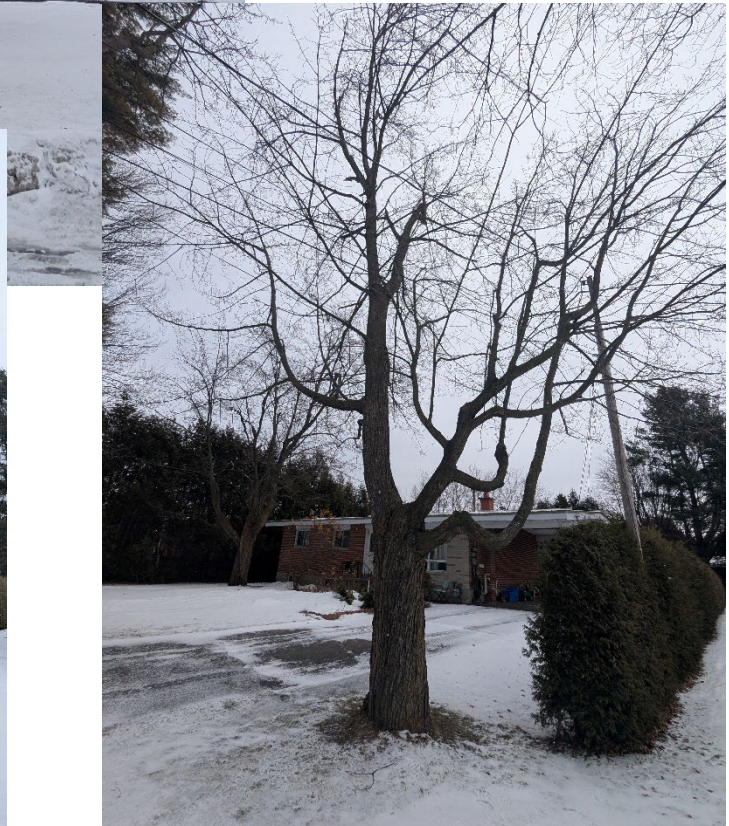
*Main union of Tree 3.*

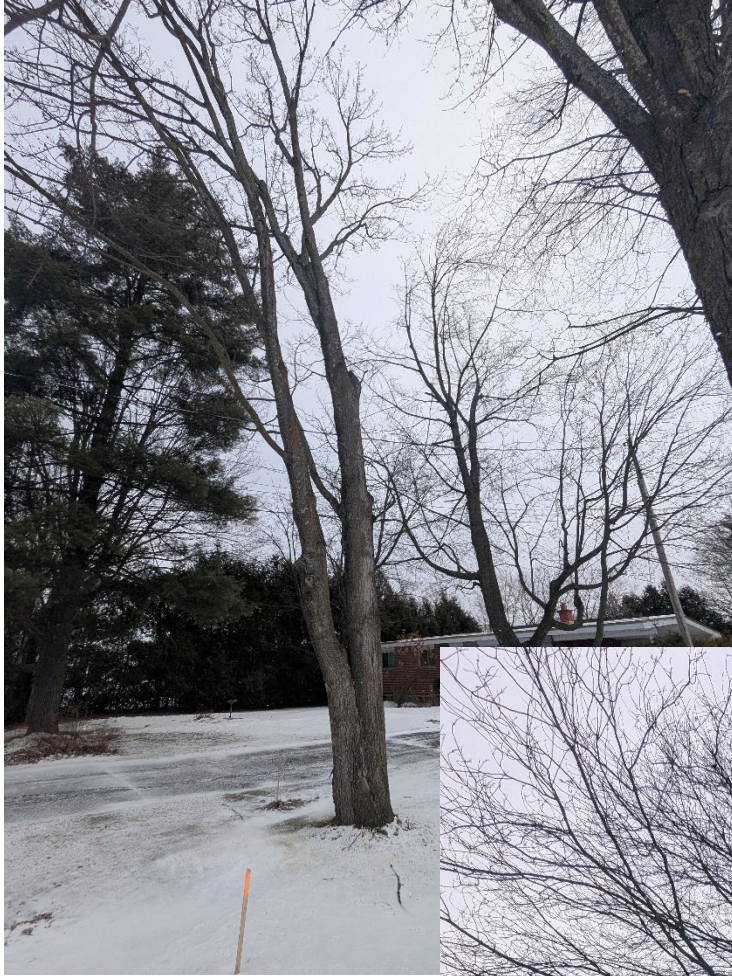
*Tree 5 - adjacent maple to be retained.*

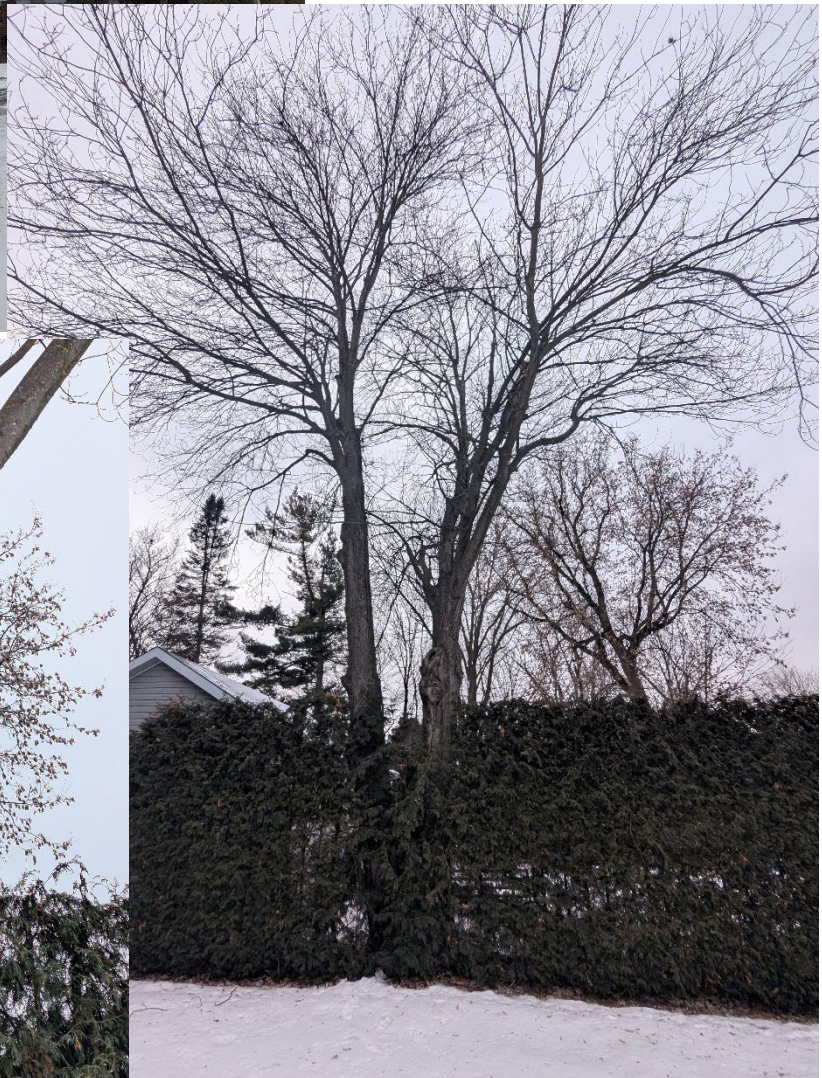
**Tree 7** is a red maple on the boundary between the subject site and the property to the west. There are two stems that split at approximately 0.8m from the ground – the 60cm stem leans over the adjacent rear yard, and the 55cm stem leans along the property line. The 60cm stem has cavities and evidence of decay at its 1<sup>st</sup> union. The 55cm stem appears to be in good condition. Excavation is expected to come to approximately 2m from the base of the tree – this is 2.5x the aggregated diameter of the tree (81cm). While this may be closer than desired, impacts of excavation are expected to be mitigated by the remaining rooting space on the subject and adjacent property – stabilizing roots can remain intact along the property line and in the adjacent rear yard. Approximately 20% of the CRZ is expected to be removed based on the attached map. To help further mitigate the impacts, roots are to be revealed along the line of excavation for the rear stairs and cleanly severed by hand by a certified arborist.

7	Red maple ( <i>Acer rubrum</i> )	55, 60	Boundary – 2536 Gravelle	Fair/Poor: 60cm stem is in poor condition, with large cavities and decay @4m, dying branches; poor main union – wound and included bark; both stems have moderate leans	Rear stairs: 2	Retain	Retain. Roots along the line of excavation are to be revealed and cleanly severed by hand by a certified arborist prior to using a machine.
---	----------------------------------	--------	--------------------------------	---	----------------	--------	---

*Tree 7 - boundary maple to be retained.*

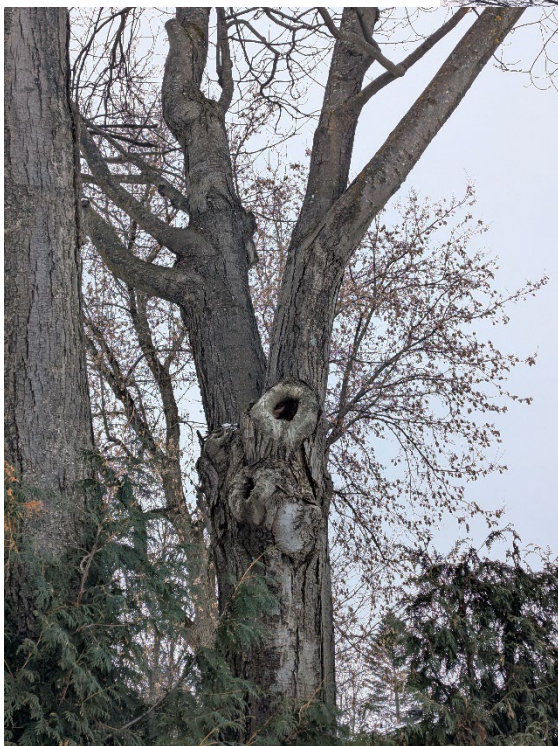
*1st union of the 60cm stem of Tree 7*
