Tree Information Report

Submitted as part of Committee of Adjustment Application to the City of Ottawacejved | Recule

November 8, 2024 2025-05-23

Property Address: 673 Tweedsmuir Avenue

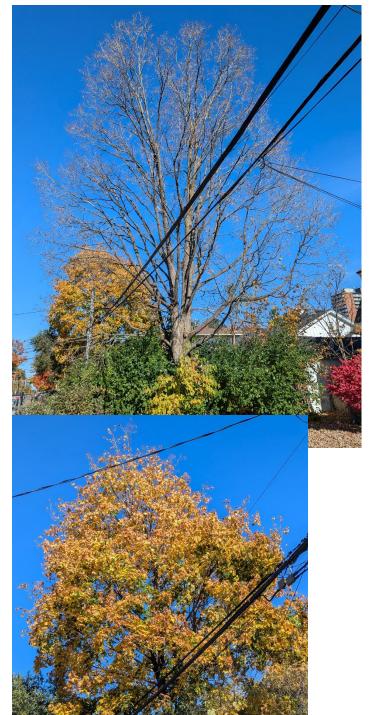
Left: Tree 1 - adjacent maple to be retained.

Below left: canopy of Tree 2 - private maple to be retained.

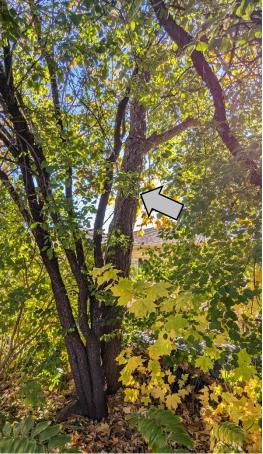
Tree 4 is an established elm (*Ulmus americana*) that likely self-seeded on the property line; it has grown with a large bend in its stem to find light from underneath the large, mature buckthorn shrub. Excavation is expected to come approximately 2m from the trunk on two sides, which is 5.4x the DBH. This is within the limits for best practices, and while the trunk has a bend, the tree appears mostly balanced as the canopy has compensated for the bend and sits mostly over the base of the tree – this likely reduces the risk associated with cutting roots. To mitigate damage to the roots, any roots that are discovered are to be cleanly severed by hand and covered with a moist organic material to prevent the wounds from drying out.

Below right: Stem of Tree 4 - boundary tree to be...

4	American elm (<i>Ulmus americana</i>)	37	Fair: curved growth out from under a large, established buckthorn shrub	Retain. Roots discovered during excavation are to be cleanly severed by hand and then covered with a moist organic material to prevent the wounds from drying out.
5 ⁴	Sugar maple (Acer saccharum)	45 (estimate)	Fair/Good: small cavity in stem; asymmetrical crown	Retain. Any roots discovered during excavation are to be cleanly severed by hand.
64	Sugar maple (Acer saccharum)	60 (estimate)	Good	Retain. Any roots discovered during excavation are to be cleanly severed by hand.
