Tree Conservation Report 424 Churchill Avenue North Ottawa, Ontario

Prepared for GSI Properties

By Arcadis IBI Group

August 12, 2024

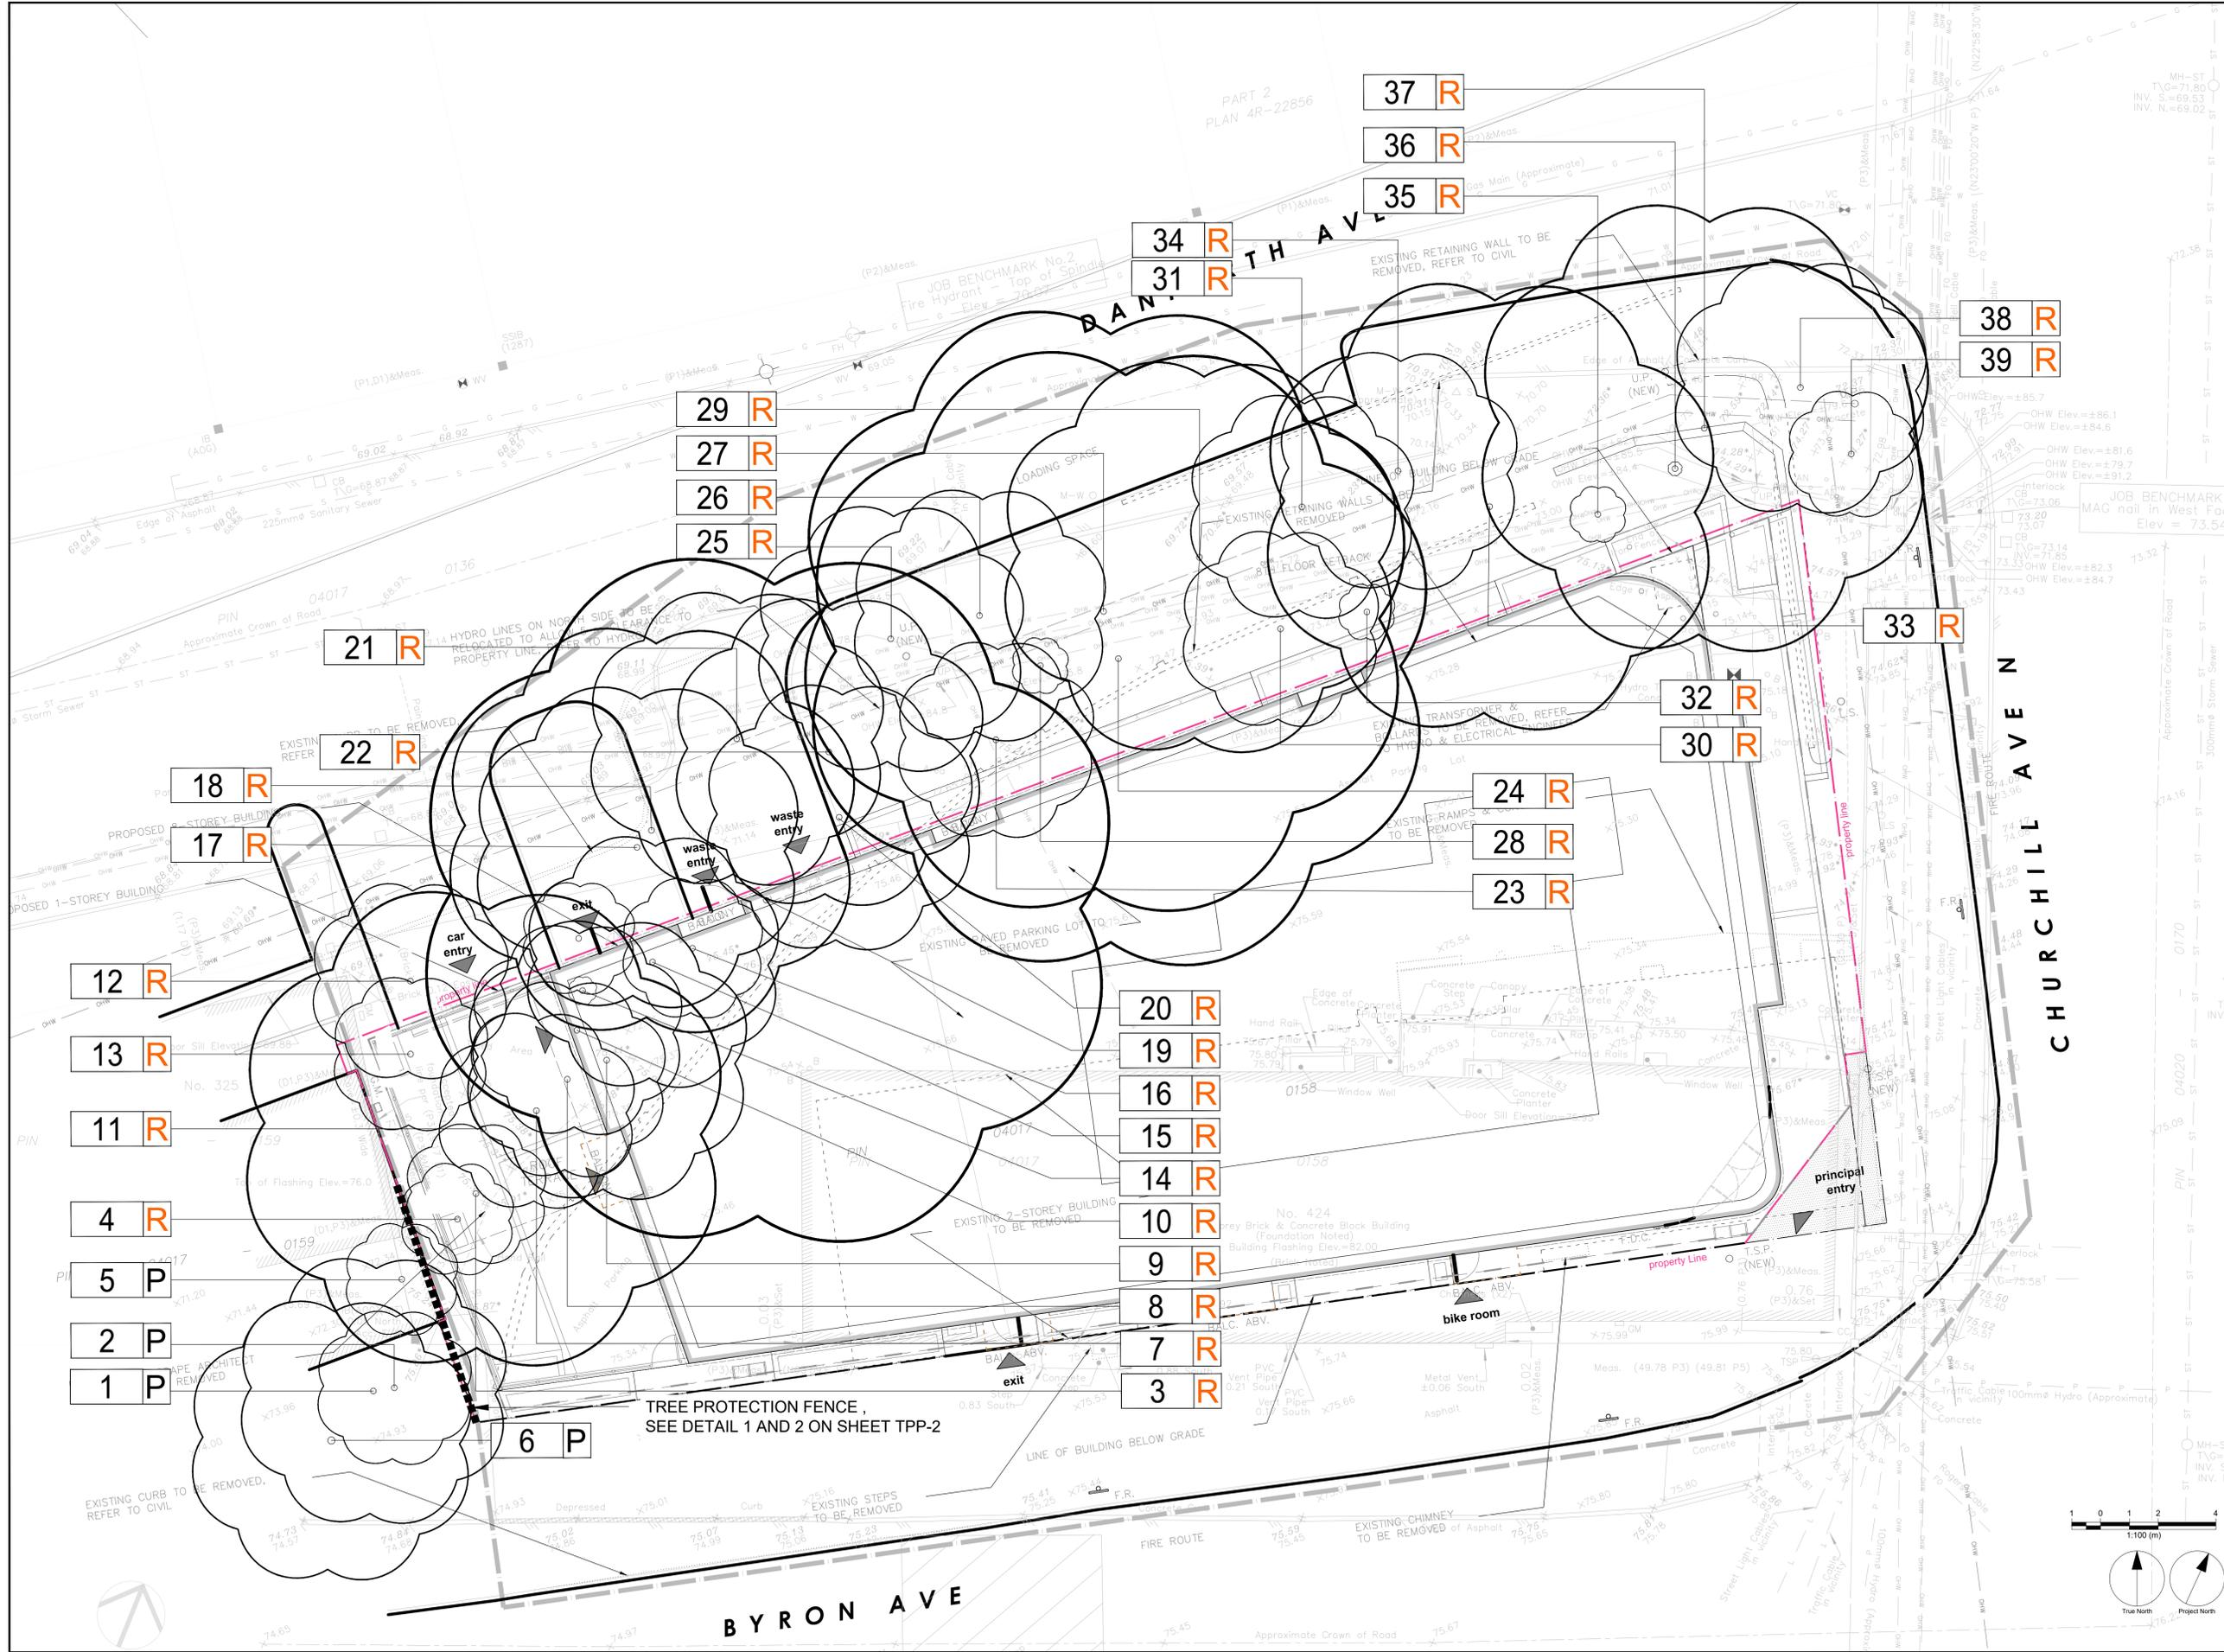
SHEET NUMBER **ISSUE**
 TPP-1 **3**

Based on the layout of the subject property, location of the trees, and necessary site work to facilitate the construction onsite, there will be no trees preserved or protected on the subject site. Tree 1, Tree 2, Tree 5, and Tree 6 will be preserved and protected on the adjacent property. Tree preservation fencing will be erected at the property limit to protect these trees during construction.

There are thirty-four (34) trees that will need to be removed to facilitate the construction of the proposed building and development. There is one (1) dead tree within property that will also be removed within the proposed building area.

Tree Protection Fencing (TPF) is to be installed on site along the western property line to protect four (4) trees on the adjacent property (Appendix A). The limits of TPF have been indicated on the Tree Conservation Plan sheet TPP-1 and shall be considered to delineate the limits of work. All TPF shall conform to the City of Ottawa's current standards and Tree Protection Specification as shown on Detail 1-TPP2.
