# **Tree Information Report v2.0**

### Submitted as part of Committee of Adjustment Application to the City of Ottawa

Address: 11 St. Claire Ave.

Date of Report: July 8, 2025

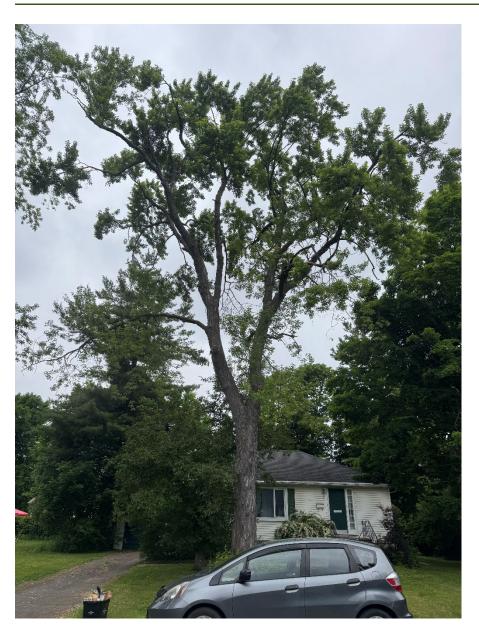
**Tree 1** is a city owned silver maple that is likely in decline. Google street view shows that this tree has been losing much of its canopy over the last 10 years, possibly from storm damage – details of the pruning history of this tree should be available within the city of Ottawa forestry services database. Although it has been identified for retention, it will undergo significant stress from the construction at this site, and once the engineering plans have been prepared, retention should be revisited with the forestry inspector. It may be that removal and replacement would be a more suitable option to ensure canopy growth over the long term. The proposed new driveway is approximately 2.1 m from tree which will result in approximately 25% of root loss, and excavation for the new home will be approximately 6 m.

Figure 1: tree 1, city owned silver maple showing some dieback

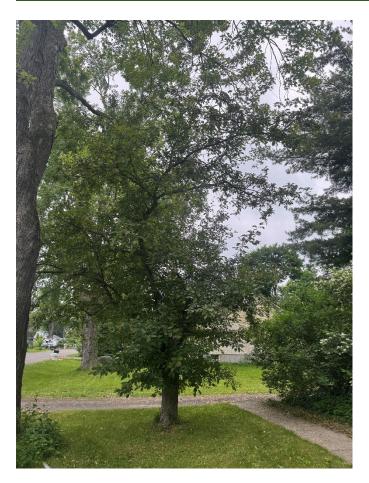
**Tree 2** is a crab apple that is in poor condition and is not suitably located relative to the new building. Removal and replacement are recommended for this tree.

Figure 2: tree 2, crabapple to be removed

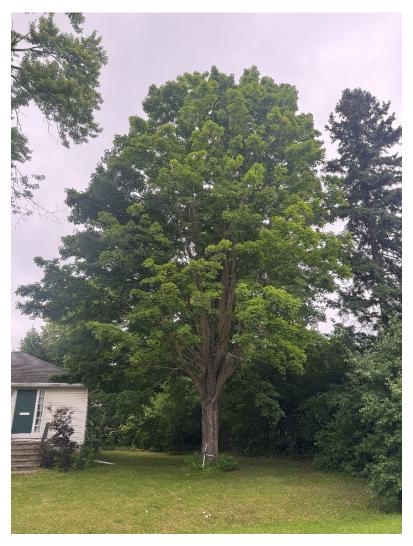
**Tree 3** is a large sugar maple. Approximately 40-45% of the roots and crown would be impacted by the proposed development. If retention of this tree were a target for this site, the unit would need to be shifted back approximately 4 m for it to be effective which would impact **trees 7,8, 12 and 13**.

Figure 3: Tree 3, sugar maple to be removed

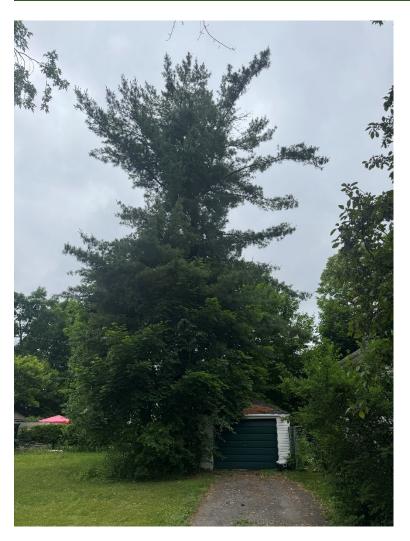
Figure 4: Tree 9, white pine to be removed

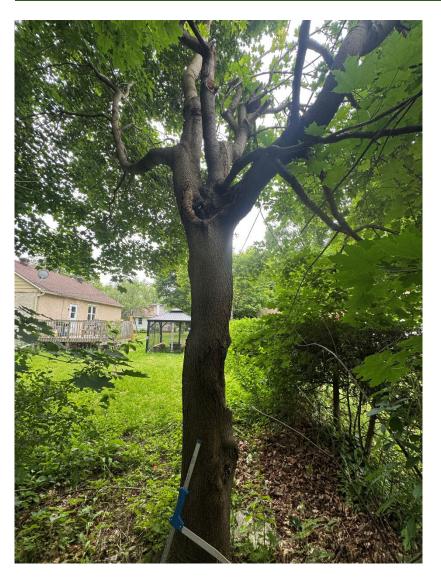
Figure 5: Tree 11, Norway maple to be removed

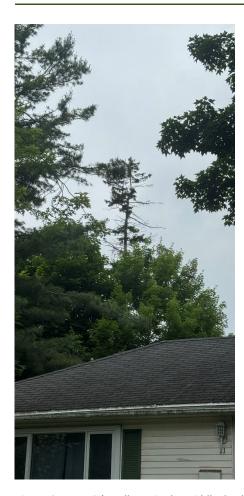
Figure 6: Tree 10 (small tree in the middle, back), Colorado spruce to be removed
