Tree Information Report v3.0

Date of Report: July 13, 2025

Property Address: 15 Deerfox Drive

Prepared by: Kevin Myers, ISA Certified Arborist®; kevin.myers@dendronforestry.ca, updated by Astrid Nielsen

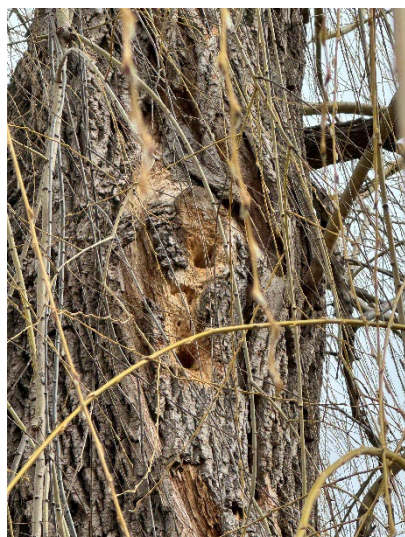
Tree 22 is a large weeping willow nearing its pinnacle of expected growth. A large portion of the root system was likely disturbed by construction on Ryland street – specifically the rear yard of 138: it appears the grade has been raised beyond the recommended 10cm, and it is possible some roots were cut during construction. The pathway and stairs have been moved as far from this tree as possible to reduce impact, and the services should also be located under or beside the walkway. The health of this tree should be monitored by city staff as it is showing signs of decline.

| 22 | Willow (<i>Salix spp.</i>) | 119 | City | Fair: large cavity at base – approx. 1/3 diameter deep; decay and woodpecker activity on trunk (small area); large branches pruned off – epicormic shoots at wounds and on trunk | House: 4 Porch: 3 Walkway: < 1 | Retain | Retain as per City of Ottawa recommendation. Roots to be revealed along the line of excavation and cleanly severed by hand prior to excavation with heavy equipment |

Above: Tree 22 - City willow to be retained.

Below left: decay and woodpecker activity in the trunk of Tree 22.

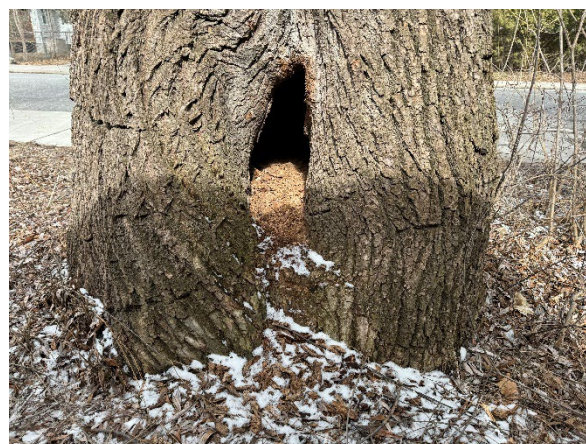
Below right: cavity at the base of Tree 22.
