Tree Information Report

Submitted as part of Committee of Adjustment Application to the City of Ottawa

Address: 447 Daly Ave

Date of Report: July 24, 2025

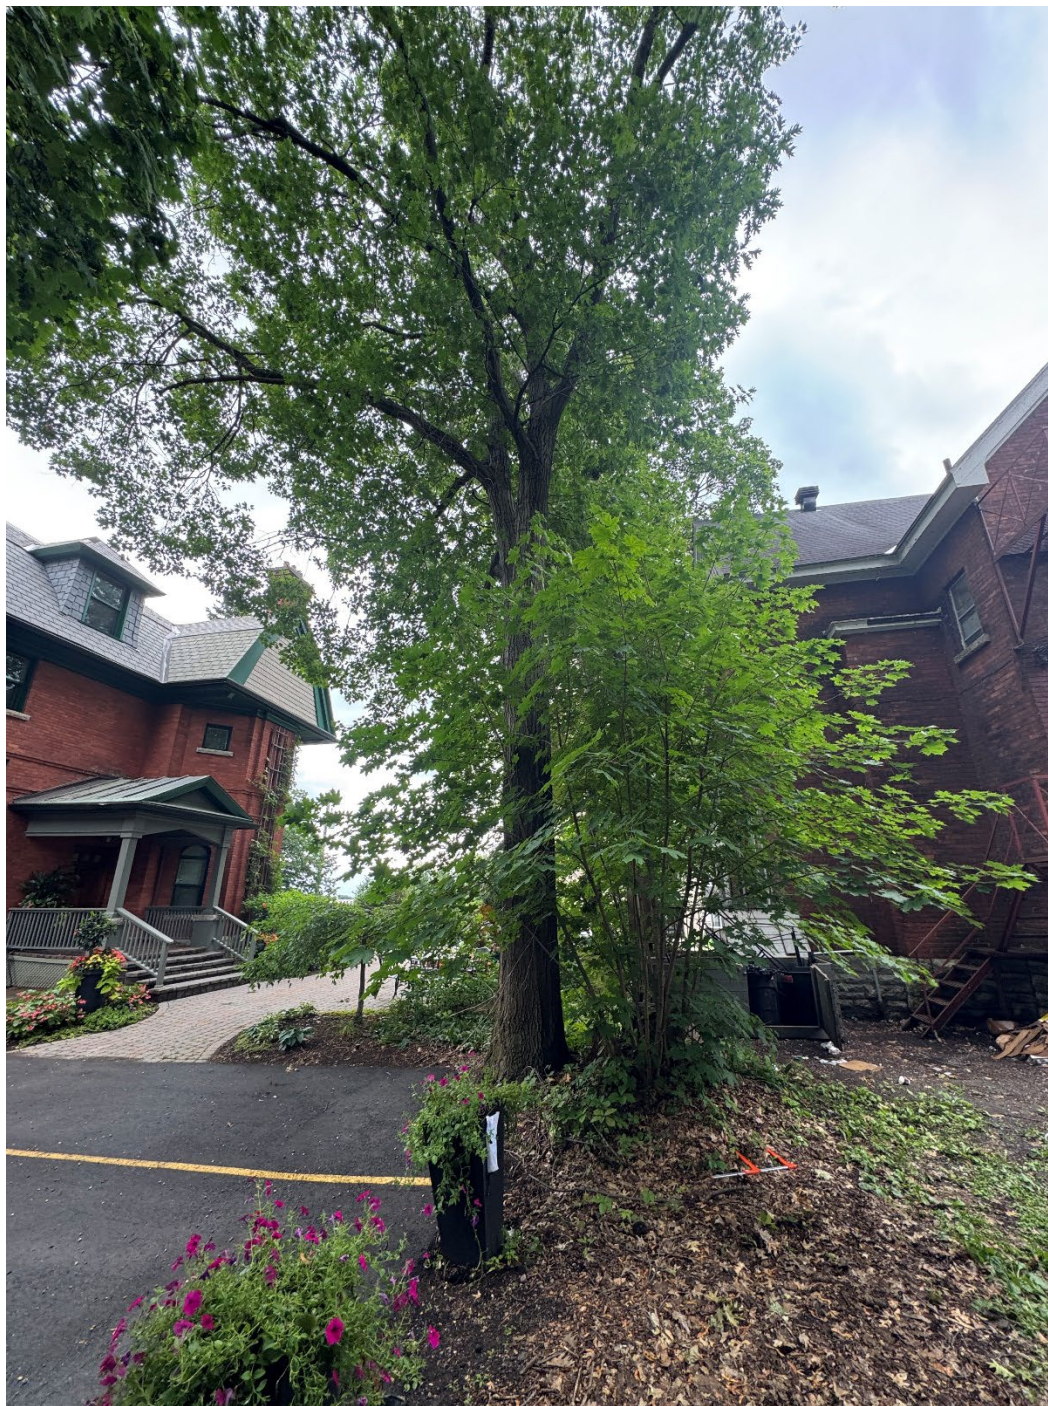
Figure 1: Tree 1, red oak on adjacent property

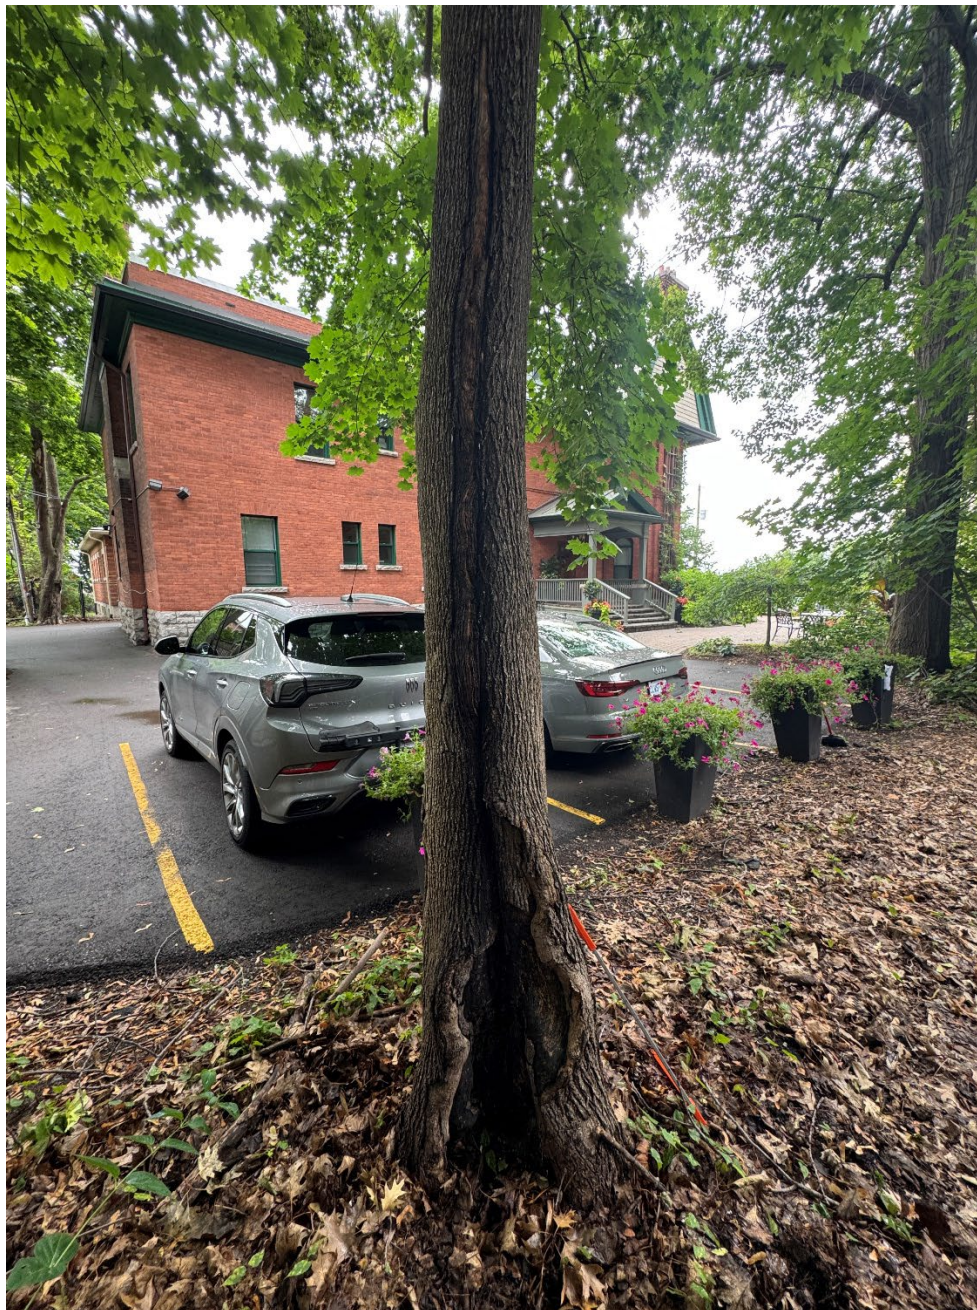
Figure 2: base of tree 2, note large wound on the upper side of the lean

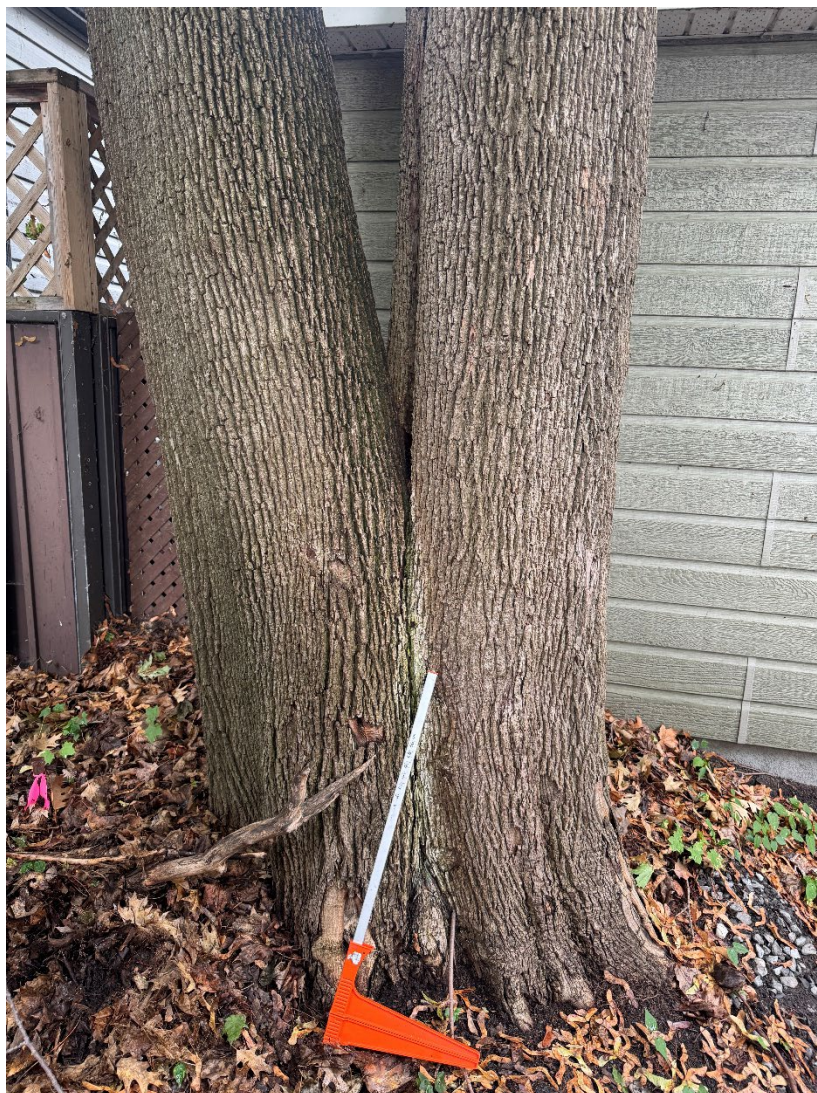
Figure 3: Tree 4, Norway maple on adjacent property, poor union at base with included back and some separation

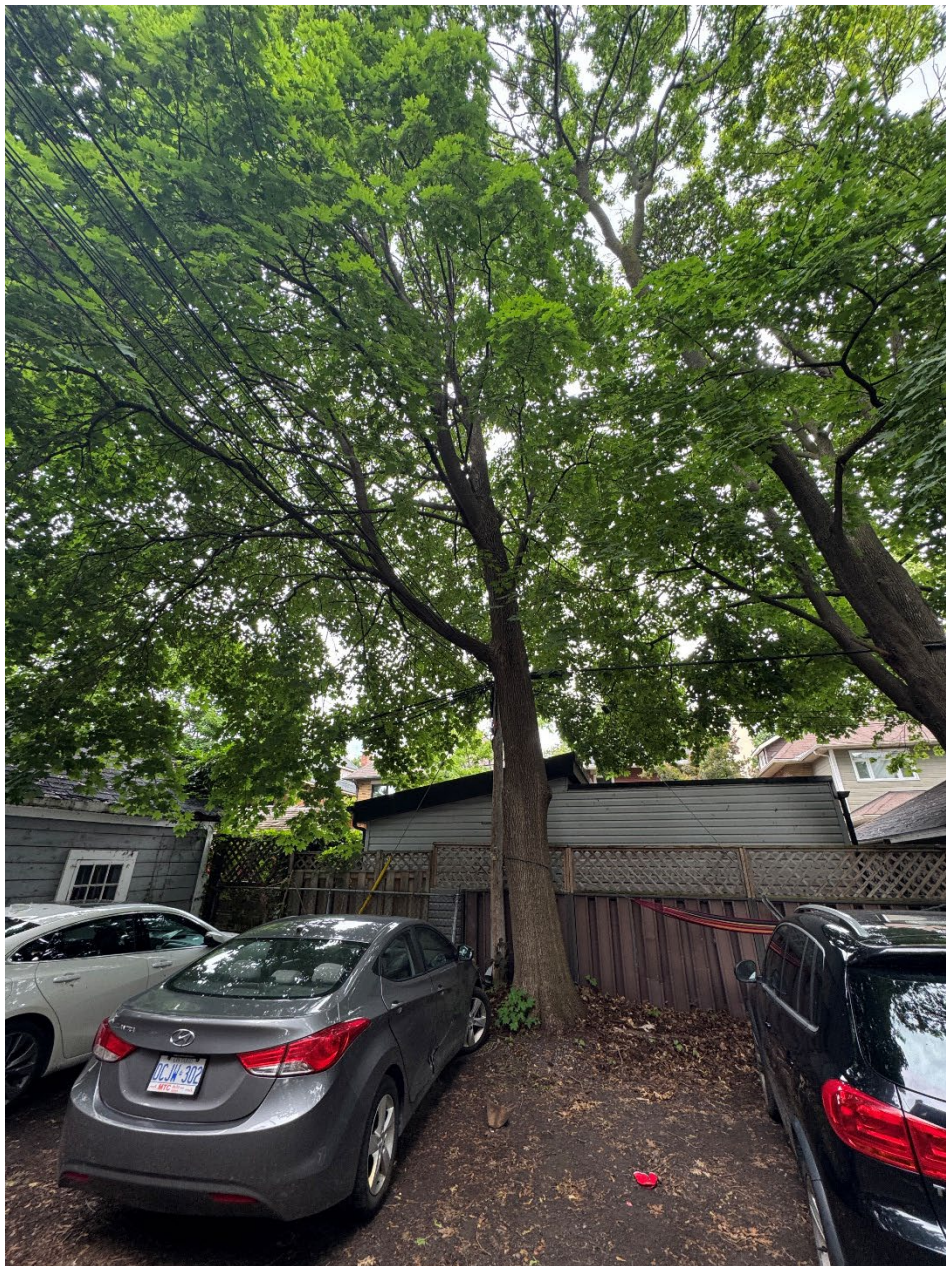
woodpecker damage		
5	Norway maple (<i>Acer platanoides</i>)	62	Subject property	Fair; large cavity at 2 m above grade, 40 X 70 cm with seam extending to it from base	Retain	Retain and protect with fencing during all site works; inspect regularly for health and signs of potential failure
6	Norway maple (<i>Acer platanoides</i>)	42	Jointly owned with 451 Daly Ave.	Good	Retain	Retain and protect with fencing during all site works

Figure 4: tree 5, Norway maple at the rear of the property. Note the current parking area and compacted soils

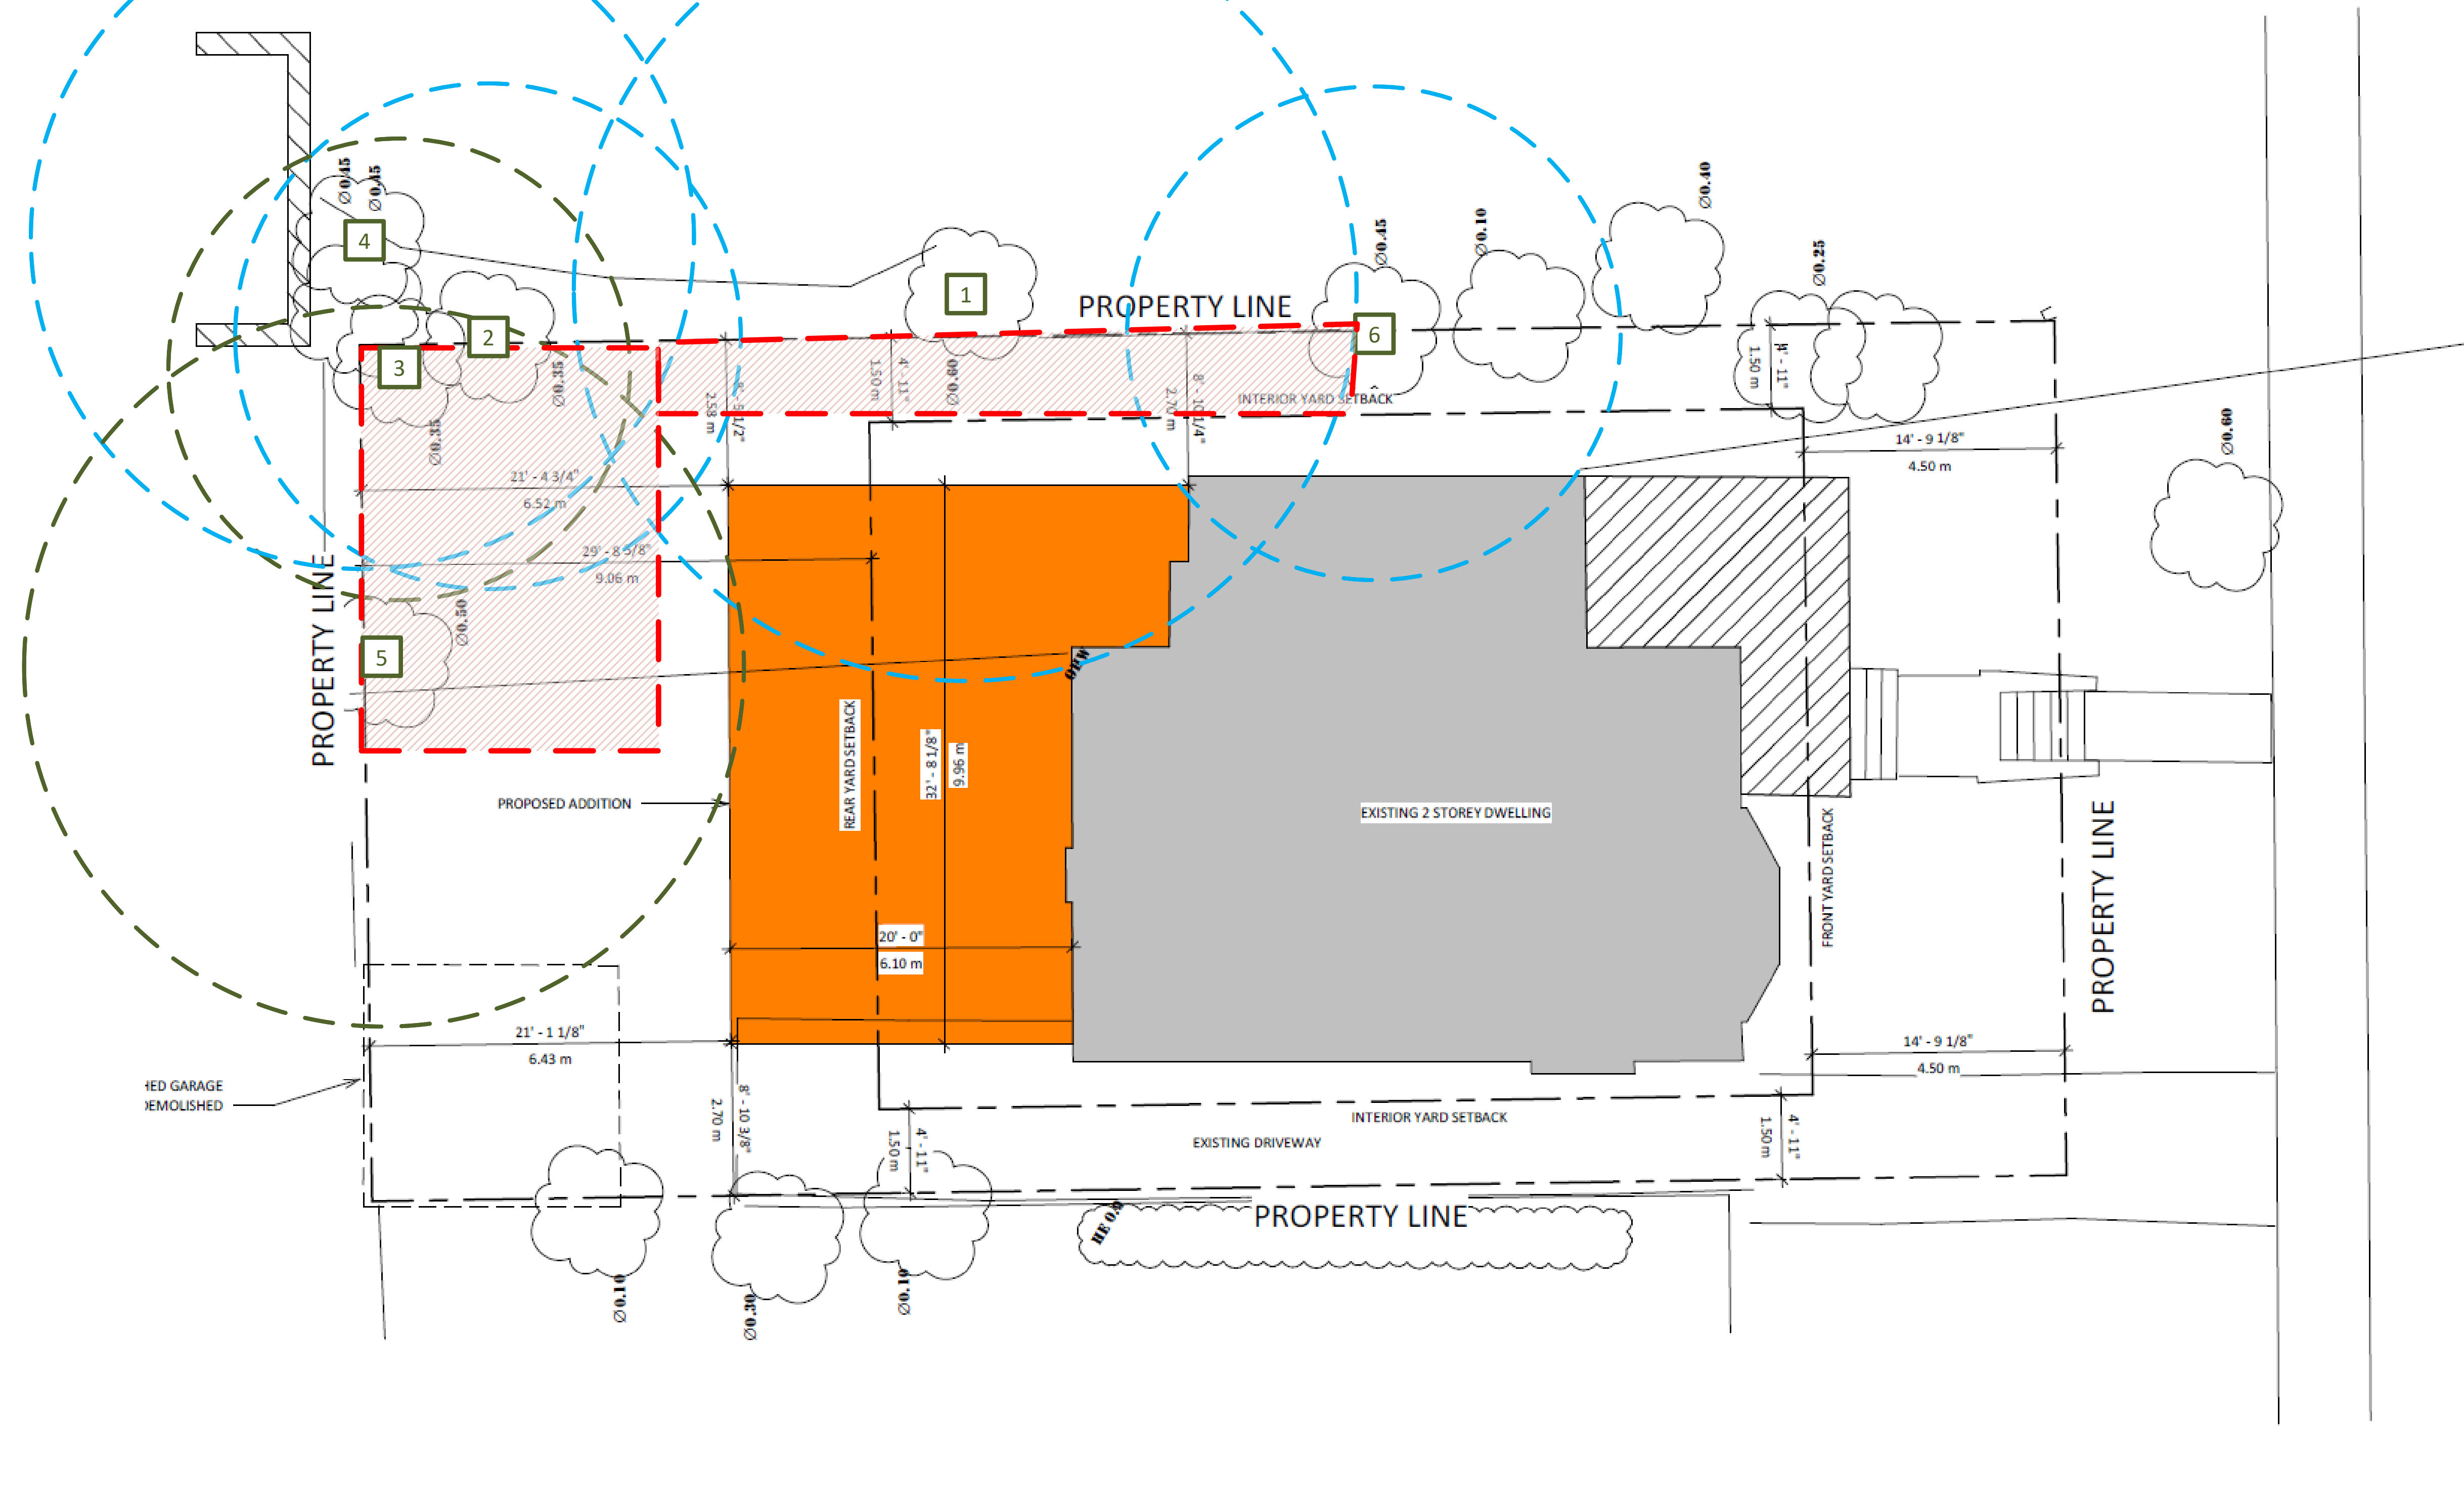
TIR Map – 447 Daly Ave		
Date	Revision	Prepared By
July 24, 2025	Version 1	AN

The proposed addition at the rear of this property will require excavation for a new foundation that is within the critical root zones of trees 1, 5 and 2 (slightly). **Tree 1** is a red oak that is situated mostly on the adjacent property. Based on a 1.2 m setback from the proposed foundation, the excavation will extend to approximately 2 m from this tree which is within 3 times the diameter, and best management practices regarding tree stability. Because the soil is heavily compacted in this area, persevering of the roots prior to excavation is not recommended. However, it would be beneficial to have an arborist on site during the excavation to address and root pruning at that time.

Prior to any site works, protective fencing should be installed around the trees as indicated in the attached Tree Information Map and maintained until all construction on site has been completed as per the **City of Ottawa Tree Protection Specifications (March 2021)**. Within the fenced area, the following tree protection guidelines should be applied:
