Tree Information Report – 6719 Barsona Place, Ottawa

This Tree Information Report is being submitted as a partial requirement for the development of this property. A site visit was conducted by Chris McIntyre, Certified Arborist ON-1219A, on December 18, 2025.

6719 BARSONA PLACE
 OTTAWA ONTARIO
 TREE INFORMATION REPORT

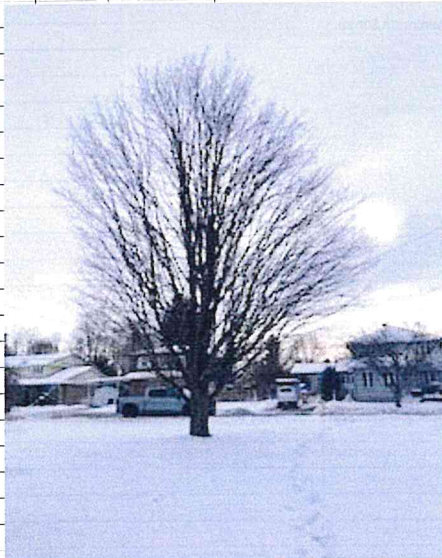
Tree 1

Tree No.	Species	D.B.H (cm)	Ownership	Condition of tree	Client's reason for removal	Arborist recommendation
1	Red maple	61	Private	Tree health, vigor and structure are all considered fair.	Within footprint of development.	Remove. Within footprint of development.
2	Norway maple	60	Neighbour	Tree health and vigor are fair. Structure is poor. Co-dominate, with heavy lean, decay present in trunk.	Tree to be retained.	Retain - protect. CRZ fencing to be installed at 5ft. Below protection measures to be implemented. Significant reduction pruning required to reduce canopy off site.
3	Manitoba maple	39	Private	Tree health, vigor are fair, structure is poor. Weak codominant union, significant lean.	Within footprint of development.	Remove. Tree is not viable long term. Conflict with construction.
4	Manitoba maple	22	Private	Tree health, vigor and structure are all considered poor.	Within footprint of development.	Remove. Tree is not viable long term. Conflict with construction.

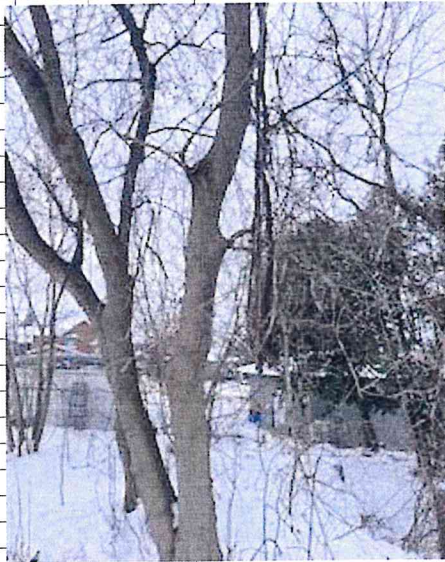
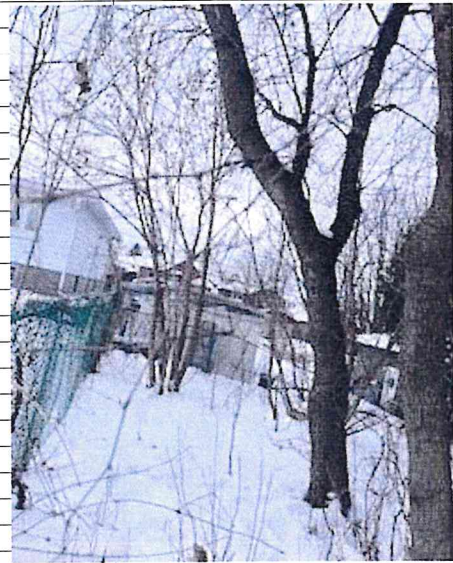
Tree 5

5	Manitoba maple	26	Private	Tree health and vigor are fair, structure is poor.	Within footprint of development.	Remove. Tree is not viable long term. Conflict with construction.
6	Manitoba maple	32	Private	Tree health, vigor and structure are all considered fair.	Within footprint of development.	Remove. Conflict with construction.
7	Manitoba maple	46	Private	Tree health, vigor and structure are all considered poor. Extensive decay present due to crown failure.	Within footprint of development.	Remove - Safety.
<p>Tree Protection Measures for Retained Trees.</p> <p>The following are measures to be implemented prior and during the construction process.</p> <ul style="list-style-type: none"> -Critical root zone of retained trees must be protected as outlined above. Snow or metal fencing must be erected around the CRZ and signage should be installed to identify tree is being protected. -Pruning must be performed prior to construction to ensure tree limbs will not be in conflict with equipment and construction. Permission must be obtained to prune Municipal or neighbors trees. (performed by Certified Arborist). -No material or equipment is permitted within any CRZ. -No signs, notices or posters may be attached to the tree. -No grade changes within any CRZ. -Ensure exhaust fumes from equipment are not directed towards tree canopy's. -After excavation is complete exposed and damaged roots should be pruned (performed by Certified Arborist).
