3. **APPLICATION TO ALTER THE SOMERSET HOUSE, 352 SOMERSET STREET WEST, A PROPERTY DESIGNATED UNDER PART V OF THE *ONTARIO HERITAGE ACT* AND LOCATED IN THE CENTRETOWN HERITAGE CONSERVATION DISTRICT**

**Built Heritage Sub-Committee / Sous-comité du patrimoine bâti  
July 11, 2016 / 11 juillet 2016**

**SUBJECT:** Application to Alter the Somerset House, 352 Somerset Street West, a property designated under Part V of the *Ontario Heritage Act* and located in the Centretown Heritage Conservation District

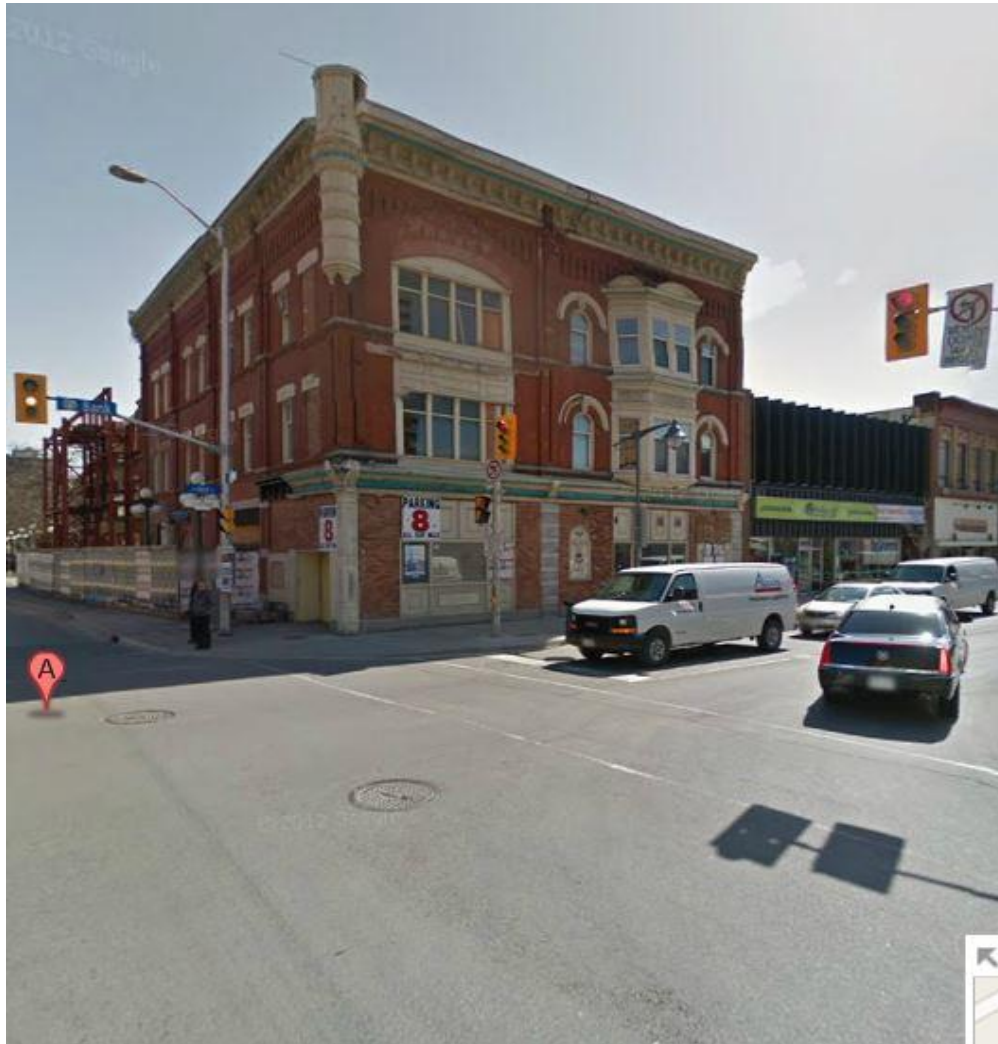
Document 2 – Current Conditions

In October 2007, Somerset House experienced the localized collapse of a load bearing wall as a result of construction activities. Subsequent to the partial collapse, the east part of the structure was demolished and in February 2008, a custom steel frame was constructed to support the eastern part of the north façade, the area of which is the subject of this report. Photographs of the current condition of the building are contained in Document 2.

Since the partial collapse and construction of the steel frame, the walls and foundations of the parts of the building affected by the original collapse have continued to be exposed to the elements, resulting in further deterioration. Efforts undertaken to proceed with the restoration, renovation and adaptive re-use of the building have not been completed by the property owner, resulting in health and safety concerns due to

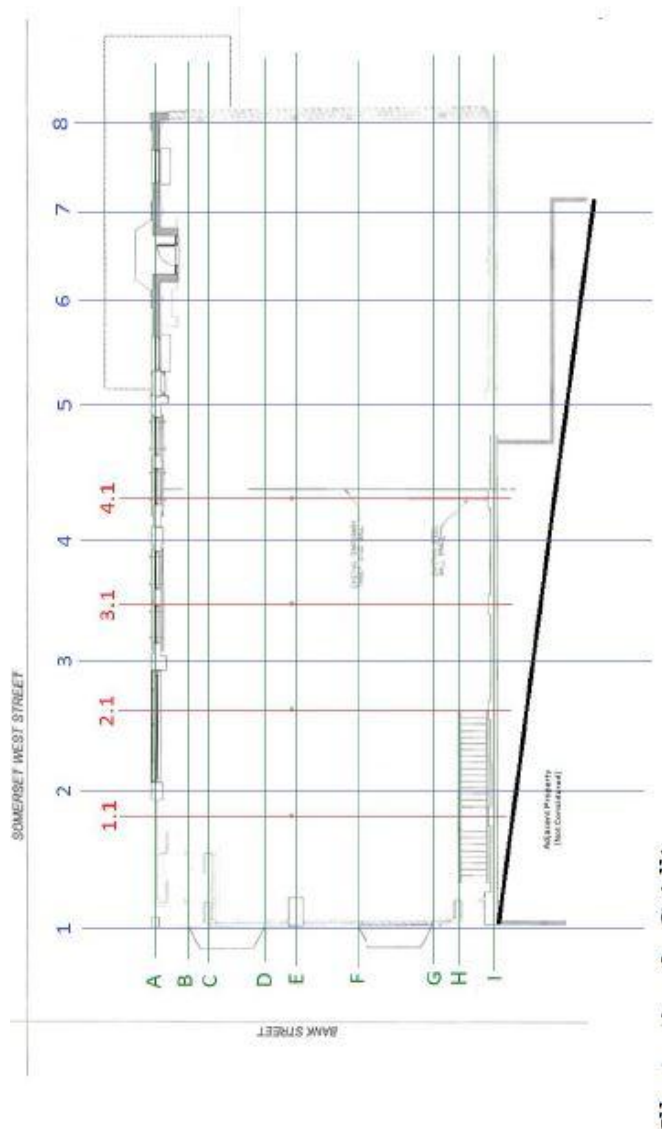
## Document 5 – CEC Gridlines

The report divides the north wall into sections, according to Illustration 1: Gridlines in Document 5. Two parts of the north wall of the building are the subject of this report: the three storey, east bay of the north wall (Gridline A from GL 4-5), and the three easterly bays (Gridline A from GL 5-8). This wall has been exposed on both its exterior and interior since the partial collapse and demolition of the building in 2008-09.

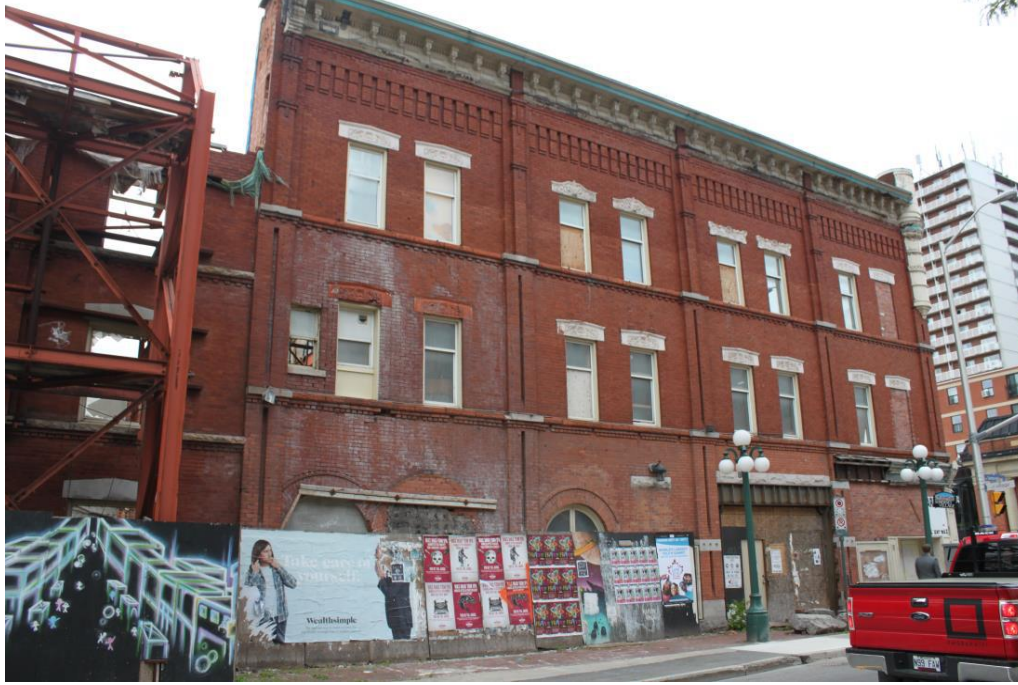
Document 6 – Fourth Bay (GL4)

Three storey, east bay of the north wall (GL 4-5) (Document 6 contains a photograph of the three-storey, east bay of the north wall (GL 4-5).

The CEL Evaluation addresses concerns regarding the most easterly bay of the three-storey portion of the building, reporting that this part of the building is in very poor condition as a result of “freeze-thaw cycling and wet-dry cycling on both faces. Units are often missing face shell and are in very poor condition.” The report indicates that “restoration may be possible” but that the success of such restoration “cannot be assured.” CEL recommends that the only approach for the wall is to replace deficient masonry units one at a time.” Due to the extent of the damage to the wall, CEL recommends temporarily bracing it until an approach to its retention can be developed.

Given the condition of the three-storey bay (GL4-5), the report is not optimistic that the in situ restoration of the wall will be possible, and recommends the recording, dismantling and re-building of the wall as an alternative. It was further noted in the report that the foundation wall in this part of the building is of concern, and requires repair.

Exterior wall, Fourth Bay, site of controlled demolition (GL 4)

The department concurs with the CEL and Ojdrovic that there are serious structural issues with the easterly most bay of the three-storey portion of the structure. Staff recommend that every effort be made during the course of the demolition and stabilization project to retain historic fabric in situ, according to plans developed in consultation with the applicant, Heritage staff and the CBO as part of the process leading to the issuance of a building permit.

The fourth bay of the three-storey structure may be salvageable. Staff recommend that the owner undertake to retain historic fabric in situ, according to plans developed in consultation with the applicant. (Recommendation 1, above) If retention in situ is not possible, the owner shall make every effort to rebuild the wall using materials from the original building to conserve the original character.

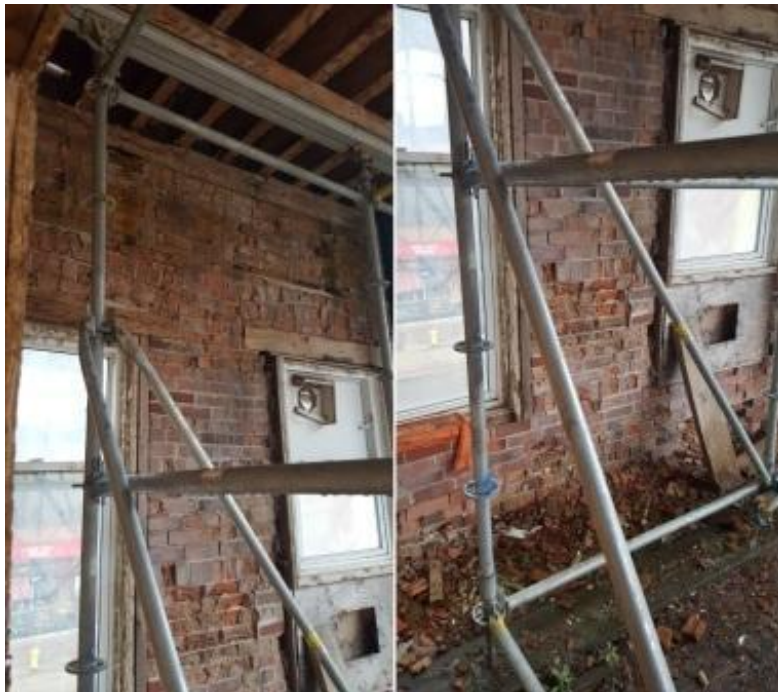
Interior wall, Fourth Bay, site of controlled demolition

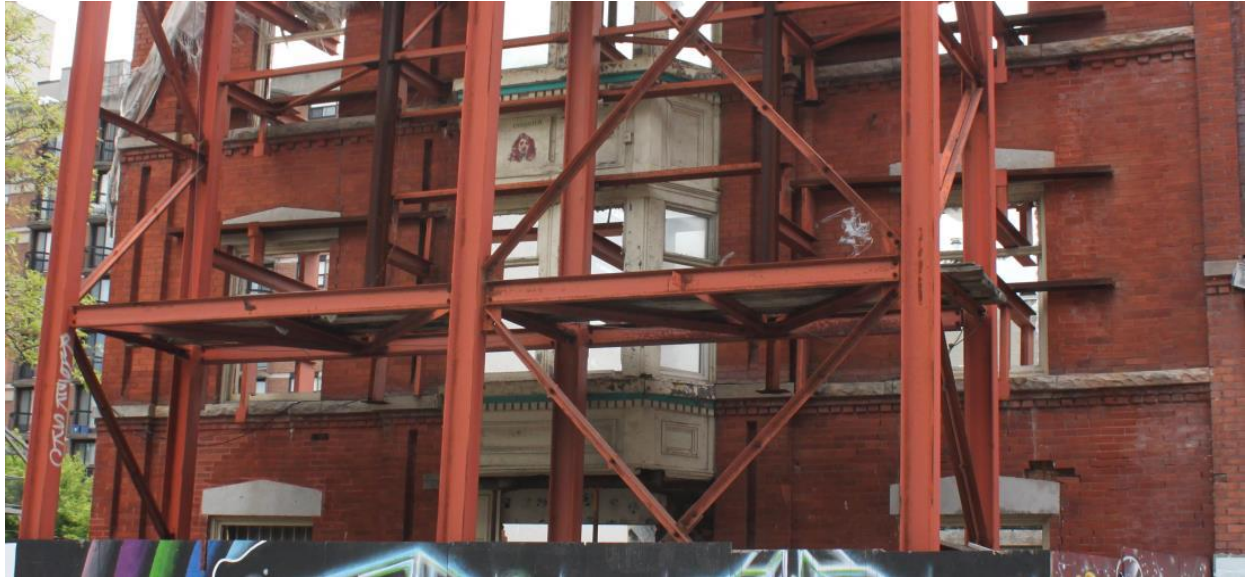
Document 8 – Three most easterly bays, (GL5 -8)

Easterly three bays of the north wall sections GL 5-8, are in Document 8, photographs of this section of the north wall.

The extent of the proposed demolition is the easterly three bays of the north wall, of the former four-storey portion of the building. This part of the wall is currently supported by a steel frame. CEL classifies this section of the north wall to be of immediate concern.

The CEL report requires the “urgent demolition” of this wall as “the lack of vertical confining load and the extended time during which the wall has relied upon exterior backup while being continually washed and exposed to freeze-thaw cycles has resulted in a wall which appears to be unstable and in need of urgent demolition.”

The Ojdrovic report agrees with the CEL report, noting that there has been considerable degradation of the building since its initial collapse. The report agrees that the three easterly bays (GL5-8) are “beyond reasonable repair in situ” and as a result demolition is appropriate. Brick and stone details from the wall could be recovered during demolition for reuse.

Exterior Wall, Easterly bays, site of complete demolition (GL 5-8)

Staff concur with CEL and Ojdrovic that the three most easterly bays of the building have deteriorated to such an extent that the restoration of this portion of the building in situ would not be possible and has no objection to the removal of this part of the building.

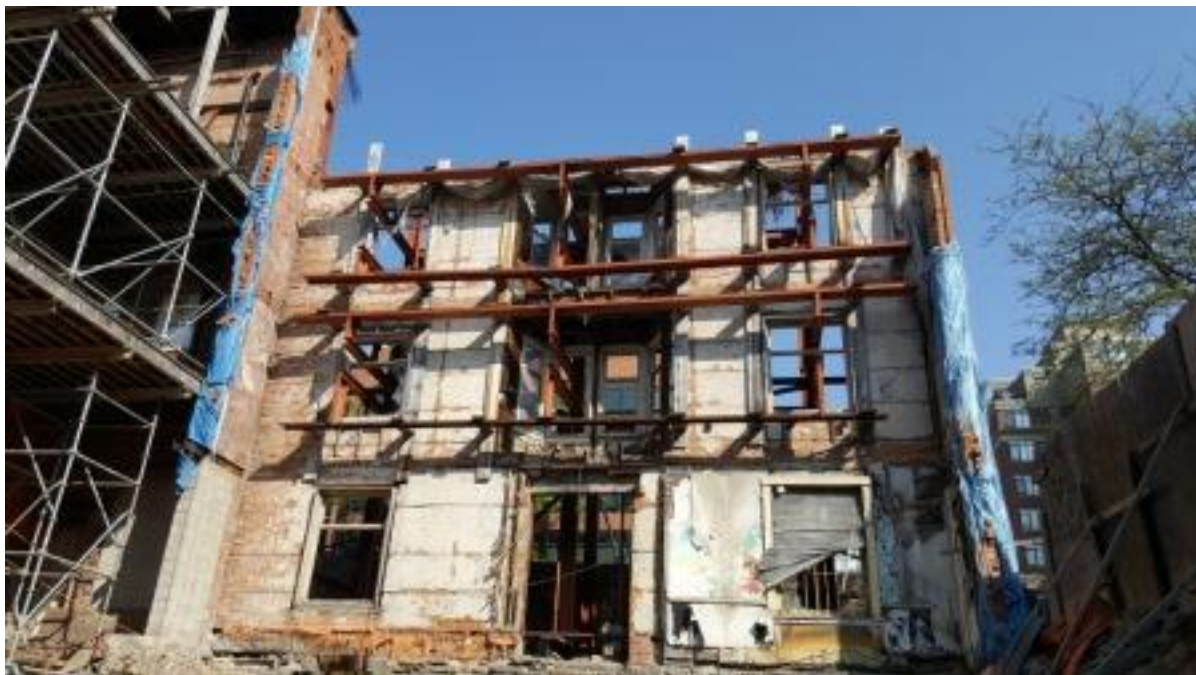
Interior wall, Easterly bays, site of complete demolition (GL 5-8).
