September 6, 2017

Re: Tree Conservation Report – 551 Fairview Avenue, Ottawa

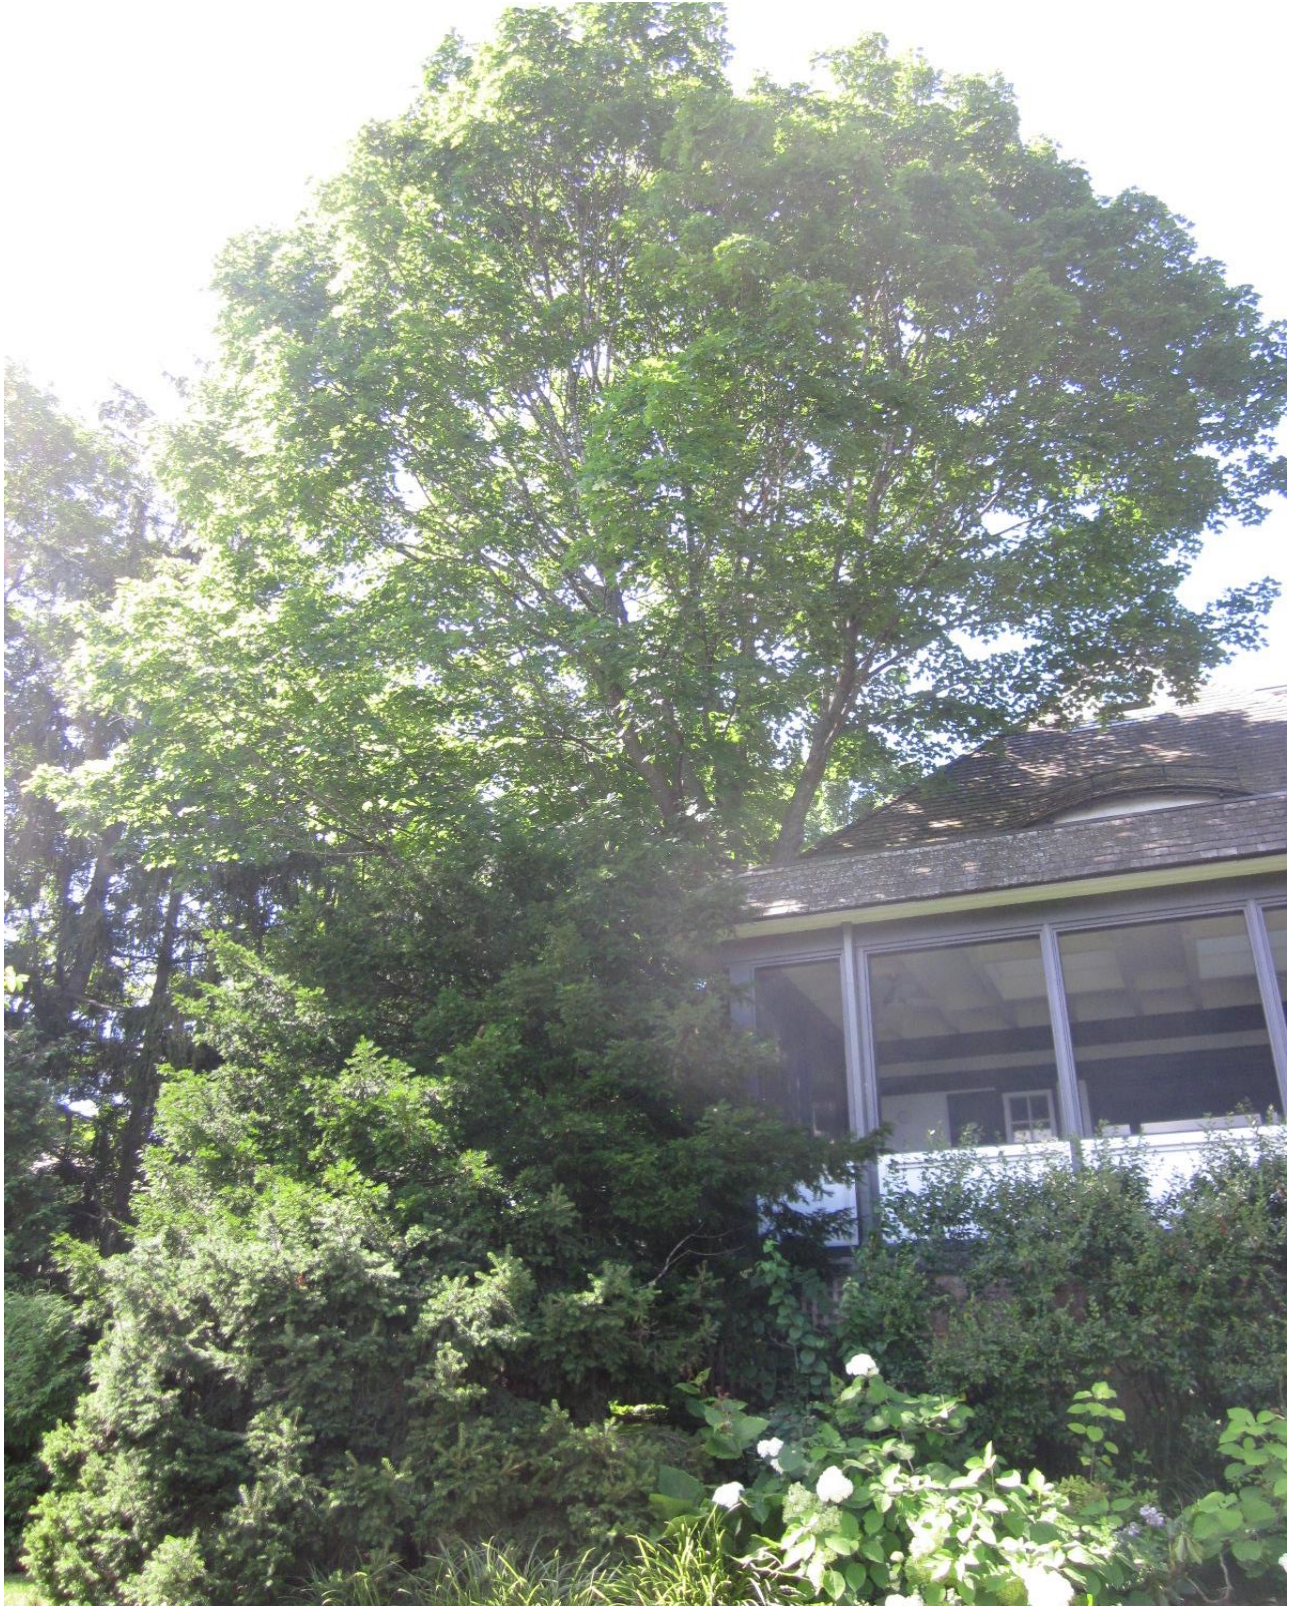
Picture 1. Sugar maple #12 at 551 Fairview Ave.

Pictures 1, 2, 3 and 4 on pages seven through ten of this report show some of the trees on the subject property. Given their location within the new pathway trees #5 (a Norway spruce) and 12 (a sugar maple) cannot be retained. Red oak #13 will likely be impacted by the excavation for the ground floor addition. However, it is hoped this tree can be retained. Several other trees will be removed due to their present poor condition. For all other trees the tree preservation and protection measures cited in this report will be undertaken to ensure they are not adversely impacted by construction.

| Tree No. | Tree Species | D.B.H (cm) | Ownership | Tree condition, general health and Status (to be removed or preserved and protected) |
|---|--|---|---|--|
| 12 | Sugar maple | 42 | Private | Good; mature; roof of porch built around main stem; upright form but asymmetrical crown; to be removed |

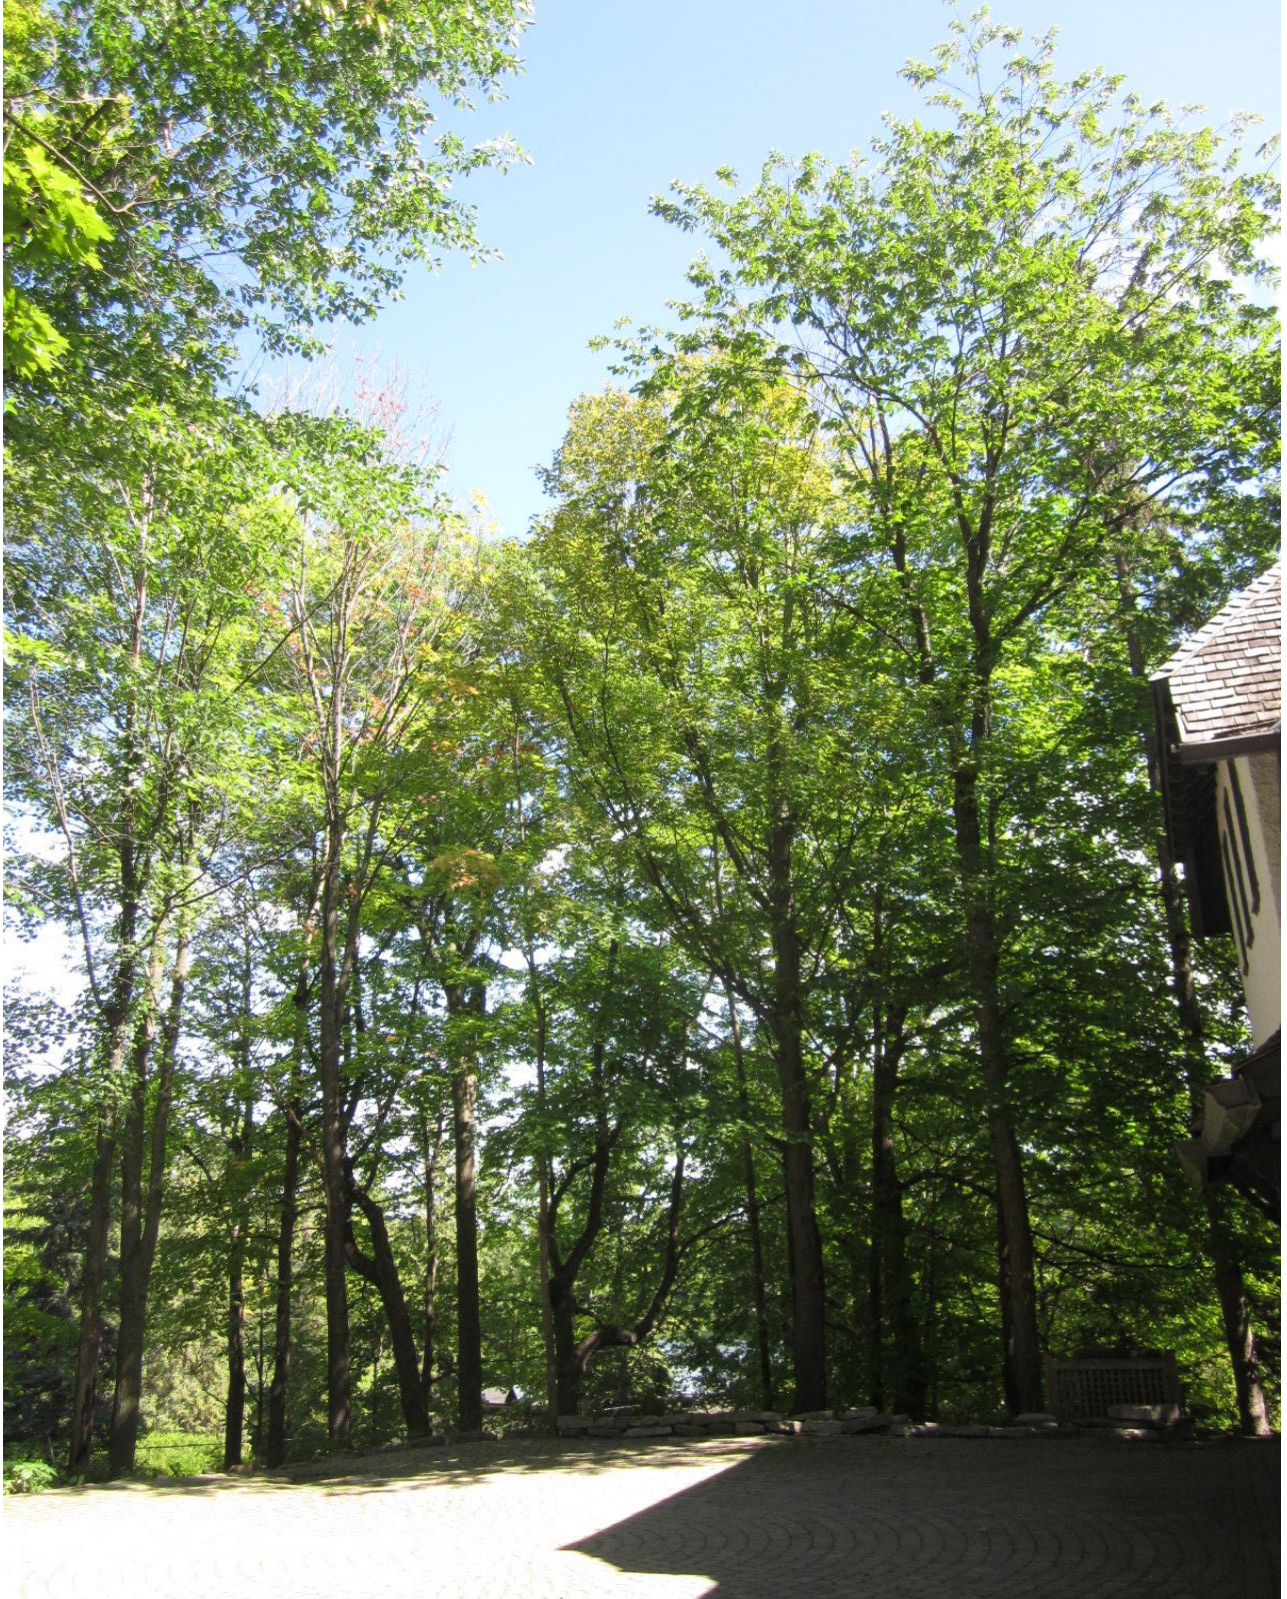
Picture 2. Trees #14, 16, 18, 34, 37 and 38 (in foreground, right to left) at 551 Fairview Ave.

| Tree No. | Tree Species | D.B.H (cm) | Ownership | Tree condition, general health and Status (to be removed or preserved and protected) |
|---|--|---|---|--|
| 14 | White spruce (<i>Picea glauca</i>) | 32 | Private | Fair; mature; crown held high due to competition with surrounding trees; heavy cone crop in 2017; to be preserved and protected |

| 16 | White elm (<i>Ulmus americana</i>) | 32 | Private | Poor; mature; crown thin and leaves chlorotic – possibly elm yellows; no outward signs of Dutch elm disease (<i>Ophiostoma novo-ulmi</i>); to be preserved and protected |
| 18 | Sugar maple | 37 | Private | Fair; mature; dieback at crown apex; growing against retaining wall; sooty cankers in lower bole; to be preserved and protected |

| 34 | Sugar maple | 29 | Private | Dead; to be removed |
| 37 | Sugar maple | 32 | Private | Fair; mature; moderate deadwood; to be preserved and protected |
| 38 | Sugar maple | 14 | Private | Fair; maturing; co-dominant stems at 2.5m from grade; growing against private hydro line; to be preserved and protected |

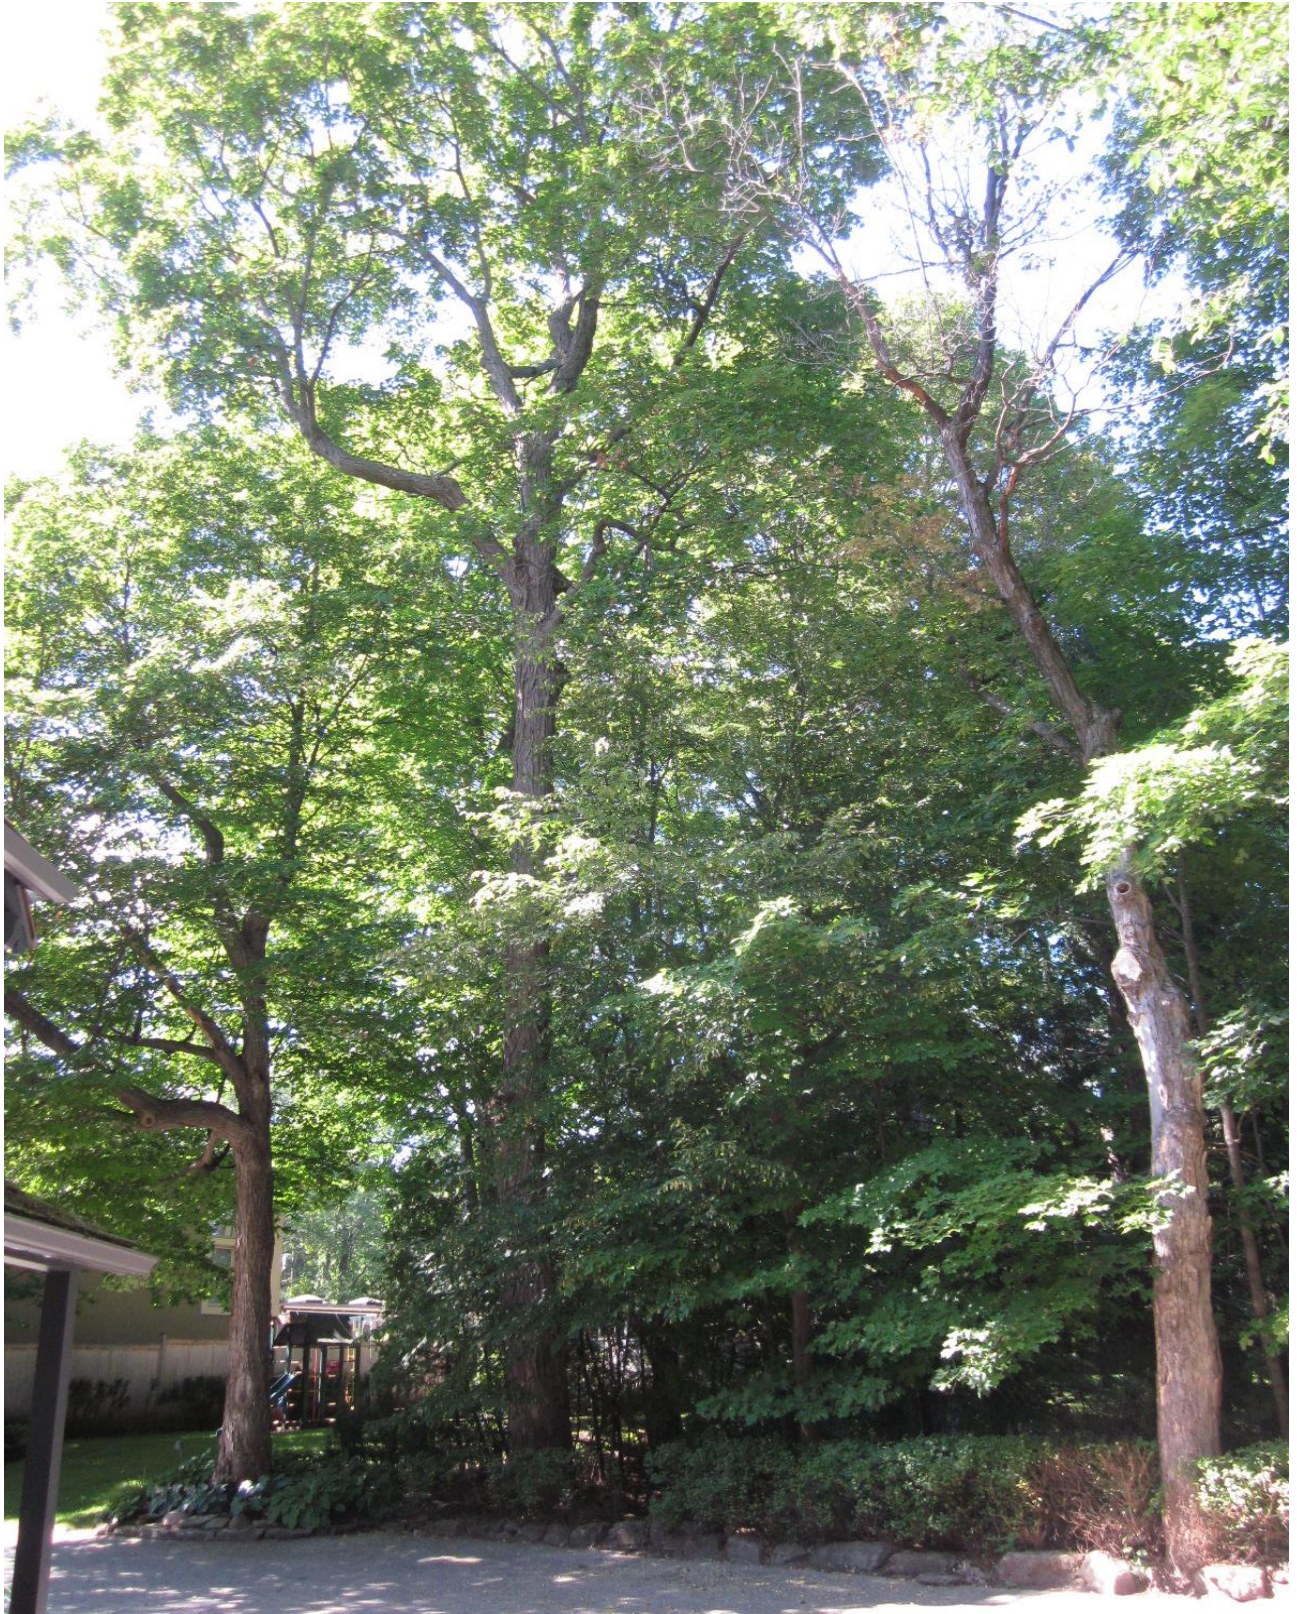
Picture 3. Sugar maple #41, 42 and 43 (right to left) at 551 Fairview Ave.

| 41 | Sugar maple | 44 | Shared | Dead; to be removed |
| 42 | Sugar maple | 64 | Shared | Good; very mature; divergent towards northeast; burl at on main stem 4m from grade; broad, dense crown with good branching; to be preserved and protected |
| 43 | Sugar maple | 56 | Private | Poor; crown very asymmetrical towards east; major deadwood & cavity over driveway (hazardous); wound on east side of root collar with early decay and insect activity; to be removed based on current condition |

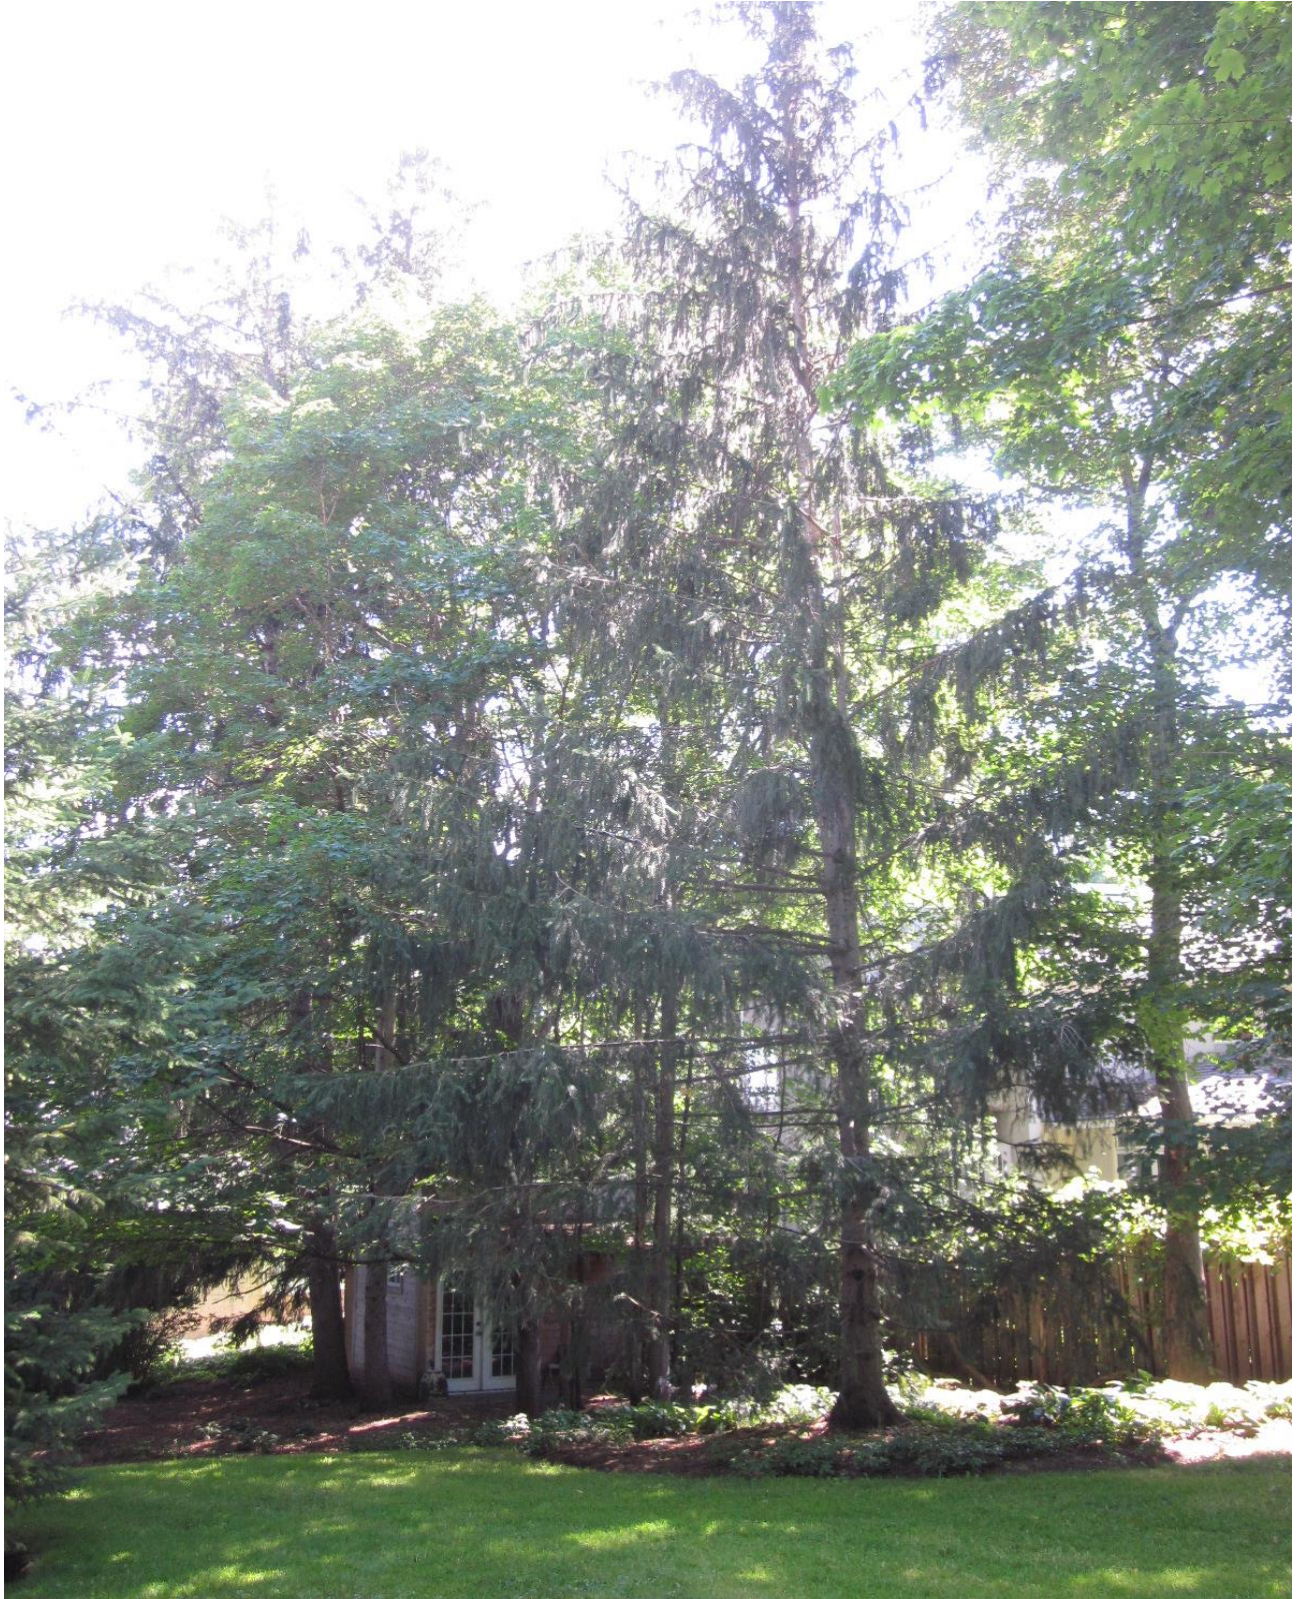
Picture 4. Trees #5 through 10 (right to left) at 551 Fairview Ave.

| Tree No. | Tree Species | D.B.H (cm) | Ownership | Tree condition, general health and Status (to be removed or preserved and protected) |
|---|--|---|---|--|
| 5 | Norway spruce (<i>Picea abies</i>) | 28 | Private | Fair; mature; poor crown density due to shading from adjacent trees; fair growth increment and needle colour; to be removed |
| 6 | Sugar maple | 32 | Private | Good; mature; mildly divergent towards southeast; to be preserved and protected |
| 7 | Sugar maple | 30 | Private | Fair; mature; mildly divergent and crown asymmetrical; to be preserved and protected |
| 8 | Norway spruce | 29 | Private | Fair; mature; poor crown density due to shading from adjacent trees; fair growth increment and needle colour; to be preserved and protected |
| 9 | Norway spruce | 41 | Private | Fair; mature; poor crown density due to shading from adjacent trees; fair growth increment and needle colour; to be preserved and protected |
| 10 | Norway spruce | 30 | Private | Fair; mature; poor crown density due to shading from adjacent trees; fair growth increment and needle colour; to be preserved and protected |
