Tree Conservation Report submitted as Partial Requirements for a Heritage Application to the City of Ottawa

TREE CONSERVATION REPORT

1 Coltrin Place, Rockliffe Park

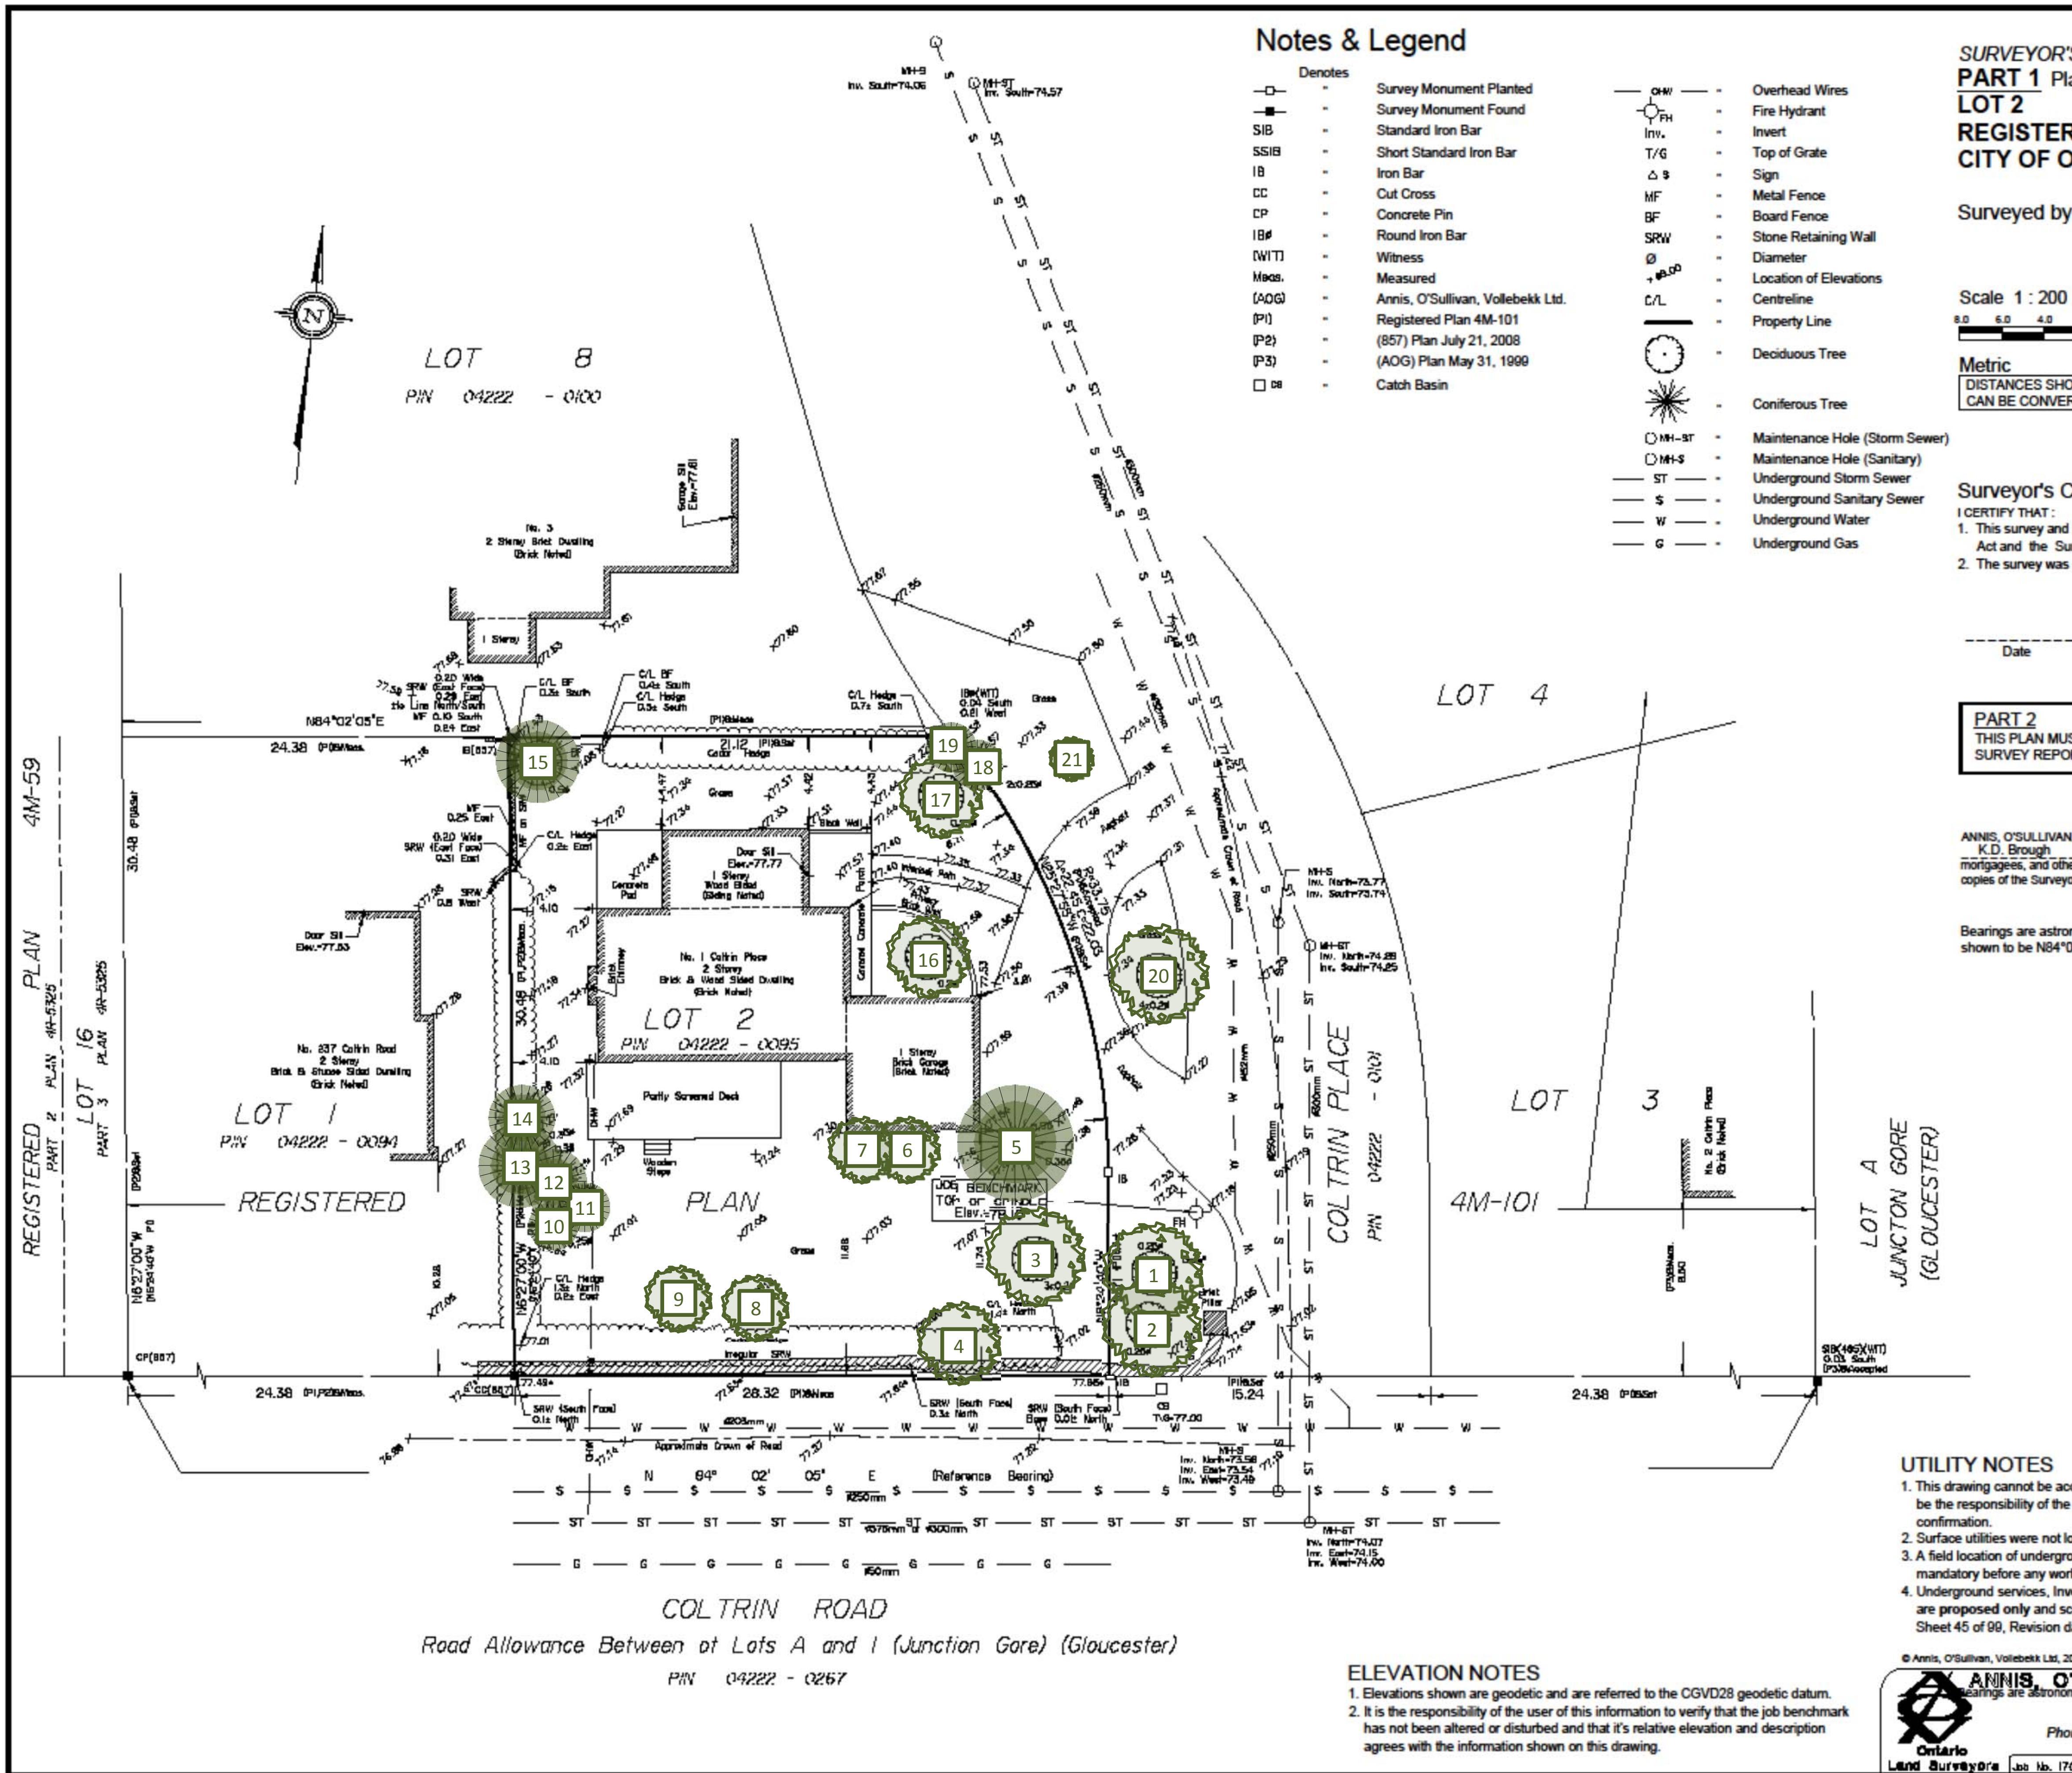
Current Vegetation – 1 Coltrin Road Tree layer prepared by Dendron Forestry Services Version 1.0, May 4, 2017

Current Vegetation (Map 1)

There are currently twenty-one trees on the site, and most are in relatively good health (see Table 1).

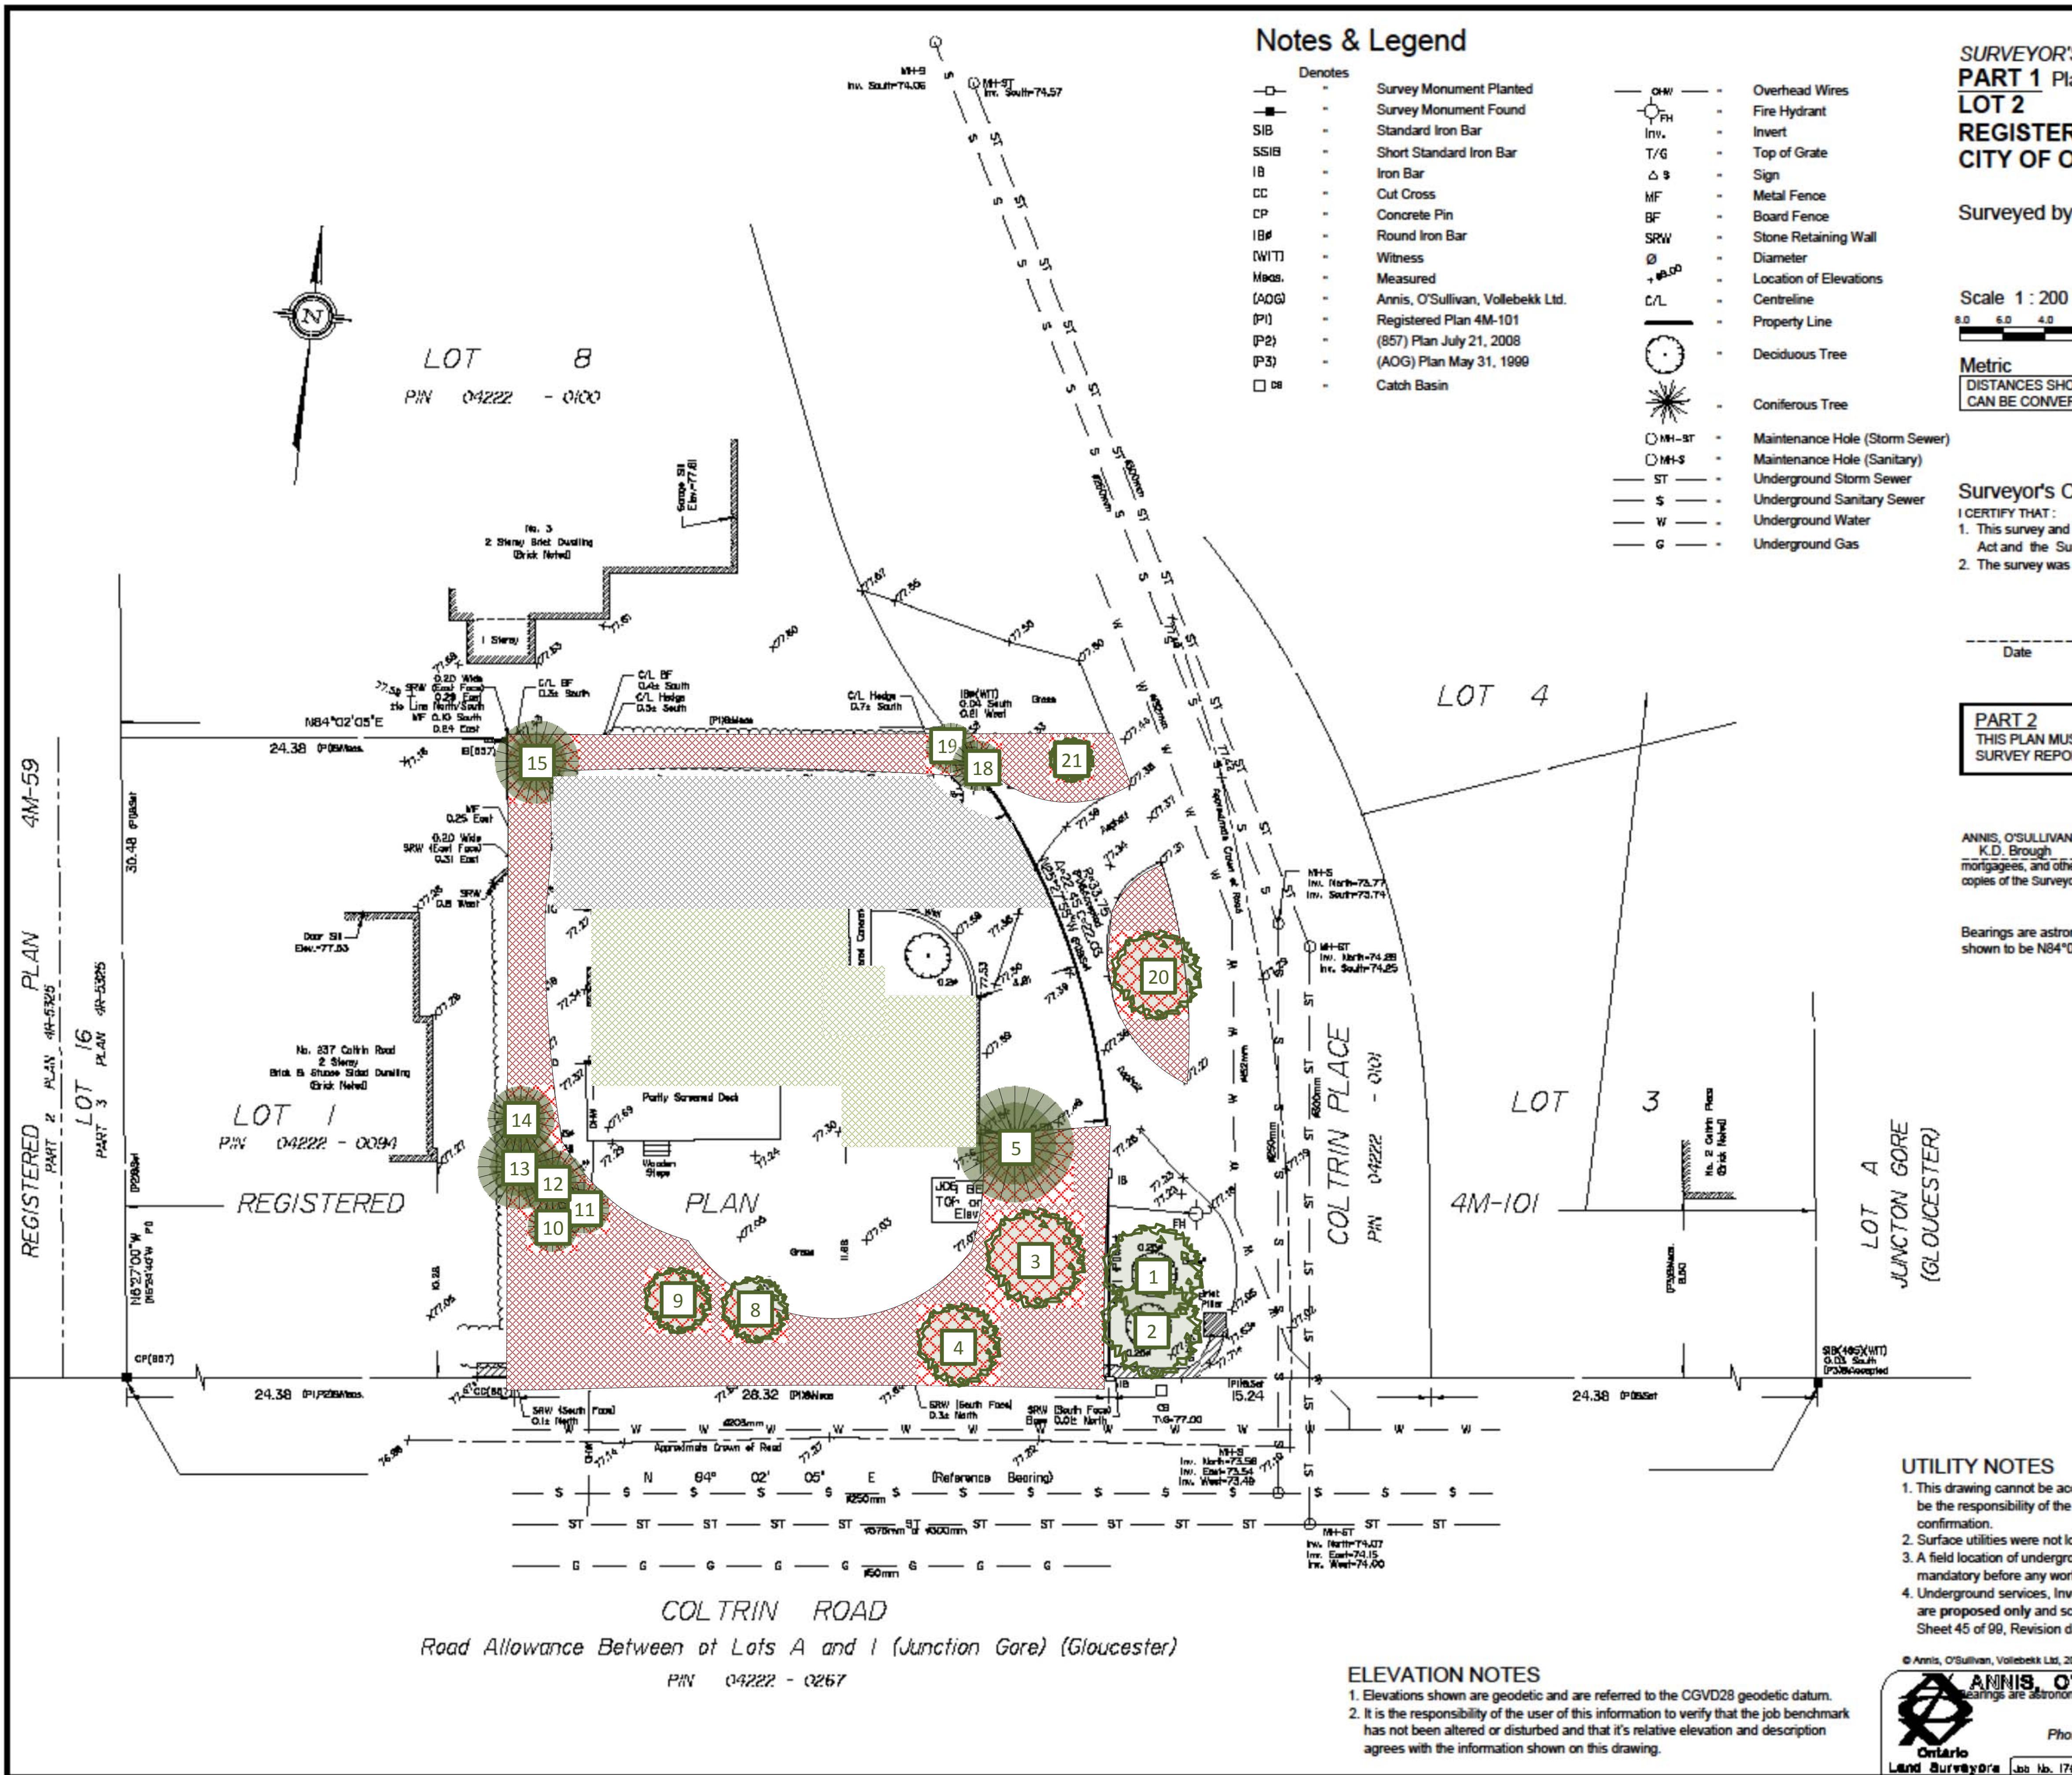
Proposed Development and Conserved Vegetation – 1 Coltin Road Tree layer prepared by Dendron Forestry Services Version 1.0, May 4, 2017

Proposed Development and Conserved Vegetation (Map 2)

The proposed development on the property will follow closely to the original footprint, resulting in relatively low impact to most trees. An approximate proposed footprint and new driveway are showing in Map 2. Trees that will need to be removed to accommodate the new residence include 6,7, 16 and 17. Trees 6 and 7 are buckthorn, an aggressive and invasive species. Tree number 16, a honey locust, will need to be removed to accommodate an addition as well as re-landscaping of the entrance way. Tree 17, a crabapple, follows along the proposed new driveway edge, and is also recommended for removal. This tree is leaning over the proposed new driveway and could be in the way of vehicles and it is in relatively poor health.

The above guidelines should apply to all trees that will be retained within the protection zone outlined on the map. Note that the fencing on the map is approximate. When installing fencing in the field, it should be kept at a distance equal to the critical root zone (crz) around the tree which is equivalent to an area with a radius ten times the diameter of the tree. Any exposed roots should be kept moist and, if possible, covered with burlap or wood chips. If it is not possible to avoid using heavy machinery in the CRZ of a tree, a protective layer on the ground made up of wood chips or plywood would help to lessen the impact of machinery and lessen soil compaction.
