TREE CONSERVATION REPORT

540 Lakehurst Road

Tree Conservation Report submitted as Partial
Requirements for a Building Permit Application, May
19, 2021

Tree Conservation Report v2.0

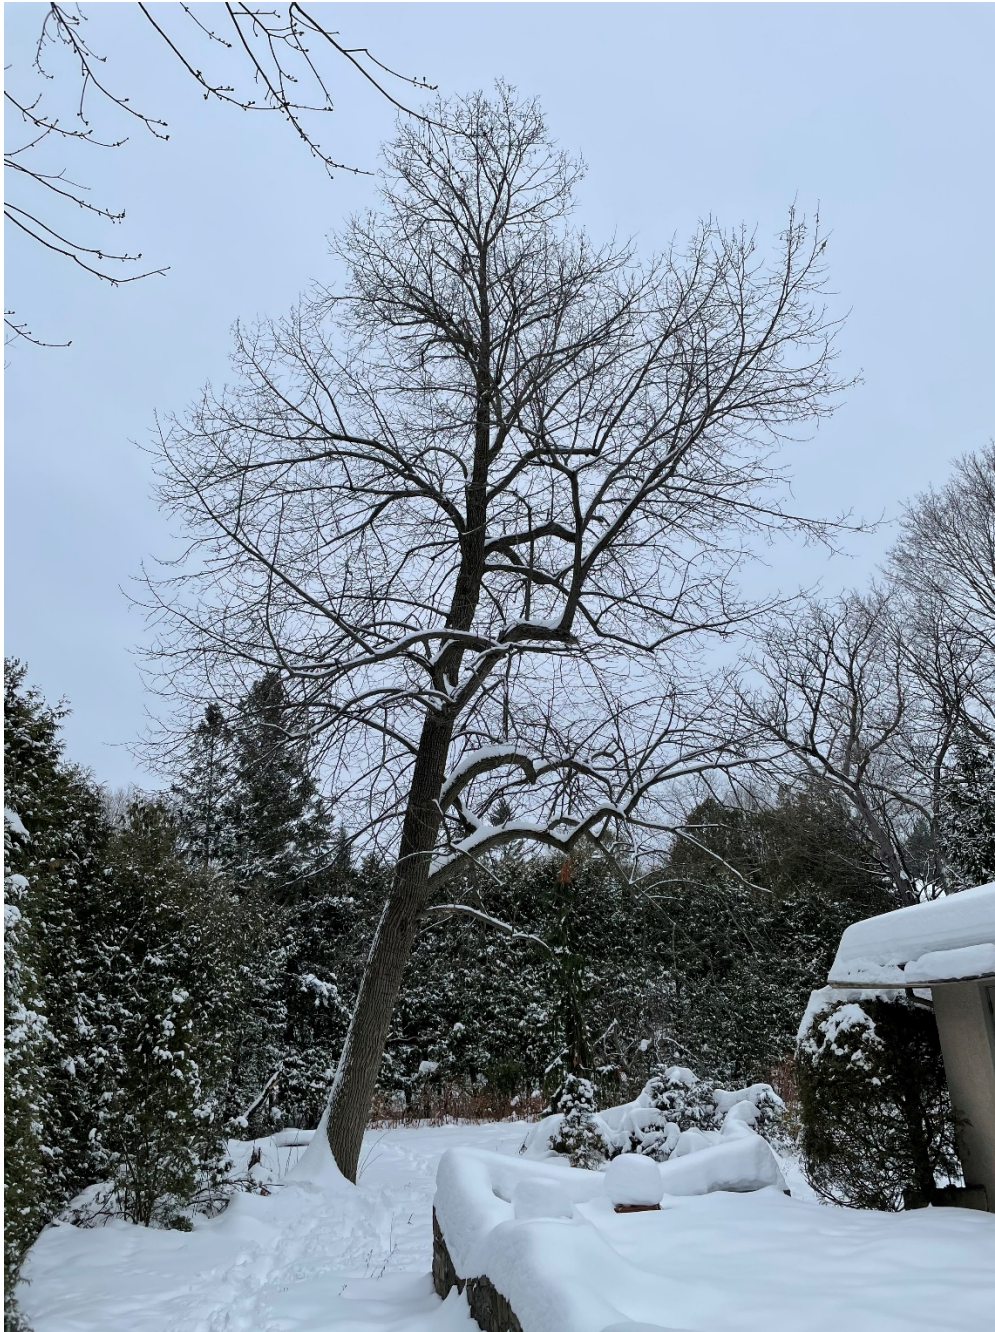
Most of the trees on this site will be retained through the proposed development. Tree 22 is directly in the footprint of the new home, and although 19 is not within the footprint, it will lose a significant amount of roots as part of the excavation. Excavation will extend to approximately 2 m from the edge of the tree, and the tree has a significant lean towards the new home. Finally, there is a significant amount of sapsucker holes along the trunk of the tree indicating that the tree is under stress. Given all these factors, removal is recommended.

Figure 1: Tree 19, basswood to be removed

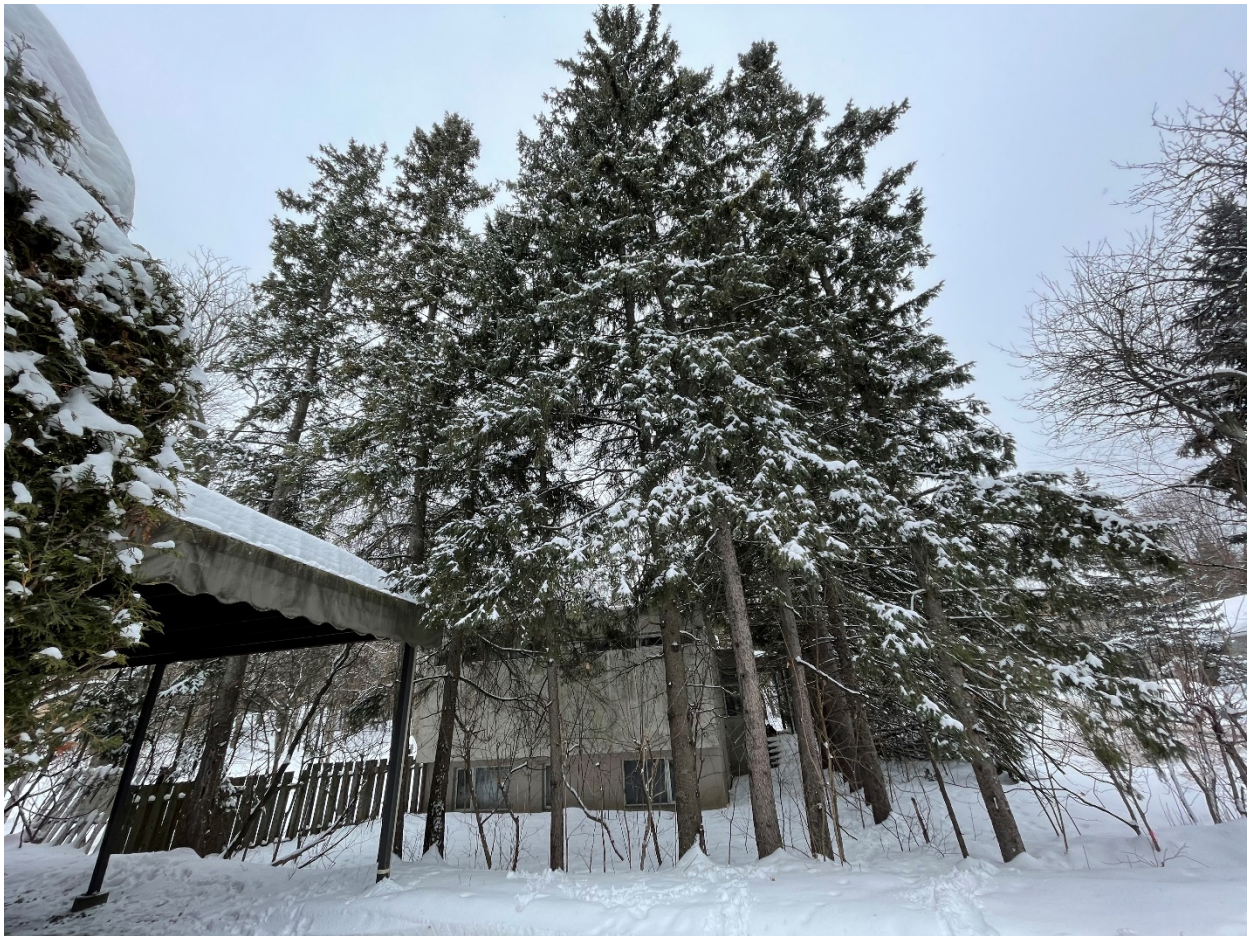
9	White spruce (<i>Picea glauca</i>)	30 cm	Jointly owned with 534 Lakehurst	Good	Retain and protect
10	White spruce (<i>Picea glauca</i>)	18 cm	Private	Fair; suppressed by other spruce	Retain and protect
11	White spruce (<i>Picea glauca</i>)	38 cm	Private	Fair/poor; suppressed by other trees; numerous large (recent) woodpecker holes	Remove based on health – Distinctive Tree Permit required
12	Balsam fir (<i>Abies balsamea</i>)	14 cm	Jointly owned with 534 Lakehurst	Good/fair	Retain and protect
13	Eastern white cedar (<i>Thuja occidentalis</i>)	18 cm	Private	Good/fair; thin crown	Retain and protect
14	Sugar maple (<i>Acer saccharum</i>)	88 cm	Jointly owned with 534 Lakehurst	Good; two co-dominant stems 44 cm each split at 2m, one stem leaning towards adjacent property	Retain and protect
15	Butternut (<i>Juglans</i>)	52, 55 cm	Private; jointly	Poor; butternut canker	Remove as soon as

Figure 2: Trees 4-12 along the west side of the property

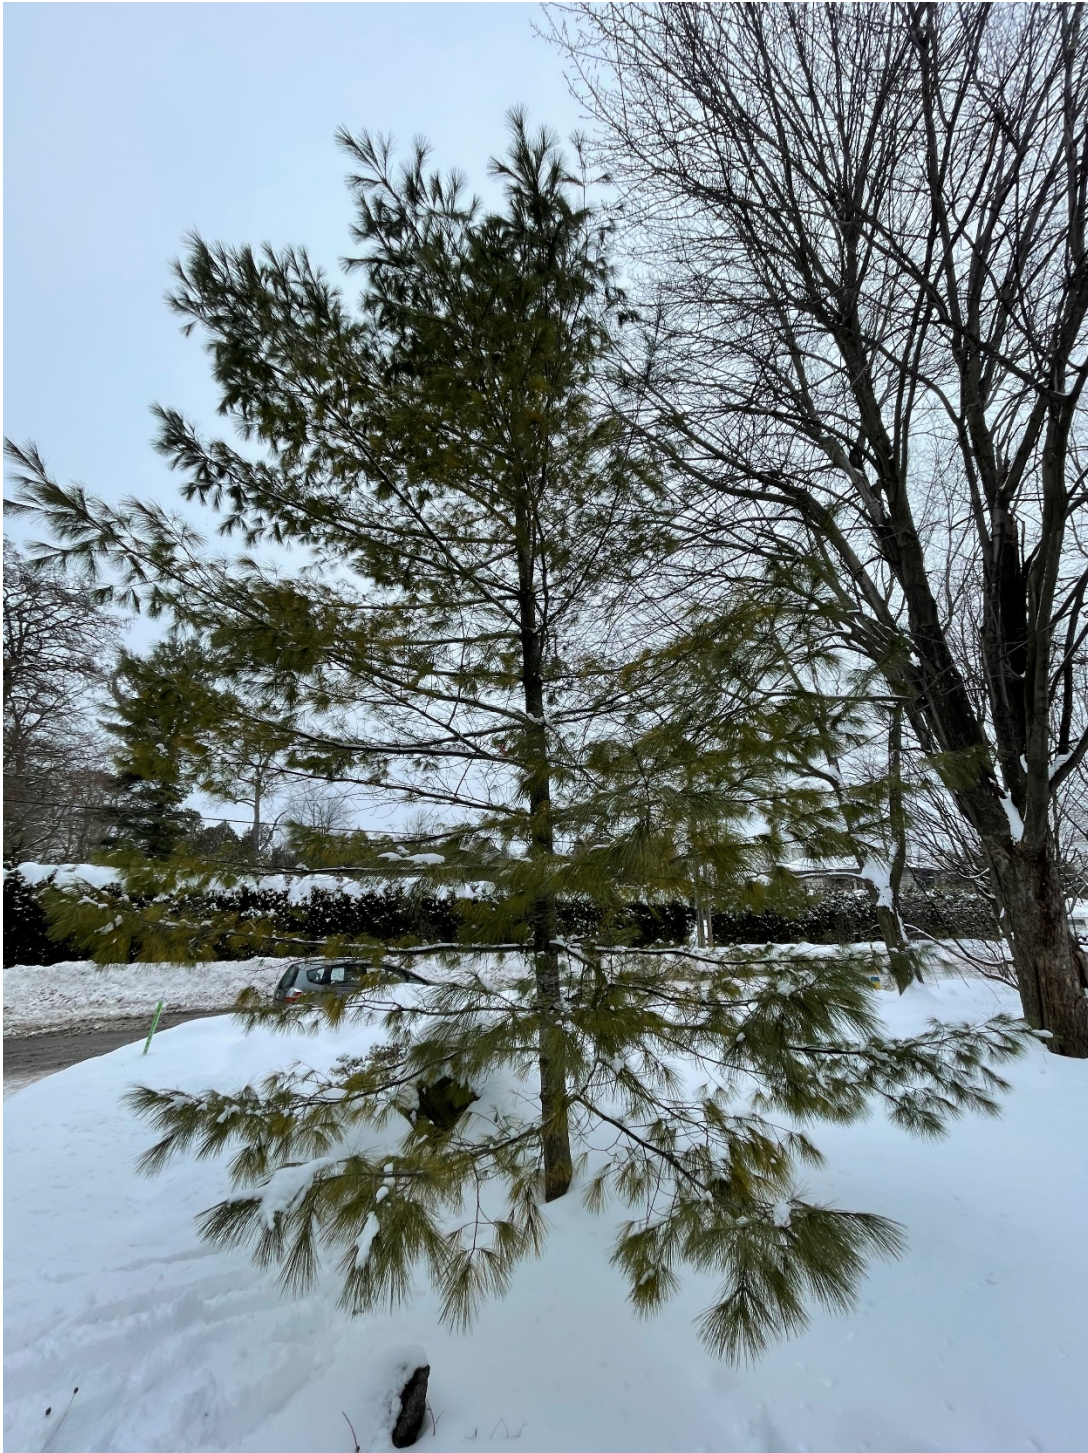
Tree 27 is a white pine that is showing signs of chlorosis as many of its leaves are yellowing. The proposed services are running directly underneath this tree, and removal is required. Originally, the services were proposed between tree 25 and 27 (further east), but in discussions with the development team, it was decided to move the services and driveway further towards the west and concentrate preservation efforts on the large maple, tree 25. The white pine is a smaller tree that is more easily replaced than the large maple.

Figure 3: Tree 27, white pine to be removed

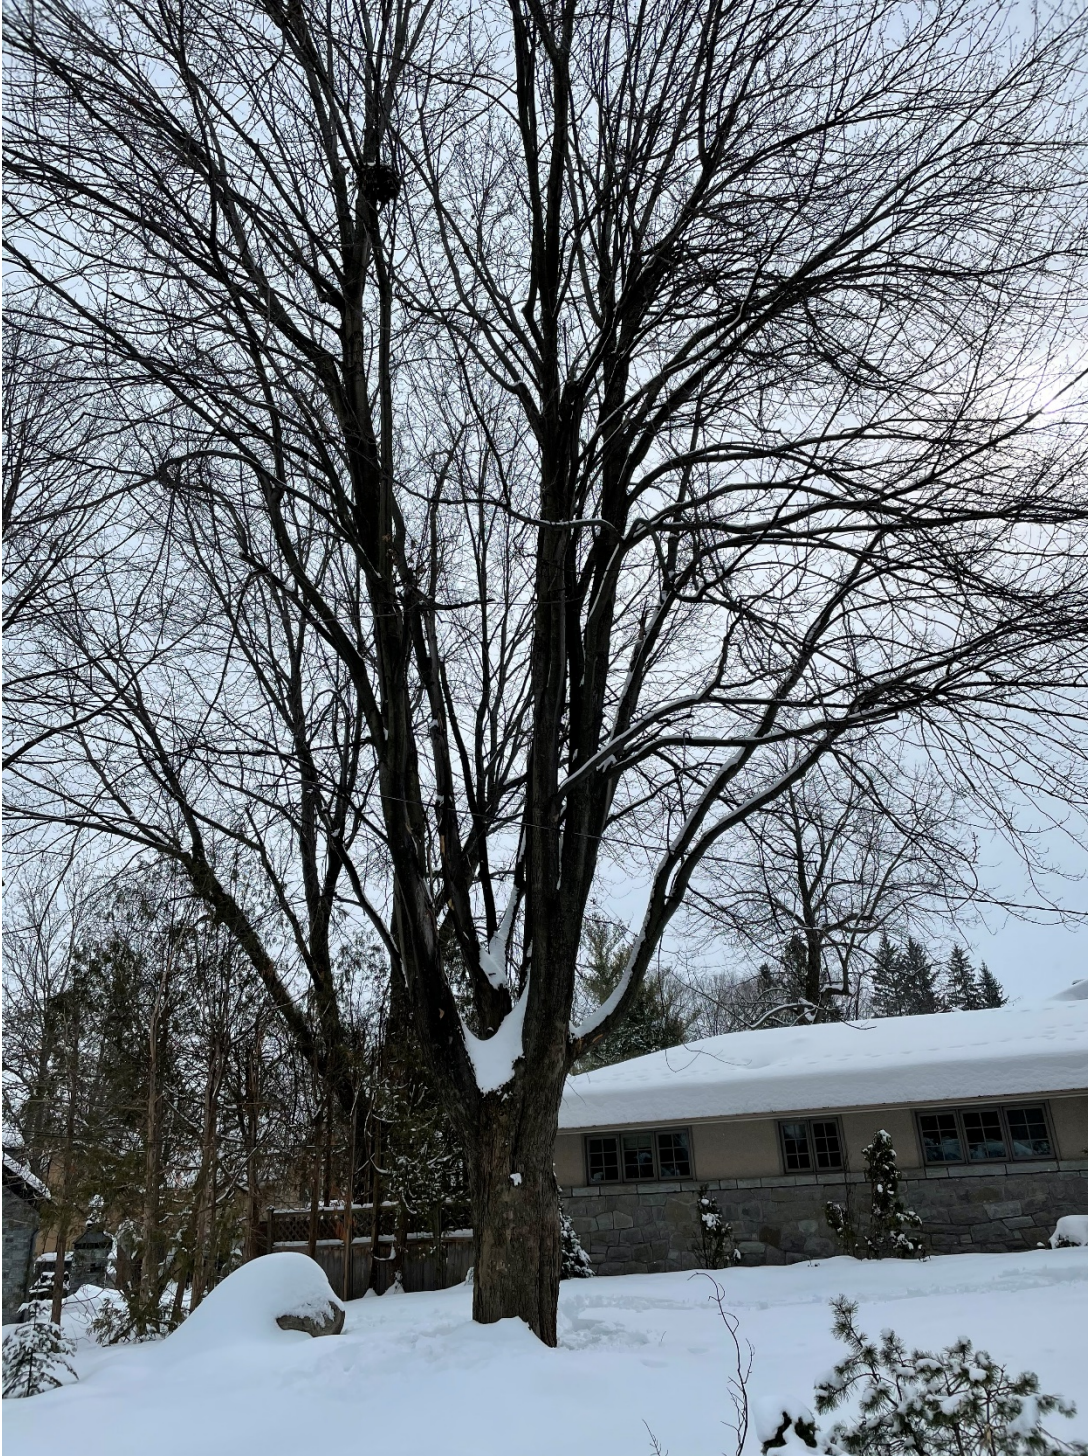
Figure 4: Large red maple (tree 25) to be retained

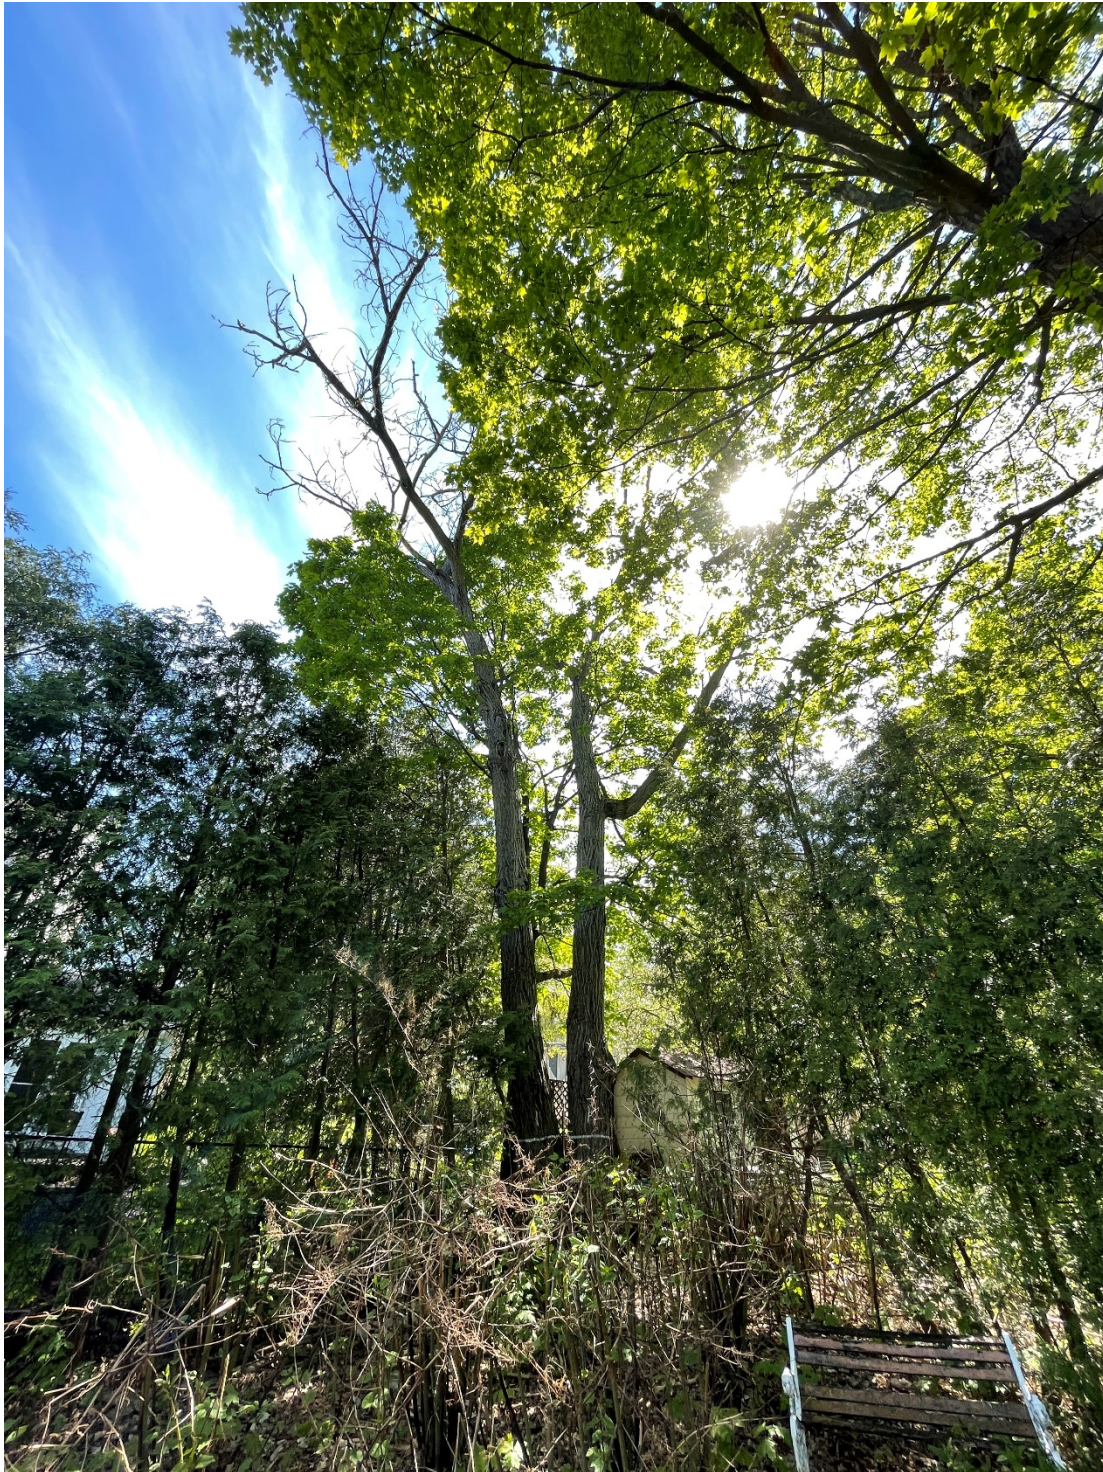
<i>cinerea</i>)		owned with adjacent property owners	present throughout; 30% live crown, dead top, significant basal decay, weak junction at base with crack	possible once the 30 days review period for the Butternut Health Assessment is up – Distinctive Tree Permit required
16	Norway spruce (<i>Picea abies</i>)	20 cm (estimate)	Private	Good	Retain and protect
17	Lilac (<i>Syringa spp</i>)	3-9 cm (5 stems)	Private	Good	Retain and protect
18	Juniper (<i>Juniperus spp</i>)	11 cm	Private	Good	Retain and protect
19	Basswood (<i>Tilia americana</i>)	64 cm	Private	Fair; sapsucker holes throughout the trunk indicating tree is under stress and likely has presence of insects, 30% lean towards house	Remove; fair health, excavation will come within 2m from trunk, potential conflict with canopy and new house; Distinctive Tree Permit required
20	White spruce (<i>Picea glauca</i>)	34 cm	Private	Good	Retain
21	White spruce (<i>Picea glauca</i>)	16 cm	Private	Good	Retain

There are two butternut trees that at the subject site – one in the back corner (tree 15) and one on adjacent property at 534 Lakehurst (tree 29). These trees are classified as endangered under Ontario's *Endangered Species Act, 2007, SO 2007, c 6*. As part of the requirements, an assessment was completed by Rose Fleguel, a qualified Butternut Health Assessor during the site visit on May 15th. She determined both butternuts to be a Category 1. A summary of Category 1 and its requirement as follows:

Figure 5: Tree 15: Butternut in poor health to be removed

The reports were submitted to the Ministry of Environment, Conservation & Parks (MECP) on May 16, and the 30-day waiting period will be June 16, 2021. After this, the trees can be removed with a Distinctive Tree Permit from the City of Ottawa.

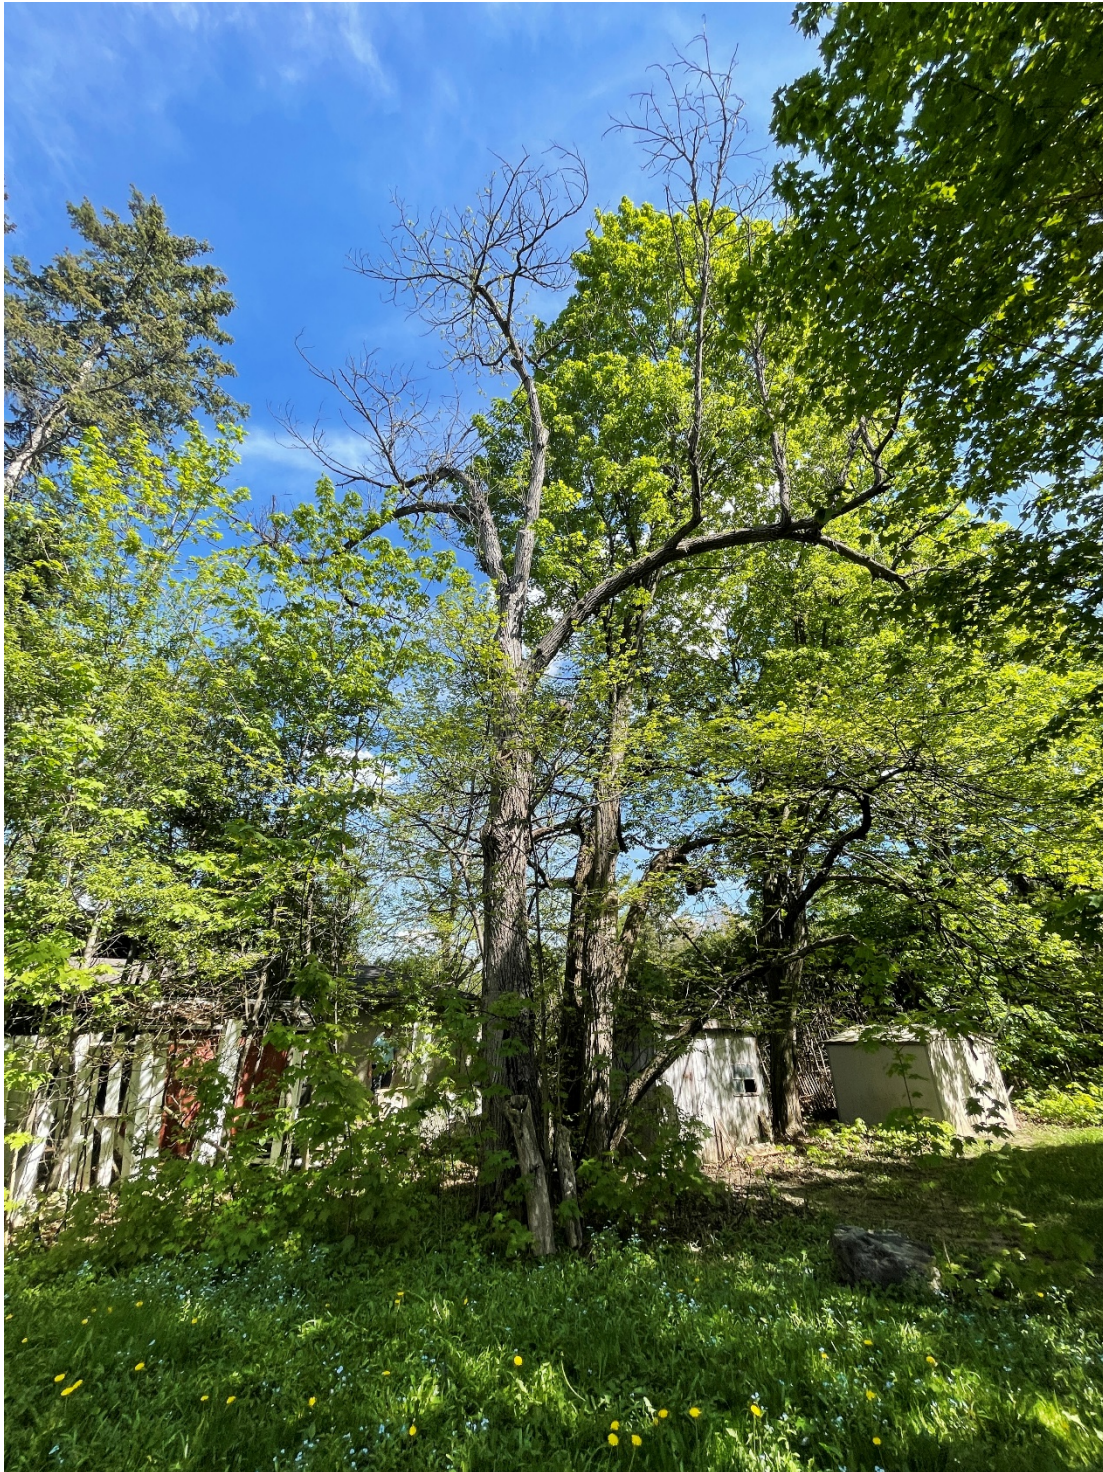
Figure 6: Tree 27, butternut on adjacent property to be removed
