Application to Demolish 323 Daly Avenue, a property designated under Part V of the *Ontario Heritage Act* and Located in the Daly Avenue Heritage Conservation District

**Built Heritage Sub-Committee
Report 24
February 9, 2022**

**Subject: Application to Demolish 323 Daly Avenue, a property designated under
Part V of the *Ontario Heritage Act* and Located in the Daly Avenue
Heritage Conservation District**

File Number: ACS2022-PIE-RHU-0006

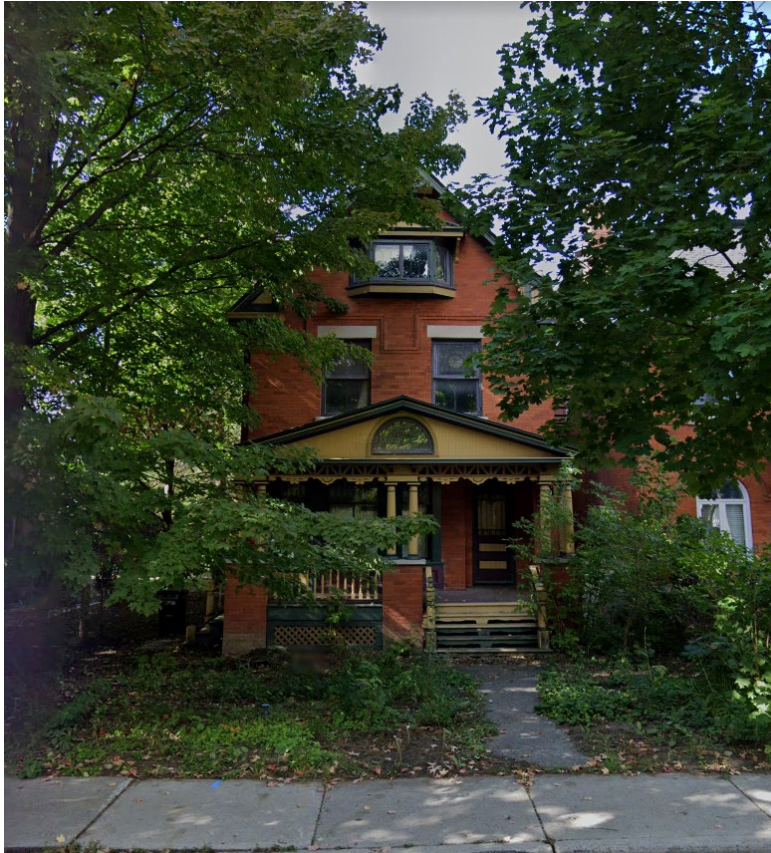
Photo of 323 Daly before the fire

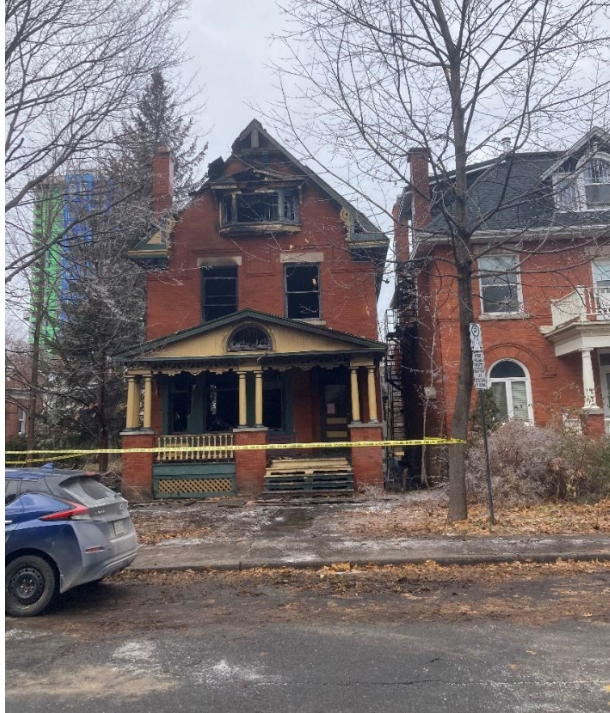
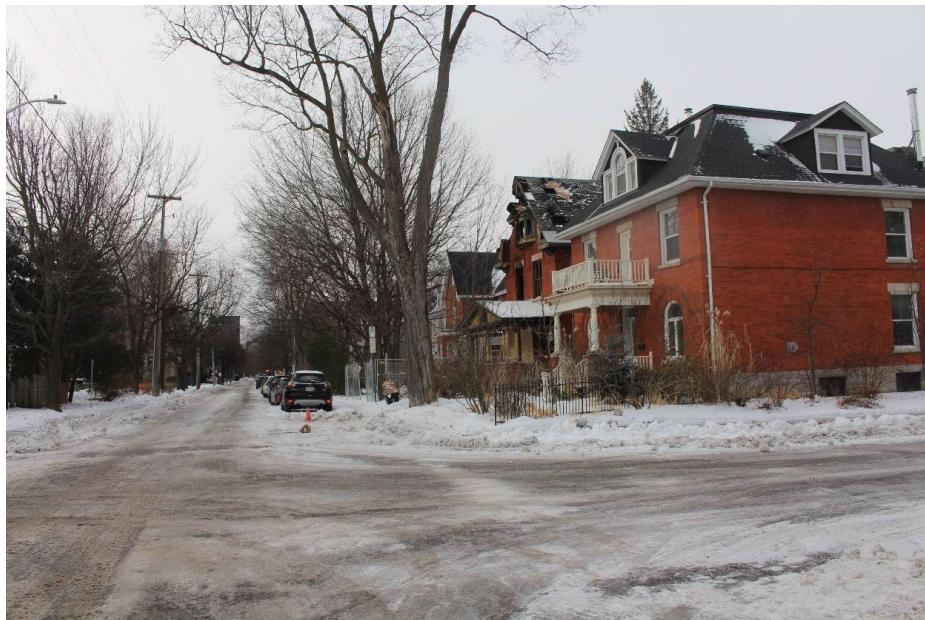
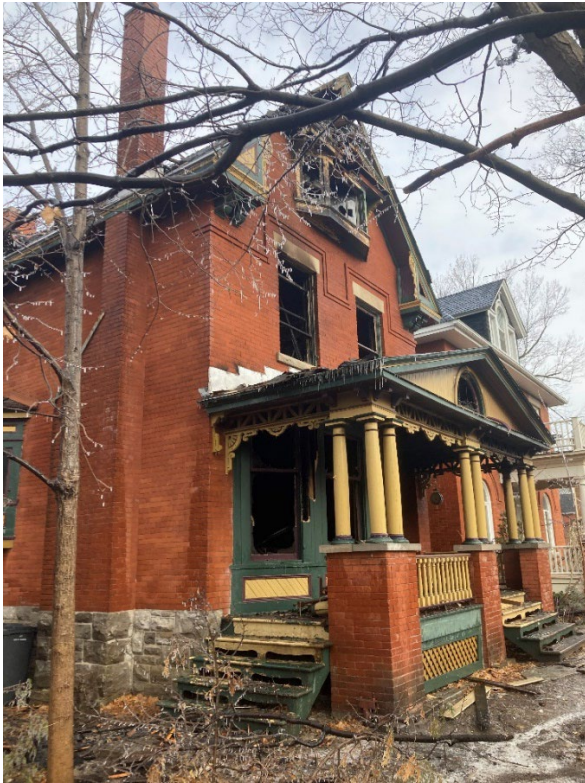
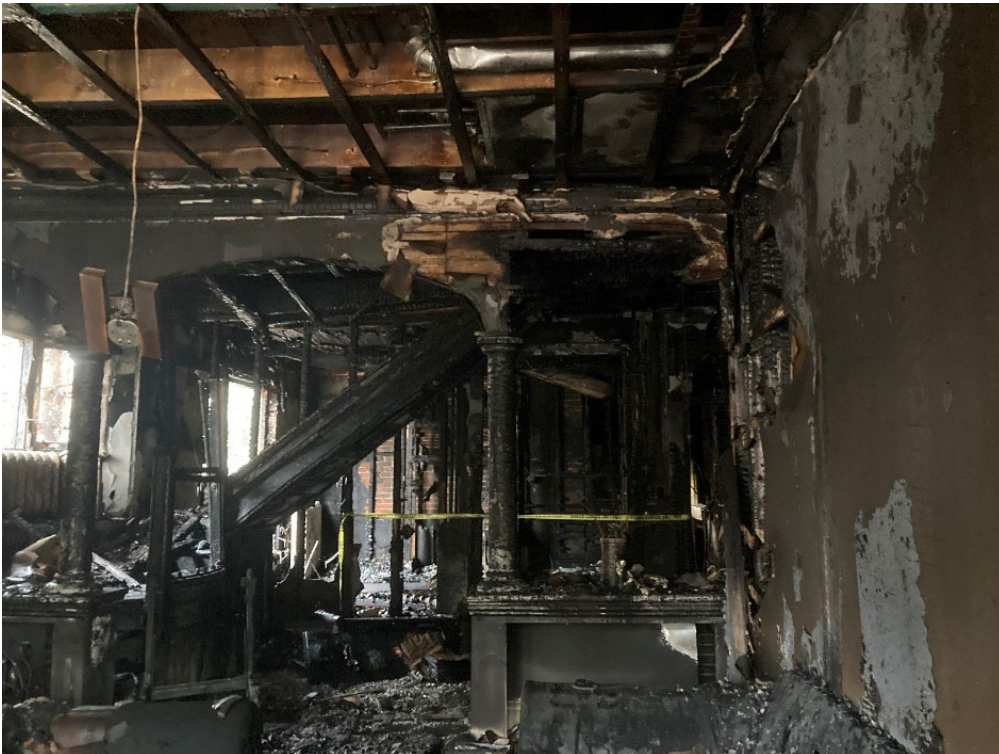
As outlined in the attached engineering studies (Documents 4-7), the damage from the fire has compromised most of the wood structure, including the floor joists and load bearing walls, above the first floor. The existing roof structure was severely damaged and has failed. The exterior brick walls appear to be undamaged by the fire, with a possible exception of the south gable and below the eaves at the southwest corner. Overall, the stone foundation appears in good condition. In terms of architectural elements, the front porch has minor localized damage at the spandrel. The bay window on the southern gable is severely damaged. Similarly, the bargeboard at the peak of the

gable and along the west slope have been destroyed. Almost all windows, with the exception of those on the rear addition, have been destroyed or heavily damaged.

In addition, beyond the immediate required stabilization, the extensive damage to the building makes the possibility of future restoration challenging. Several heritage attributes were damaged, destroyed or had to be removed as a result of the fire, including the porch (minor damage), the bargeboard (destroyed), the bay window (severely damaged), the upper portion of the south brick gable (damaged) the gable roof (destroyed) and most windows (damaged/destroyed).

Photos after the Fire
