Tree Information Report v2.0

Submitted as part of Building Permit Application for the City of Ottawa

Address: 619 Manor

Date: November 9, 2021

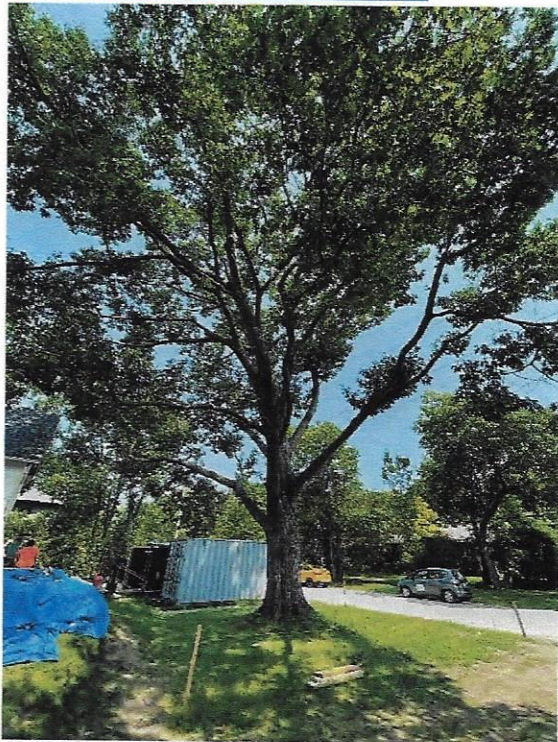
Figure 1: Tree 1, large red oak to be retained

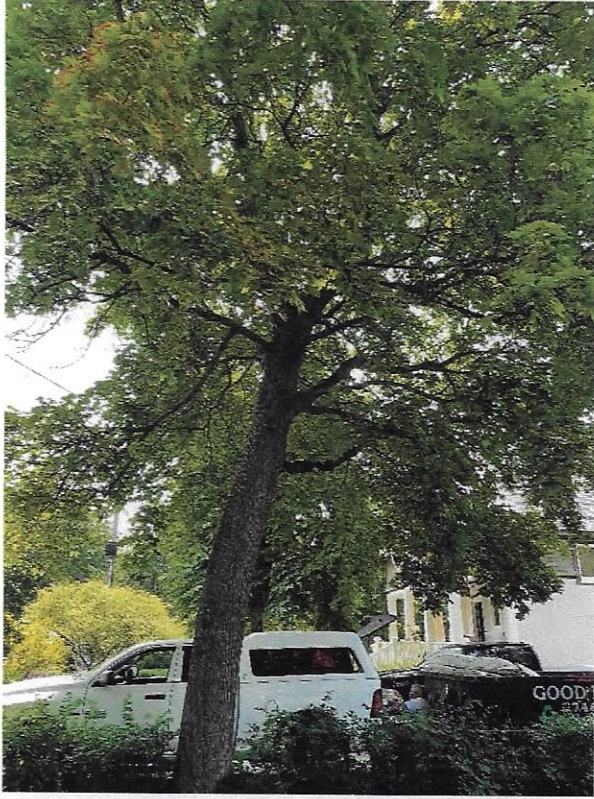
Figure 2: Tree 2, Jointly owned Norway maple

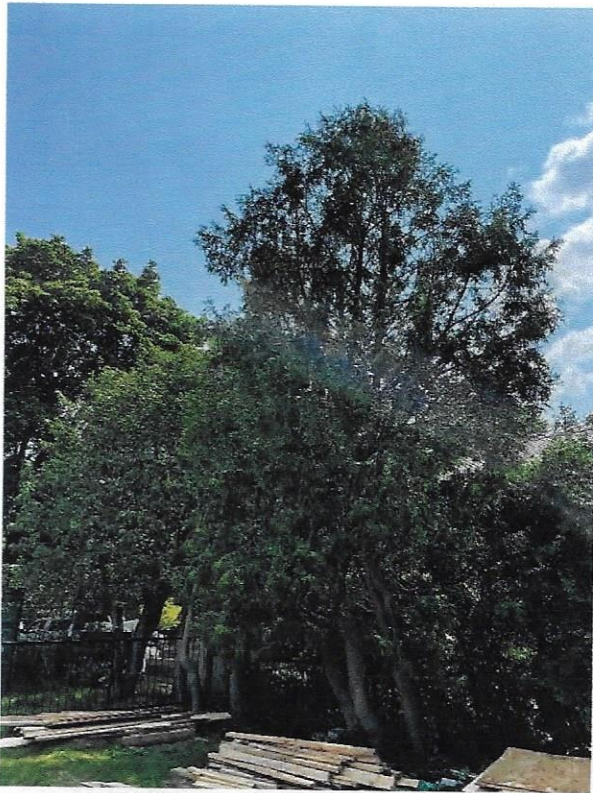
Figure 3: Eastern white cedar trees along the southern property line

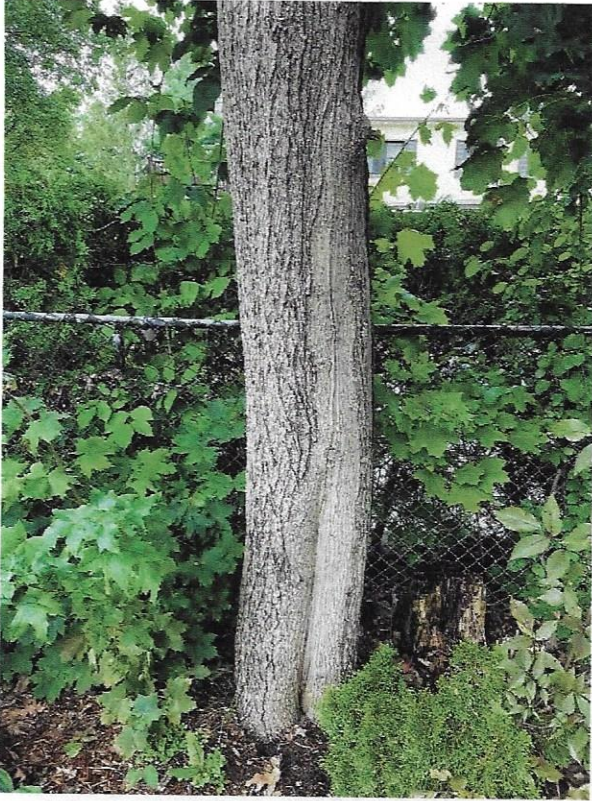
Figure 4: Tree 5, Norway maple to be removed

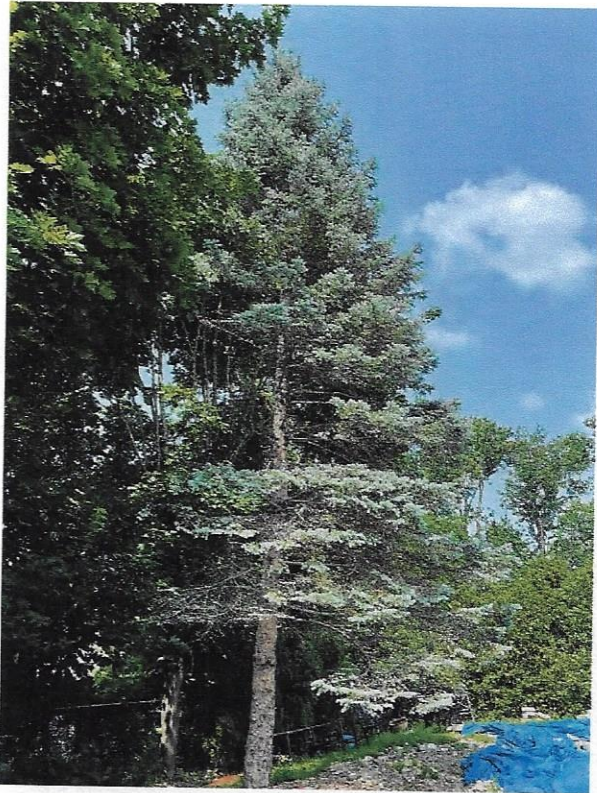
Figure 5: Tree 6, Colorado blue spruce to be removed

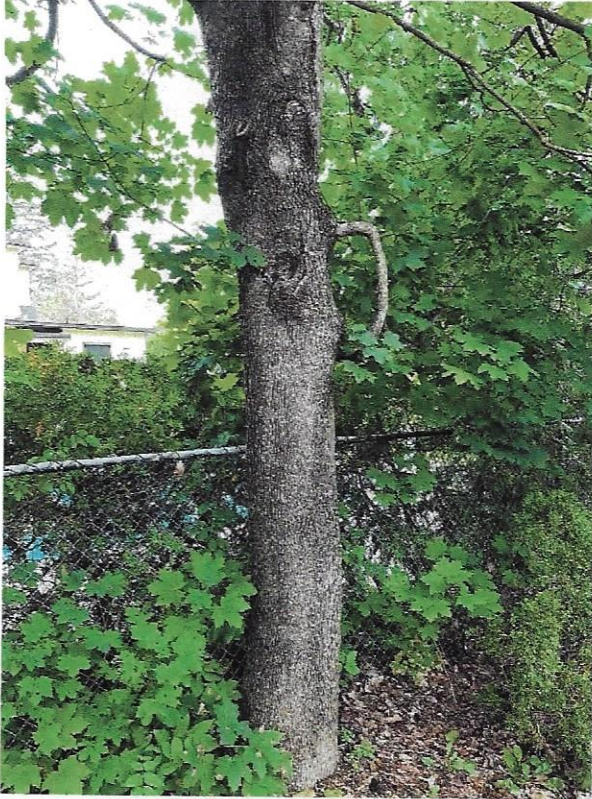
Figure 6: Tree 7, Norway maple to be removed

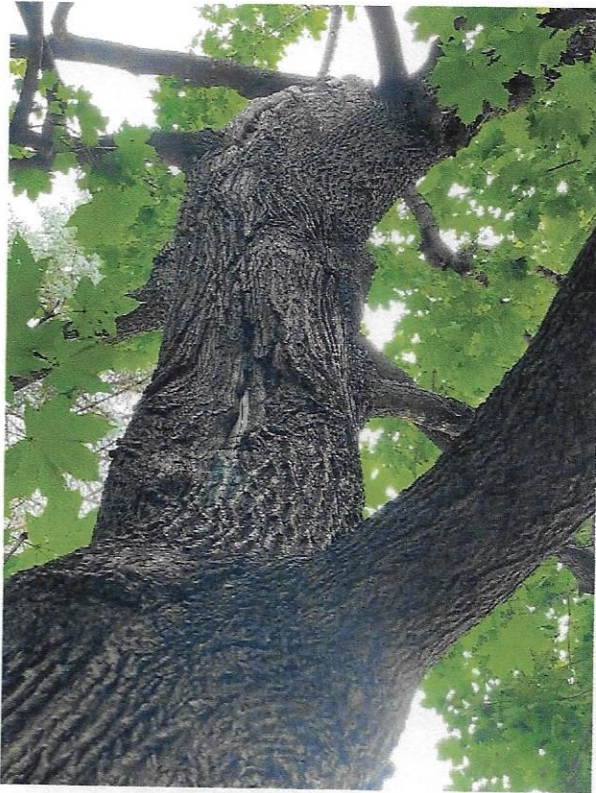
Figure 7: Canker in crown of tree 7

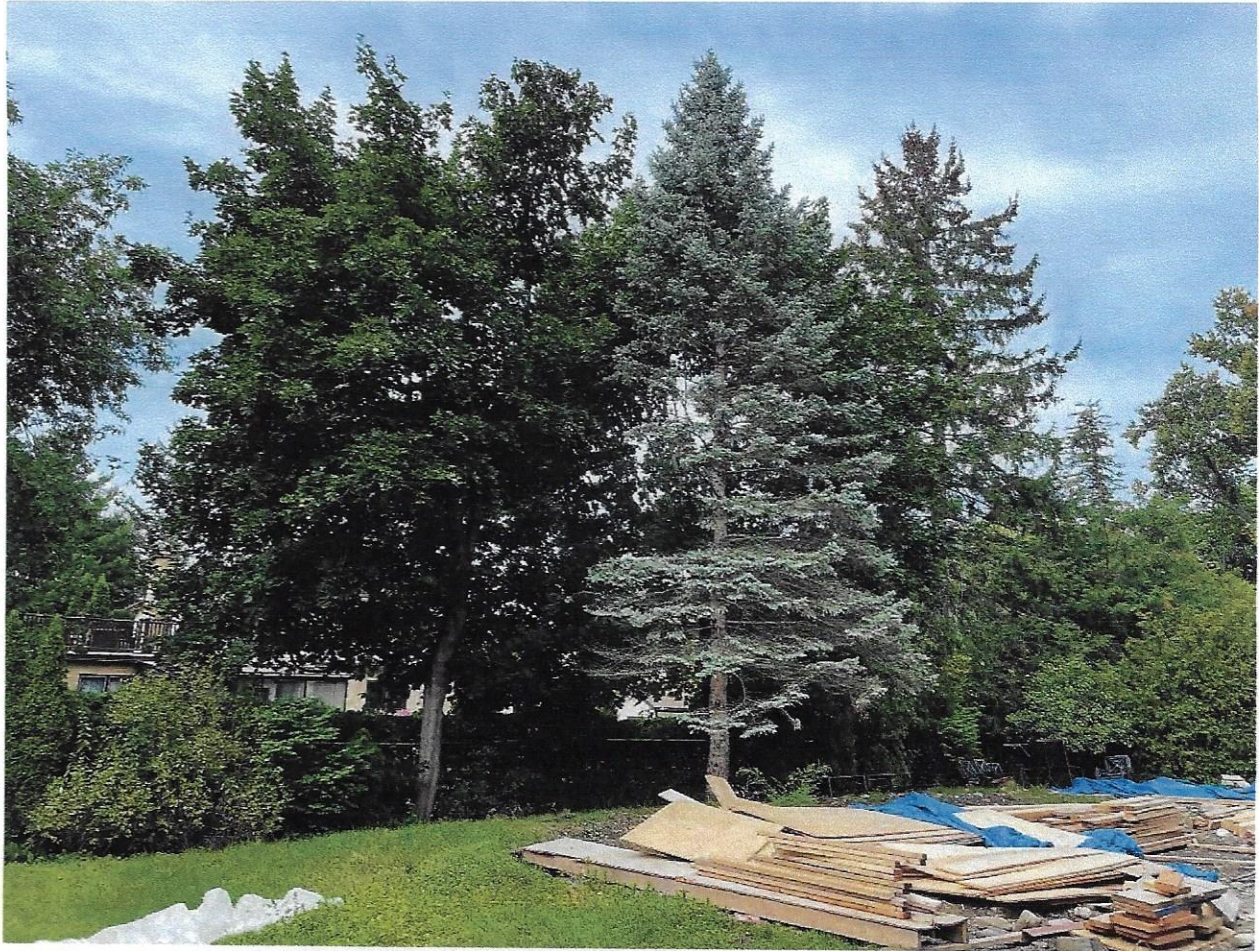
Figure 8; Picture showing trees 5-7, pool will be installed where the blue spruce is located
